Rail Accident Investigation Branch

Rail Accident Report

Overturning of a tram at Sandilands junction, Croydon 9 November 2016

Report 18/2017
v2.2 - October 2020

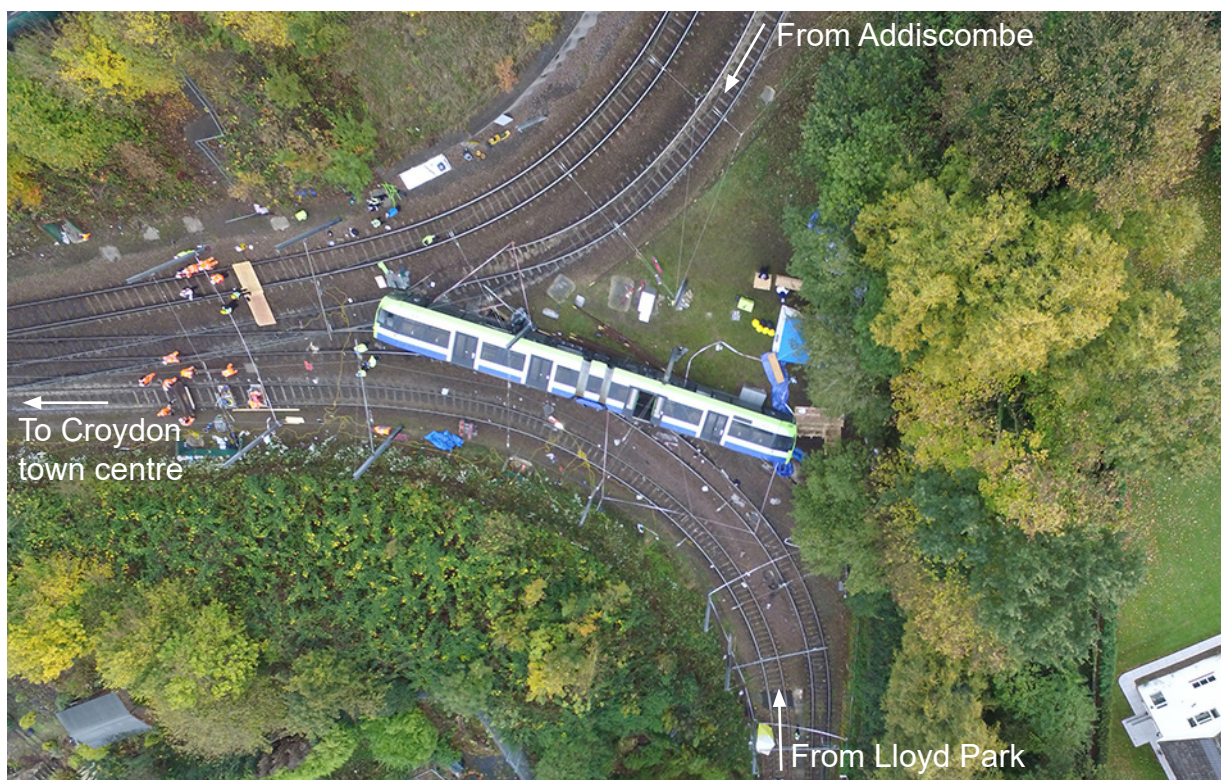
Figure 4: Final position of the tram

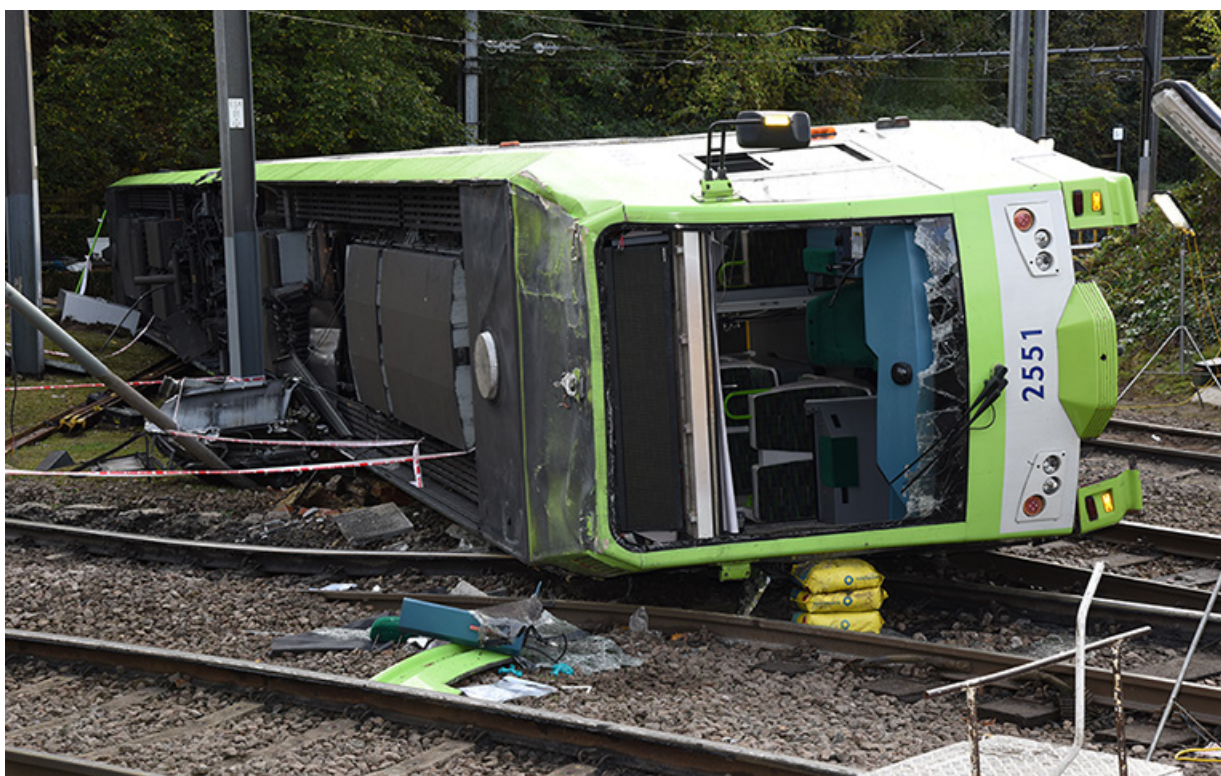
Figure 16: Front of tram with windscreen removed to evacuate passengers (initial hole formed by tram drivers/police officer, remainder removed by fire service)

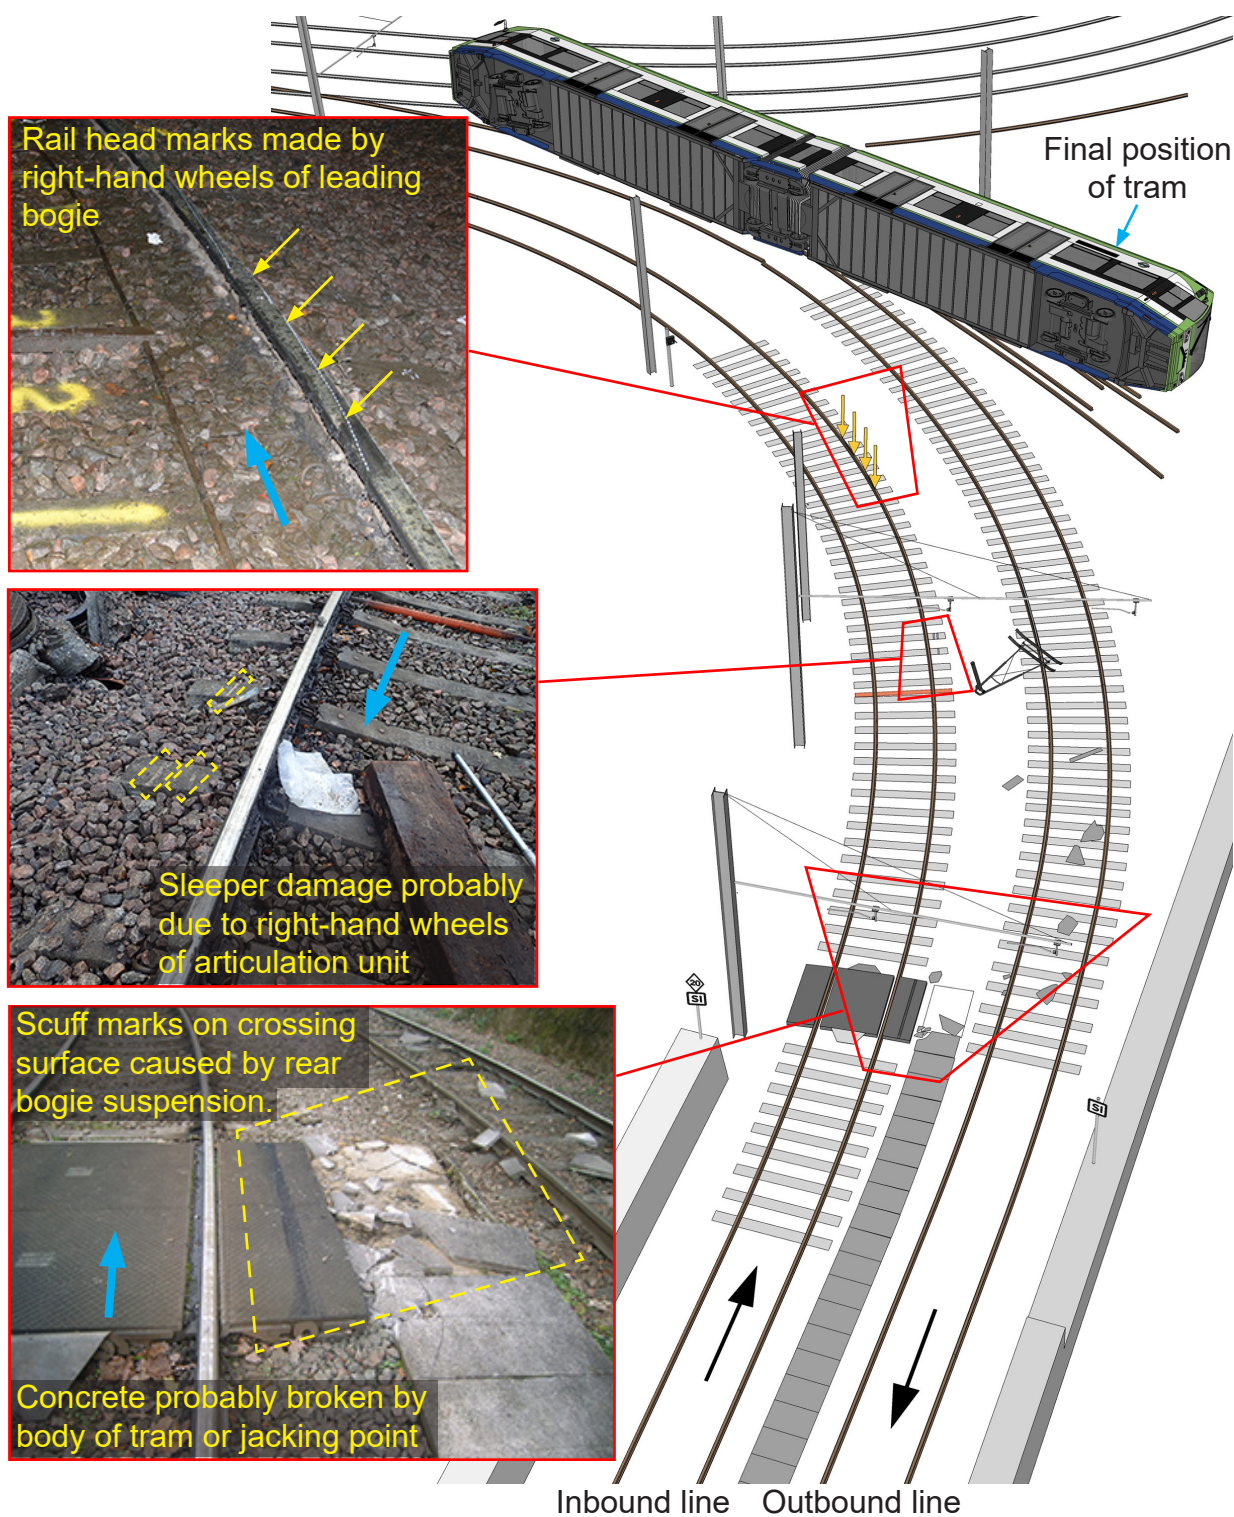
Figure 17: Marks indicating position tram derailed (blue arrows in photographs indicate tram's direction of travel)

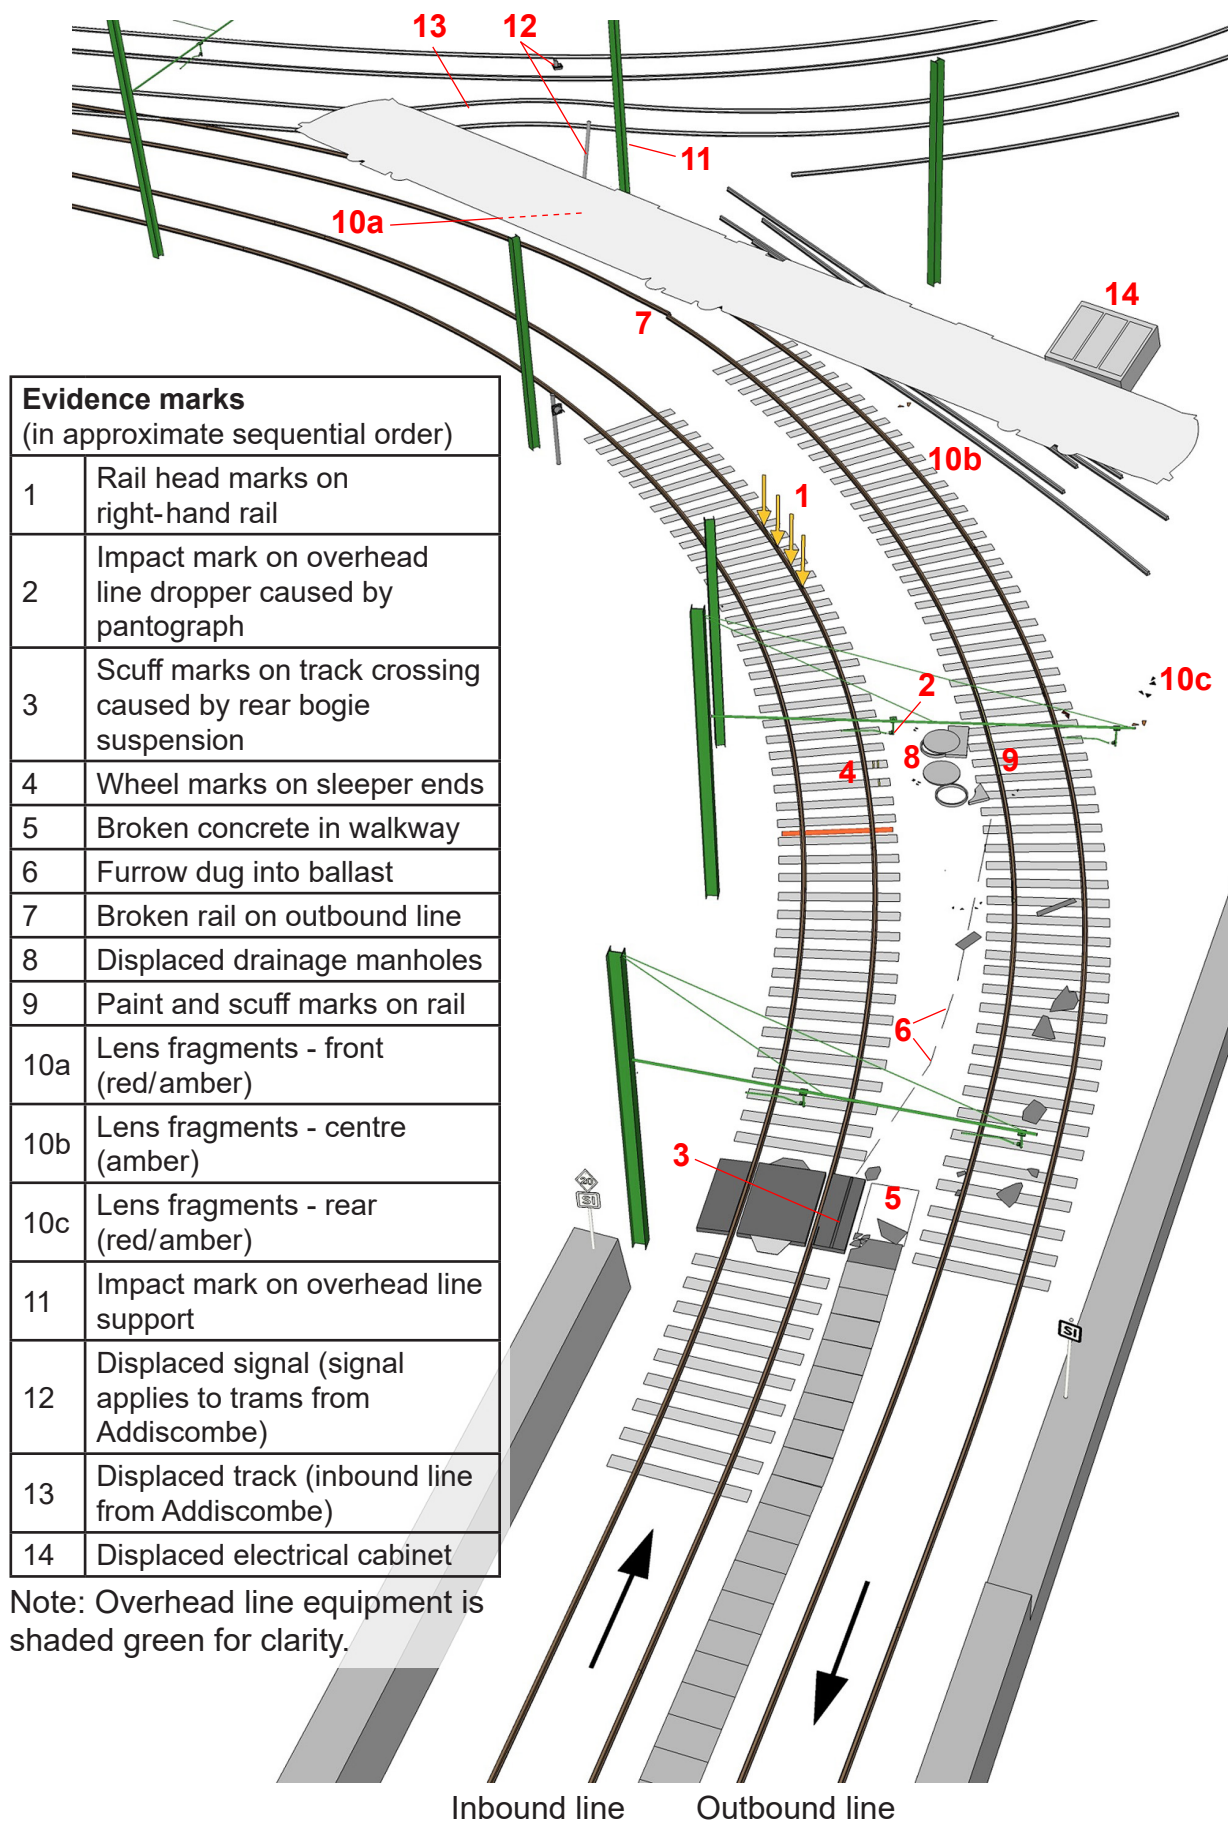
116 At the time the tram left the track (figure G.1), the roll induced on the vehicles as a result of the lateral acceleration led to the pantograph striking an OHLE *dropper* and the pantograph becoming detached (figure G.2). The roll also led to the outer lower edge of the trailing vehicle rubbing and breaking concrete walkway slabs on the ground (figure G.3). The tram continued to roll as the tram travelled across the gap between the inbound and outbound lines of the south curve.

Figure 22: Witness marks used to determine path of tram after leaving the track

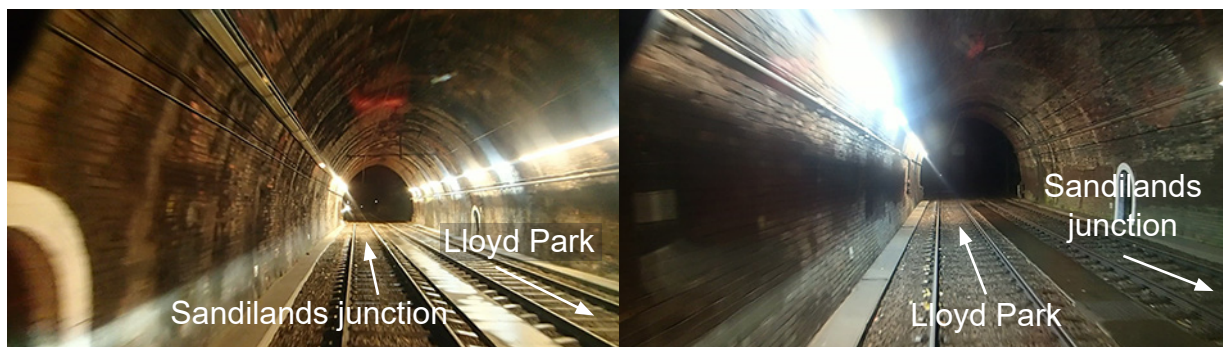
167 At the time of the accident, only some light units were illuminated in the end sections and the arrangement of lit lights was different at each end. For 58 metres at the Sandilands end of the tunnels, almost all lights were illuminated on the right-hand side of the tunnel when heading towards Sandilands, while lighting on the left-hand side was limited to the final 14 metres before the exit. Travelling through the final 58 metres at the Lloyd Park end (when heading towards Lloyd Park), almost all lights were illuminated on the left-hand side while almost none were illuminated on the right-hand side (figure 24). TRL considered the lighting in the context of its highway design expertise and reported that the lighting would not have been a strong informational cue concerning direction of travel. Some light units were unlit in the central part of the tunnel. There is no evidence that unlit light units contributed to the accident.

Figure 24: Exiting the tunnels towards Sandilands junction (left image, accident situation) and Lloyd Park (right image)

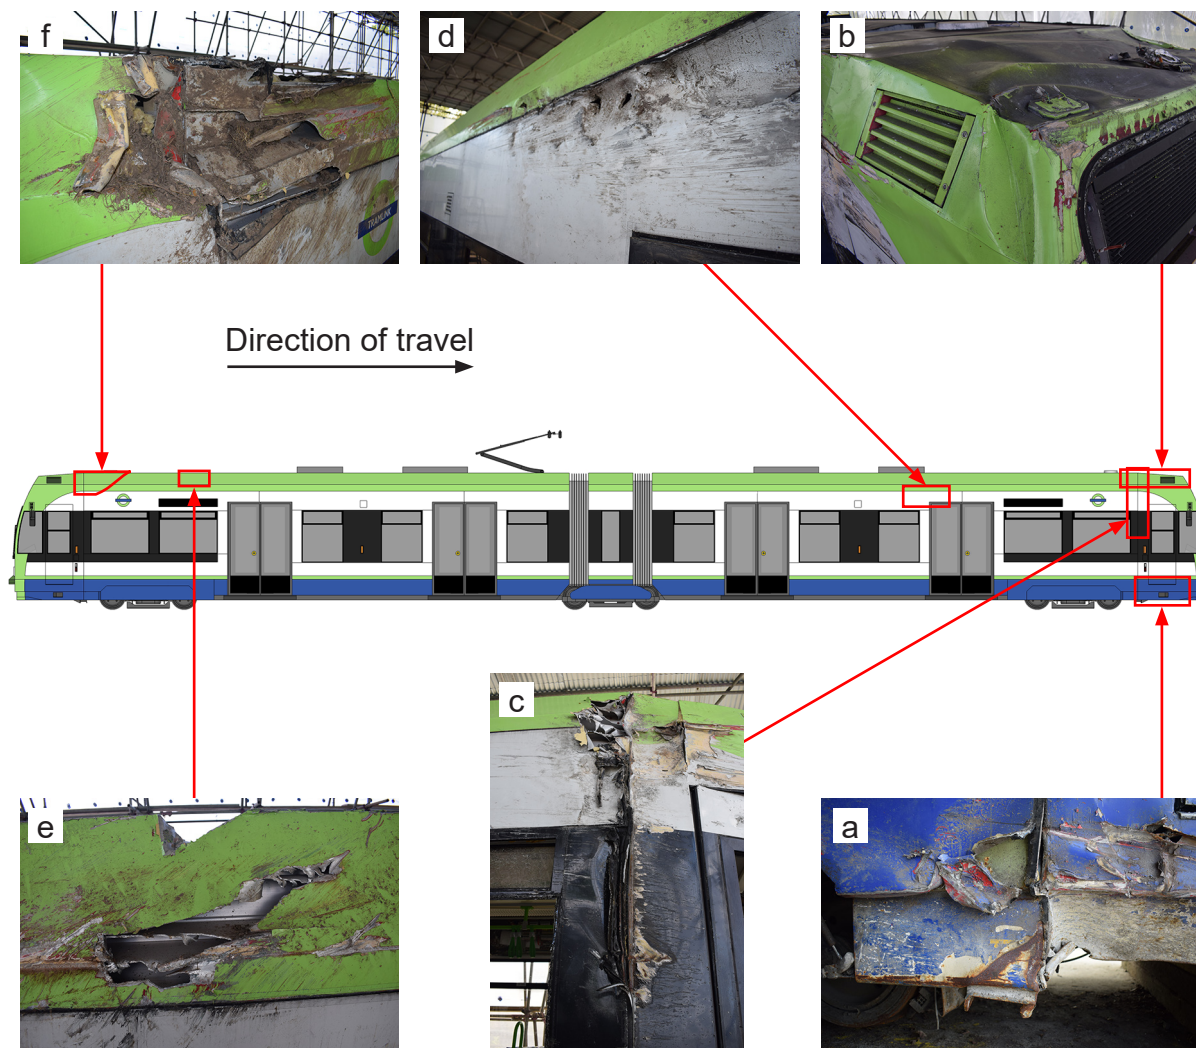
Figure 32: Significant areas of damage to tram 2551

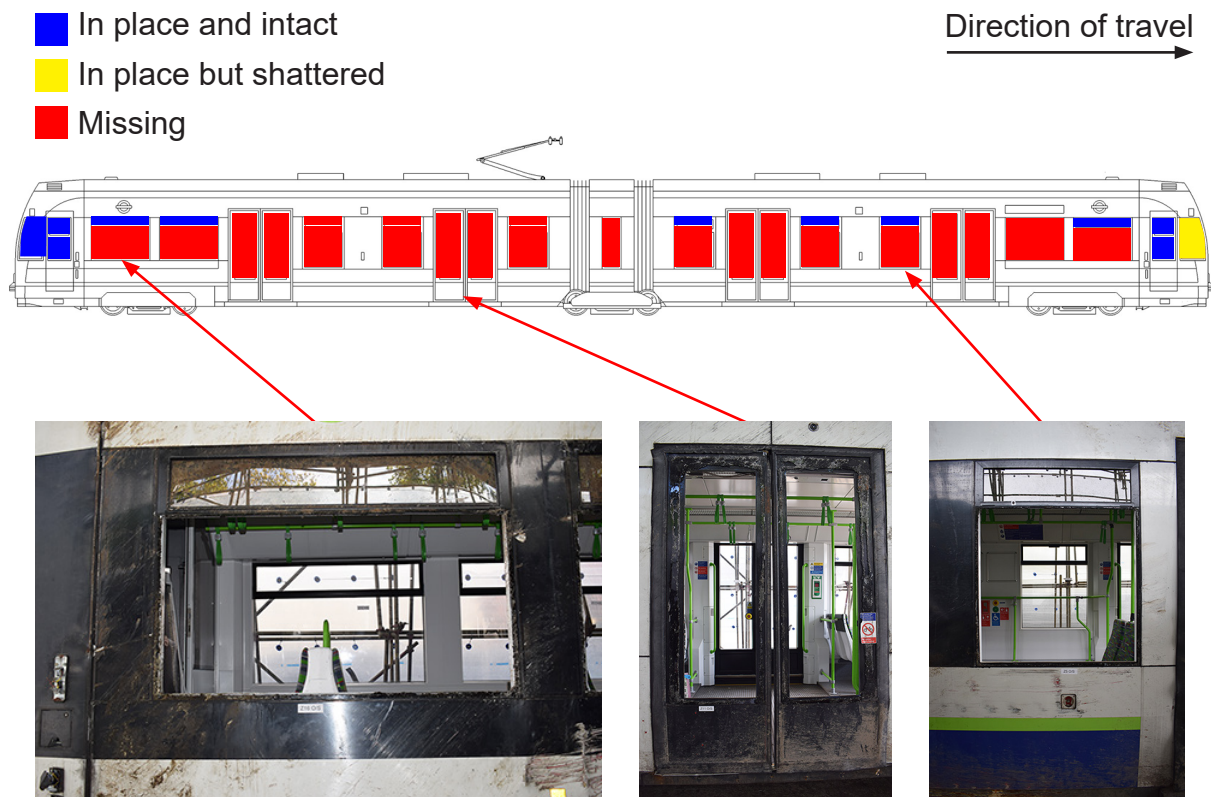
Figure 35: Damage to windows on right-hand side of tram 2551

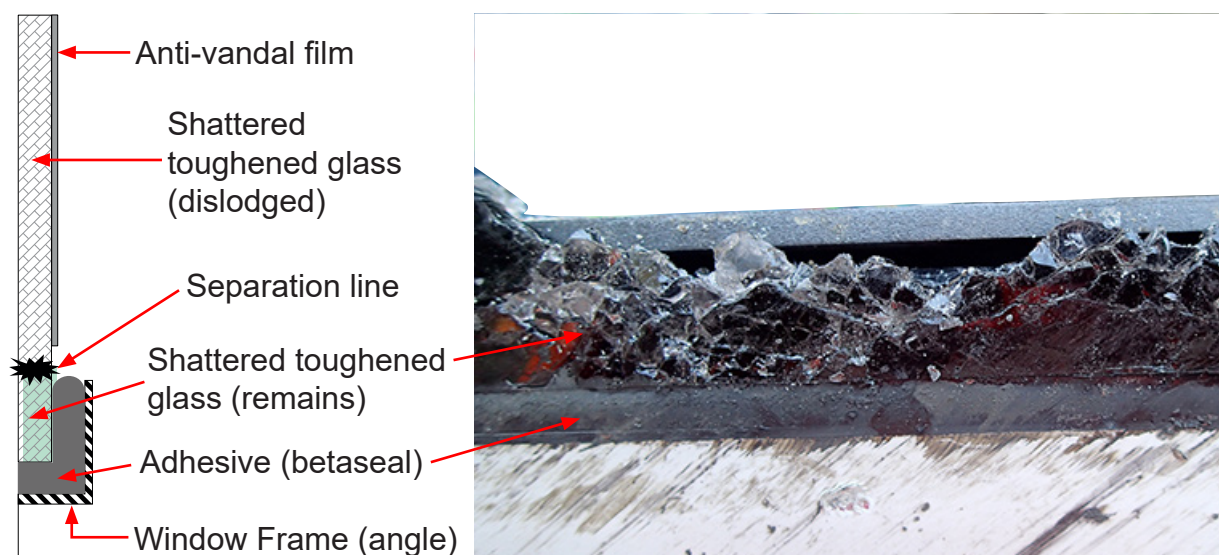
Figure 36: Typical failure mode of the tram's windows

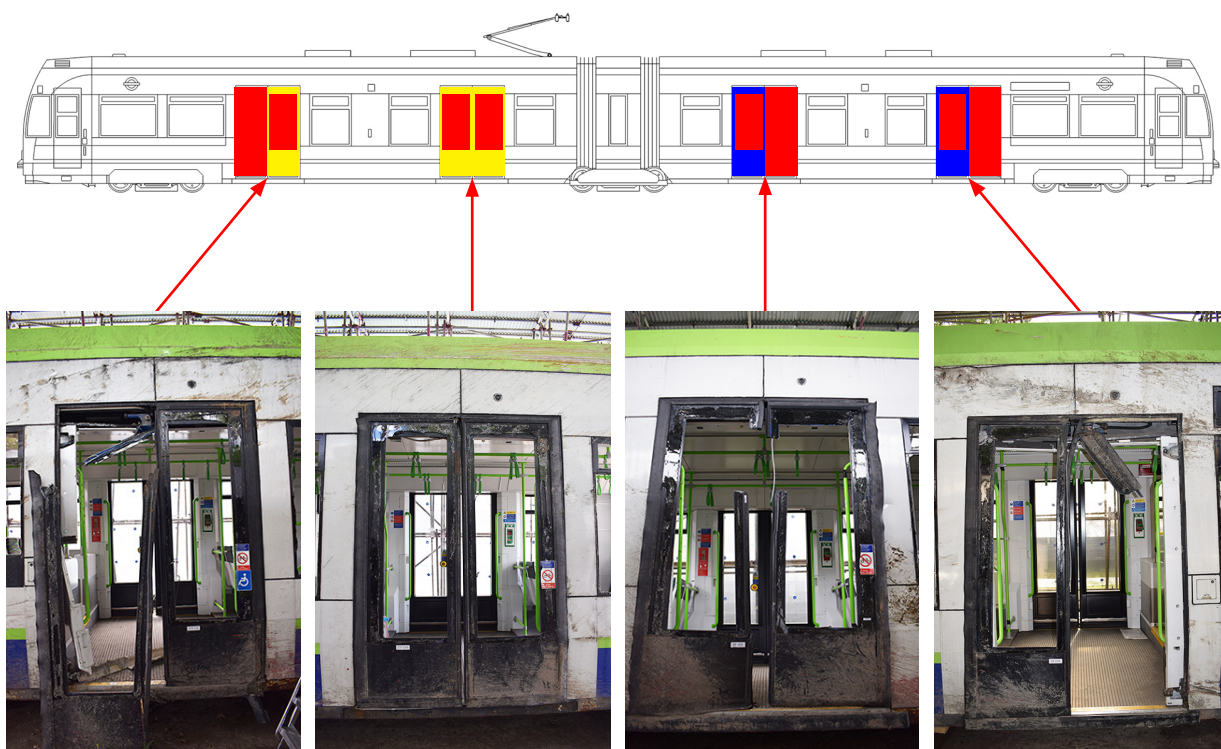
Figure 39: Damage to the tram's doors (note that in the third photograph the right-hand door has been repositioned)

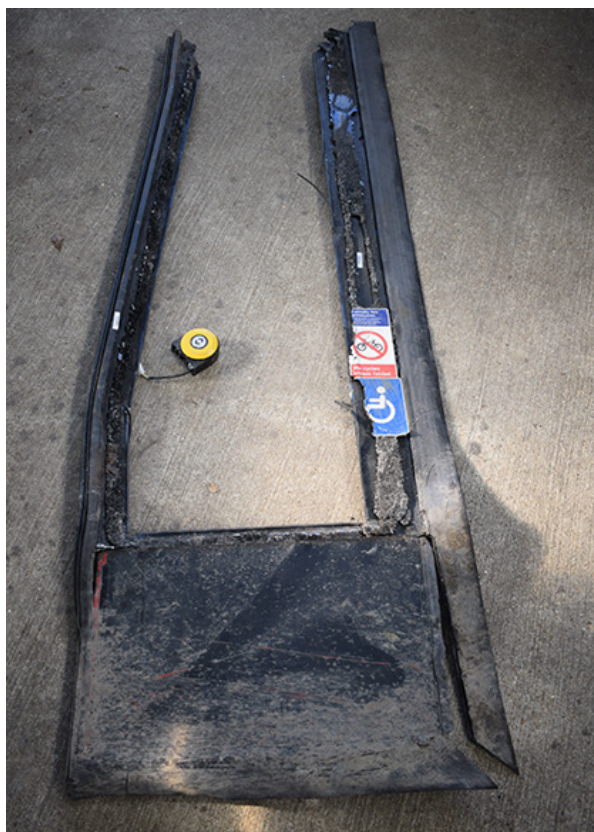
Figure 40: Typical door damage

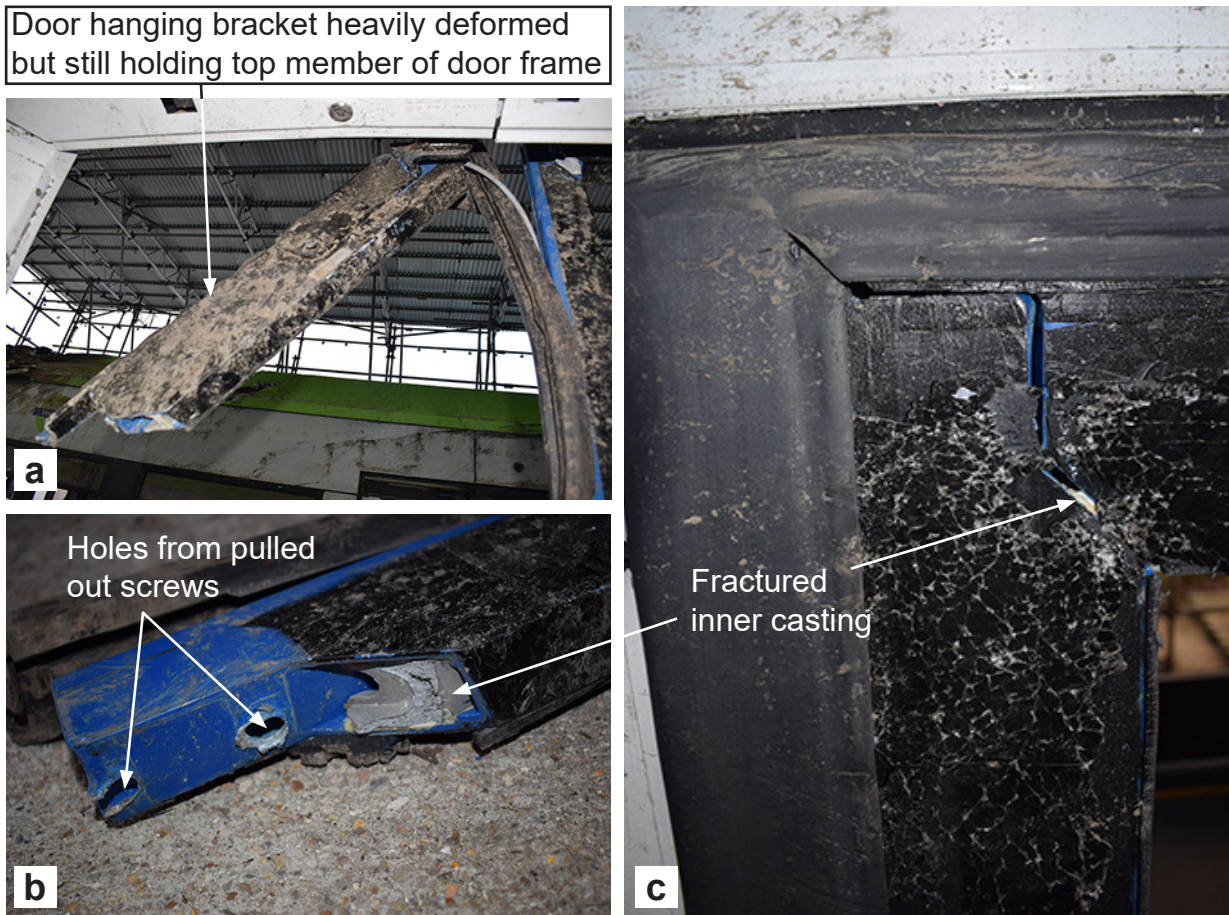
Figure 41: Typical door failure mode (see figure 37 for component locations)

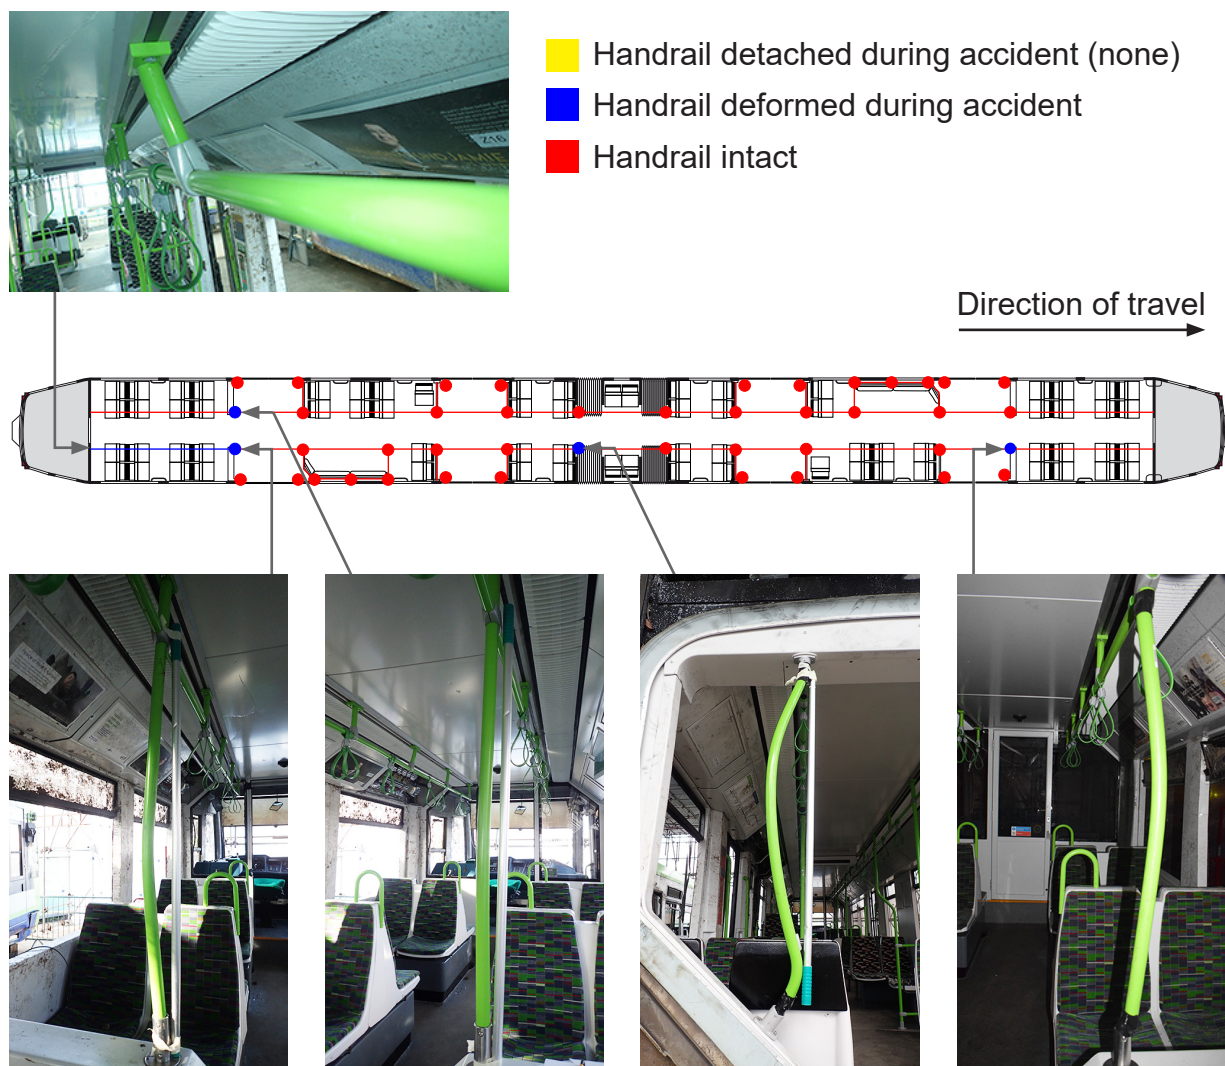
Figure 42: Extent of damage to handrails

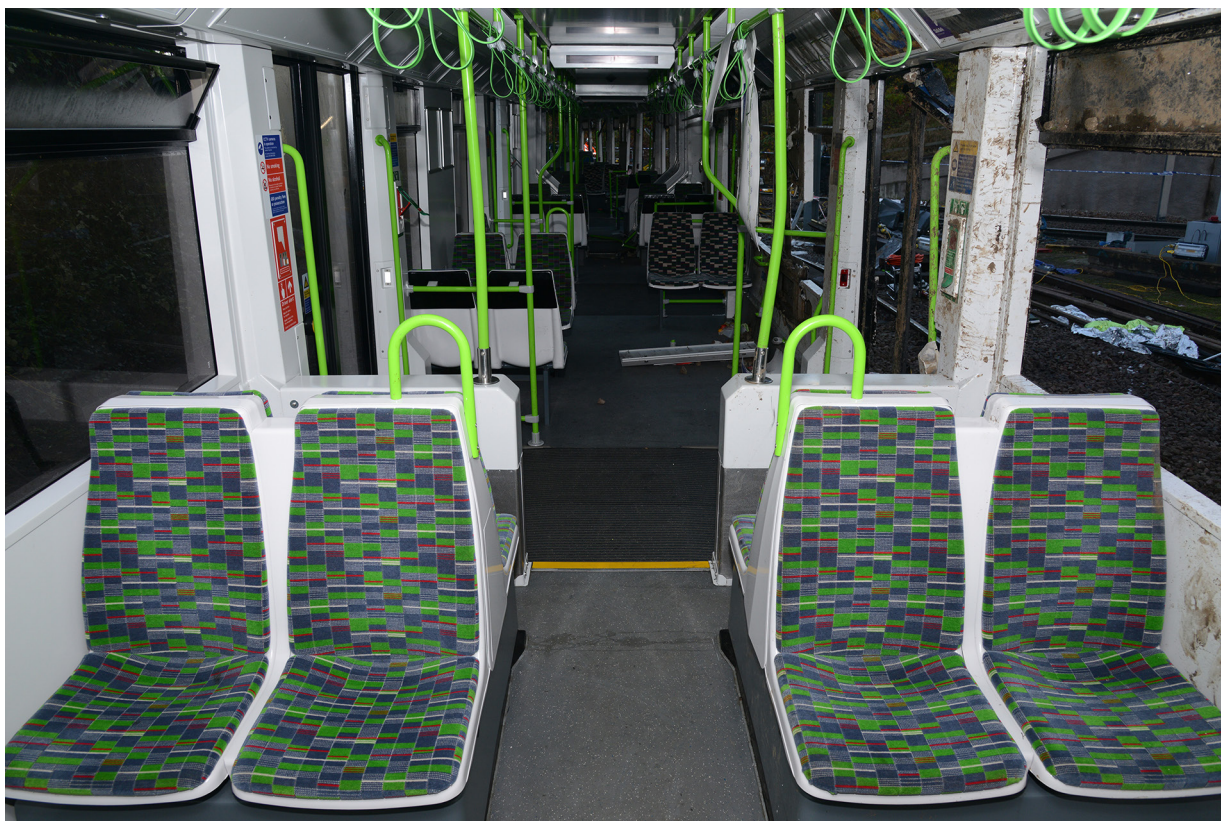
Figure 43: Typical interior area of tram, post-accident

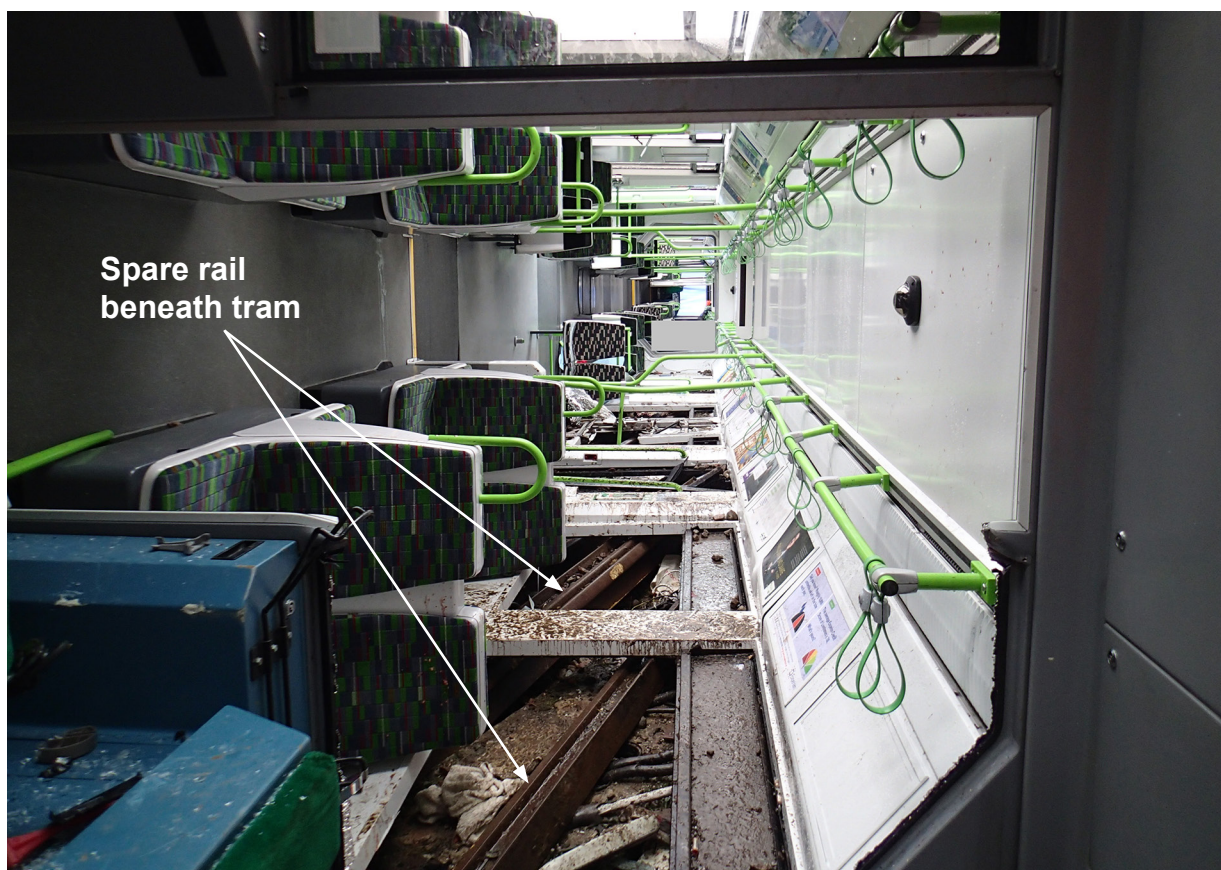
Figure 45: Tram 2551 overturned at accident site showing ground beneath broken windows (rails had been stored on the ground between the north and south curves before the accident, see figure 8)

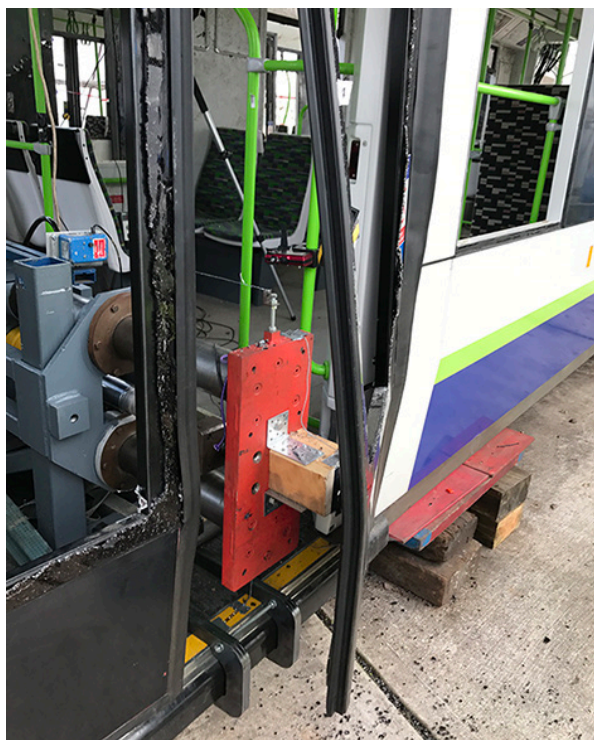
Figure 49: Door deformation due to load applied at level where people appeared to have struck the door

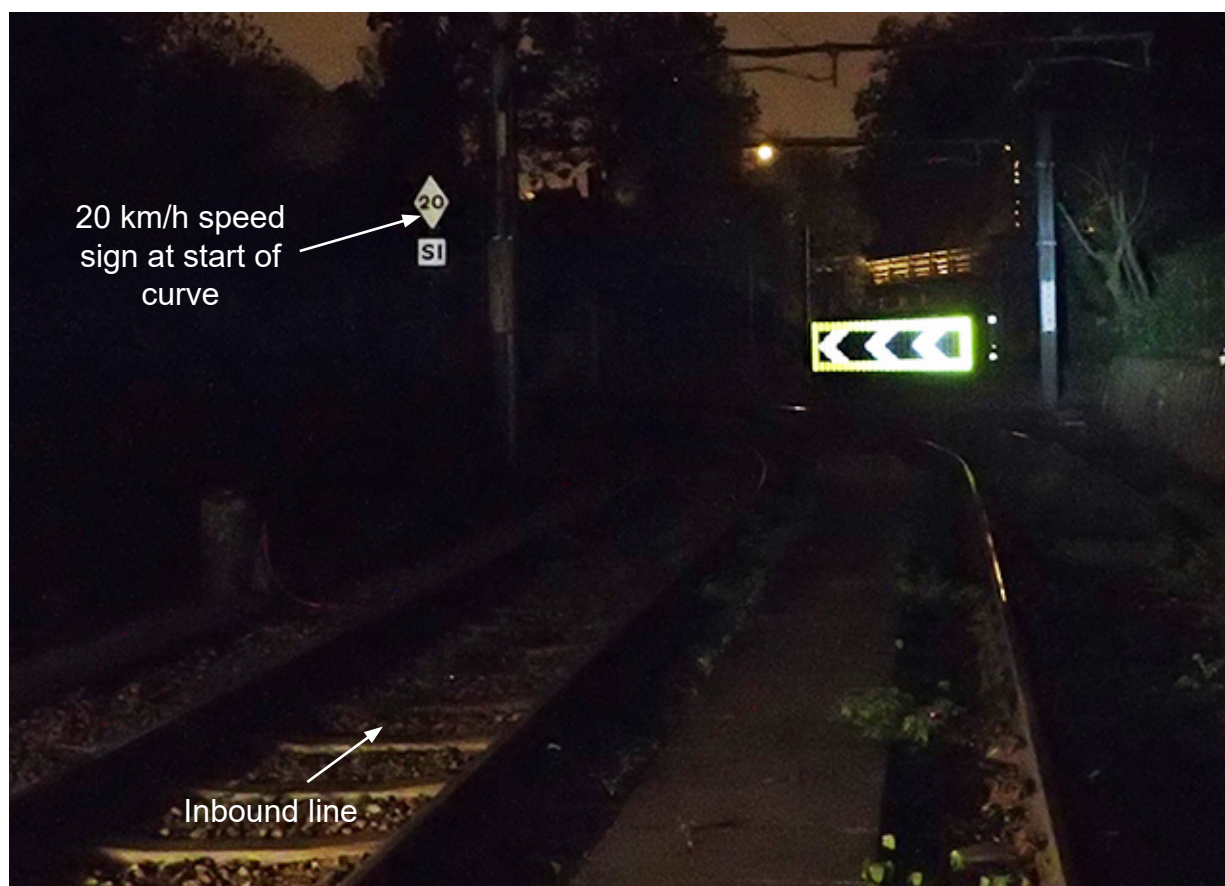
Figure 54: Chevron sign fitted as part of the signage changes at Sandilands south curve after the accident
