# Rail Accident Investigation: Interim Report

**Collision near London Waterloo station,  
15 August 2017**

Report IR2/2017  
December 2017

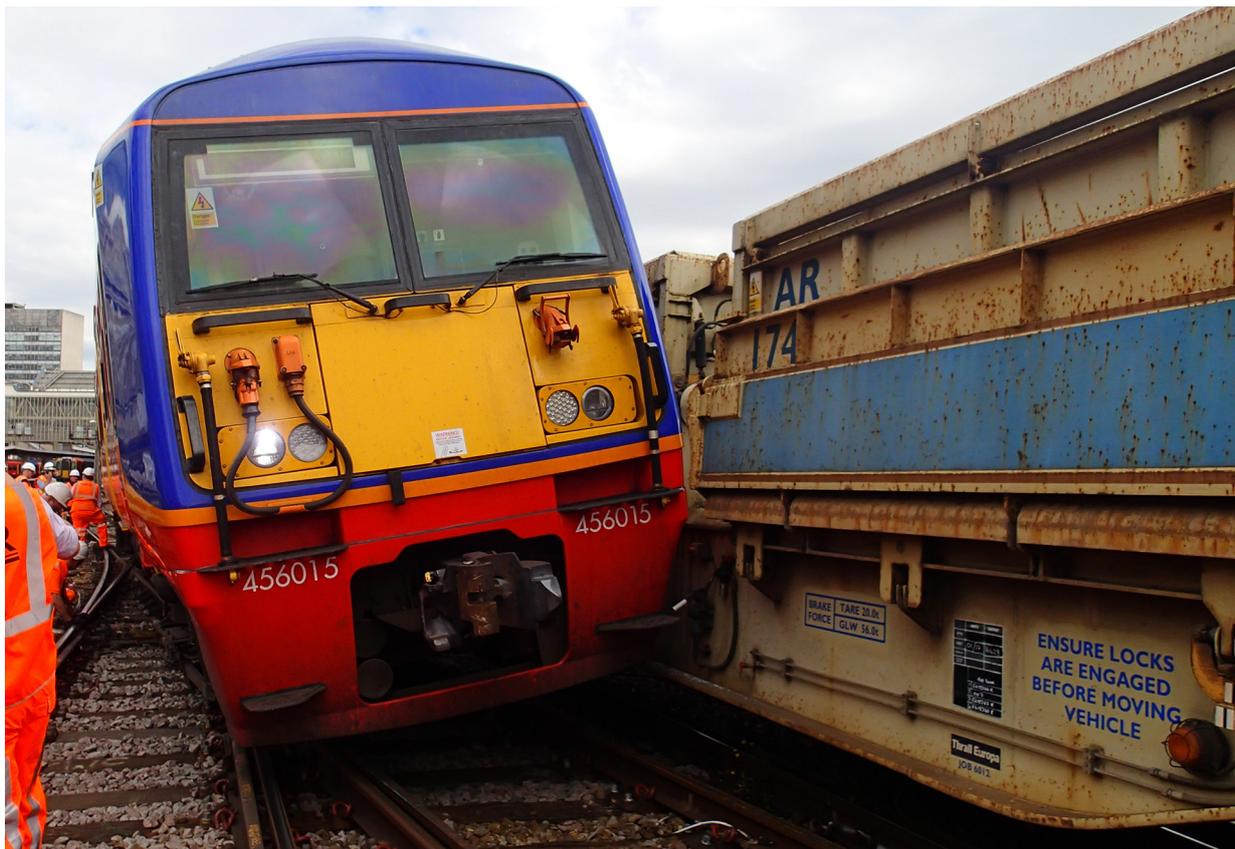
- 1 At around 05:42 hrs on Tuesday 15 August 2017, a passenger train leaving London Waterloo station and travelling at about 13 mph (21 km/h), collided with a stationary engineering train. There were no injuries, but both trains were damaged and there was serious disruption to train services.

- 3 The collision occurred because a set of *points*<sup>1</sup> was not in the correct position and directed the passenger train away from its intended route. When the train passed over them, the points were in this position because of a temporary modification to the points control system, which also caused the train driver and signaller to receive indications that the points were correctly set.

Figure 1: Passenger and engineering trains after the collision

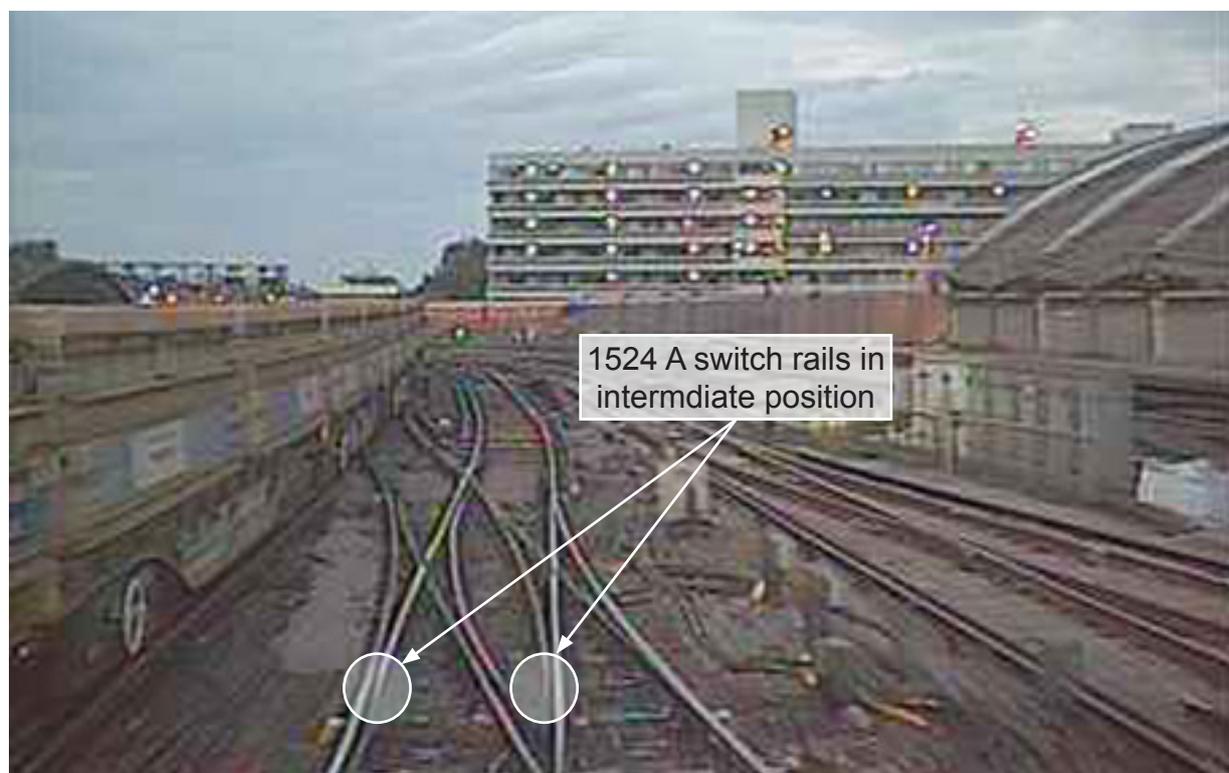
- 20 The collision occurred at 05:42 hrs as train 2D03, the 05:40 hrs Waterloo to Guildford service, was leaving platform 11. When the front of the train was around 65 metres from the platform end, and while travelling at 15 mph (24 km/h), it was directed to the left on 1524 A points and collided with the engineering train. Images from forward facing CCTV equipment shows that both *switch rails* of 1524 A points were lying midway between their normal and reverse positions (figure 4).
- 21 The driver had noticed that the points were not correctly set and applied the train's brakes around 3 seconds before the collision. This reduced the train's speed from 15 mph (24 km/h) to 13 mph (21 km/h) prior to the impact. The train came to a stop with the left hand wheels of the leading coach above the left-hand rail.

Figure 4: View from the train's forward facing CCTV of 1524 A points lying midway between normal (left switch rail closed) and reverse (right switch rail closed) (see appendix)

- 22 No one was injured, although there was some damage to the leading coach and to the engineering train. The accident caused severe disruption.
- 23 The train was directed to the left because the points which should have been set in the normal position were incorrectly lying in an intermediate state, close to the reverse position. The signalling system incorrectly indicated that the points were correctly set and safe, which meant that neither the signaller nor the driver were made aware of a problem.

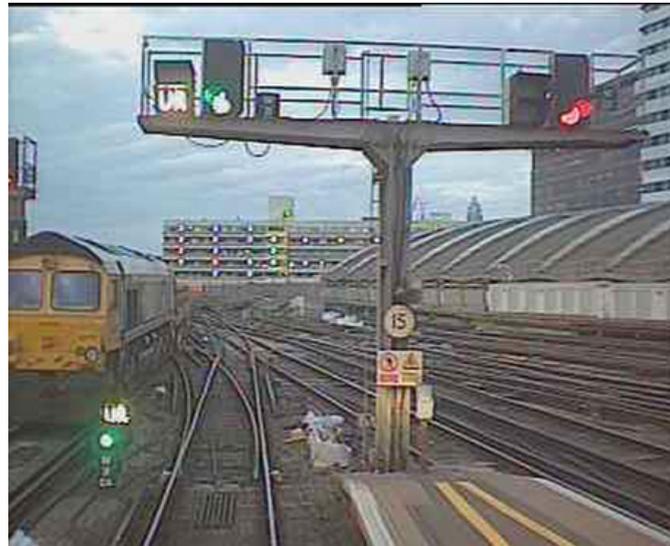
Figure 5: View from the train's forward facing CCTV of the green signal and 'UR' (Up Main Relief) route indication, duplicated at high and low levels, at the departure end of platform 11

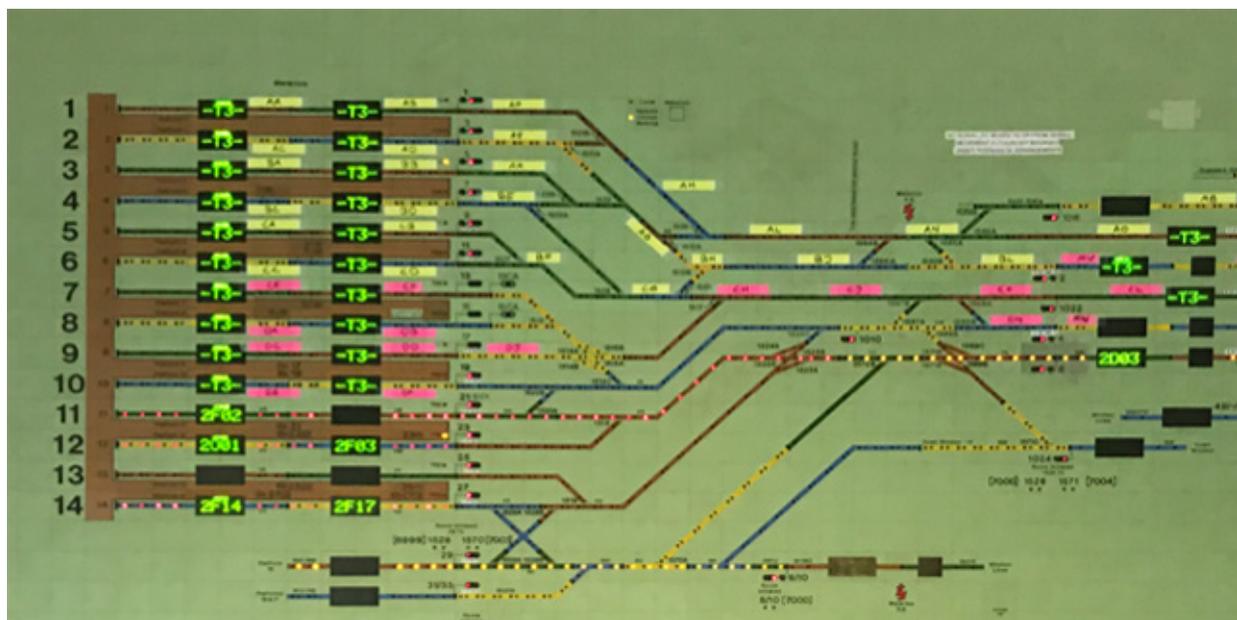
Figure 6: Signaller's view: the section of Wimbledon ASC panel showing the route out of platform 11, set for and occupied by train 2D03 (note that the engineering train was not displayed to the signaller, because indications on that part of the panel had been disconnected as the area was a worksite, not an operational railway).

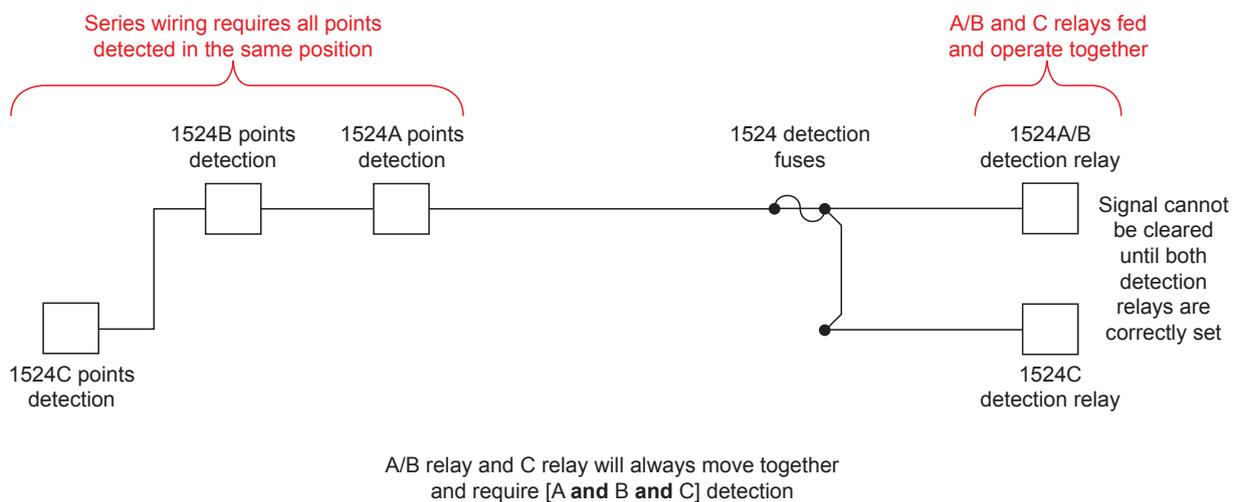
Figure 7a: 1524 points detection wiring as installed before work began

- 25 Before the works began, the point detection for 1524 points had the detector for each end wired in series, meaning that all three ends must be in the same position before any current was returned to the detection relays. This current was then used to power the relays for 1524 A and B and 1524 C detection (figure 7a). Further circuitry required both detection relays to be correctly energised before trains were permitted to approach 1524 points.

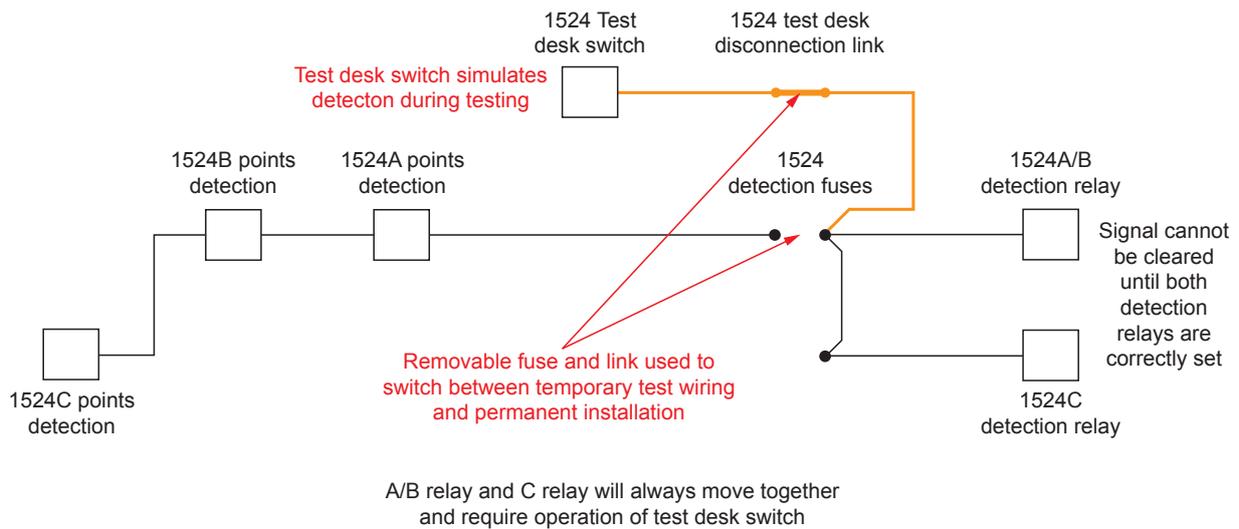
Figure 7b: 1524 test desk wiring as designed (shown when test desk in use)

- 26 The signalling system had been fitted with a test desk, in advance of the August 2017 partial closure, to enable signalling functions to be simulated, so aiding testing during the works. This had been designed based on the signalling system wiring which existed in June 2016 and was installed and tested in August and September 2016. The test desk was only permitted to be used while trains were prevented from operating, and so the signalling testers had a process for removing fuses from the operational circuits and inserting *links* into the test desk circuits to use the test desk. This process was reversed before the line was restored to normal working (figure 7b).

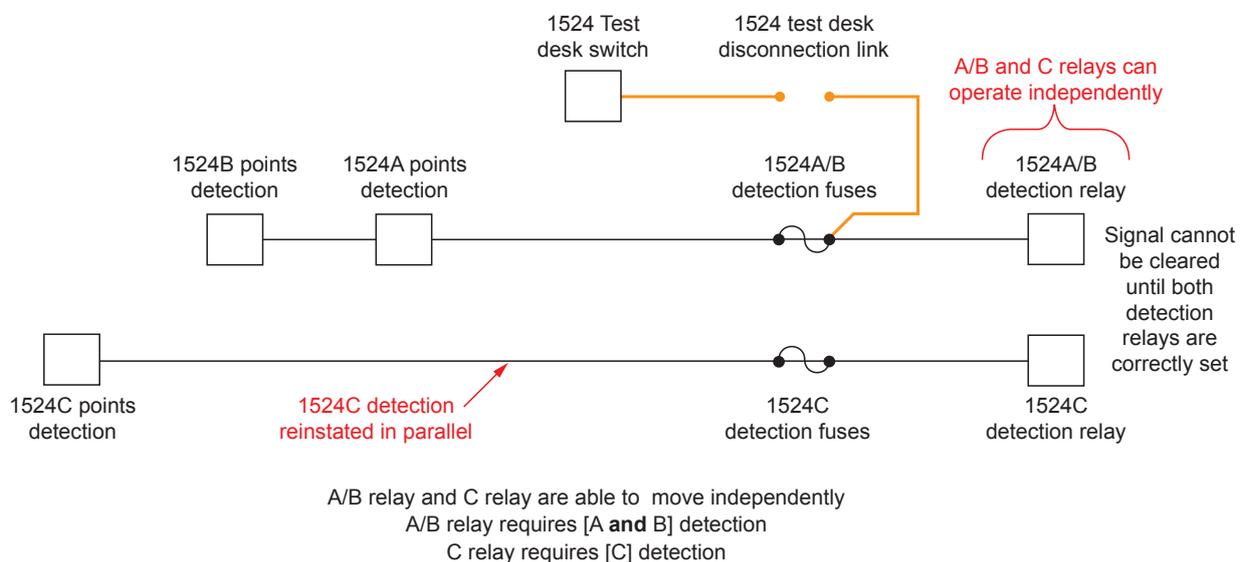
Figure 7c: change of circuit design: after location W14 abolished (shown with test desk 'switched' out)

27 To make room for the new station layout, it was necessary to relocate a track-side signalling location case, W14, which contained part of the wiring for the detection circuits for 1524 points. As part of the relocation, the design of the point detection wiring was modified to bring it in line with typical modern design. The detection for 1524 A and B points was now being returned to the relays on a separate circuit to the detection for 1524 C (figure 7c). As in paragraph 24, further circuitry required both detection relays to be correctly energised before trains were permitted to approach 1524 points, so the safety of the signalling system was unaffected by this change.

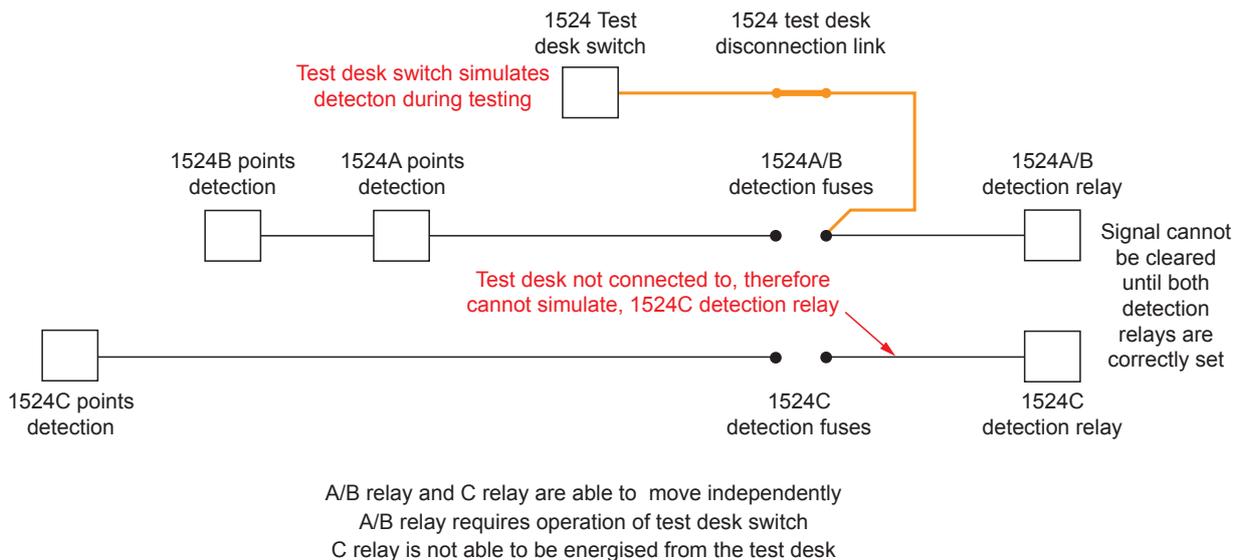
Figure 7d: 1524 points in test mode after location W14 abolished

28 The modification to the wiring of the point detection circuits in location case W14 and Waterloo relay room during the partial closure of Waterloo Station meant that the test desk no longer simulated the detection of 1524 points correctly because 1524 C points were no longer included in in the circuit that the test desk switch was connected to (figure 7d).

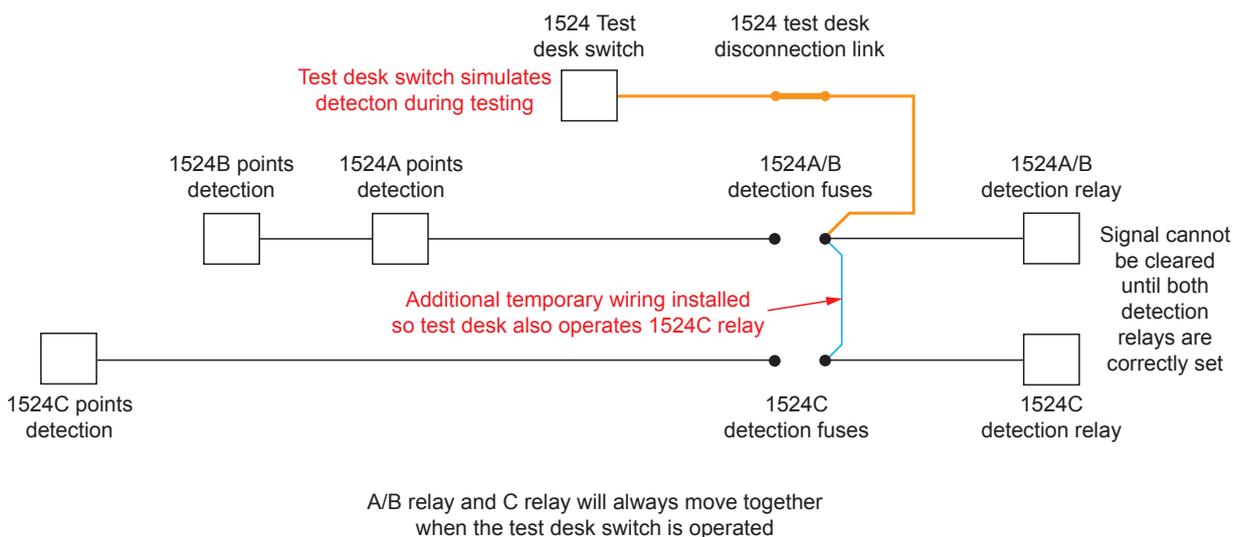
Figure 7e: 1524 points at time of testing, temporary wires added so that the test desk operated both sets of relays

29 On the weekend of 12/13 August 2017, while trains had been stopped from running on the lines leading to 1524 points, a temporary wiring modification was made in the relay room in an attempt to restore the correct operation of the 1524 points test desk switch. This modification (figure 7e) was not reviewed by a signalling designer and was incorrectly left in place when the railway was returned to operation on the morning of 14 August. Contrary to Network Rail standards, no test log or modification record has been found, and the RAIB is still investigating the exact circumstances surrounding the installation of this temporary wiring modification. Leaving this modification in place when the railway was returned to operation had the effect of changing the logic between the point detection and the relays so that if either 1524 A and B or 1524 C point ends were detected on the ground, the system reported all ends detected.

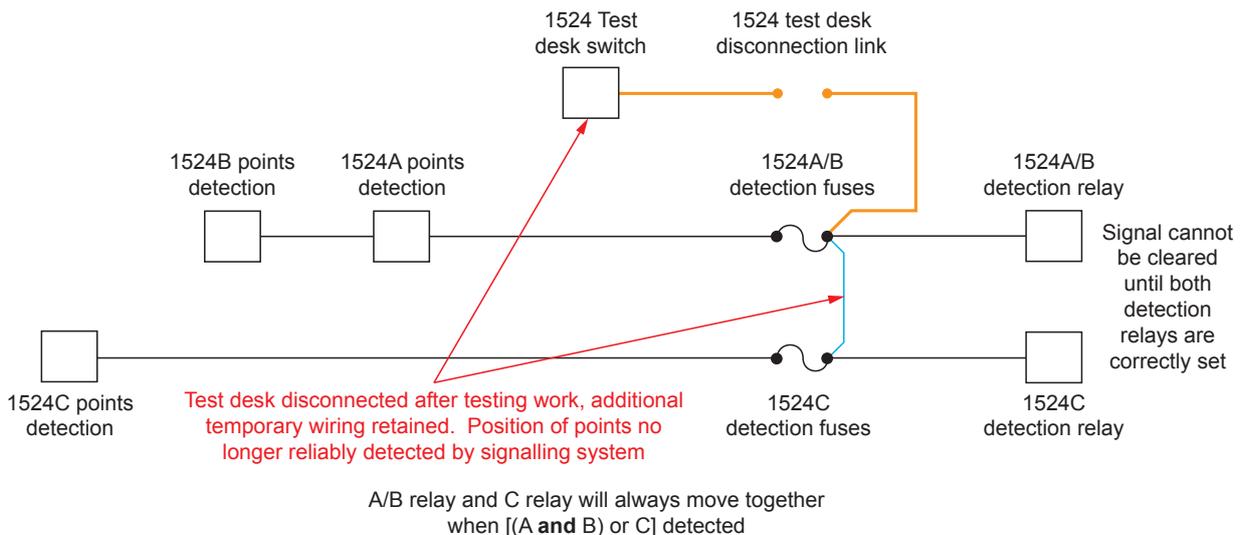
Figure 7f: 1524 points detection at time of derailment

- 30 During the night of 14/15 August, signalling testers at Wimbledon Area Signalling Centre (ASC) were checking signalling routes into Waterloo station. One of these routes required 1524 points to be called reverse (commanded to reverse position). The tester believed that all ends of 1524 points were secured in the normal position<sup>3</sup>, so did not expect them to move.
- 31 When 1524 points were called reverse, the A and B ends were free to move to the reverse position. The C end remained in the normal position as this end had been clipped in the normal position. As a result of the temporary wiring in the relay room (figure 7f), once A and B reached the reverse position all three ends of the points would have registered as reverse in the signalling system.

- 32 When the route was cancelled and the testers returned the points switch on Wimbledon ASC signaller's panel to the normal position, points 1524 A and 1524 B began to move to the normal position. When the points had been moving for around one second and reverse detection was lost, normal detection was gained via the correctly detected C end and the temporary wiring. As soon as this normal detection was obtained, the power to the point motors was cut, resulting in the points remaining unlocked<sup>4</sup> and at, or close to, the reverse position.

- 33 At 05:17 hrs train 2F02 from Guildford to Waterloo passed over 1524 A points in the trailing direction as it travelled into platform 11, pushing the switch blades partially towards the normal position. The signalling system did not indicate this to the signaller because the point detection was maintained normal by the C end and the temporary wiring. Without this indication, the signaller had no means of detecting that this 'run through' had occurred. At 05:35 hrs train 2O02 from Wimbledon also ran through the points on its way into platform 12; again, this was not detected by the signalling system. The passage of the trains through the points was not sufficient to place the points fully into the normal position. Even if the points had been moved fully to the normal position, the clamp lock mechanism would have needed to be powered to engage the locks.
