Derailment of a passenger train near Wimbledon, south-west London, 6 November 2017

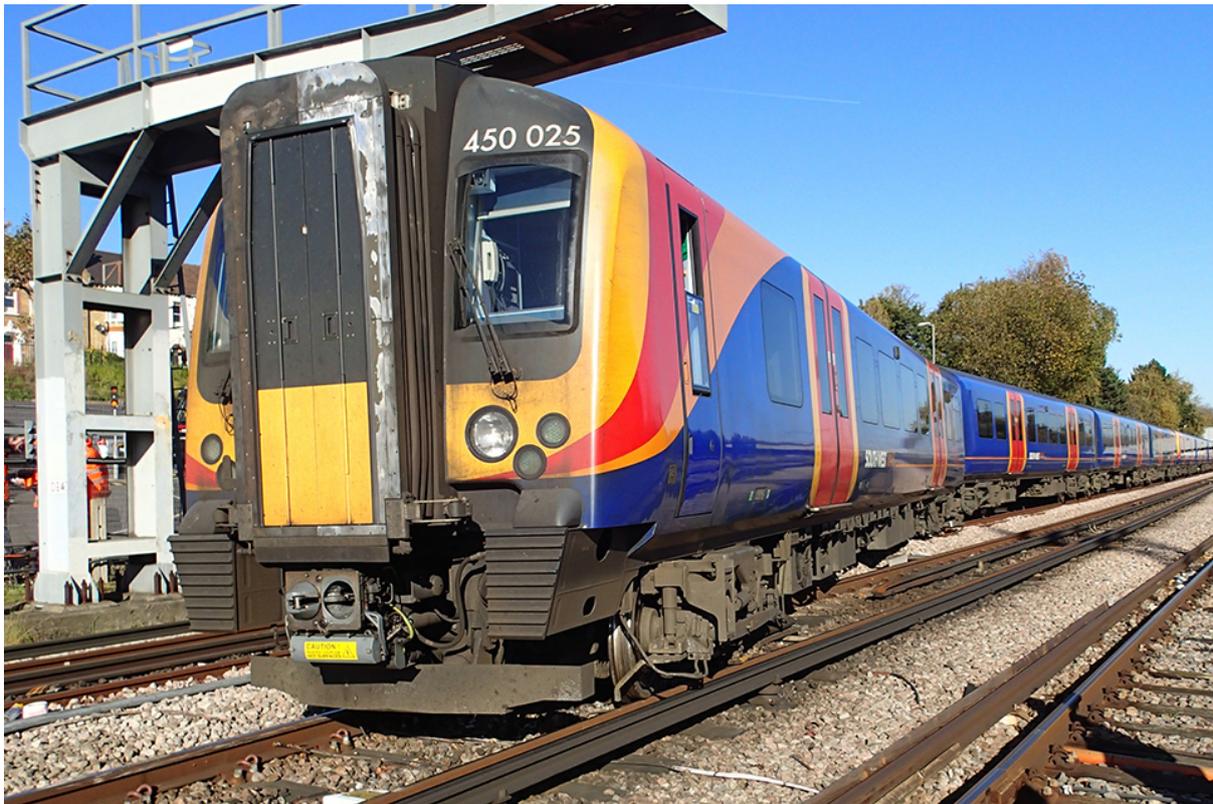
At around 06:08 hrs, all wheels under the last carriage of the 04:54 hrs Basingstoke to London Waterloo train service derailed shortly after leaving Wimbledon station (figure 1). The train, operated by South Western Railway, had travelled 348 metres after leaving the station and reached 19 mph (30 km/h) when the derailment occurred. The train continued in this derailed state for a further 185 metres causing significant damage to the track.

The rear of the derailed train

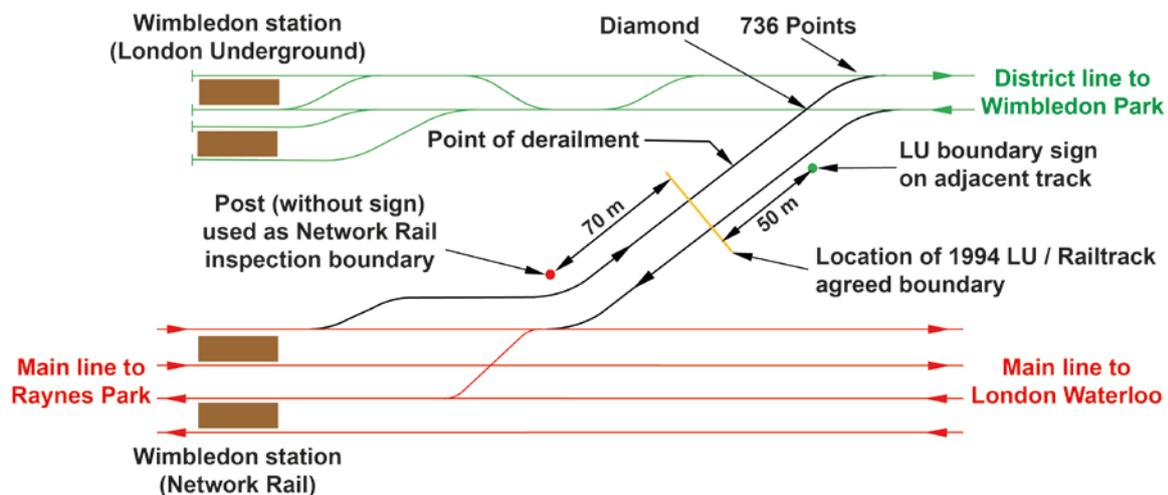
London Underground has stated that the track maintenance boundary was set in 1994 as part of a demarcation agreement between LU and Railtrack, the mainline infrastructure owner before Network Rail. However, the track patrol diagrams provided to the LU and the Network Rail patrollers were found to stop short on both sides of this agreed boundary, leaving a gap between them.

Schematic diagram showing relative locations for the point of derailment, boundary markers and agreed boundary position

The LU diagrams state that patrollers are required to inspect the crossover and diamond associated with 736 points. Those responsible for the LU patrol inspections also referred to an internal document titled ‘Inter Infraco Track Boundaries’ dated 5 May 2009. This document defined the boundary as ‘up to and including fishplates on NR [Network Rail] side of crossover leading from 736 points’. These limits approximately align with an LU maintenance boundary sign installed alongside an adjacent track which the LU patrollers stated they had been using as the patrol limit. This was around 50 metres short of the boundary agreed in 1994. The derailment occurred on LU infrastructure around halfway between this sign and the 1994 agreed boundary.

The diagrams provided to the Network Rail patrollers state the limit of inspections are at 8 miles 38.5 chains from London Waterloo via East Putney. This is approximately 40 metres along the link line and about 70 metres before the agreed boundary. The manager responsible for the Network Rail patrollers stated that a post near this location was used as the boundary marker. Historic photographs indicate that no sign indicating this, or any other information, had been attached to the post for many years.
