Rail Accident Investigation Branch

Rail Accident Report

**Freight train derailment at Lewisham,
south-east London
24 January 2017**

Report 04/2018
February 2018

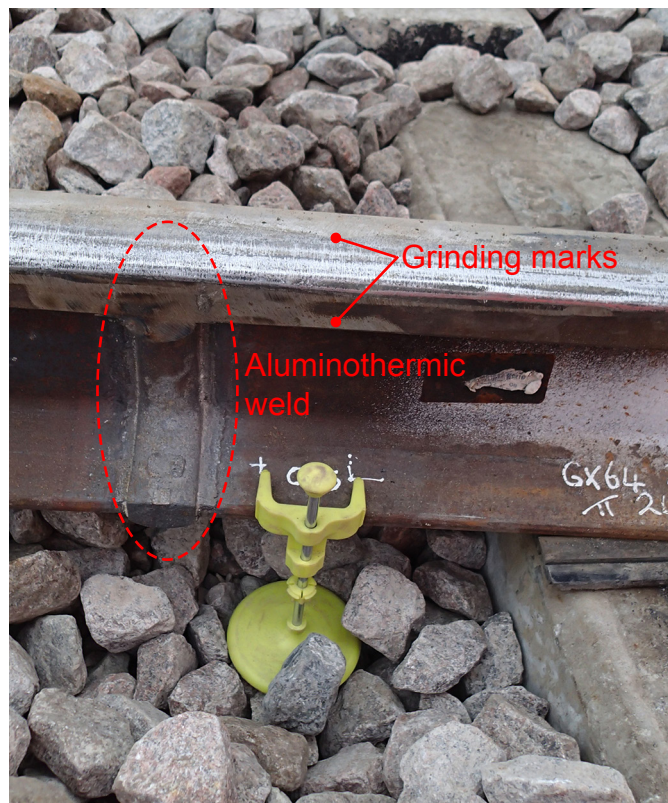
- 46 The *gauge face* and the rail head close to the area of the aluminothermic weld were relatively rough due to grinding work that had been undertaken to dress the weld (figure 7). Similar grinding work had been done to dress an aluminothermic weld around 800 mm further along the Up Courthill Loop line on the right-hand rail.

Figure 7: Aluminothermic weld on the left-hand rail of panel 13 (photograph shows a void meter used to measure track deflection)

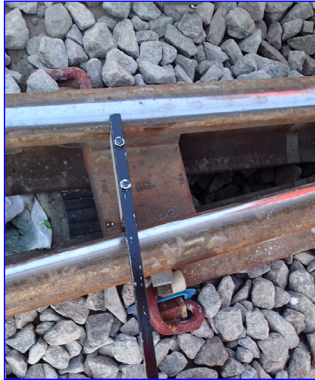
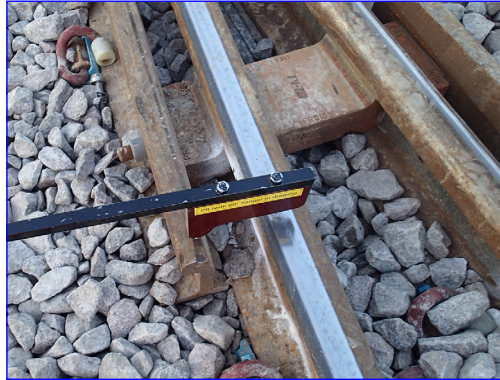
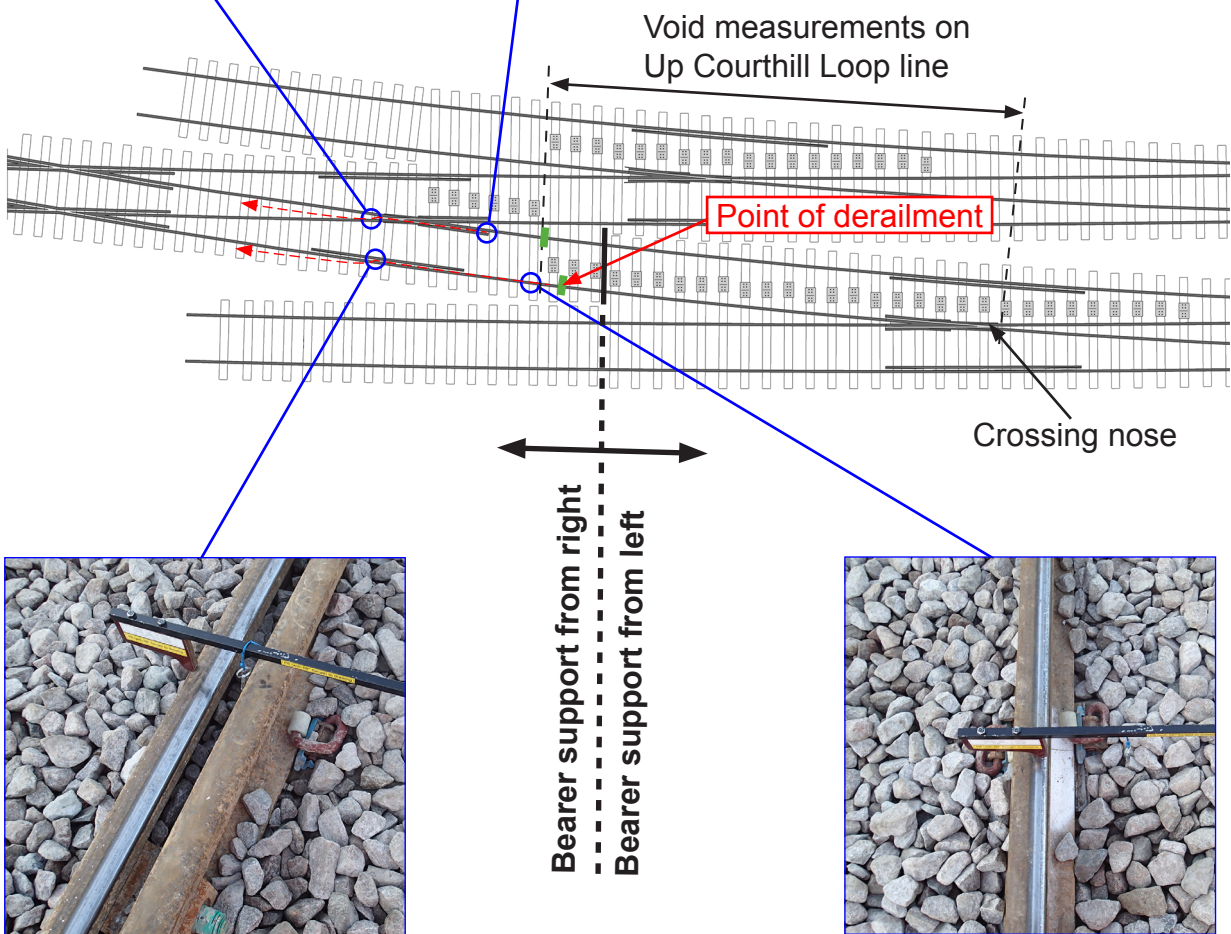
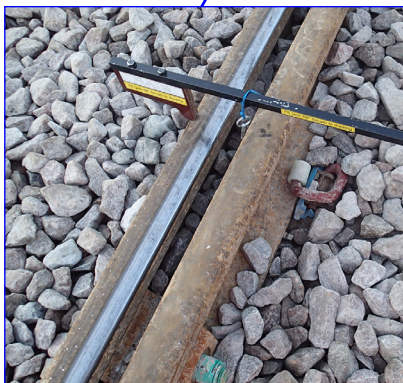
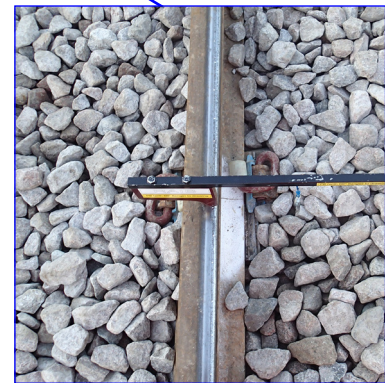
- 45 The RAIB inspected the track and found four sets of marks on the left-hand rail of the Up Courthill Loop line that were consistent with the flanges of the left-hand wheels of the four *wheelsets* of wagon 16 climbing on to the rail head, running along the top and then dropping into the *six-foot* between the Up Slow and Down Slow lines. The first mark started close to an *aluminothermic* weld located within the three short bearer sections on the left-hand rail of panel 13 (paragraph 36). The RAIB found complementary marks on the right-hand rail showing that opposite wheels of the wheelsets had dropped into the *four-foot* of the Down Slow line after the *crossing nose*, the flanges of two of the wheels having first run on top of the *wing rails*. Distortion of the track further along the Down Slow line, and other damage, indicated that the leading end of the first wagon to derail was then pulled to the right by the wagon ahead, which was correctly running on the Up Courthill Loop line. The forces involved would explain the separation of the train, between wagon 15 and 16, and wagon 16 overturning.

Figure 8: Key features of the track in the vicinity of the point of derailment (photographs show wheelset template used to identify and match derailment marks)

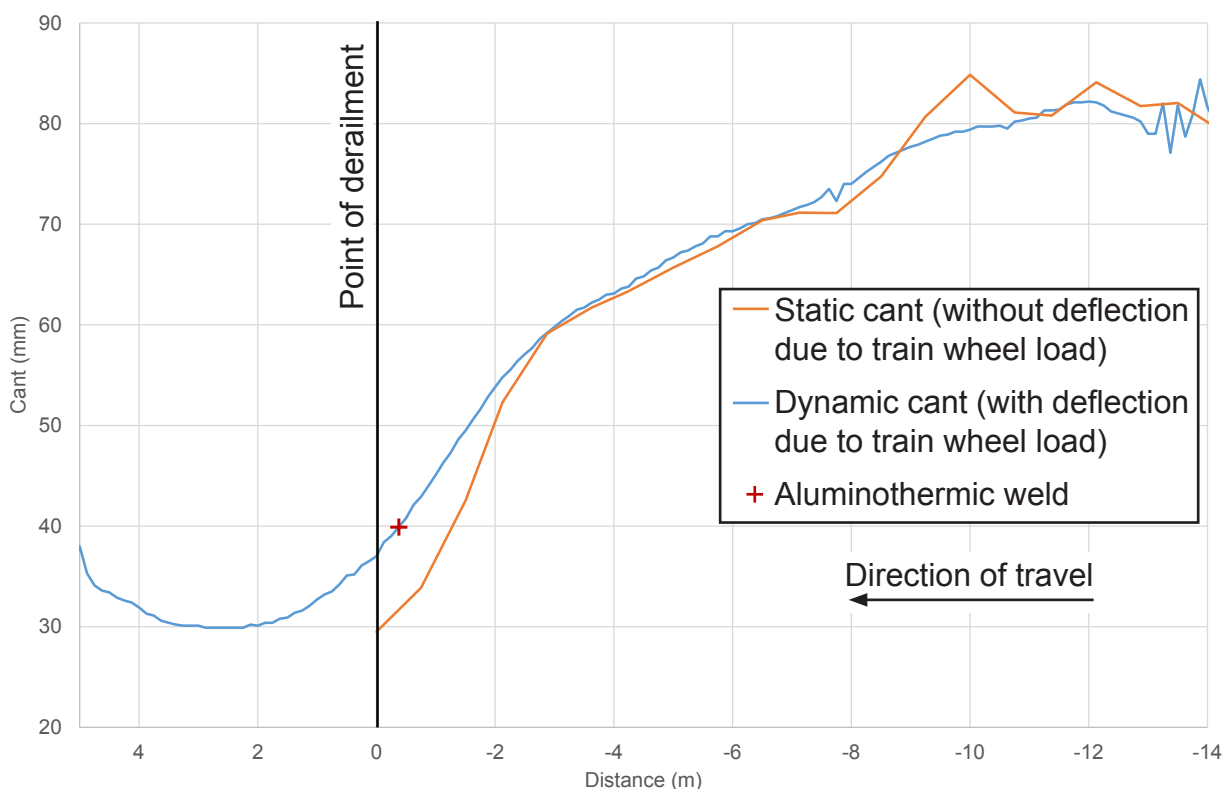
Figure 9: Static and dynamic cant measured on the Up Courthill Loop line after the derailment

- 52 The RAIB observed that both the static and dynamic cant on the approach to the point of derailment (figure 9) resulted in short and long base twists that were of the same sense and that would cause wheel unloading at the leading left-hand wheel.

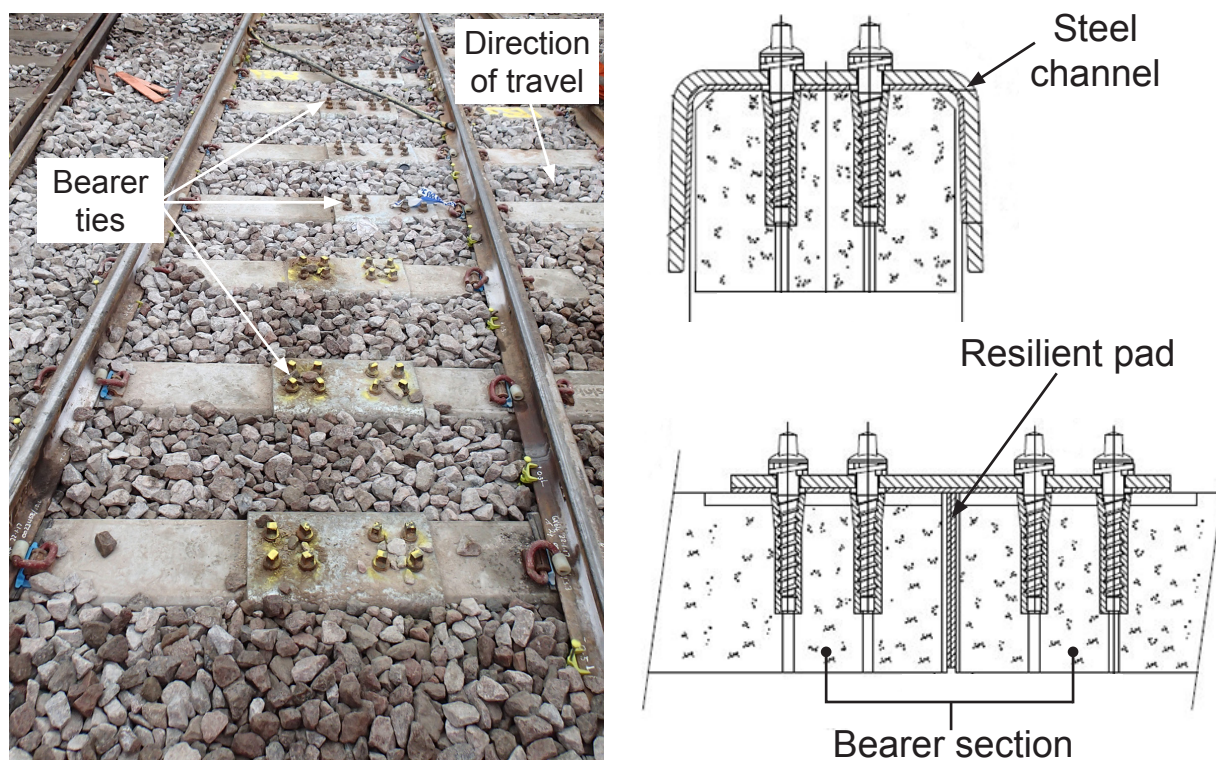
Figure 10: Bearer ties on the Up Courthill Loop line (drawings courtesy of Network Rail)

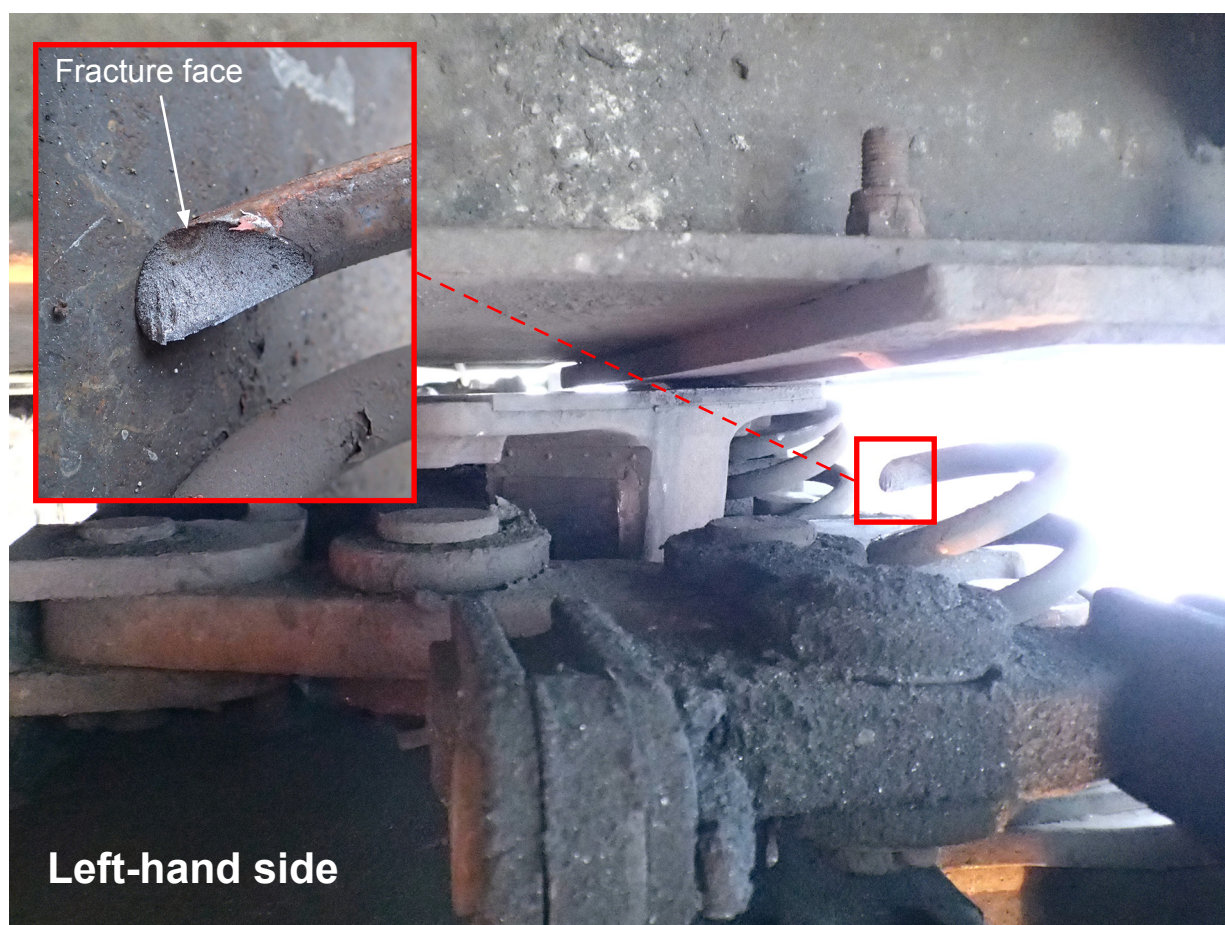
- 66 All the side-bearer units on the wagon had become dislodged, and a number of secondary springs had fractured, including one on the left-hand side of the leading bogie (figure 12). The dislodgement was almost certainly as result of the wagon running derailed or overturning. Although the fracture faces were bright and there was little corrosion, detailed examination revealed marks that indicated that the fracture had been growing progressively (figure 12 inset) and it is possible that the spring failed beforehand. The RAIB found a spring that had failed in a similar manner on wagon 18, one of the wagons that did not derail. A more detailed examination of side-bearer components revealed evidence that some guide posts had failed and shortened, and that some had been contacting the underside of the top plate (figure 13). While this suggested reduced side-bearer gaps that may, in certain circumstances present an increased derailment risk, more detailed examination discounted this as a factor in this derailment (paragraph 75).

Figure 12: Dislodged side-bearer and fractured secondary spring found on the leading bogie of wagon 16

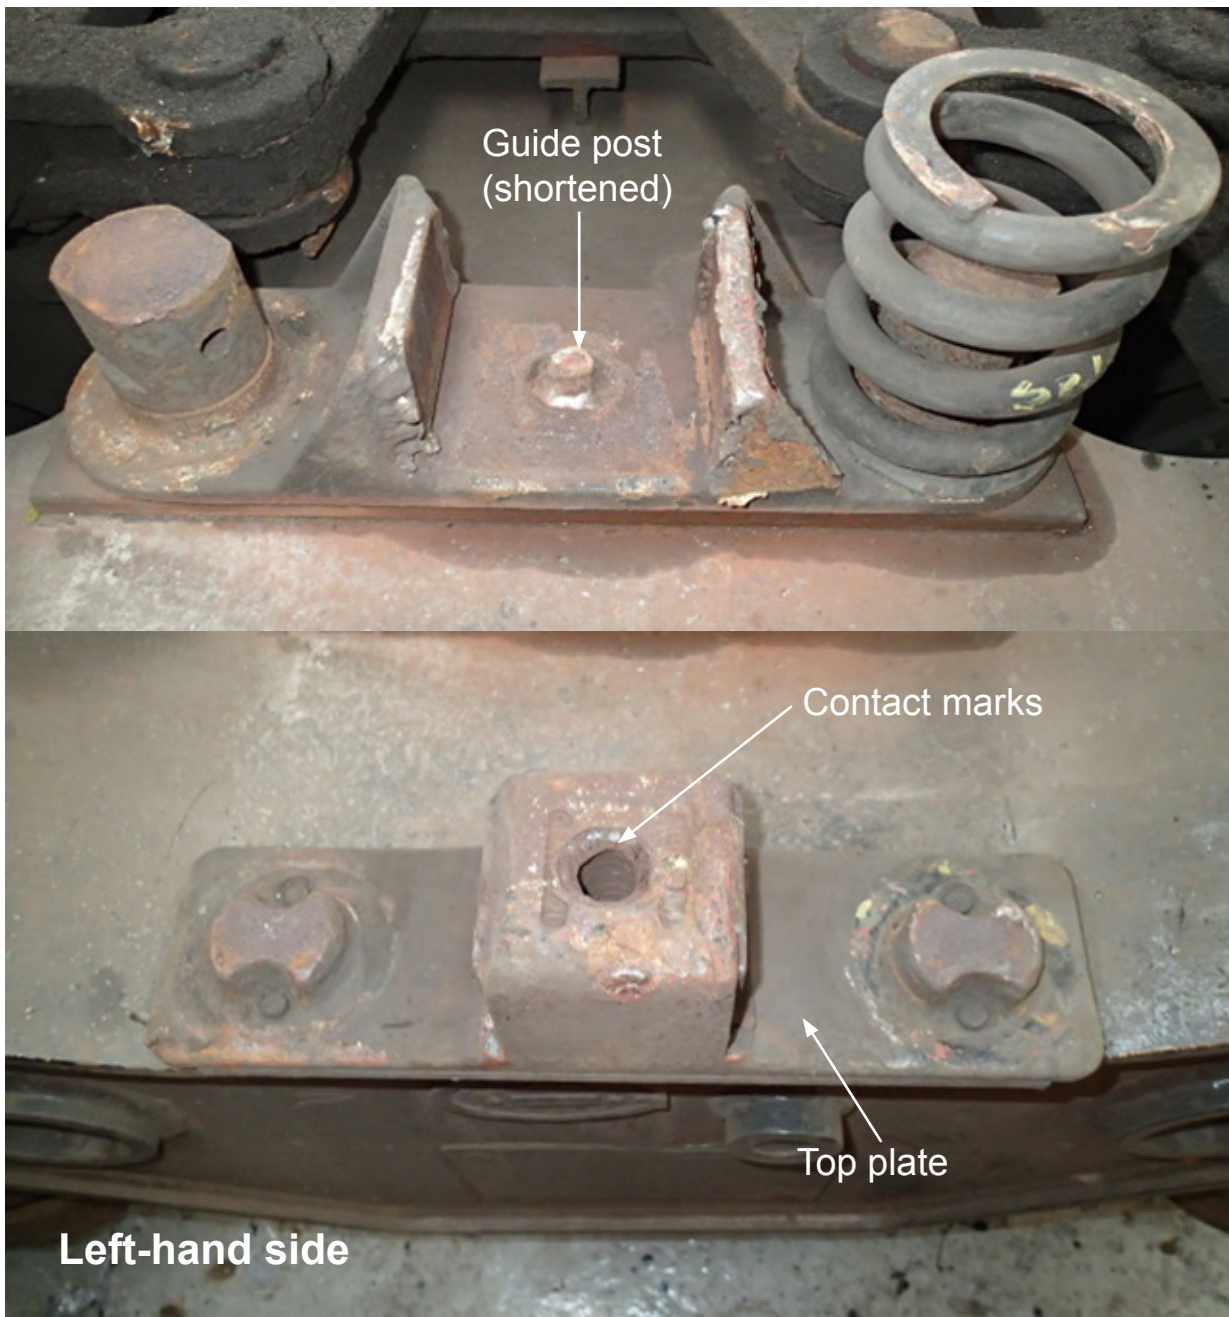
Figure 13: Side-bearer components from the left-hand side of the trailing bogie on wagon 18, showing guide post damage and contact marks

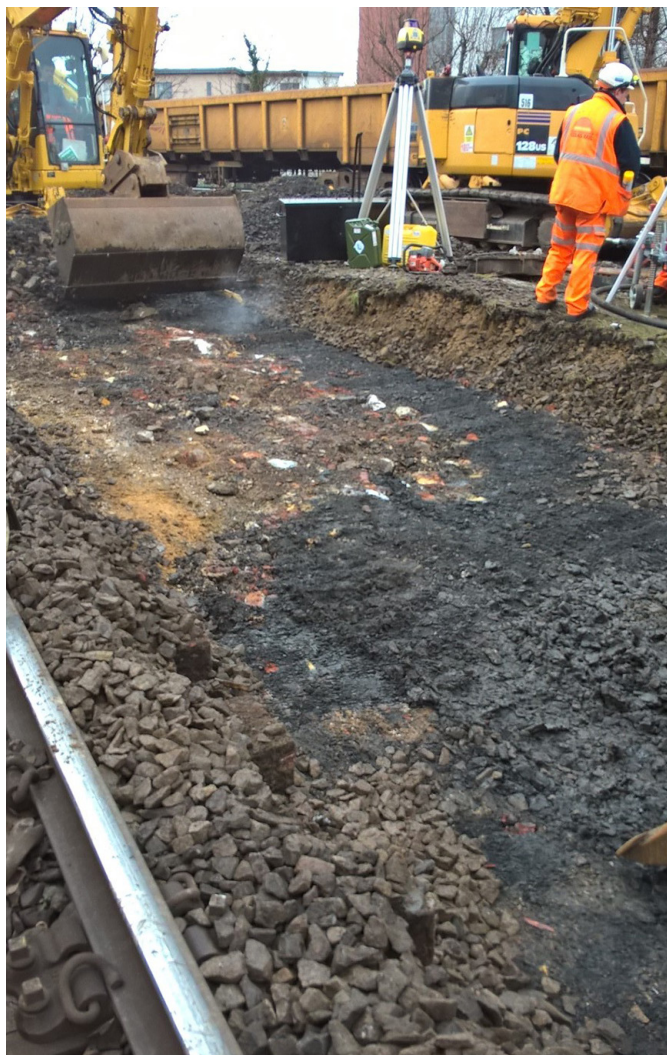
Figure 15: Excavation of the track bed close to the point of derailment on 14 January 2017 (photograph courtesy of Network Rail)

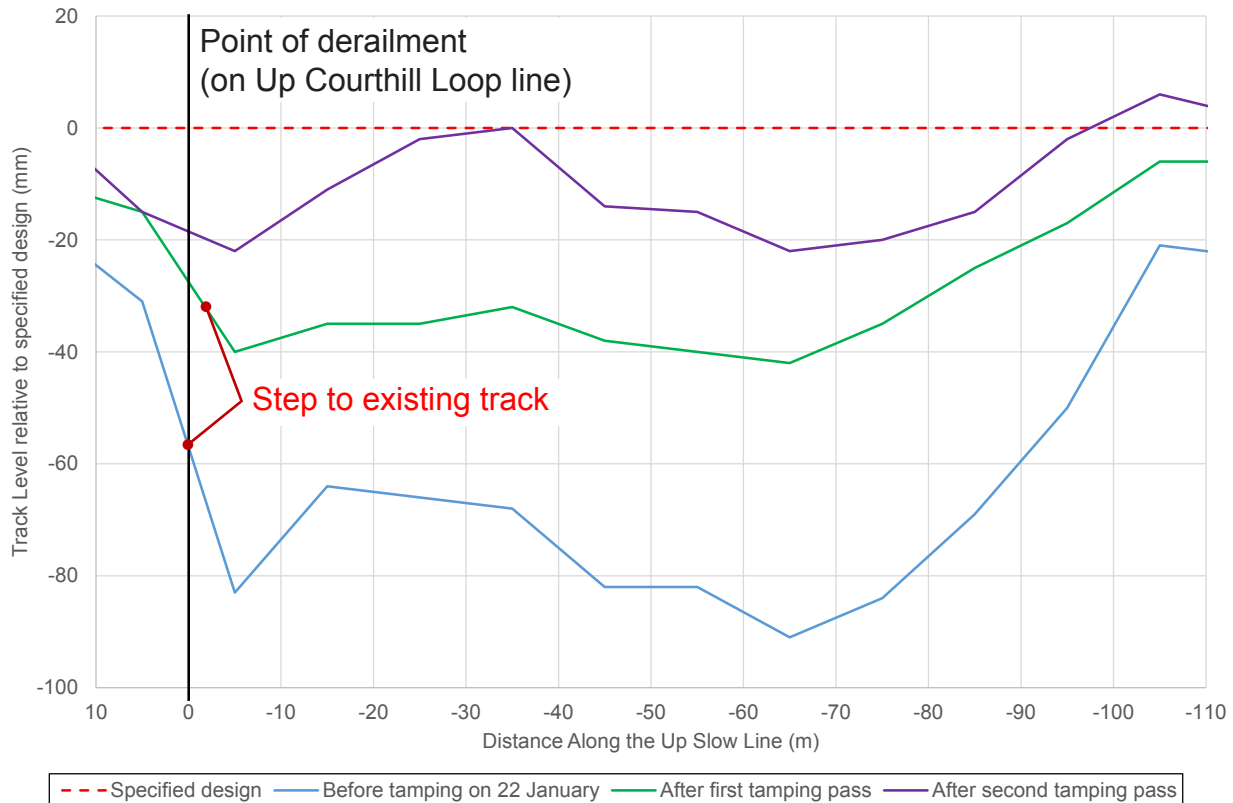
87 Machine DR 75502 started tamping the Up Slow line at 06:05 hrs. It was known that the track on the Up Slow line had been installed too low¹² (paragraph 31) and it had settled further over the intervening week. Unfortunately, it was not possible to achieve the amount of lift needed with one tamper pass (paragraph 34). The need for the second tamper pass meant that machine DR 75502 remained occupied until 09:30 hrs leaving no time for it to then tamp the Up Courthill Loop line before it was due to depart. Figure 16 shows the level of the track at the start of the tamping work, and that achieved after each tamping pass. It also illustrates the step at the transition to the existing track that witness evidence suggests was of concern to the lead engineer during the Core Works (paragraph 31).

Figure 16: Level of the Up Slow line prior to the tamping work on 22 January 2017, and after each tamping pass

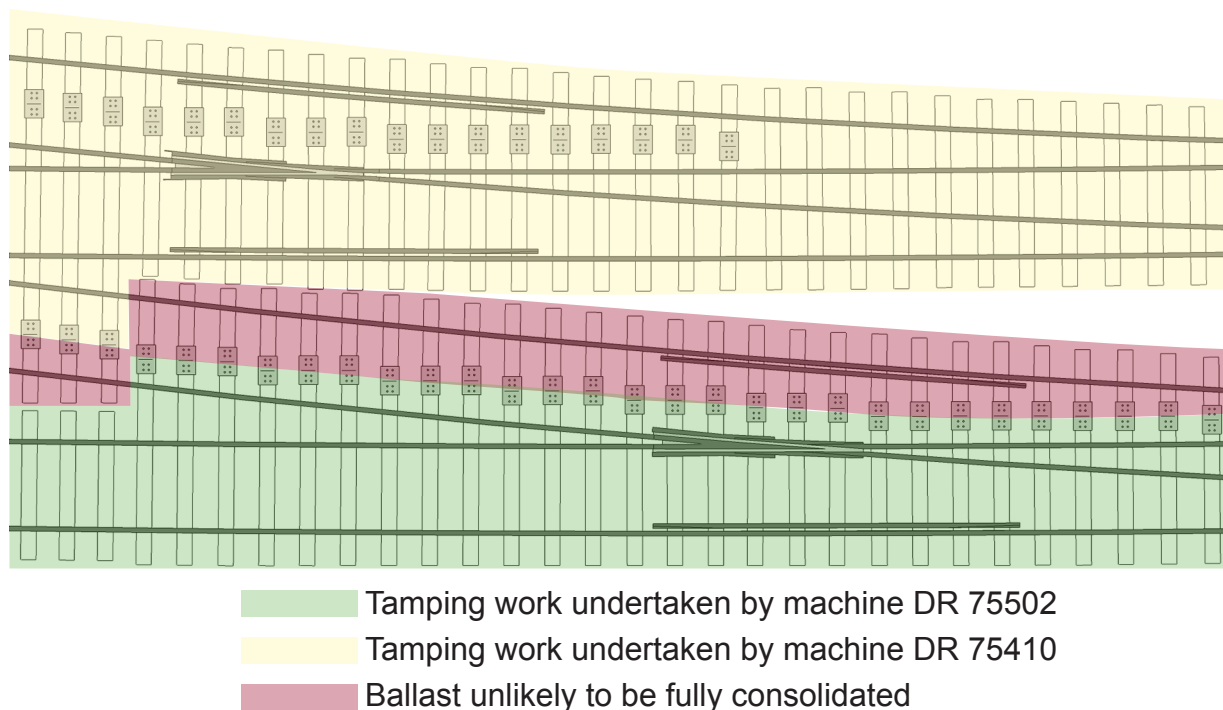
91 Figure 17 shows the areas on the Up Courthill Loop line where the ballast is unlikely to have been fully consolidated by the tamping undertaken on 22 January.

Figure 17: Areas of the double junction affected by tamping work on 22 January 2017

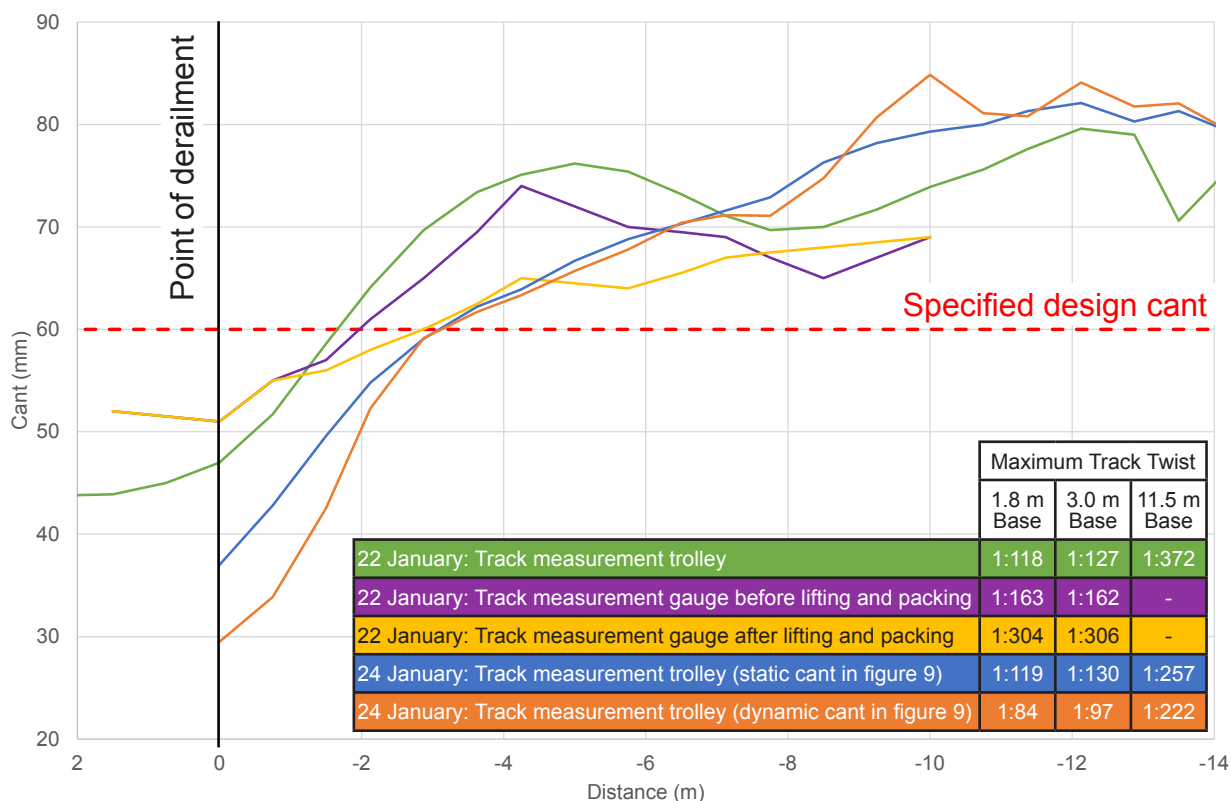
94 Figure 18 shows the cant levels that were measured on the Up Courthill Loop line to verify the manual repair undertaken during the follow-up work, and how this then deteriorated over 28 hours to form the track twist feature on which wagon 16 derailed. It also summarises the associated maximum twist levels on the immediate approach to the point of derailment: over three metres, and over the wheelbase (1.8 metres, short base twist) and bogie centres (11.5 metres, long base twist) of a JGA wagon.

Figure 18: Track cant on the Up Courthill Loop line

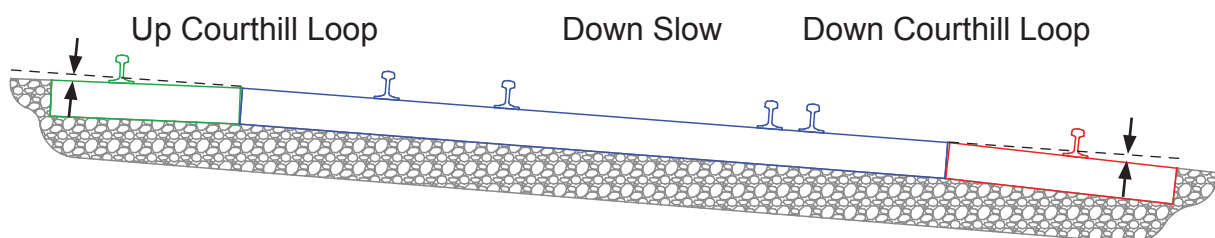
106 The bearer closest to the point of derailment supports three lines. It has a bearer tie in the four-foot of the Up Courthill Loop line as well as in the four-foot of the Down Courthill Loop line. The bearer section supporting the Down Slow line is continuous in between (figure 6). The RAIB analysed the track measurement trolley recordings made during the follow-up work (paragraph 35) and the void measurements and track measurement trolley recordings made after the derailment (paragraph 47). With reference to figure 19, it found that, at the time of the follow-up work, the cant on the individual lines on the bearer varied: the static cant on the Up Courthill Loop line was less than that on the Down Slow line (in the middle of the bearer), and the static cant on the Down Courthill Loop line was more. The different amount of cant on each line is explained by the fact that the bearer ties were acting as hinges, which allowed the bearer sections to rotate relative to one another. By the time of the derailment, the static cant on the Up Courthill Loop line had reduced considerably further. The dynamic cant was even less, evidencing how vulnerable the short bearer section under the left-hand rail was to inadequate track bed support.

Figure 19: Track cant on the bearer closest to the point of derailment

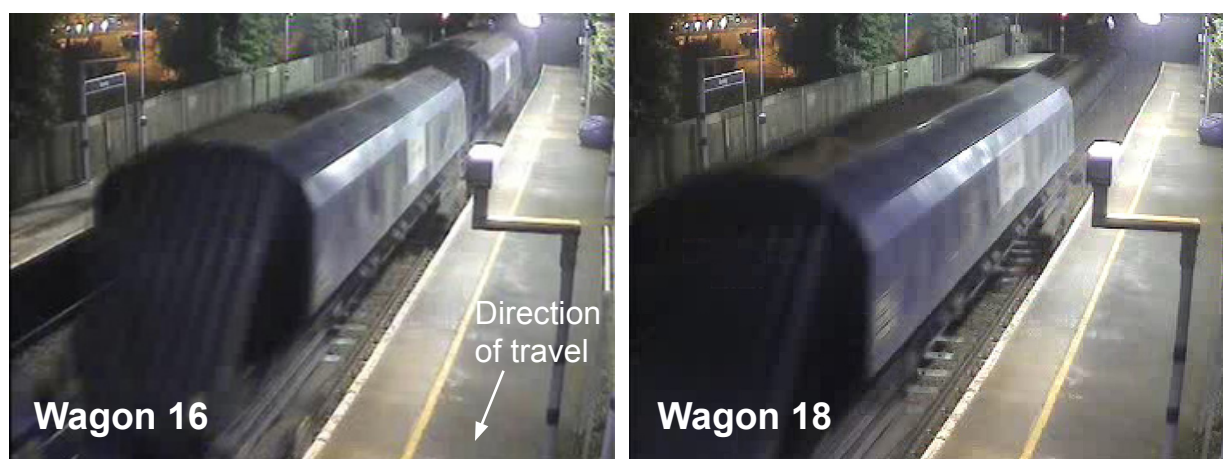
- closed circuit television (CCTV) images of train 6M90 passing Bexley station, which show the profile of the sand in wagons 16 and 18 was similar (figure 20); and
- that wagons 16 and 18 were loaded using the same process (paragraph 38).

Figure 20: CCTV images of train 6M90 passing through Bexley station on 24 January 2017 (images courtesy of London and South East Railway Limited)
