AAIB Bulletin

3/2018

Published 8 March 2018

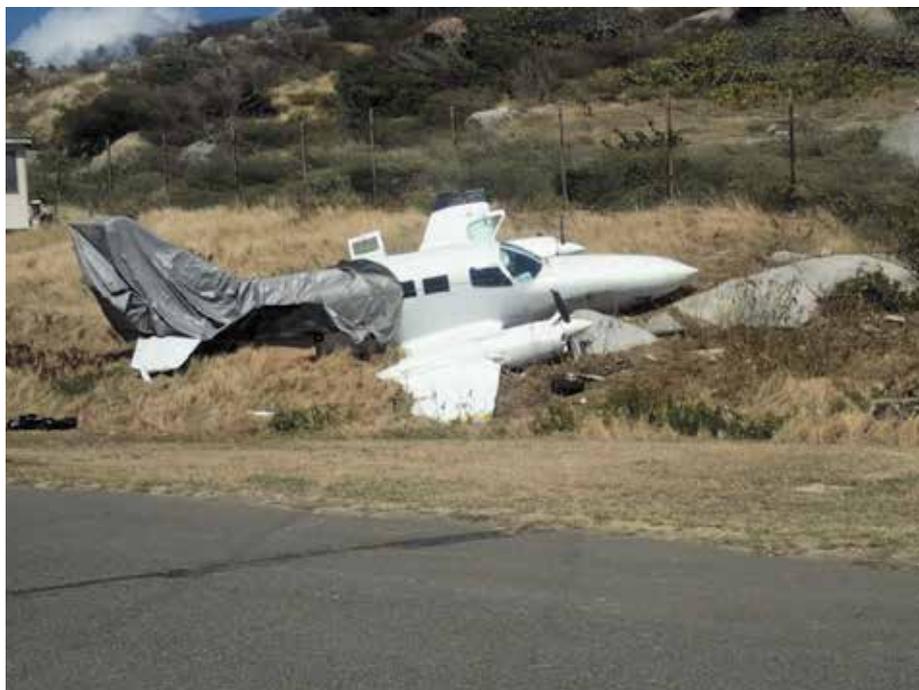
Figure 2

General view of the accident site

Distinct tyre marks from all three wheels were visible across the apron and grass and this indicated heavy sideward loading as the pilot tried to turn to avoid over-running into the sea. There was no evidence of locked brakes, such as pronounced skid marks or marks caused by loose stones dragged across the surface.

As the aircraft traversed the grass it struck a frangible runway sign before passing through a low retaining wall. The nose landing gear collapsed and the right main landing gear was broken off. After encountering rising ground and colliding with a group of substantial rocks, the aircraft slewed to rest through about 45°.

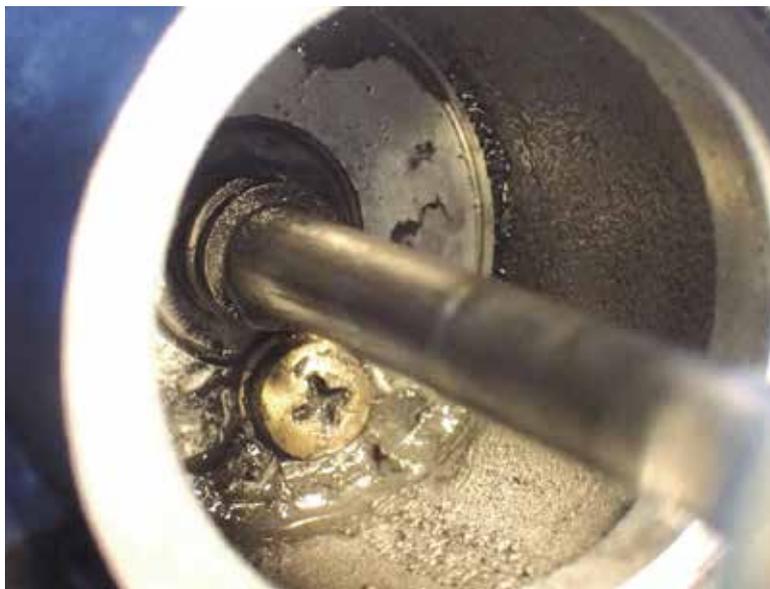
Figure 4

Debris and contamination inside the oil reservoir was analysed and identified to be general environmental dirt and aluminium flakes (Figure 4).

Debris in the left master cylinder oil reservoir

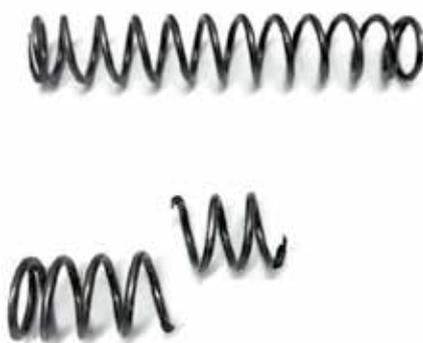
Figure 5

The piston rod and return spring were removed, revealing two pieces of a broken return spring in the lowest section of the housing bore. The broken pieces, when placed end to end, had a combined length that was approximately half a complete spring (Figure 5). The coil was wound in the opposite direction to the intact spring.

The intact piston return spring and the remains of the broken spring

The omission of the rubber ring seal from the left master cylinder would have had no effect on braking performance but was indicative of a shortfall during maintenance. The remains of a broken spring in the left master cylinder was unlikely to have interfered with system operation but they also were indicative of a shortfall during maintenance. The operator did not know when the spring failure occurred and considered the omission to remove the broken parts to be an error on their part.

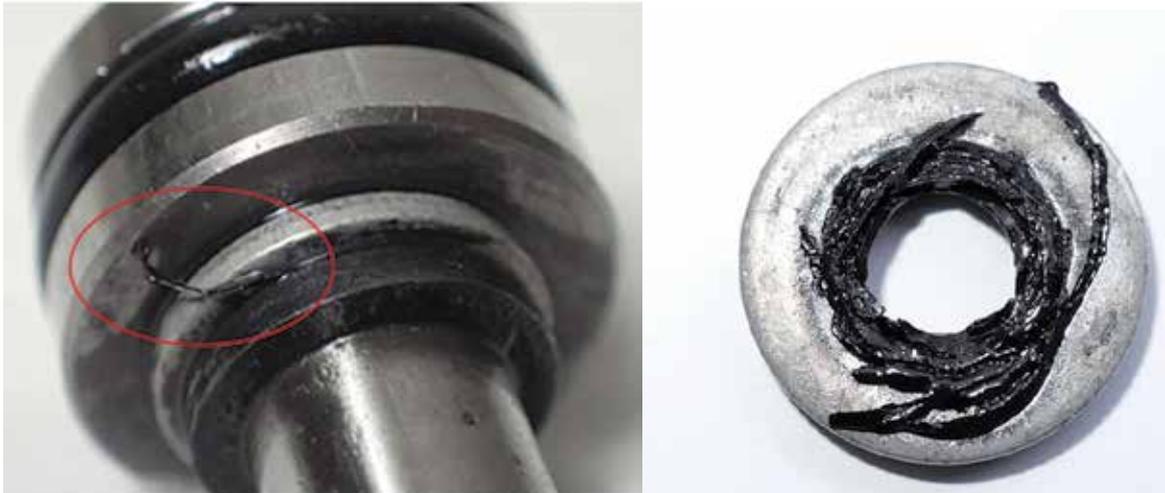
Figures 6a and 6b

Examination of the piston rod revealed debris trapped between the stat-o-seal and the washer (Figure 6a). This was subsequently identified to be part of the stat-o-seal, which was in poor condition (Figure 6b).

Trapped seal debris and general condition of the stat-o-seal

The stat-o-seal in the left master cylinder was degraded to the extent that it was breaking apart and its ability to create a reliable, effective seal would be compromised. A leak past

the stat-o-seal will have an adverse effect on brake performance and, in the worst-case scenario, will result in the brake pedal bottoming and total brake failure on the affected system.

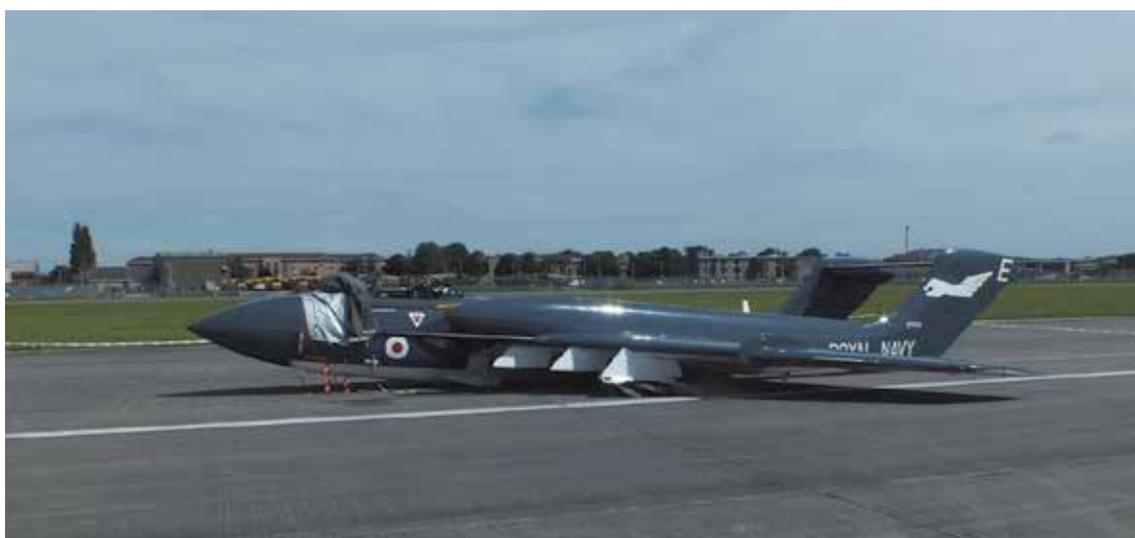
There was no fire or fuel leakage but the aircraft had sustained significant damage to its fuselage underside, particularly in its engine bay area including the accessory gearbox casing. Figure 1 shows the aircraft on the runway.

G-CVIX on the runway prior to recovery

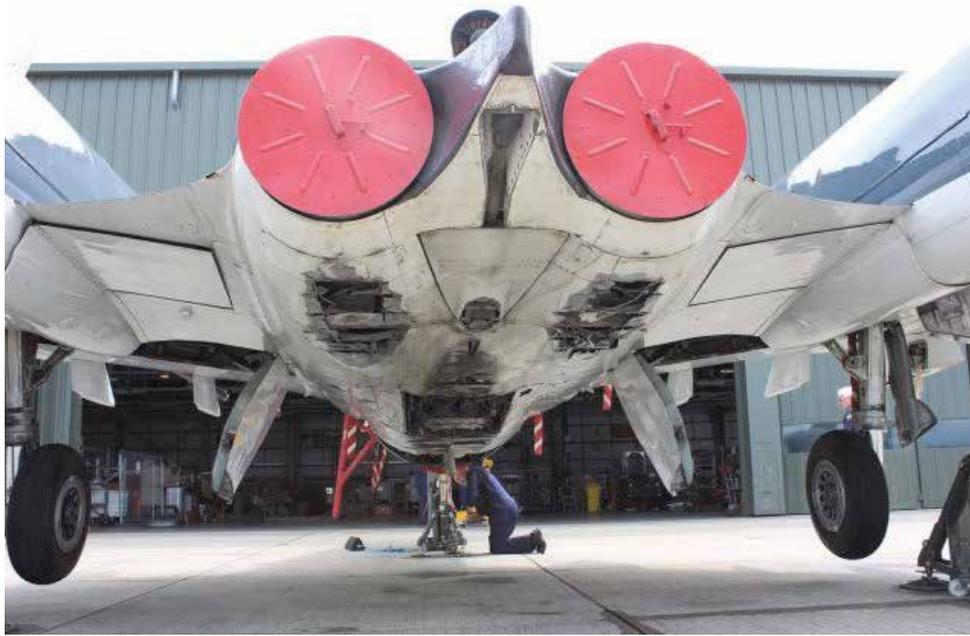
The surface of the runway had caused severe abrasion through the aluminium alloy fuselage skin, stringers and frames and into the casing of the accessory gearbox, to the extent that some of the gear train was exposed. The reinforced section, which attaches the drop tanks to the pylons, was all that remained of the left and right drop tanks still attached the aircraft. The canopy and its frame sustained damage consistent with being ejected from the aircraft whilst still at speed and landing behind the aircraft. There was no fuel leakage or fire during the landing. Figure 2 shows the damage to the underside of the aircraft.

Damage to the underside of G-CVIX.

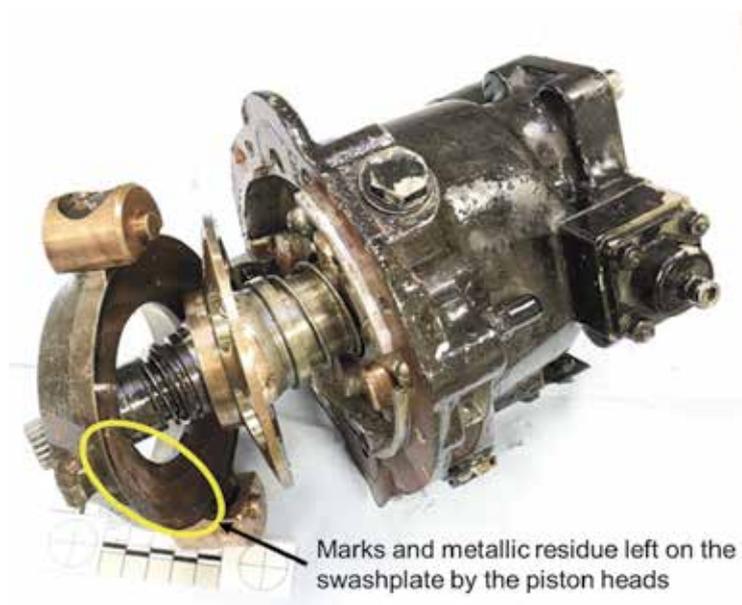
Figure 3

The Red pump shown with its cover plate removed

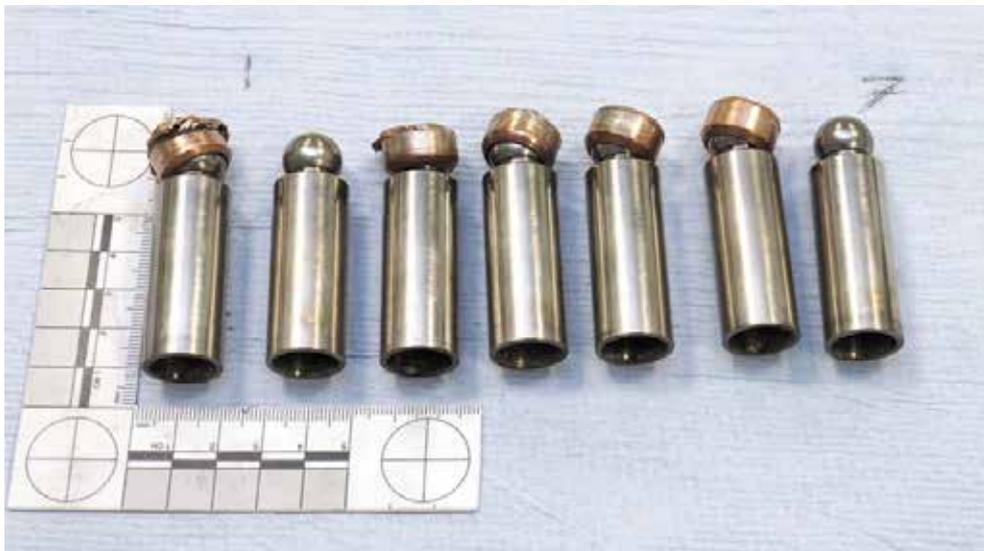
Figure 4

synchronising plate, were free to move and were undamaged. The servo piston and linkage to the swashplate was also seized. All the piston head collars had fragmented leaving just the ball and socket at the top of each piston (Figure 4).

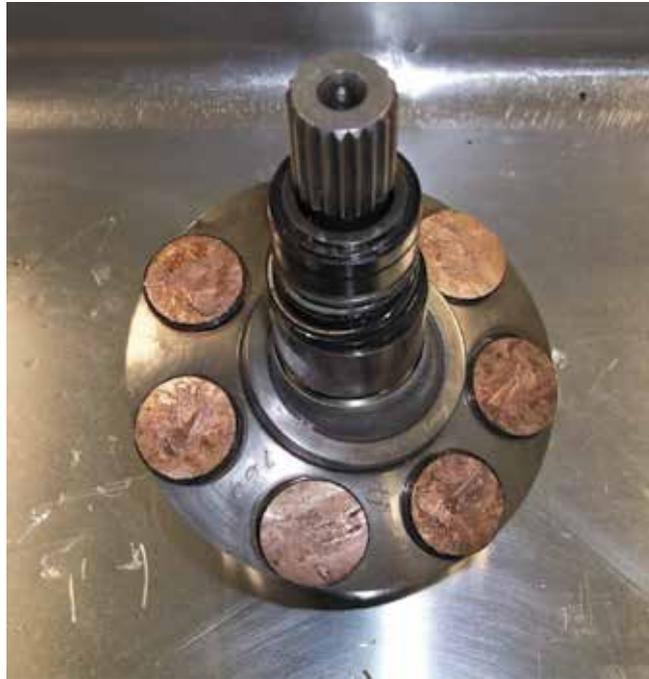
Figure 5

where they contacted the swashplate but were otherwise intact and correctly positioned in the synchronising plate. The servo piston was correctly attached to the swashplate and free to move. Figures 5 and 6 show the Green pump components.

Green pump piston heads and synchronising plate

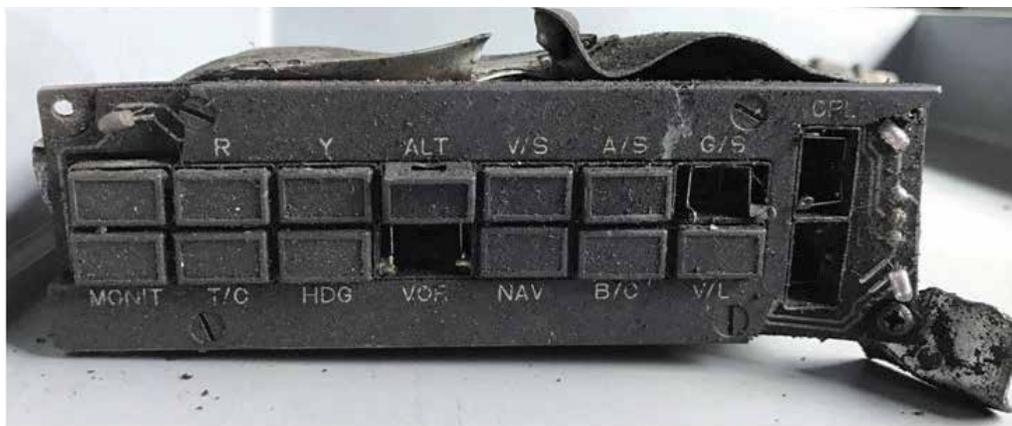
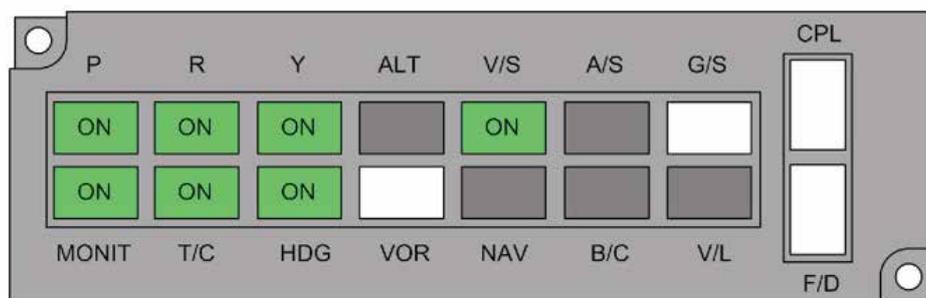
Figure 6

The autopilot mode control panel (Figure 6) was recovered from the wreckage trail. The control panel was substantially intact apart from the 'VOR', 'G/S', 'CPL' and 'F/D' buttons, which had separated during the accident and were not located.

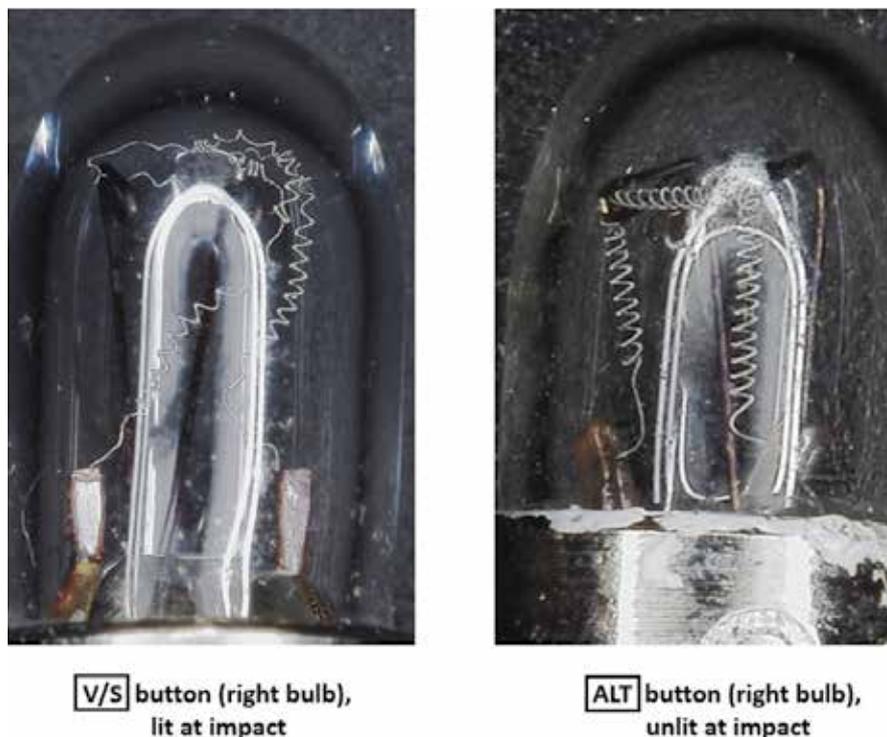
Figure 7

The push-button switches were disassembled and their lightbulbs removed for visual examination by microscope. This examination showed that a number of bulbs' filaments were stretched, with the double-helix coils elongated, consistent with bulb illumination at impact. By contrast, the remaining bulbs examined did not exhibit any evidence of filament hot-stretching, indicating that those bulbs were unlit at impact (Figure 7).

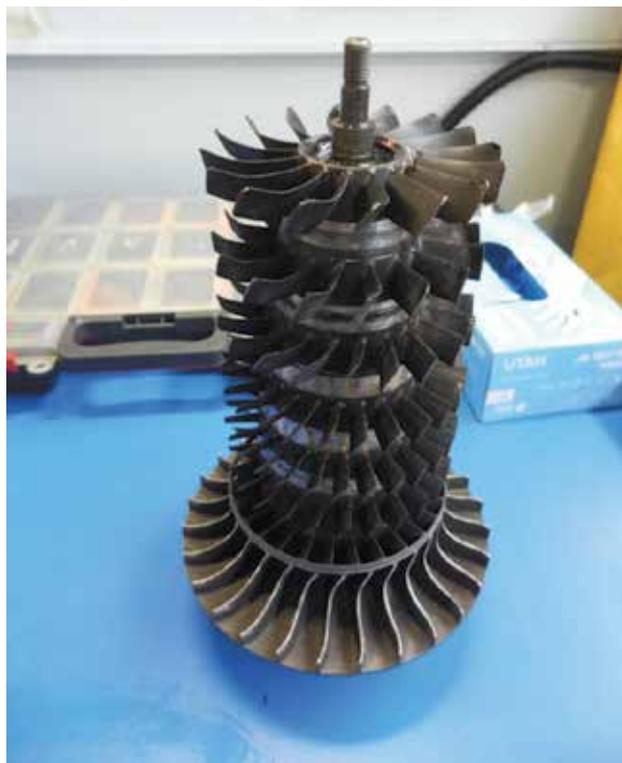
Figure 8

During the removal of the compressor from the gearbox, it was found that the retaining feature of the impeller drive coupling shaft had failed, allowing the shaft to be released. Examination of the remains of the shaft showed evidence of bearing impact marks on the shaft consistent with forces experienced during the impact sequence. Disassembly of the compressor and impeller module revealed that all the compressor vanes and stators were present. However there was clear evidence of rotational damage to the forward stages of the axial compressor (Figure 8), with associated loss of the compressor abraidable liner. There was also evidence of rotational contact between the impeller and the impeller shroud.

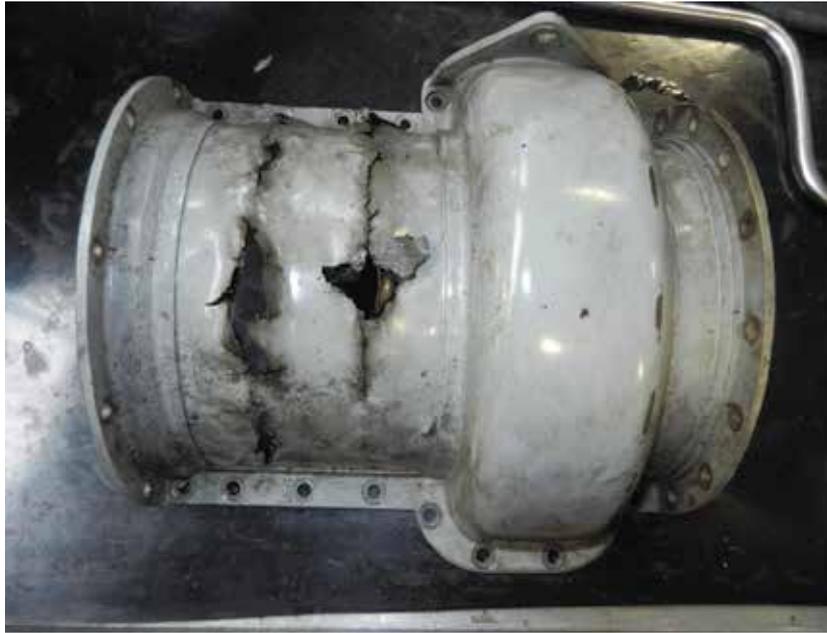
Figure 9

The compressor case exhibited multiple penetrations (Figure 9) typical of significant axial compressor blade release.

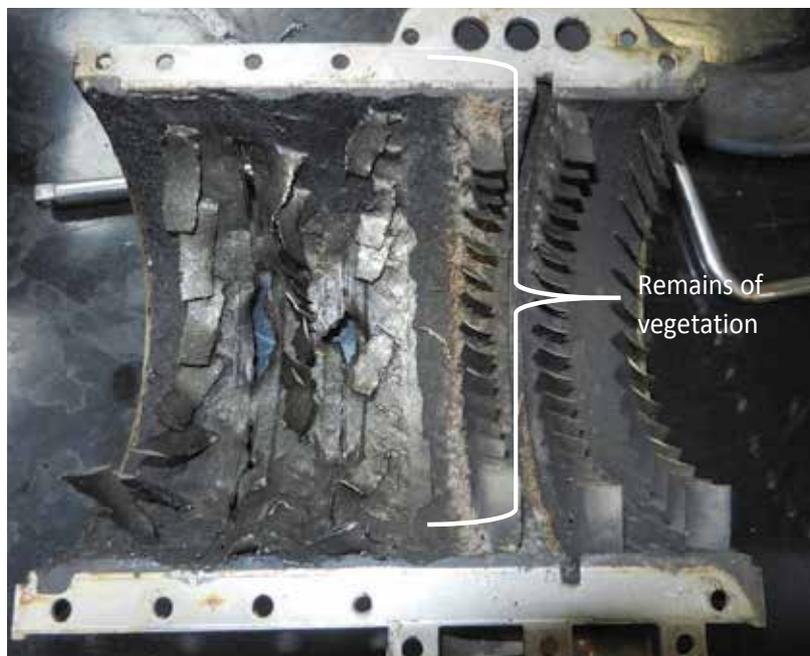
Figure 10

Disassembly of the compressor assembly revealed significant damage to all the stator vanes in the first three stages of the axial compressor, and the remains of vegetation was observed on the fourth stage stator vanes (Figure 10).

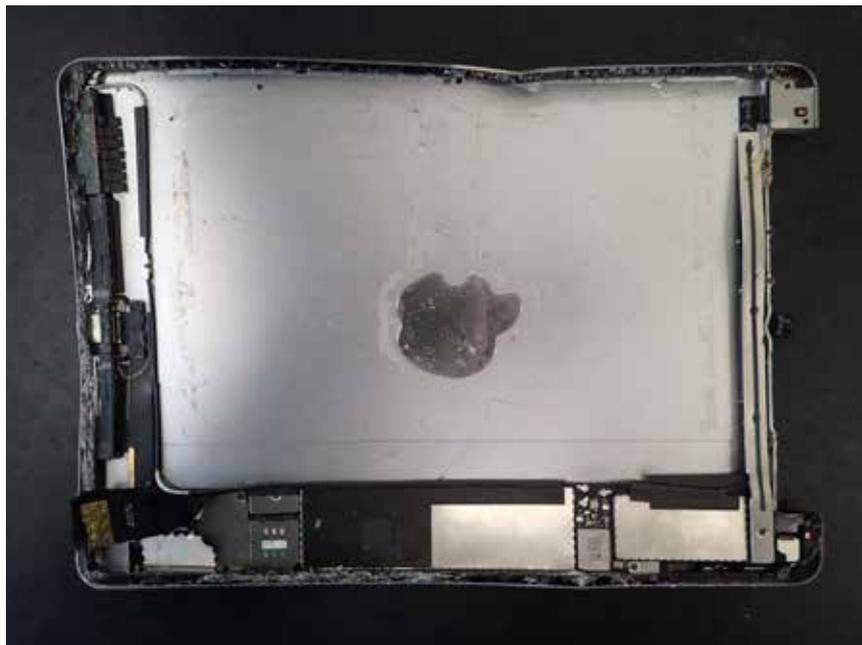
Figure 12

The logic board (containing the memory) and battery were still attached to the base of the iPad, which was slightly bent and dented (Figure 12). The logic board was removed from the iPad base and slaved into a similar iPad mini whose own logic board had been removed. The memory was downloaded using a commercially available data extraction and analysis software tool.

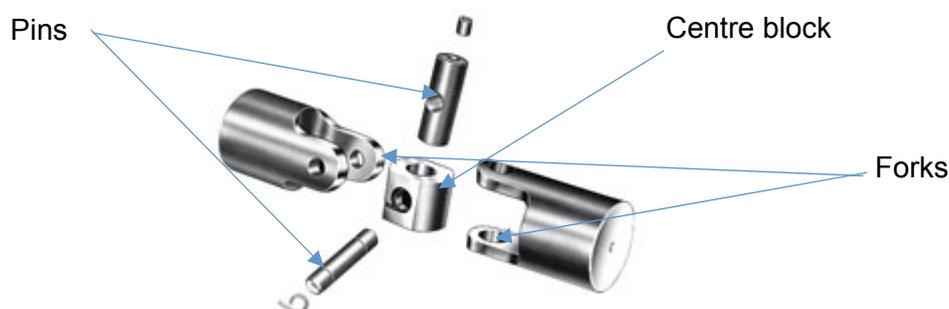
Figure 2

It was not possible to carry out any investigation of the aircraft's instrumentation due to impact damage. Examination of the aileron control circuit confirmed that it had been correctly rigged but the universal joint within the control circuit had fractured and the centre block was missing, Figure 2.

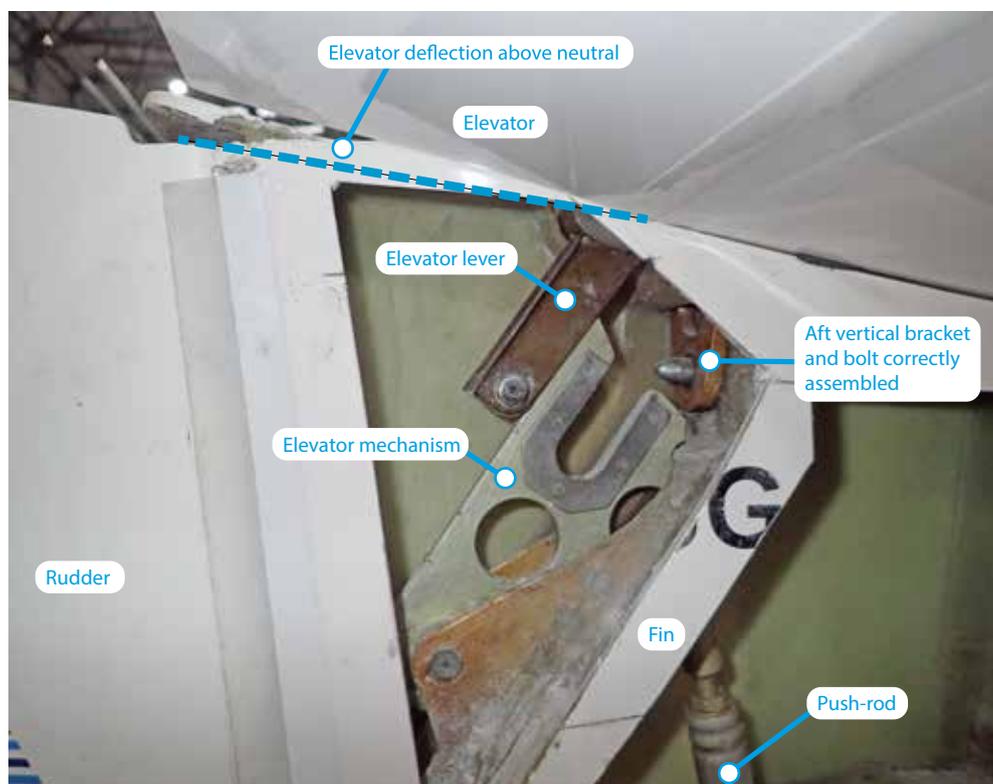
Figure 6

The tailplane was correctly seated on top of the tail fin with no obvious gap between the tailplane and the fin. Access panels were cut in the tail fin to inspect the elevator control connection. It was observed that the tailplane structural connections were correctly made, and the securing bolt correctly inserted. However, the elevator lever was not engaged in the elevator mechanism, but was instead sitting aft of the mechanism (Figure 6).

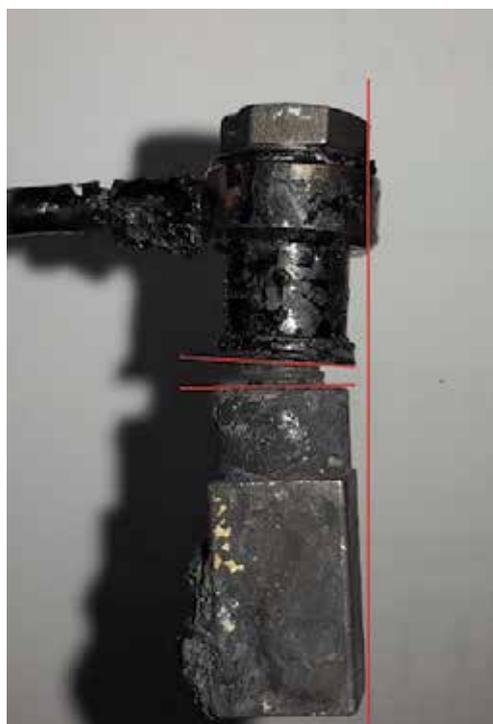
Figure 1

Following removal, the operator initiated a more detailed examination of the affected parts. It identified that the terminal lug was not parallel to the terminal block; this could allow the mounting screw to become loose, creating a high resistance connection with the potential for overheating, Figure 1. No reason for the incorrect alignment was identified.
