SAFETY FLYER TO THE FISHING INDUSTRY

Fishing vessel, *Enterprise* (SH323), Fatal man overboard, 6 November 2017

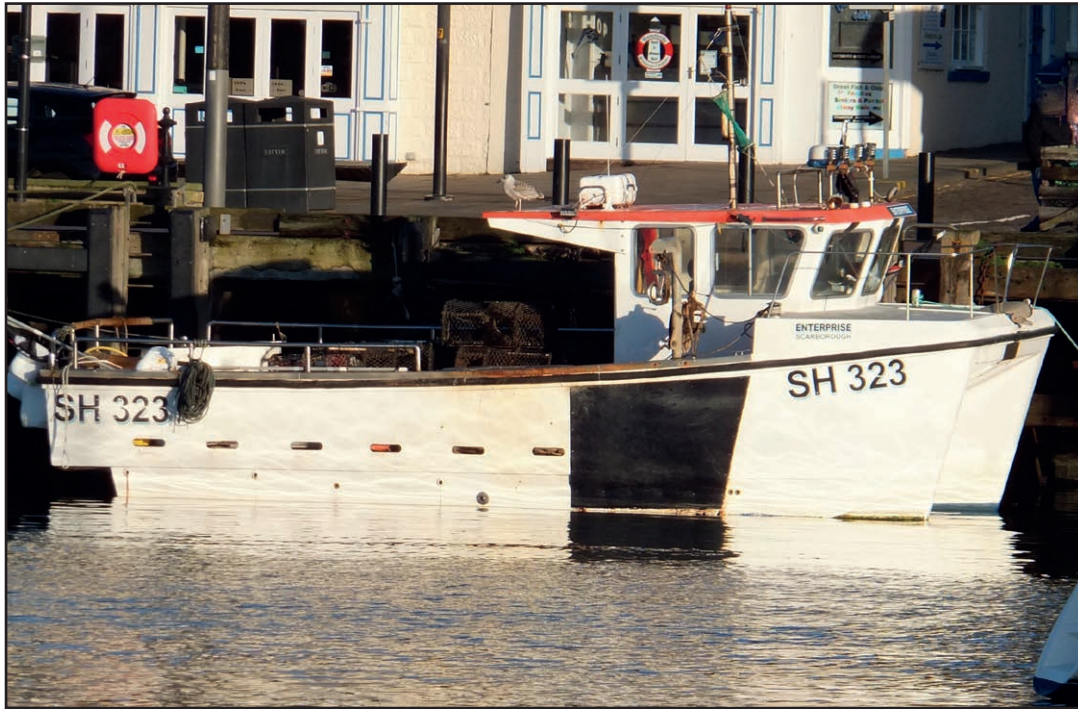
On 6 November 2017, a deckhand on board the 8.95m potter *Enterprise* died after becoming caught in the backrope and then being dragged overboard. He had left a 'safe zone' protected by pound boards as a fleet of pots was being shot away. As the deckhand walked forward towards the wheelhouse, his left leg was snared in a loose bight of the running backrope. The bight quickly tightened and the weight of the shooting pots dragged the deckhand through the shooting door and under the water. Another deckhand grabbed the backrope, but he was unable to hold on to it.

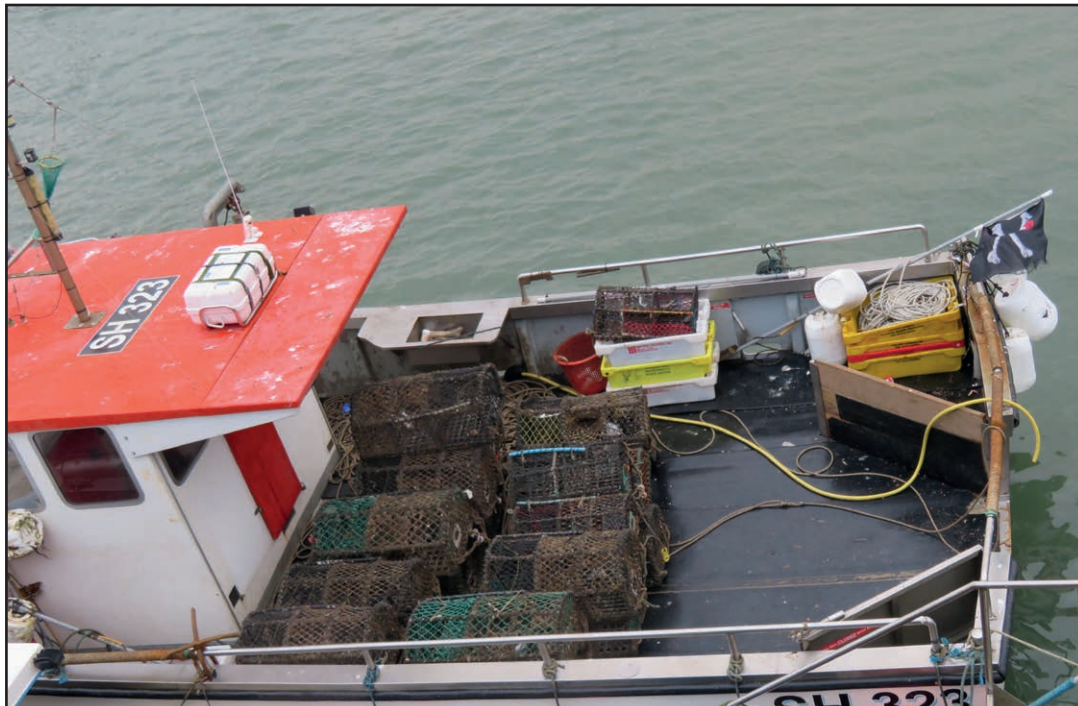
After dropping the anchor and marker buoy at the start of the shooting process, it was the deckhand's usual routine to remain in the 'safe area' behind the pound boards until only five or six pots remained on deck. The deckhand could then walk over the relatively clear deck towards the wheelhouse to drop the remaining anchor and marker buoy. This time, the deckhand left the 'safe area' without apparent reason, and attempted to cross over the running backrope while about 20 pots remained on deck. The deckhand had worked on board *Enterprise* for several years, and had been cautioned previously by its skipper for occasionally leaving the 'safe area' prematurely and crossing the running backrope.

2. Self-shooting arrangements, which in this case included the fitting of a shooting door and pound boards, reduce the risk of entanglement with the running line. Nonetheless, it is essential that crew remain separated from the backrope and pots as they are deploying. This requires a safe shooting routine to be established, and for the crew involved to rigorously adopt the routine and not place themselves in harm's way.
