AAIB Bulletin

5/2018

Published 10 May 2018

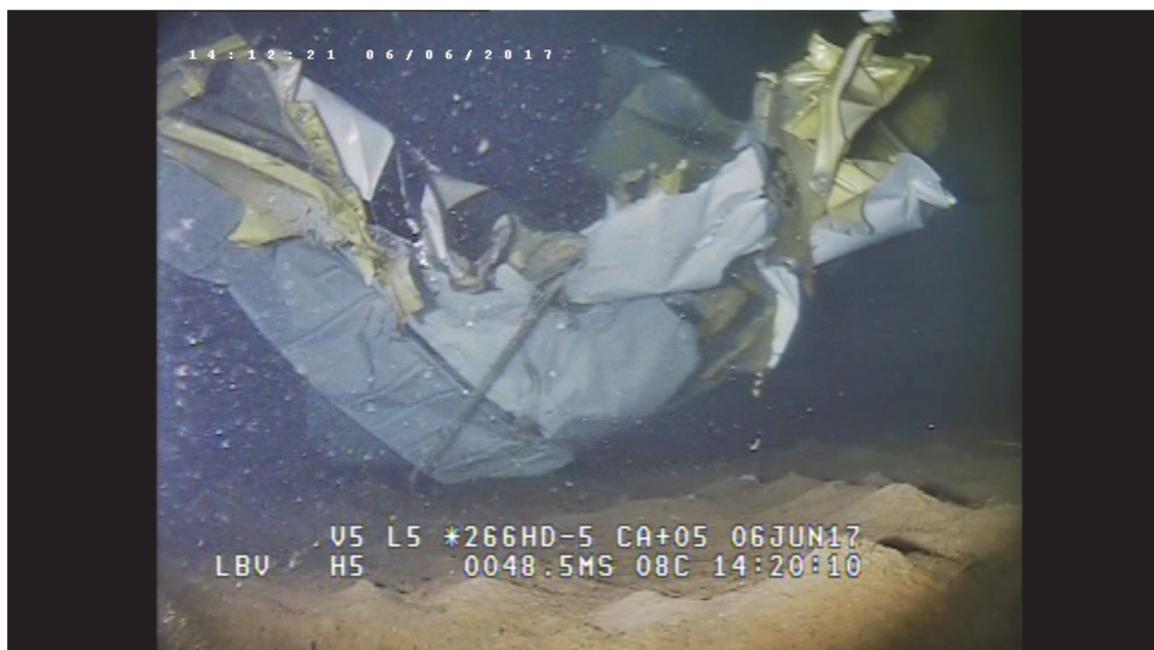
Figure 7

The witness descriptions of the floating sections of the aircraft, the AAIB examination of the aircraft seats, and the condition of the left wing found on the seabed (Figure 7) all indicate that the aircraft broke up when it struck the water.

Left wing on seabed

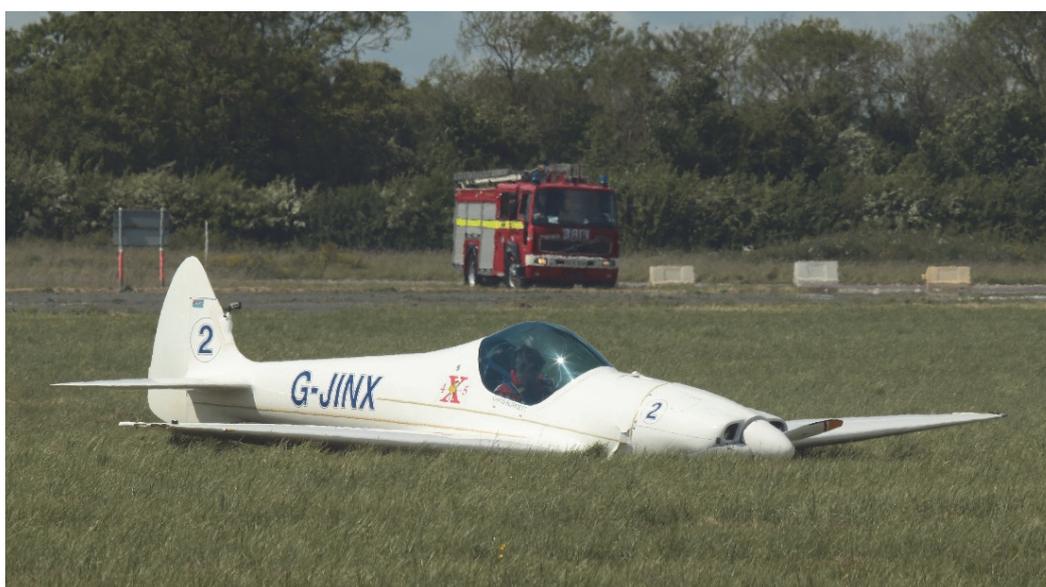
Figure 2

G-JINX after accident
(Picture courtesy of Peter Thomas)

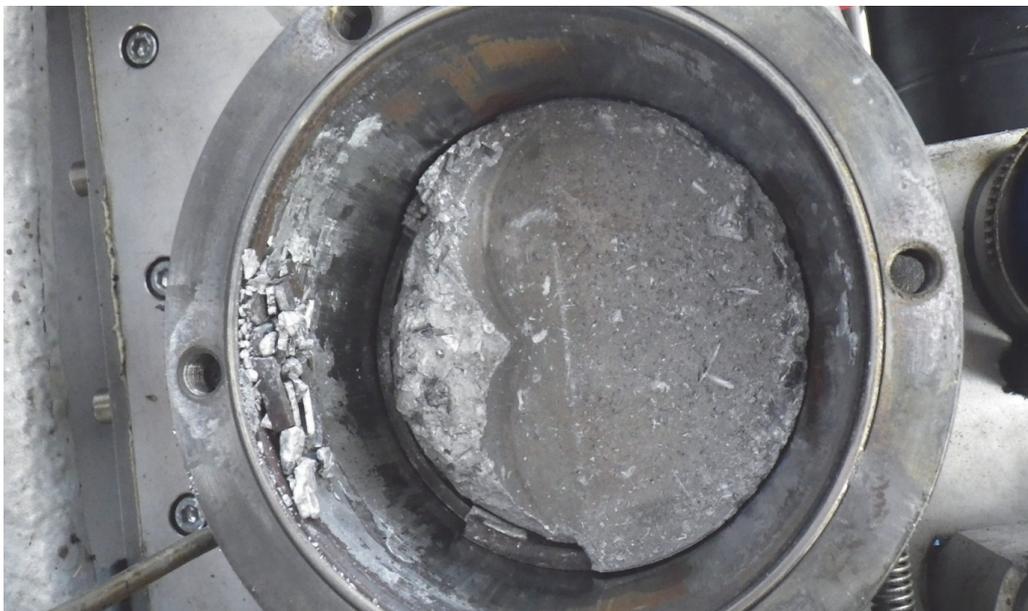
Figure 7

The engine could not be rotated by hand. Externally there was no obvious damage other than to the oil cooler and propeller. On removing the cylinder heads it was discovered that the No 3 piston had been badly damaged and a significant section had broken away (Figure 7). There was no evidence of detonation or cracking of the piston. The inside of the cylinder was dry, and marks on the side of the piston and inside of the cylinder bores indicated that the piston had seized in the cylinder. The piston rings and scraper had all been damaged. The remaining three cylinders were also dry and there was damage to the sides of all the pistons and cylinders indicating that the pistons had expanded and had started to 'grab' the side of the cylinder.

Damage to No 3 piston and cylinder

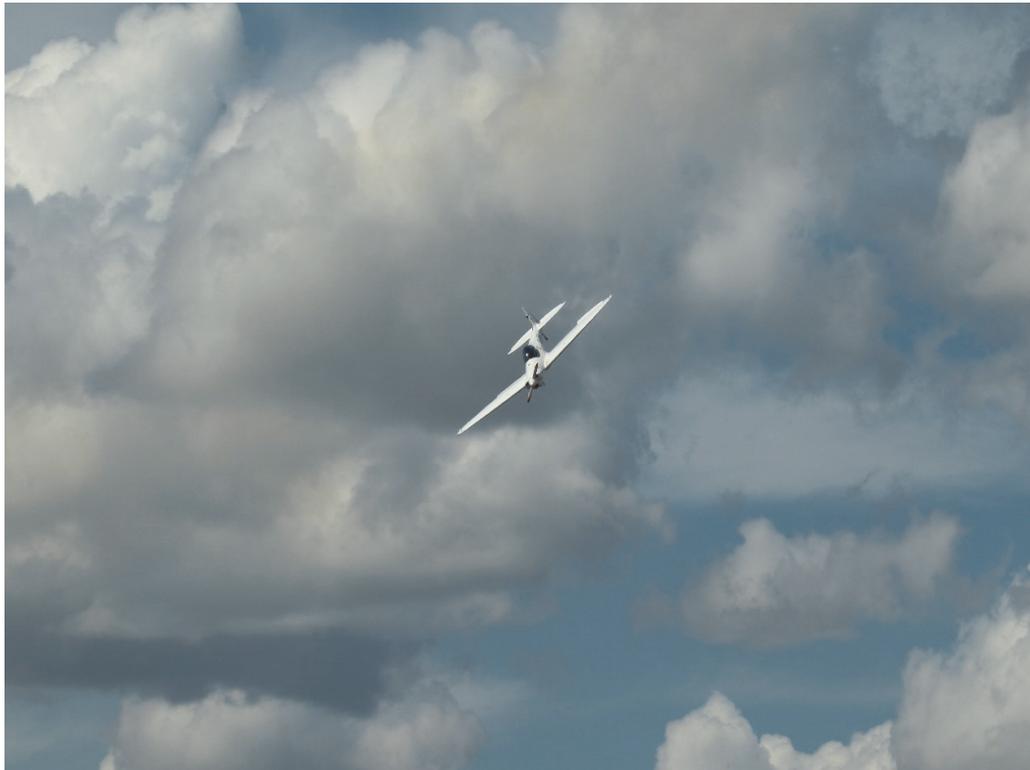
Figure 9

G-JINX shortly before ground impact
(Picture courtesy of Peter Thomas)

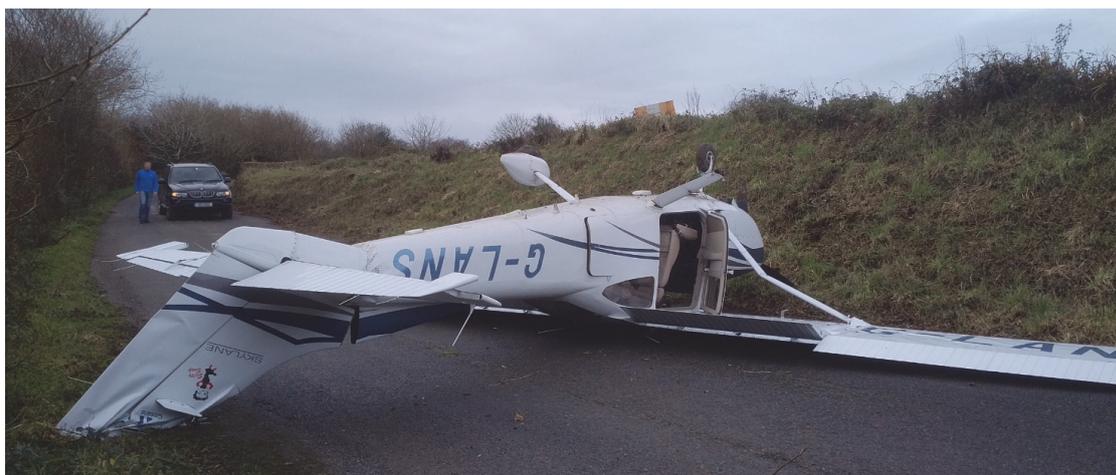
Figure 1

G-LANS inverted on the perimeter road following the accident.

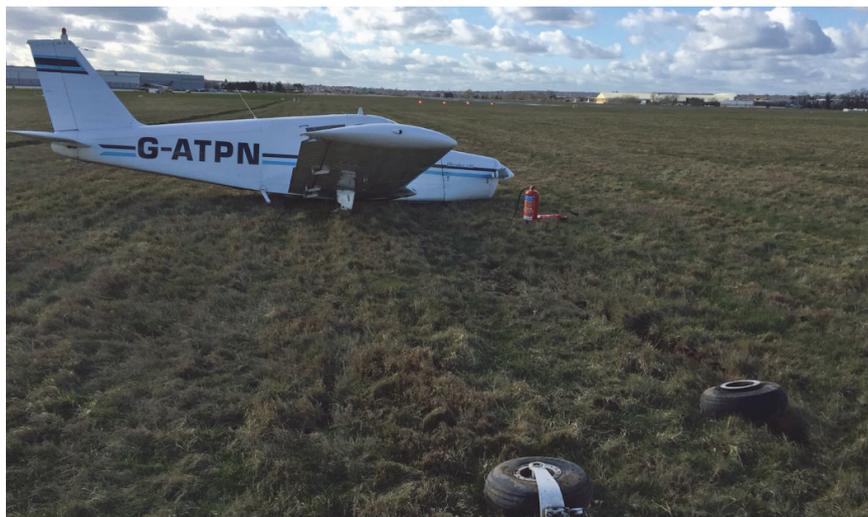
Figure 1

G-ATPN in its resting position approximately 95 m from the centreline of Runway 23

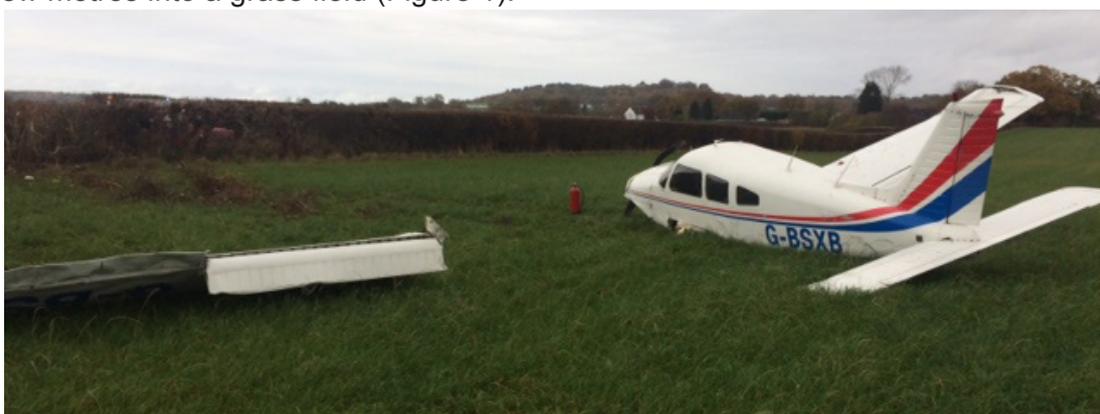
Figure 1

G-BSXB, with its left wing detached, facing back towards the second hedge

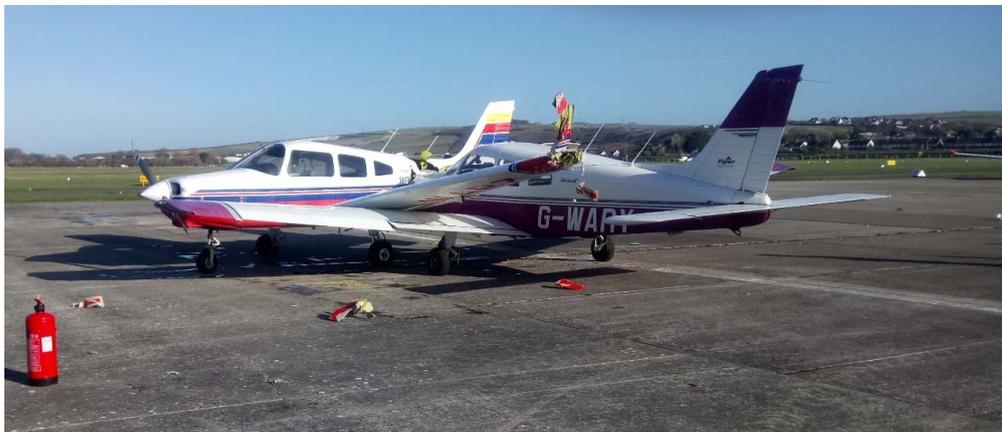
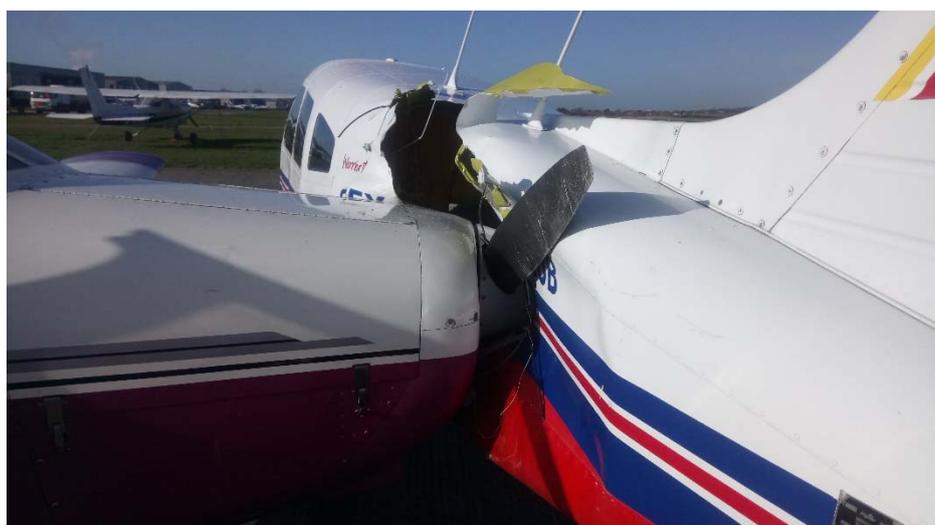
until the turning propeller penetrated its rear fuselage and brought everything to a stop. The aircraft were now interlocked and substantial damage was caused to G-WARZ, as shown in Figures 1 and 2.

G-WARY and G-WARZ interlocked
(Pictures courtesy of Shoreham Airport)

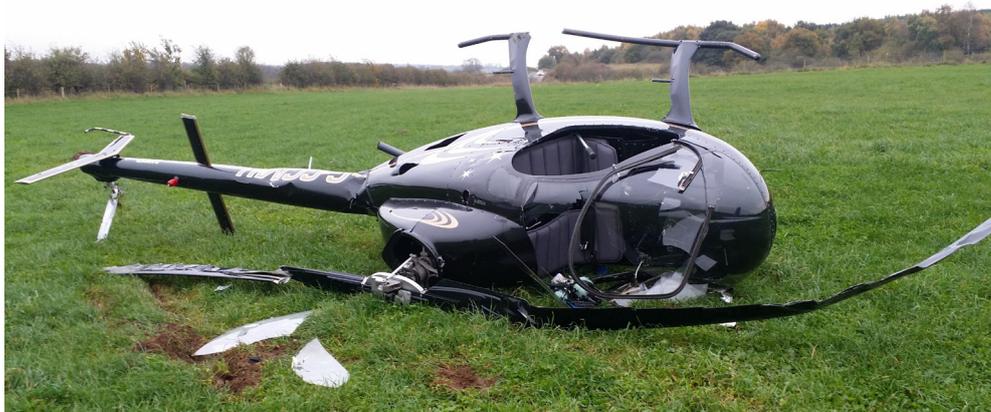
Figure 1
G-CCMU after the accident

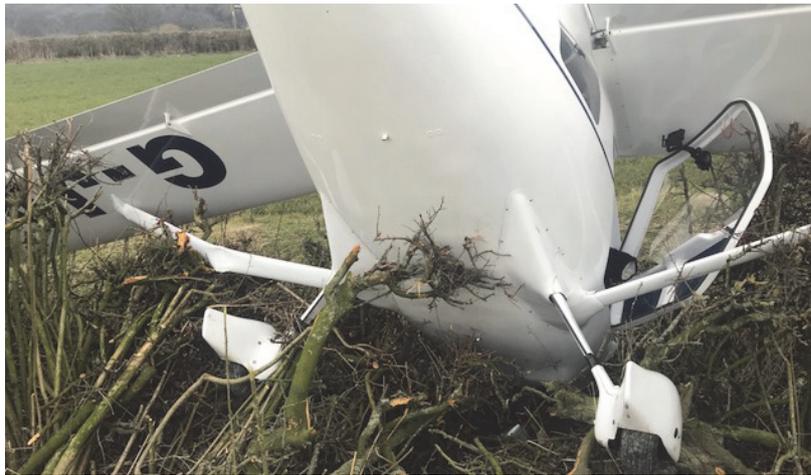
Figure 1

G-JAXS enmeshed in the airfield boundary hedge
