# Rail Accident Report

## **Passengers struck by a flying cable at Abergavenny (Y Fenni) station 28 July 2017**

Report 06/2018  
May 2018

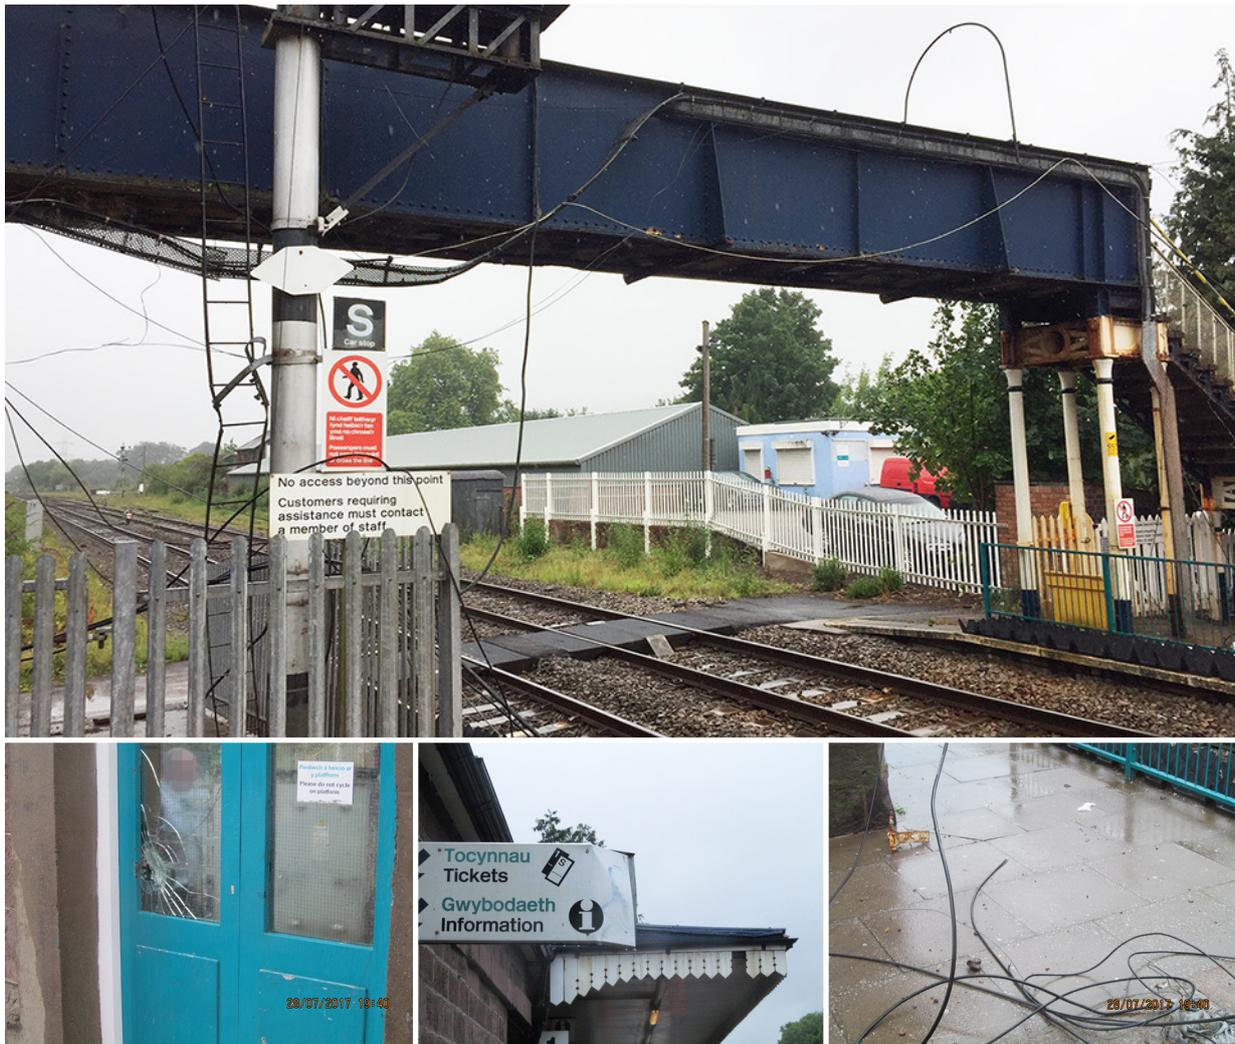
- 4 The free end of the cable whipped round, and it struck a group of passengers on the footbridge stairs and caused minor injuries to three of them. A member of station staff who was on the platform and close to the footbridge, reported hearing a noise as the cable broke free and ducking just as the flying cable end passed over his head. The accident caused damage to cables and the cable tray running over the footbridge, station buildings and to other equipment on the station (figure 2).

Figure 2: Damage to the cable tray running over the footbridge, station buildings and to other equipment on the station (main image courtesy of Network Rail and inset images courtesy of British Transport Police)

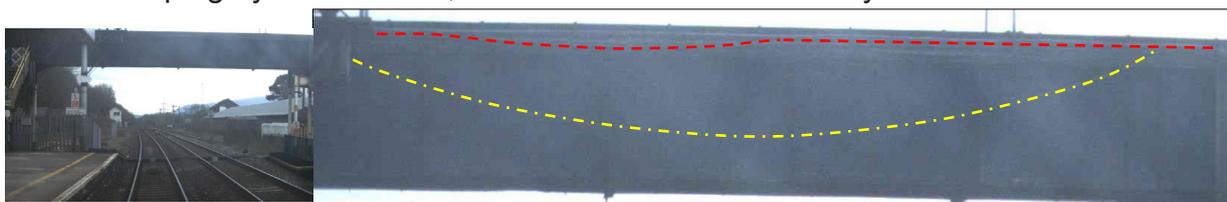
**26 February 2016: Image from Network Rail infrastructure measurement train**  
 Cable drooping by ~0.1 metres, telecommunications cable by ~1.0 metres

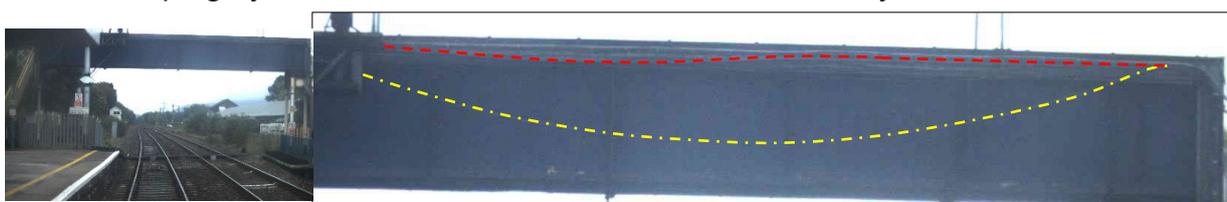
**7 October 2016: Image from Network Rail infrastructure measurement train**  
 Cable drooping by ~0.15 metres, telecommunications cable by ~1.0 metres

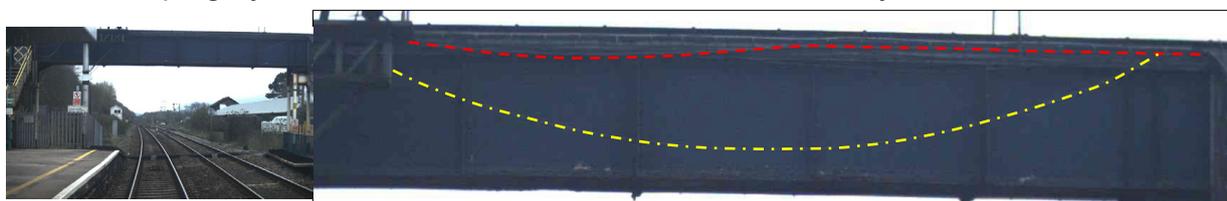
**24 March 2017: Image from Network Rail infrastructure measurement train**  
 Cable drooping by ~0.15 metres, telecommunications cable by ~1.15 metres

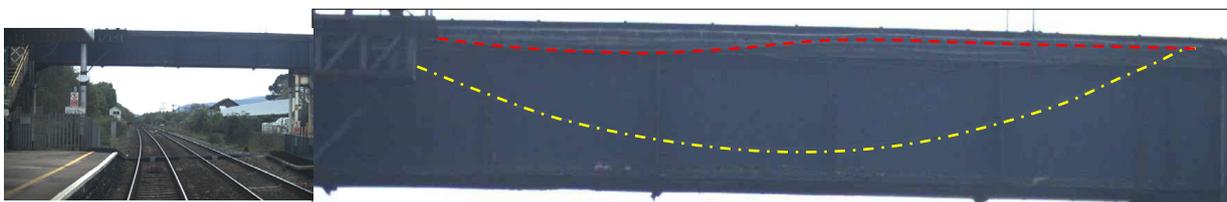
**21 April 2017: Image from Network Rail infrastructure measurement train**  
 Cable drooping by ~0.17 metres, telecommunications cable by ~1.15 metres

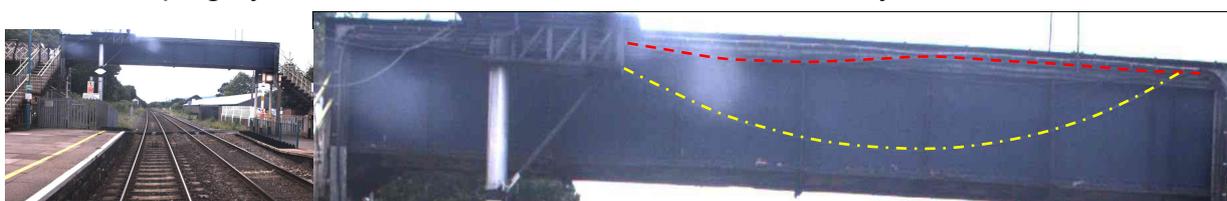
**14 July 2017: Image from Network Rail infrastructure measurement train**  
 Cable drooping by ~0.17 metres, telecommunications cable by ~1.15 metres

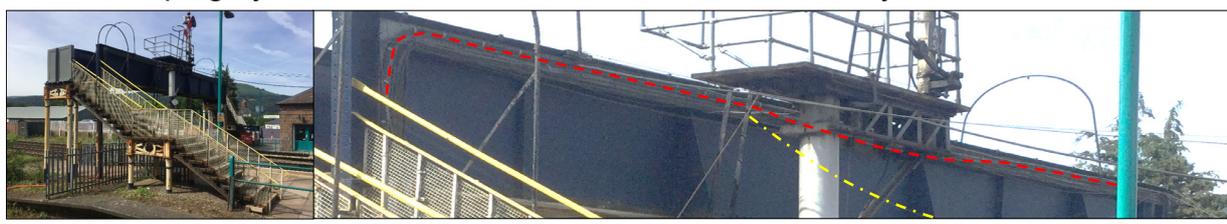
**17 July 2017: Image from Network Rail site visit to station**  
 Cable drooping by ~0.17 metres, telecommunications cable by ~1.15 metres

*Figure 7: Images of the electrical supply (highlighted in red) and telecommunications (highlighted in yellow) cables drooping from the footbridge from February 2016 to July 2017 (images courtesy of Network Rail)*

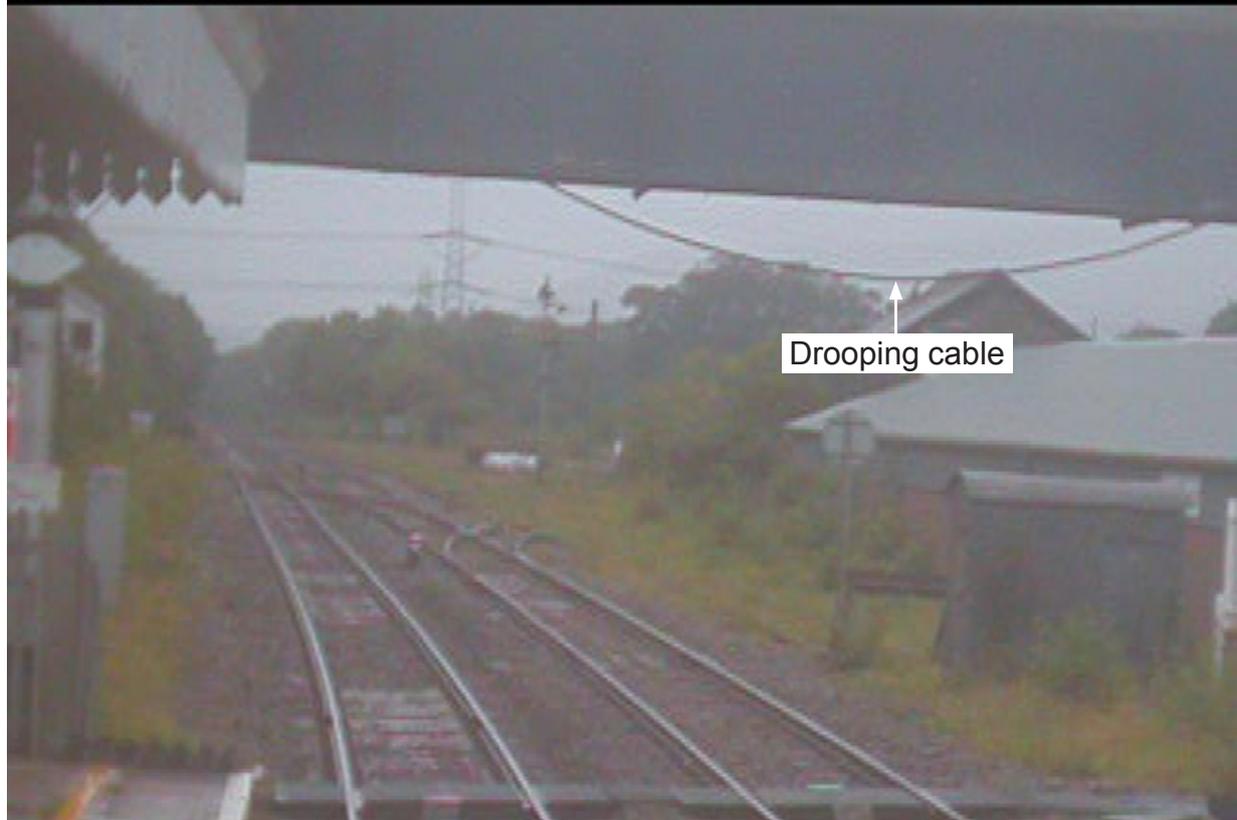
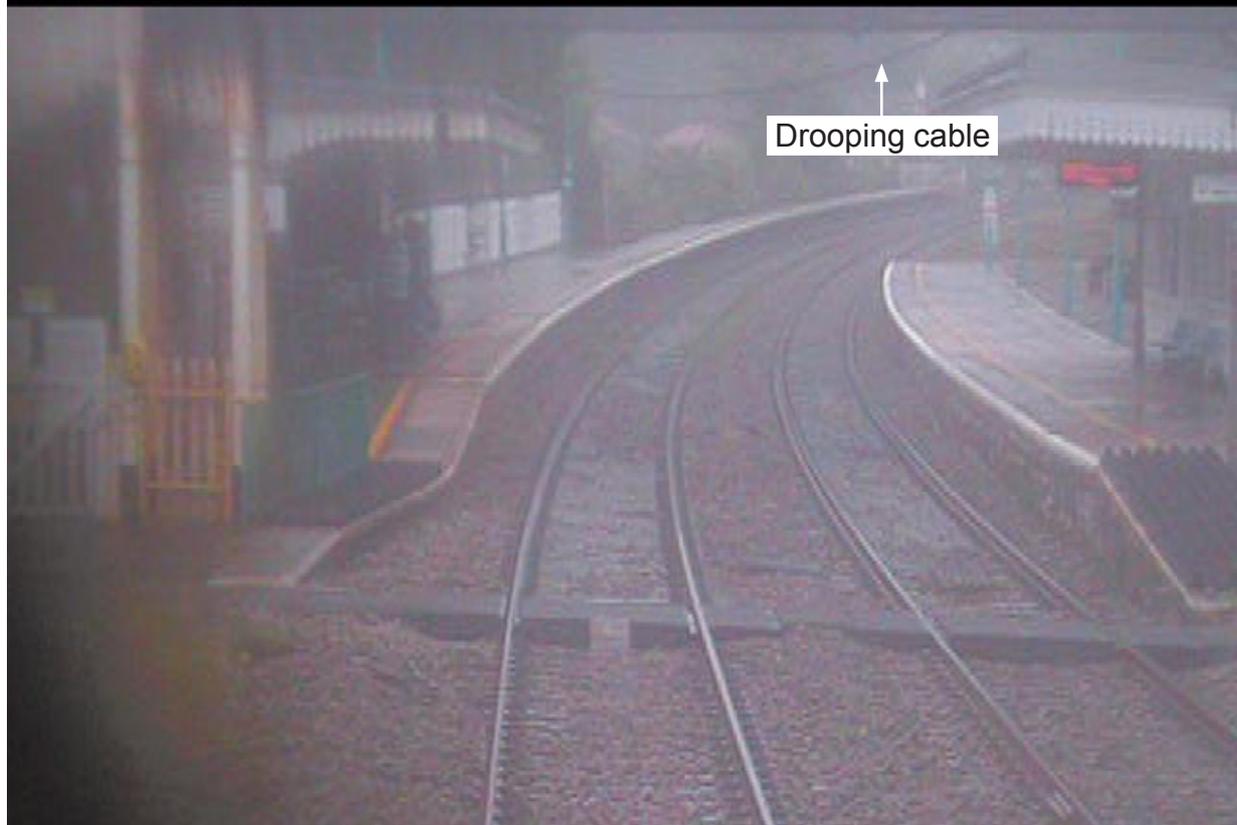
Drooping cable

Figure 9: CCTV images recorded by the last southbound train (top image) and last northbound train (bottom image) at Abergavenny prior to train 1W96 (images courtesy of Arriva Trains Wales)

- 29 CCTV footage recorded by trains in the hour before train 1W96 arrived at Abergavenny station, shows the electrical supply cable drooping about 0.55 metres below the bottom of the footbridge (figure 9). At this height, the cable was able to strike the roof of train 1W96 and then snag on it (paragraphs 18 to 20). The position of the telecommunications cable cannot be seen in the CCTV footage as the image quality was affected by the poor level of ambient light. However, this cable was not reported to have caused any of the injuries.

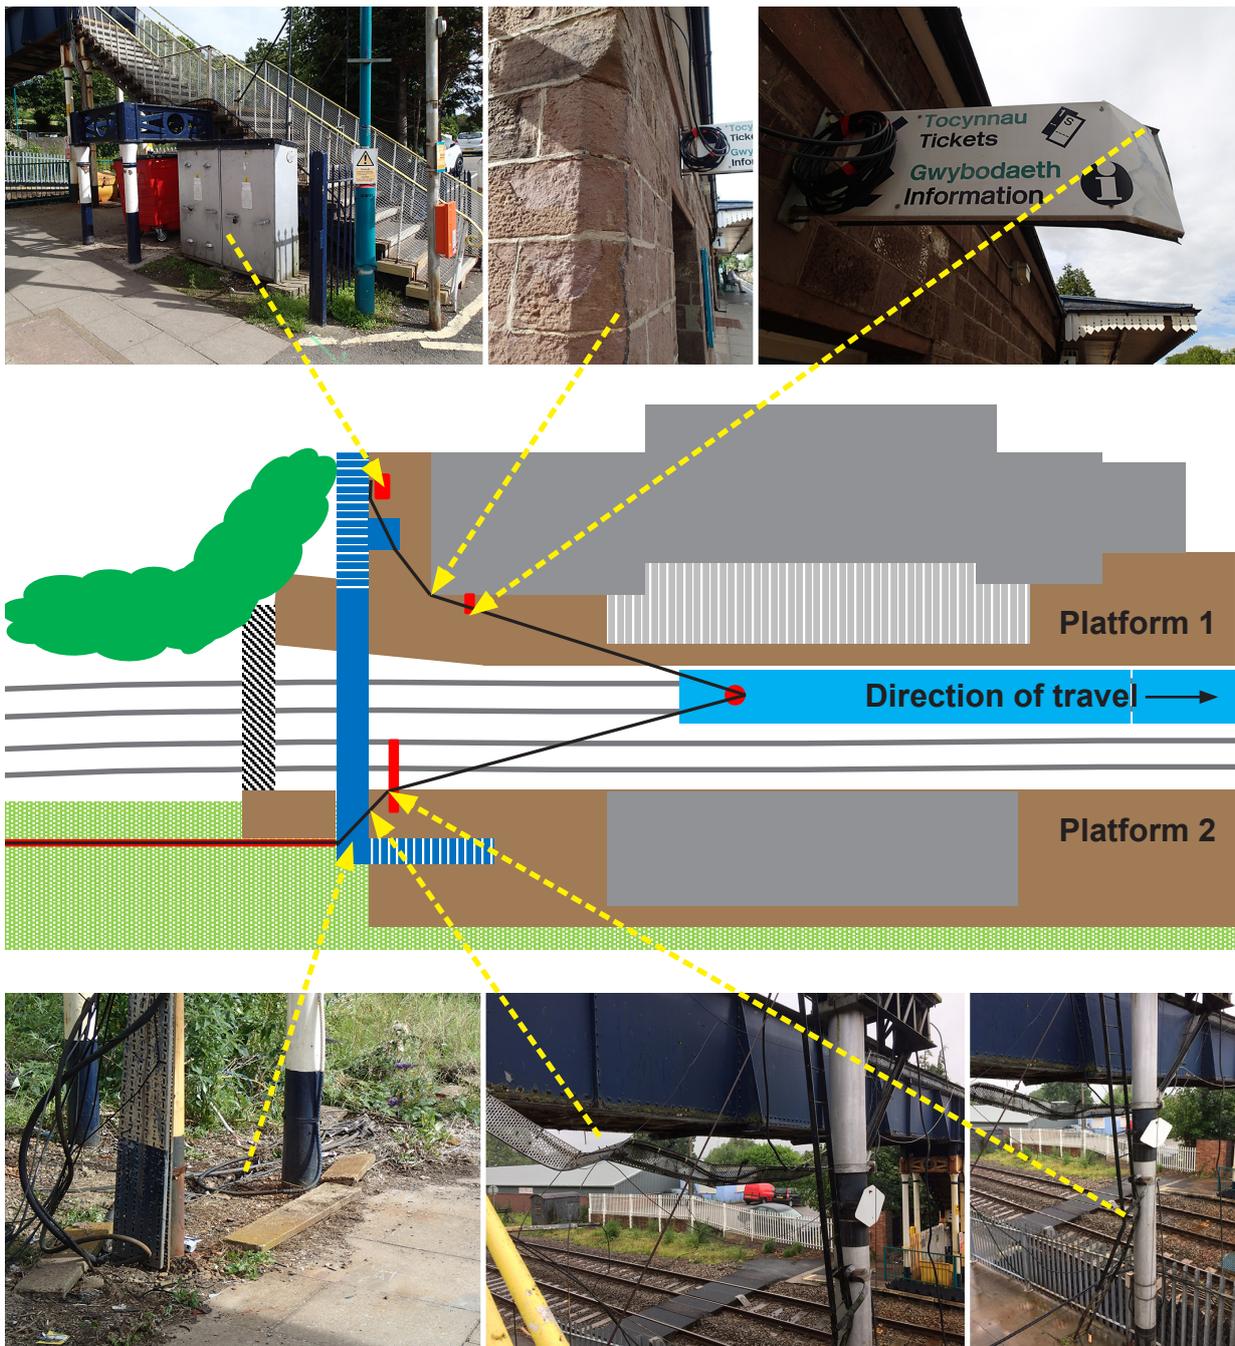
- 19 A witness standing on platform 1 was watching the train as it arrived and noticed both the electrical supply and telecommunications cables snag on the roof of the rearmost vehicle of the train. Once snagged, these cables were pulled off the cable tray they were attached to. The electrical supply cable was pulled from its fixings on the footbridge stairs and out of a cable trough (figure 10). While being pulled, this cable caused damage to other cables, the cable tray, a signal ladder and a station sign (figure 10). It also moved a wheeled bin which struck and broke a pane of glass in the waiting room door (figure 2).

Figure 10: Diagram showing the position of the electrical supply cable as the train pulled it and photographs of the damage caused to various items (bottom middle and bottom right images courtesy of Network Rail)

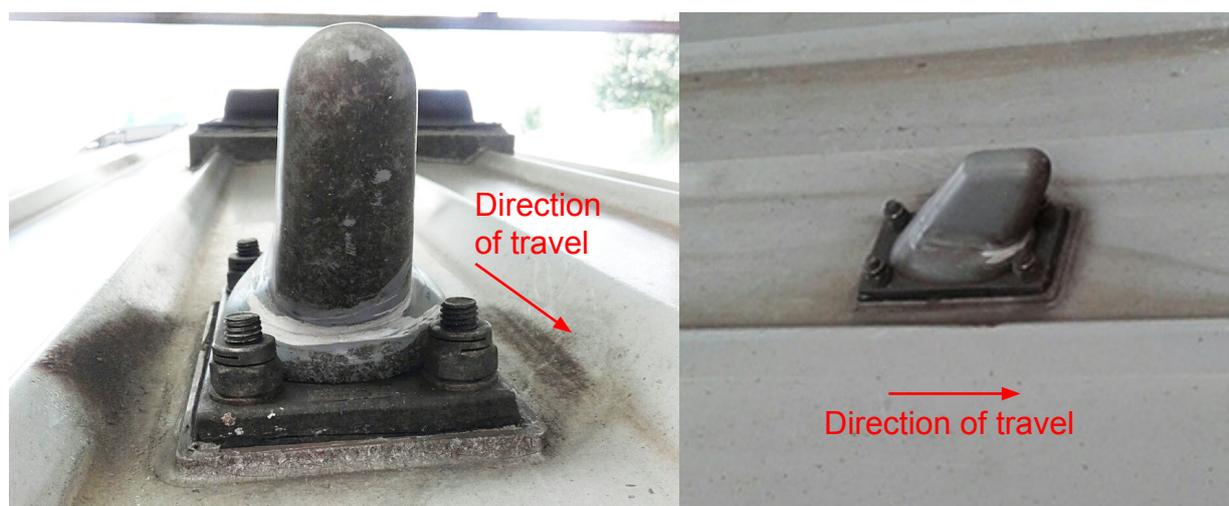
33 On Monday 31 July, Arriva Trains Wales maintenance staff carried out an examination of the train at roof level. Staff found no obvious marks on the roof of the locomotive's leading cab but did find minor damage and witness marks on the roofs of the coaches which continued to the DVT at the rear of the train. The final witness mark found was on the radio antenna (figure 14). The shape of the antenna, which was raked forwards in the direction of travel at the time, increased the likelihood of the cable becoming snagged. The antenna is the highest point on the vehicle, mounted just off the centre line of the roof.

Figure 14: The radio antenna on the roof of the DVT (images courtesy of Arriva Trains Wales)

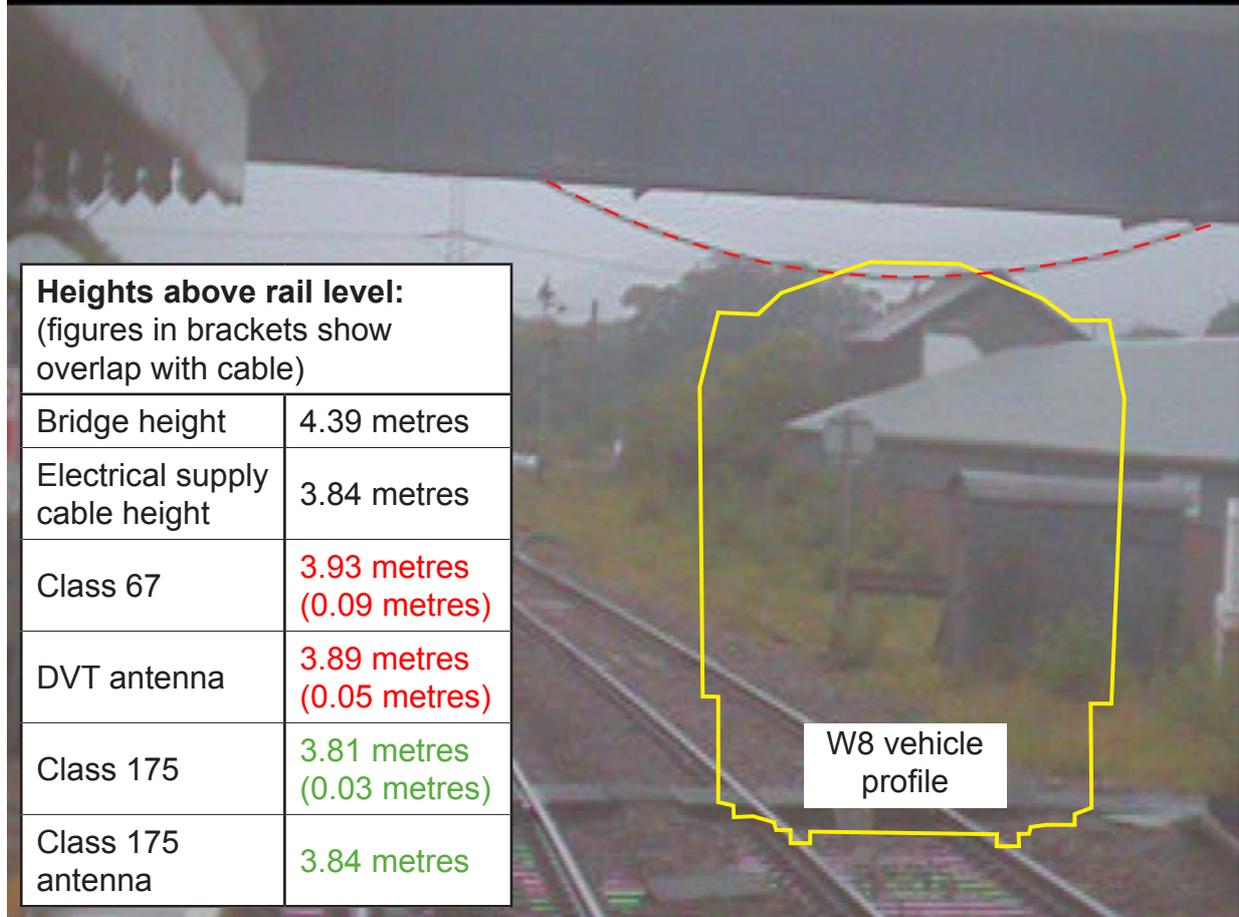
- 39 Figure 16 shows the nominal heights above rail level for the locomotive and the DVT. It also shows the nominal height above rail level for a class 175 unit, which was the type of train that had formed the previous passenger services through Abergavenny and had recorded CCTV footage showing the drooping cable (paragraph 15). The lower height of the class 175 unit probably explains why the previous train did not snag the cable as it passed under the footbridge.

Figure 16: Vehicle heights above rail level in relation to the electrical supply cable drooping from the footbridge (background image courtesy of Arriva Trains Wales)

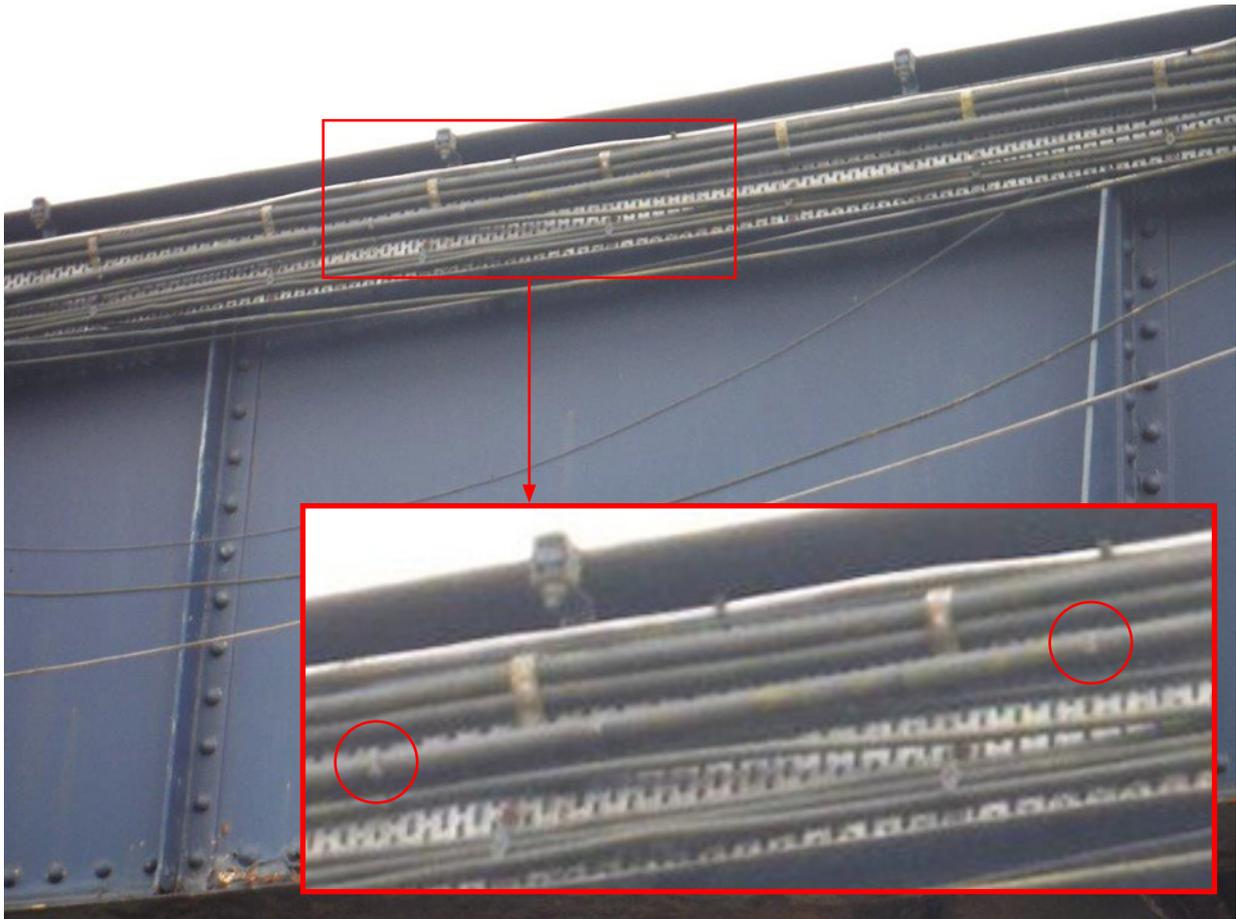
- 41 The cable was attached to the cable tray using 4.6 mm wide black nylon cable ties which were spaced about every 0.4 metres (figure 17). The vertical orientation of the cable tray meant that the cable ties directly supported the weight of the cable (paragraph 30).

Figure 17: Photograph taken in December 2016 showing the electrical supply cable attached to the cable tray by cable ties (image courtesy of Centregreat Engineering)

- 42 Advice from the manufacturers of nylon cable ties often states that this type of cable tie is not suitable for outdoor applications. This is because the ties become brittle over time when used in an outdoor environment, because the nylon degrades when subjected to ultraviolet radiation, temperature cycles and moisture.
- 43 Once one cable tie had broken, the cable ties either side would have had to support a greater weight. The increased load on these cable ties would have caused them to break, probably more quickly than the first, leading to the successive failure of the cable ties, and the cable drooping further with each failure.

- 44 The installation of the cable did not comply with the requirements in British Standard BS7671:1992, 'Requirements for Electrical Installations', commonly referred to as the 16<sup>th</sup> edition of the Institution of Engineering and Technology wiring regulations. The 16<sup>th</sup> edition of the wiring regulations applied from 1991<sup>4</sup> to 2007; it is thought that a replacement cable tray was installed in the early 1990s (paragraph 13). The installation was also not compliant with the current (17<sup>th</sup>) edition of the standard which has applied since 2008. BS7671 is not prescriptive about what cable fixings should be used for an electrical installation, but within chapter 52, section 522 covers the selection and erection of wiring systems<sup>5</sup> in relation to external influences. In section 522.11, titled 'Solar radiation and ultraviolet radiation', paragraph 522.11.1 states 'Where significant solar radiation or ultraviolet radiation is experienced or expected, a wiring system suitable for the conditions shall be selected and erected or adequate shielding shall be provided'. The installation did not comply with this requirement as nylon cable ties are not suitable as fixings when exposed to ultraviolet radiation and these fixings were not shielded.

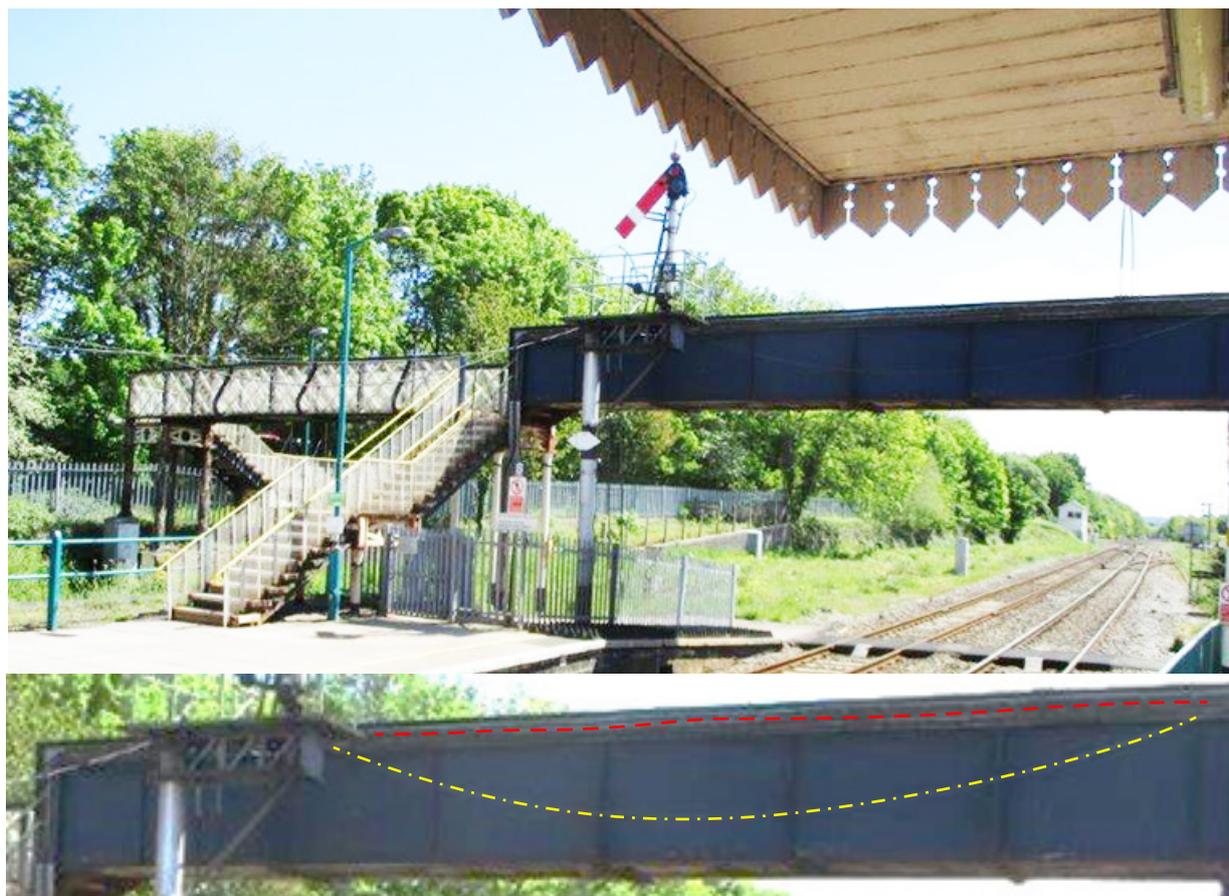
- 55 The footbridge structure at Abergavenny forms part of the station lease between Network Rail and Arriva Trains Wales (paragraph 8). This meant that it was subject to a detailed operational property inspection by Network Rail every five years, with yearly visual inspections in between. The last detailed inspection took place in May 2016, no visual inspection has taken place since then.
- 56 A photograph taken during the last detailed inspection in May 2016 (figure 20) shows the cable had begun to droop. It was drooping by about 0.1 metres from its normal position, over a length of about 3 metres. The telecommunications cable can be seen drooping about one metre from the top edge of the footbridge.

Figure 20: Photograph of the footbridge taken during the last detailed inspection in May 2016 with drooping electrical supply (red) and telecommunications (yellow) cables (image courtesy of Network Rail)

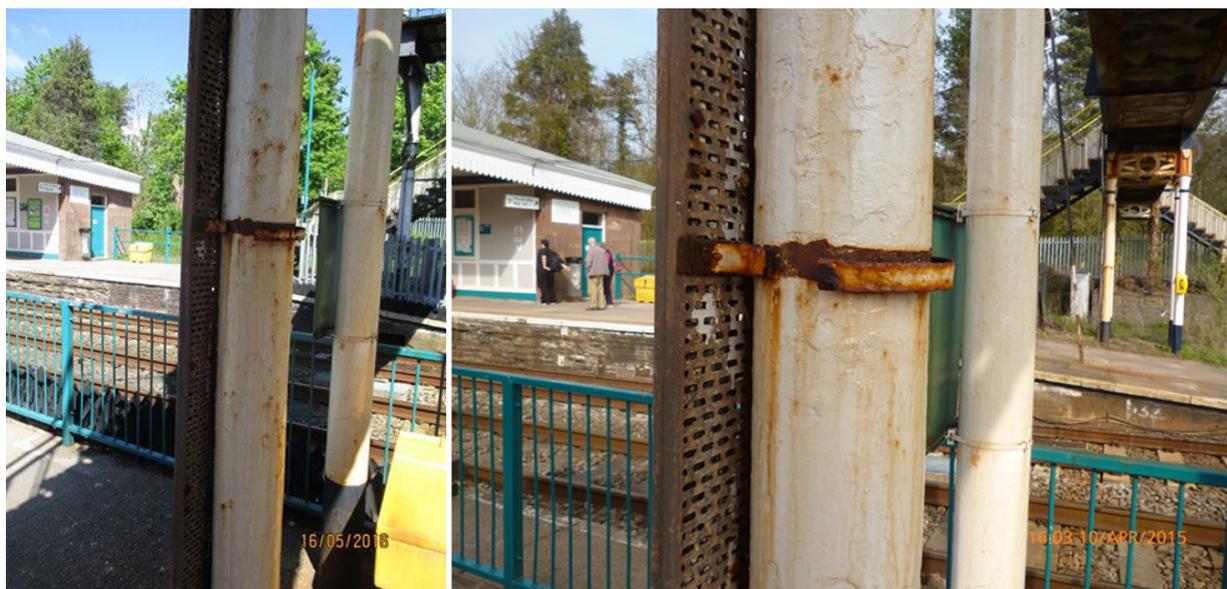
- 59 The records from the last detailed operational property inspection in May 2016 included three defects related to how the cable tray was attached to footbridge. Brackets that fasten the cable tray to the footbridge were found to be corroded and broken (figure 21).

Figure 21: Photographs of the cable tray bracket defects found during the last detailed inspection in May 2016 (images courtesy of Network Rail)

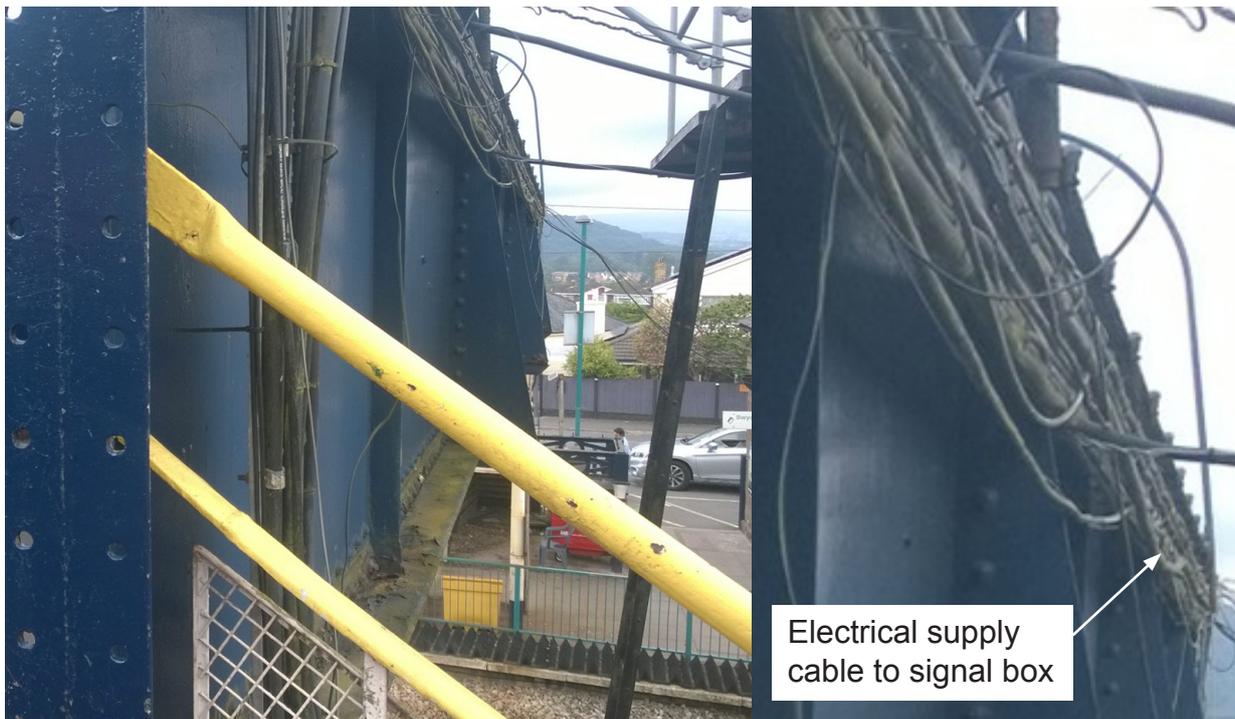
- some cables were not attached to the cable tray, but instead to other cables by nylon cable ties.
- 69 Requirements for cabling that crosses the operational railway underneath the track are set out in Network Rail company standard NR/SP/SIG/19812 'Cross Track Cable Management'. Network Rail had identified that it needed to manage the risks associated with the installation of cables passing under the track, primarily to ensure track, and in particular its geometry, can be maintained appropriately. There is no directly equivalent standard to manage the risks associated with routing cables over the operational railway via structures.

Figure 22: Photograph of the cables and cable tray running over the footbridge at Abergavenny station on 19 July 2017 (images courtesy of Centregreat Engineering)

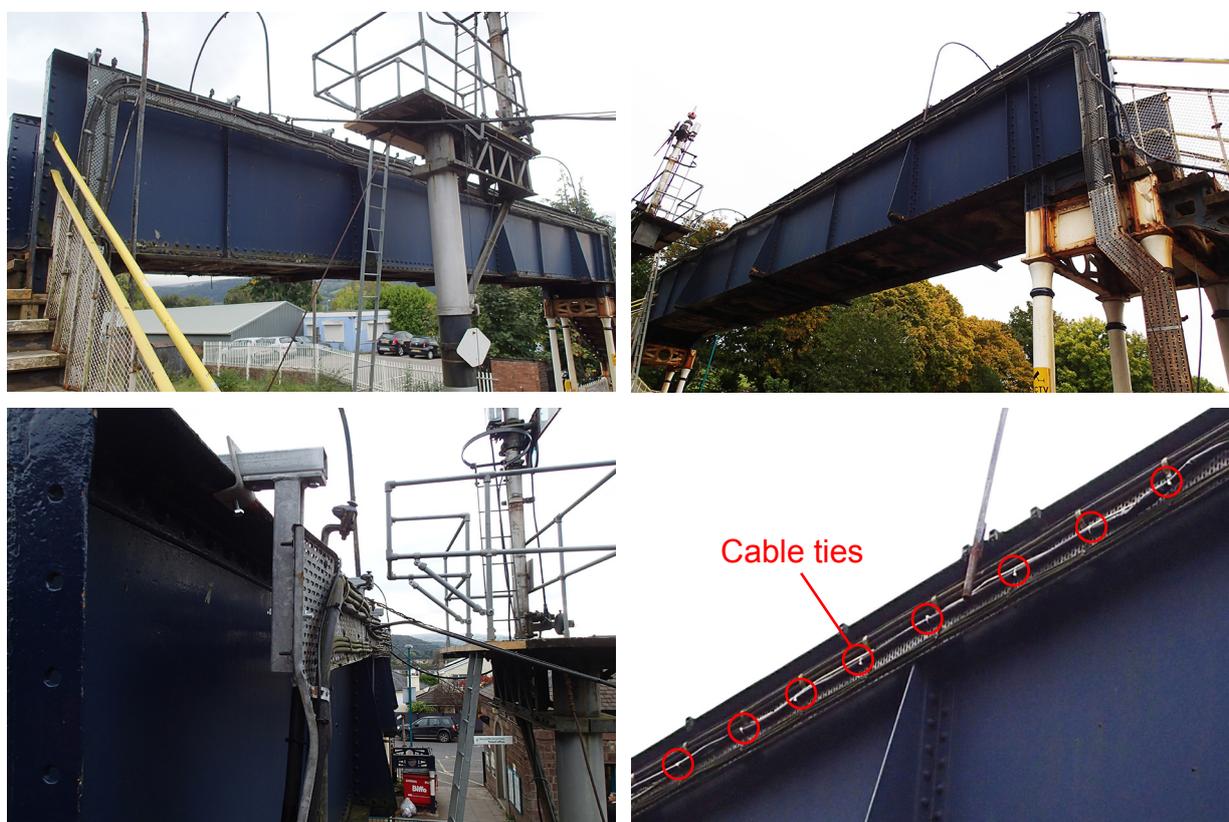
Figure 23: The repairs made to the footbridge cable tray after the accident

- 81 After the accident, Network Rail made temporary repairs to support the cable tray using rope so that the railway could reopen that evening. Network Rail carried out further work during August to provide new brackets to support the cable tray. However, these repairs resulted in the cable again being fixed to the cable tray using nylon cable ties (figure 23).

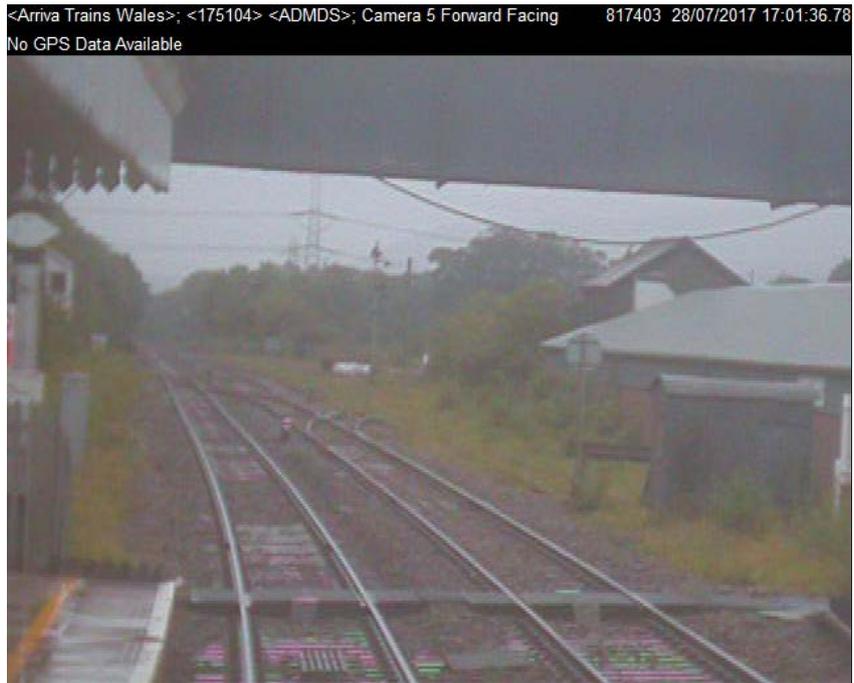
Figure 1: FFCCTV footage from a preceding train, showing the drooping power cable.
