SAFETY FLYER TO THE FISHING INDUSTRY

Flooding and foundering of the trawler *Ocean Way* on 3 March 2017

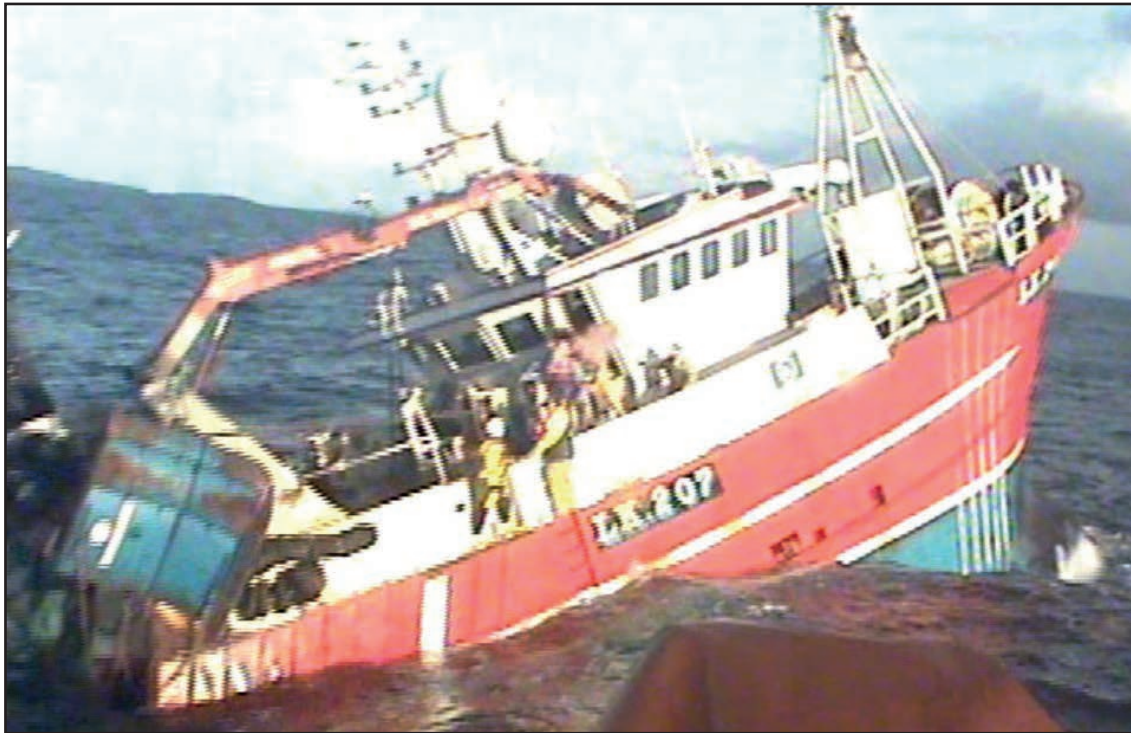
Ocean Way listing to port and trimmed by the stern just prior to foundering

At 0834 on 3 March 2017, the twin-rigged stern trawler *Ocean Way* foundered 18 nautical miles north-east of Lerwick, Scotland. *Ocean Way*'s crew was rescued uninjured and returned to shore by the Lerwick lifeboat. *Ocean Way* was lost because of an uncontrolled flood in the aft compartment; the source of the flood was almost certainly hull damage caused during the recovery of the port trawl door after the nets had been fouled on an obstruction.

The crew attempted to control the flood using the fixed bilge pumps in the engine room and portable submersible pumps via the aft compartment escape hatch. As the flooding took hold in the aft compartment, *Ocean Way* adopted a bow up trim that rendered the pumping from the engine room ineffective. In addition, the portable pumps were susceptible to blockages by debris in the aft compartment and the flood was never brought under control. *Ocean Way* was lost when the aft compartment escape hatch submerged, resulting in overwhelming downflooding.
