## Introduction

This notice is intended to inform all consignors, consignees and operators of LLWR approved TC14 and TC19 drums of clamping band failures; remedial actions being taken and advise Customers on actions they should take. Please circulate this information to all relevant personnel within your organisation.

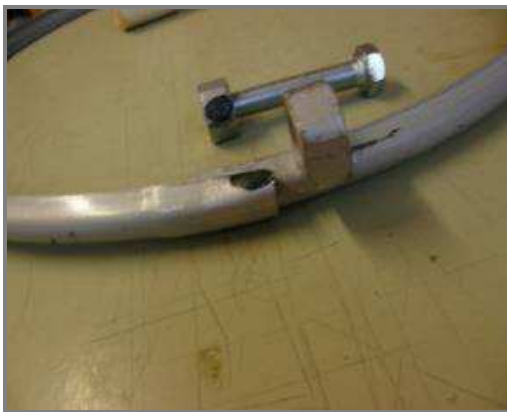
The component failures are all regarding the spot weld used to secure the locking ring nut to the steel (zinc plated) clamping band (see fig 1 and 2 below). In totality LLWR are only aware of six affected TC14 drums, and a single TC19 drum clamping ring out of over 10,000 drums manufactured.

Fig 1 – A clamping band with a failed spot weld (nut detached)

We are investigating an alternative method for fixing the nut to the ring that will be compliant with the existing licence and UN approval to minimise disruption to customers.

Customers are advised to review whether they would like to replace the clamping band before consigning any future TC14 or TC19 drums.

LLWR will provide new replacement clamping bands (with the additional welds) to all Customers wishing to replace their existing clamping bands.

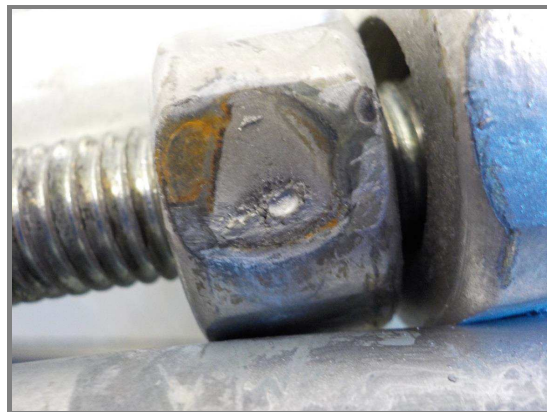
Fig.2 – close up of failed spot weld on nut showing reduced cross-sectional area of bonding
