Rail Accident Investigation Branch

Rail Accident Report

Collision at Stainforth Road level crossing, 11 January 2018

Report 08/2018
July 2018

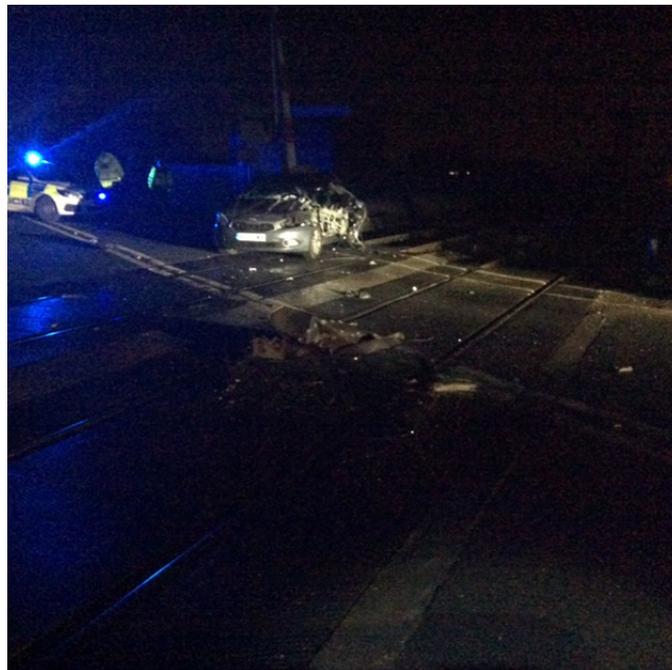
- 24 As she approached the crossing, the northbound car driver saw the wagon standing in front of her on the crossing and swerved to try and avoid a collision. Despite this, the passenger side of her car struck the wagon and the car was spun around, eventually coming to a rest pointing westwards (figure 5). Photographs of the damage sustained to the car and to the wagon involved show that the passenger side of the car collided with the headstock and buffer of the wagon (figures 6 and 7). Once the car had stopped moving, the car driver got out. As she did so, she saw the train pull away. The OTDR recorded that the train had been at a stand for 1 minute and 52 seconds.

Figure 5: Photograph of the crossing taken following the accident (image courtesy of Network Rail)

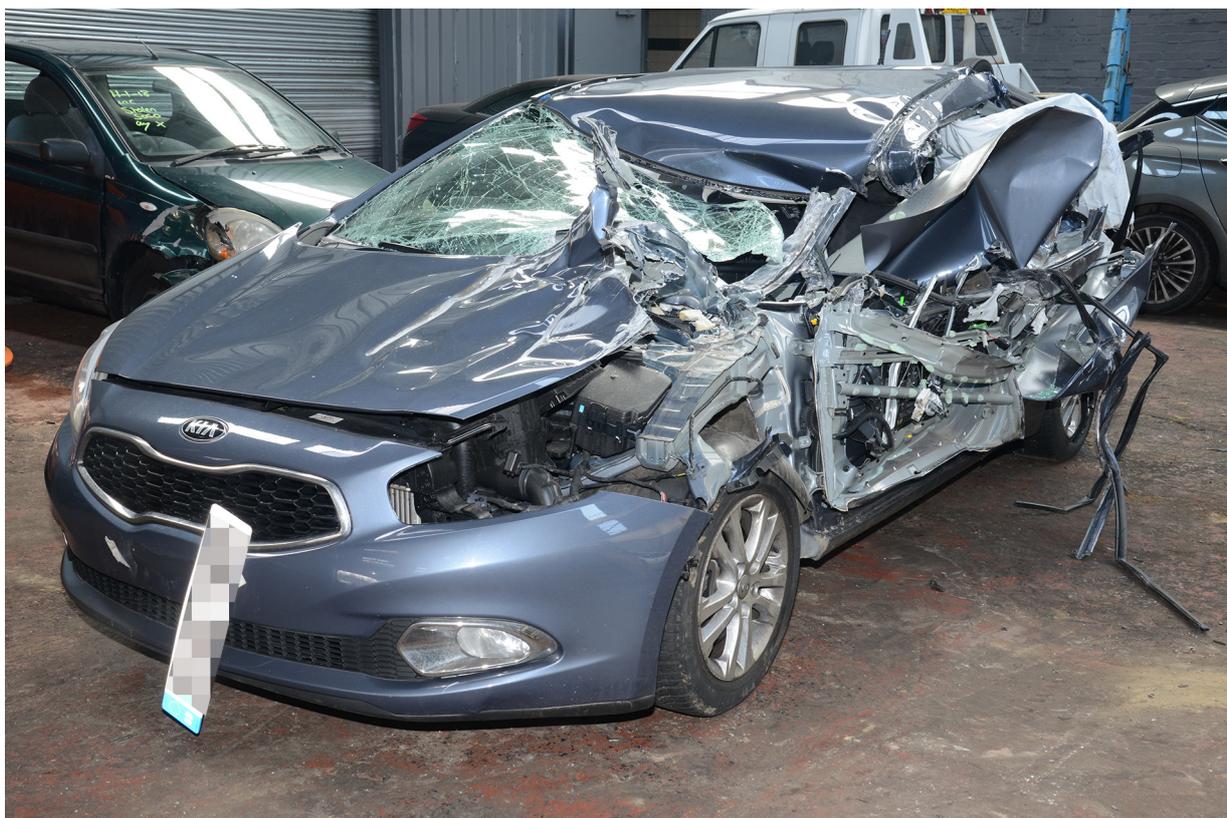
- 4 The driver of the car suffered scratches and bruises but her car was damaged beyond economic repair. The wagon sustained minor damage.

Figure 6: The damage sustained by the car as a result of the accident (image courtesy of the British Transport Police)

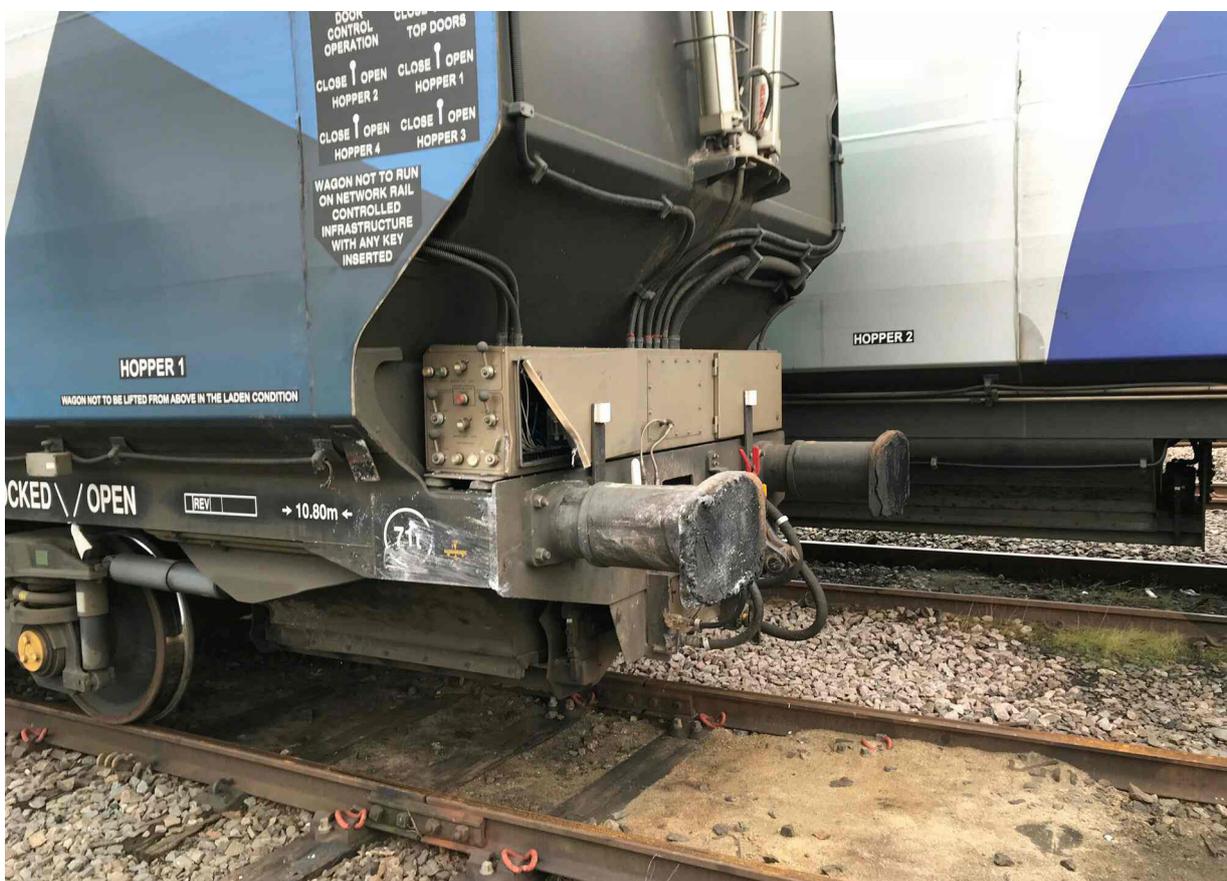
Figure 7: The damage sustained by the rearmost wagon as a result of the accident (image courtesy of Network Rail)

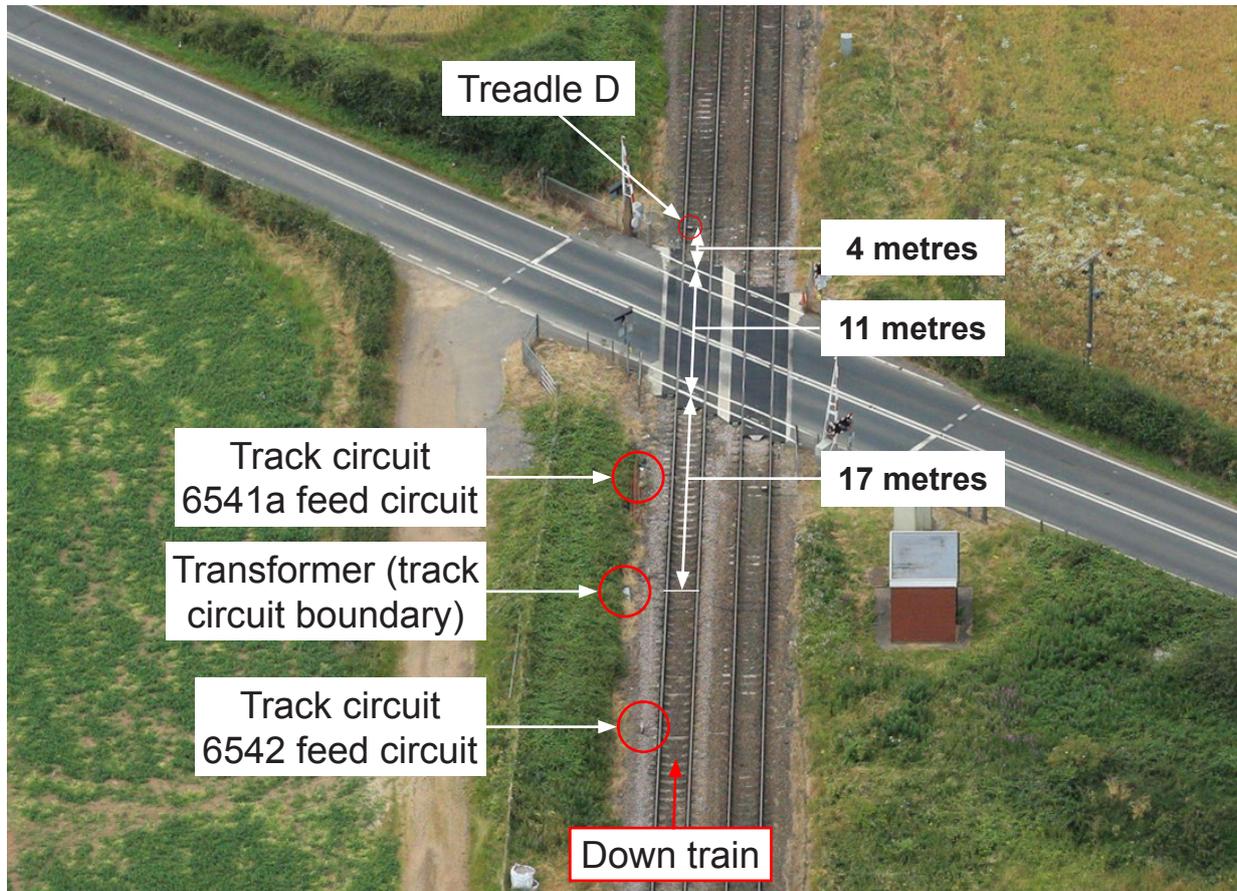
- 29 Track circuit 6542 terminates short of the crossing. The Down Skellow line immediately on approach to the crossing surface, the crossing surface itself and the track beyond it are monitored by track circuit 6541a. Occupation of this track circuit alone will not activate the road closure sequence. Network Rail stated that early designs of AHB had this arrangement so that the presence of tracked vehicles or salt in the crossing surface would not cause the crossing to close erroneously.
- 30 The track circuits in place at the crossing are of the audio-frequency type. This means there are no insulated block joints marking the boundary between circuits. Network Rail stated that the transformer unit located around 17 metres on approach to the crossing was used as the boundary between track circuits 6542 and 6541a (figure 11).

Figure 11: The track circuit and treadle arrangement at Stainforth Road AHB (underlying image courtesy of Network Rail)

- 33 Stainforth Road AHB will therefore start to re-open to road traffic when the rearmost axle of an approaching train passes a point around 17 metres on approach to the crossing. Allowing a nominal 3 metres for the overhang of a wagon's body, and taking into account the 11 metre width of the crossing's surface, trains on the Down Skellow line will therefore have to travel around 31 metres after the crossing's re-opening sequence has started, before they completely clear the crossing's surface. For a train travelling at the maximum permitted linespeed of 50 mph (80 km/h) this will take about 1.4 seconds.
