AAIB Bulletin

8/2018

Aircraft Type and Registration:	Piper PA-28RT-201 Cherokee Arrow IV, G-BHAY	
No & Type of Engines:	1 Lycoming IO-360-C1C6 piston engine	
Year of Manufacture:	1979 (Serial no: 28R-7918213)	
Date & Time (UTC):	11 September 2017 at 0956 hrs	
Location:	Wolferton, Norfolk	
Type of Flight:	Private	
Persons on Board:	Crew - 1	Passengers - 1
Injuries:	Crew - 1 (Fatal)	Passengers - 1 (Fatal)
Nature of Damage:	Engine front fuselage, wings and landing gear severely disrupted	
Commander's Licence:	Private Pilot's Licence	
Commander's Age:	58 years	
Commander's Flying Experience:	1,129 hours (of which 406 were on type) Last 90 days - 15 hours Last 28 days - 10 hours	
Information Source:	AAIB Field Investigation

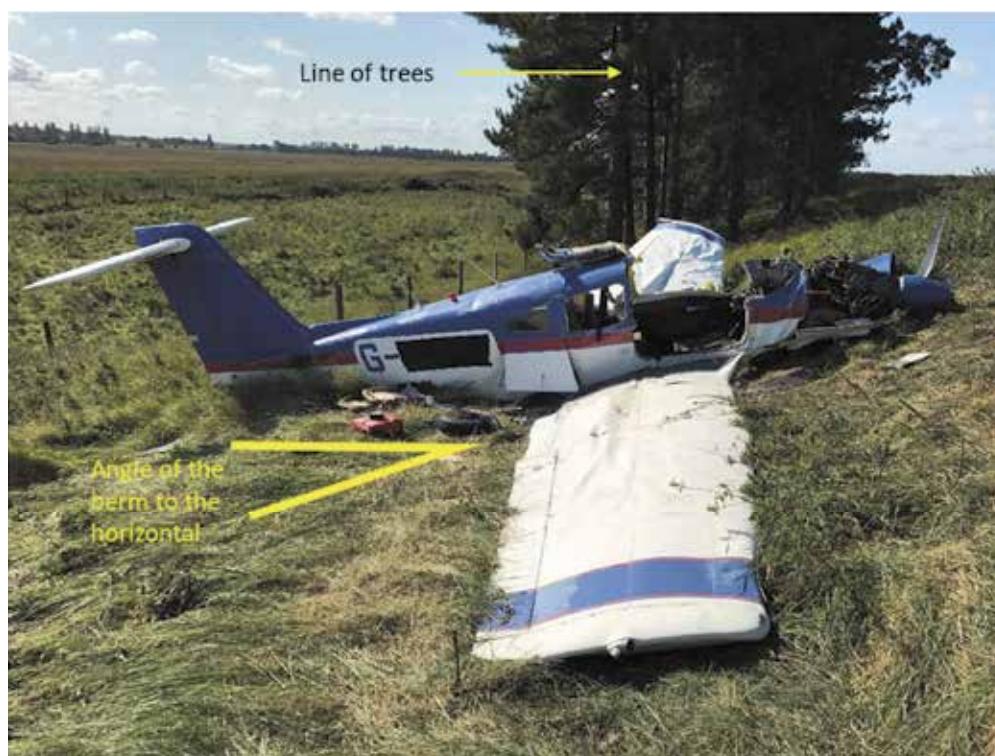
Figure 3
Accident site

The accident site was on private agricultural land towards the top of a berm (the old sea wall) which formed part of the secondary inland sea defences on the north Norfolk coast. There was a line of coniferous trees to the west of the accident site, visible in Figure 3; these were about 25 ft high.

The pilot was found in the left front seat and his passenger in the right front seat and the aircraft was upright on a northerly heading, complete except for the upper engine cowling which had detached during the impact and landed nearby. The windscreen had fragmented and the fuselage distorted in the severe vertical deceleration, so that the door frames and roof section were cut and folded back by the emergency services to release the pilot and passenger. The landing gear had been in the down position but the nose gear had been forced back up into its bay by the impact. The right main landing gear had been forced rearwards and detached from the wing whilst the left had remained attached but was also distorted rearwards.

One of the propeller blades was intact and the other blade had bent backwards under the nose of the aircraft. The propeller showed no signs of rotating when the aircraft hit the ground. There were no ground marks behind the aircraft and the only ground marks apparent were within the 'footprint' of the aircraft which were only visible after the aircraft was lifted during recovery.

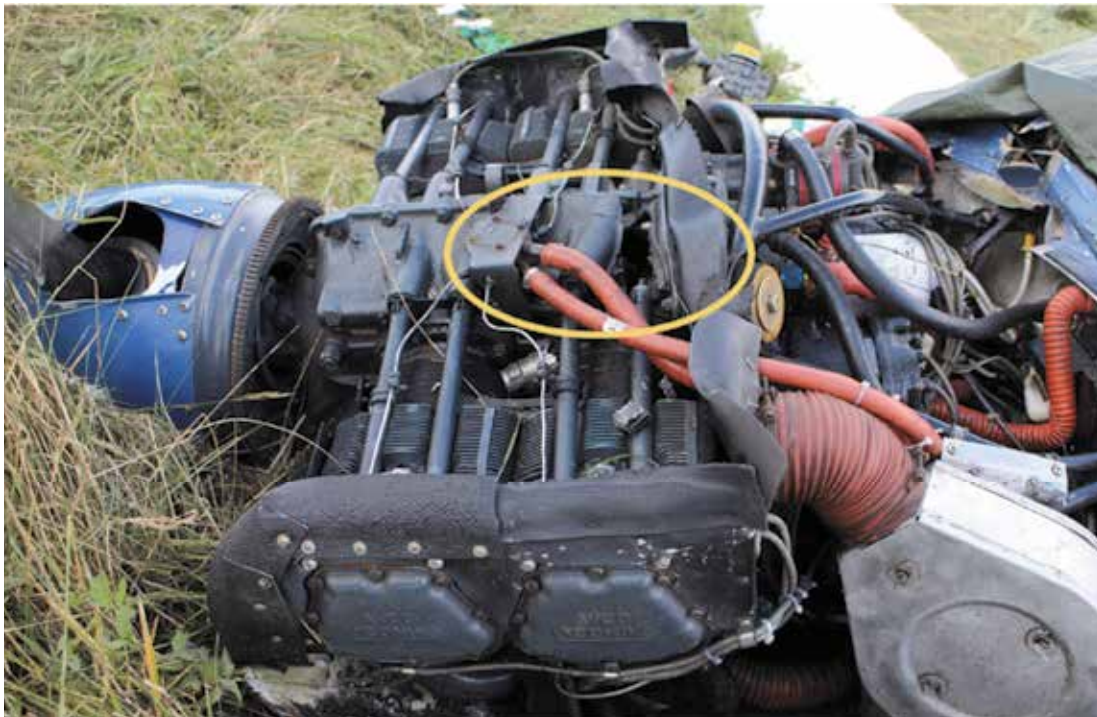
Figure 4
Crankcase damage

Both wing tanks contained fuel and approximately 40 imp gal (48 US gal) were drained from the fuel tanks at the accident site. The top of the engine was exposed and the crankcase had a large hole near the base of the No 4 cylinder, exposing the remains of the No 4 piston connecting rod. Figure 4 shows the damage to the crankcase.

The oil dip stick was not in contact with any oil and was dry. The underside of the sump was covered in a film of engine oil, although there were no obvious signs of leakage or weeping joints around the engine. However, as observed at the accident site, the crankcase had a large hole in its upper surface through which could be seen the remains of the No 4 connecting rod big-end. There was also sign of a partial rupture near the camshaft forward end where a piece of debris had become trapped between one of the cam lobes and the crankcase. The internal crankcase web above the sump had also been holed by debris impact.

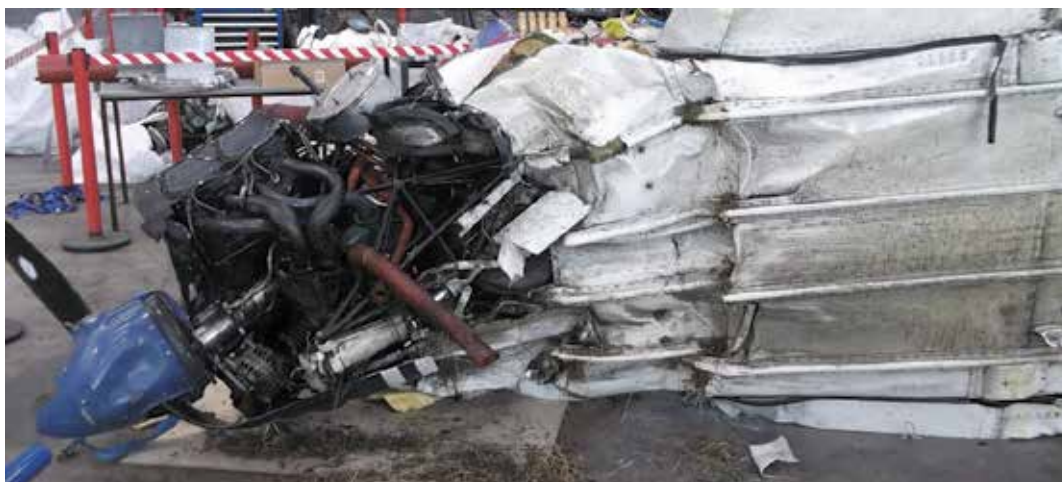
Detailed examination showed that the rudder, tailplane and elevator were attached correctly and relatively undamaged but that the area beneath the engine and cockpit around the fire wall was crushed and severely buckled upwards and rearwards by the vertical deceleration when the aircraft struck the berm. The entire underside of the fuselage was covered in engine oil and oil was still seeping from fuselage skin joints and seams. Figure 5 shows the condition of the forward underside of the fuselage and Figure 6 shows oil seeping from the fuselage skin joints.

Forward underside of the fuselage

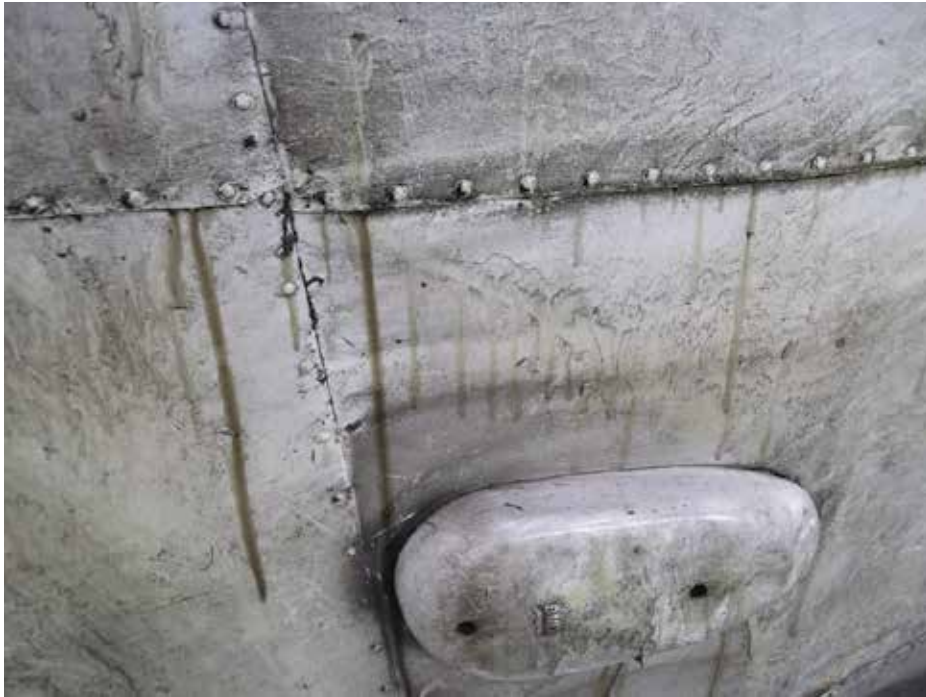
Figure 6

Oil seeping from the fuselage skin joints

The No 1 and No 2 pistons show significant exhaust 'blow-by' and contamination of the oil control rings and this led to the severe fouling of the No 2 cylinder spark plugs. This was probably the point where the pilot detected the engine rough running and prompted his MAYDAY call. It is known that blow-by can cause pressurisation of the crankcase which in turn causes oil to be ejected from the breather. The breather exit tube is situated behind the nose landing gear bay on the underside of the aircraft and excessive oil loss through the breather tends to cover the area behind the breather and be carried by the airflow rearwards, consistent with the oil-soaked fuselage underside in this case.

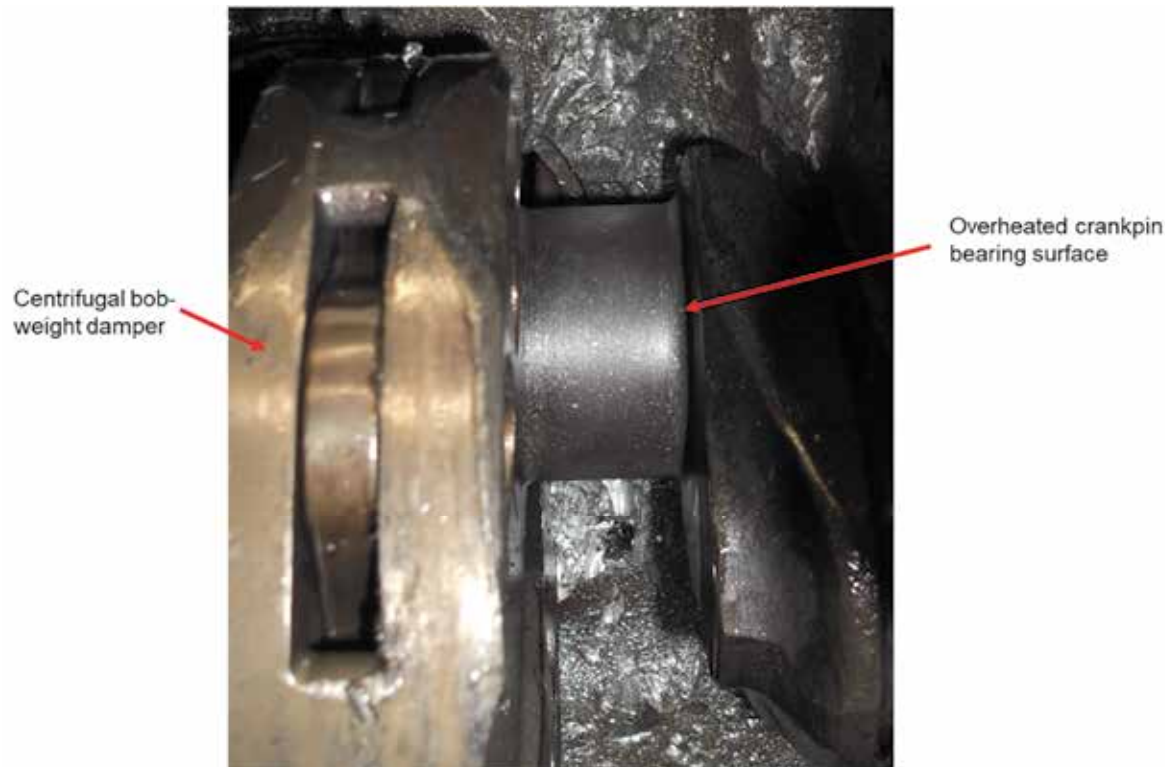
The crankshaft was in one piece and but showed signs of rubbing and discolouration due to excessive heat on the rear main journal, the No 4 crankpin and the No 2 crankpin. There were also debris impact marks on the surfaces of the No 3 and No 4 crankpin surfaces. Figure 7 shows the overheated condition of the No 4 crankpin.

No 4 crankpin condition

In general, big-end bearings are the first to suffer as a lubricating system starts to fail. In this case, the No 4 big-end loosened as its bearing overheated, disintegrated and induced stresses in the half-cap bolts, which failed, allowing the connecting rod to detach from the crankshaft. This allowed the connecting rod free to flail as the engine continued to run for its last few seconds, with the No 4 big-end half-cap, bolts and bearing remains becoming caught up in the bobweight damper sweeping them around between it and the No 3 big-end and connecting rod, causing it to disintegrate. The No 4 connecting rod eventually forced its way out of the crankcase and the engine stopped.

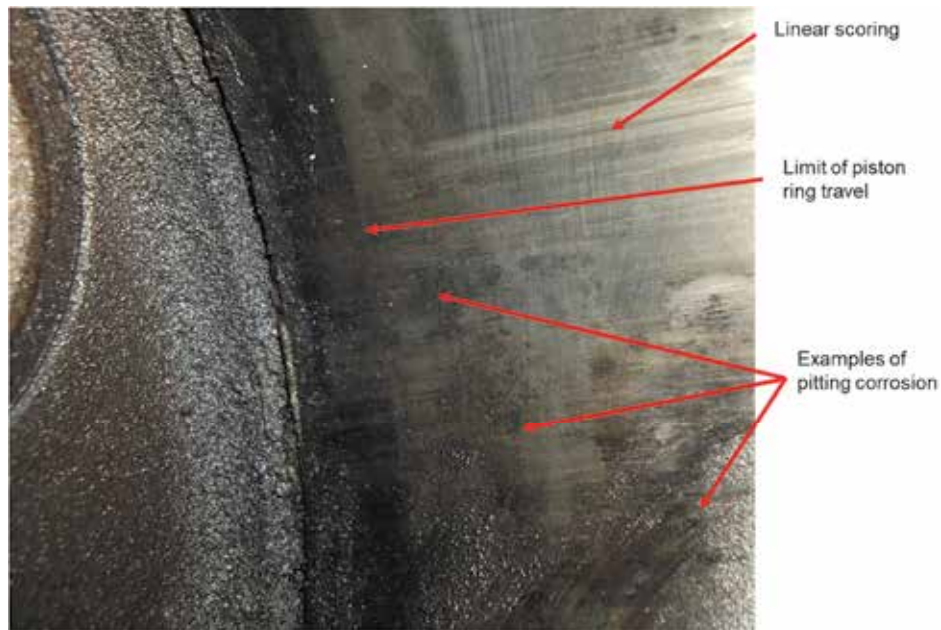
The No 1 and No 2 cylinder liners had linear scoring within the piston-swept area. There was heavier localised scoring where debris had been picked up on the piston skirt and small areas of pitting corrosion were present in both cylinders, were smoothed by the action of the piston and oil control rings. The pitting corrosion was more prevalent in the No 2 cylinder and heavier pitting corrosion was present at the top of both cylinders, outside the piston-swept area. Figure 8 shows the corrosion in the No 2 cylinder.

An example of the pitting corrosion in the No 2 cylinder

Between November 2015 and July 2016 the aircraft was parked outside at Newcastle International Airport, nine miles from the sea and in inclement weather conditions. There is no evidence that the engine had been inhibited during the aircraft's period of inactivity and it is likely that corrosion took hold during this period. This was evident in the No 1 and No 2 cylinder walls, with localised pitting corrosion at the top of the cylinder and within the piston-swept area. The engine manufacturer's Service Letter (Number L180B, dated 13 November 2001) is clear on the actions to be taken to prevent engine deterioration and notes that active corrosion can occur in a short period of time.

The engine failure was due to oil loss caused by damage and premature wear to the oil control rings. The engine had been inactive for several months, and probably had not been inhibited in accordance with the manufacturers guidance, leading to the formation of corrosion within the engine.

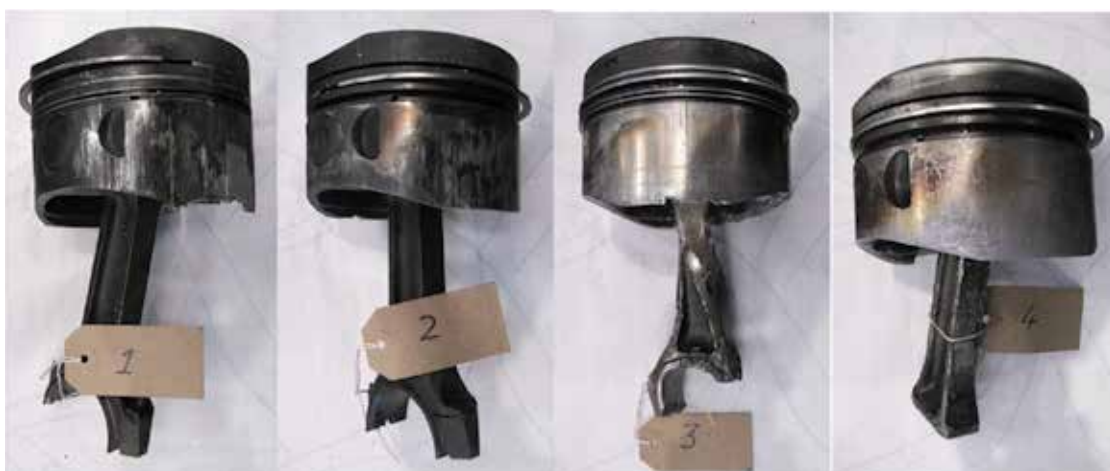
By contrast the No 3 and No 4 pistons were in better condition and had stopped in their respective cylinders when their big ends detached from the crankshaft. There was no evidence of blow-by and no scoring of the piston skirts. However, the underside of the pistons was covered in multiple debris strike marks and the No 3 connecting rod was bent and twisted and its half-cap, end bolts and bearing shells pulverised. The No 4 connecting rod and associated parts had similar damage and fragments of the No 3 and No 4 bearings had evidence of excessive heating and swaging whilst under load. Figure 9 shows the condition of the pistons and damage to the connecting rods.

Pistons and connecting rods

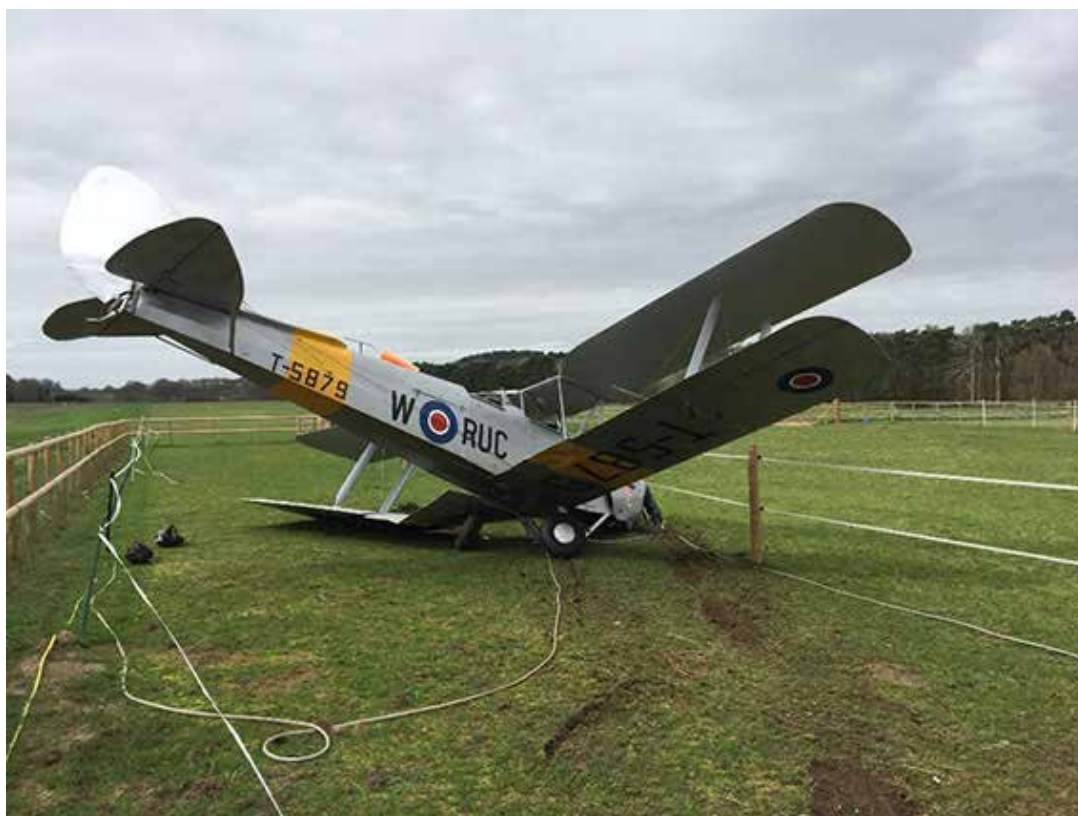
Figure 1

The pilot in command (PIC), flying in the front seat, was providing familiarisation training for a new syndicate member, who was in the rear seat. The wind was assessed to be approximately 12 kt at 25° from the left; within, but close to, the crosswind limit for the takeoff. The PIC was satisfied that the new syndicate member was a capable pilot and allowed him to have control for the takeoff. During the takeoff roll, the aircraft became airborne 5 kt below the normal 'unstick' speed. At this time, the PIC called "airspeed" and was about to take control when a gust lifted the left wing. The right wing stalled, causing the aircraft to descend and turn to the right from a height of approximately 10 ft. The aircraft struck a wooden fence running parallel to the grass runway and came to rest on its nose with a buckled landing gear (Figure 1).

G-AXBW where it came to rest to the right of the grass strip

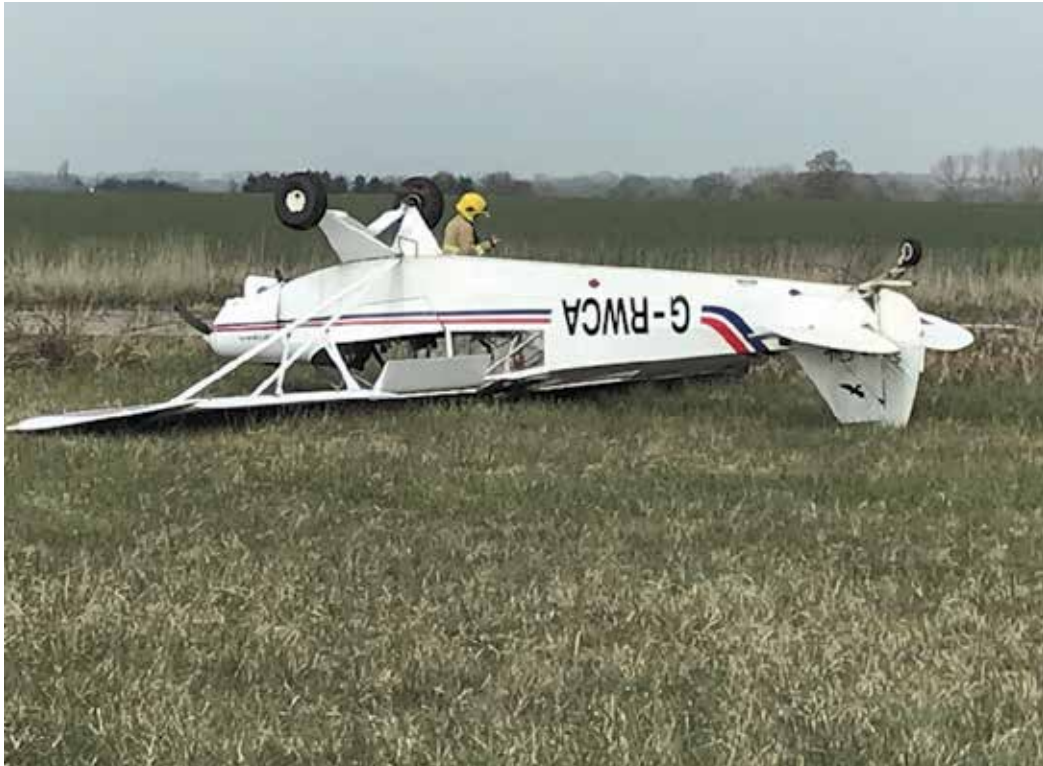
Figure 1

Accident site

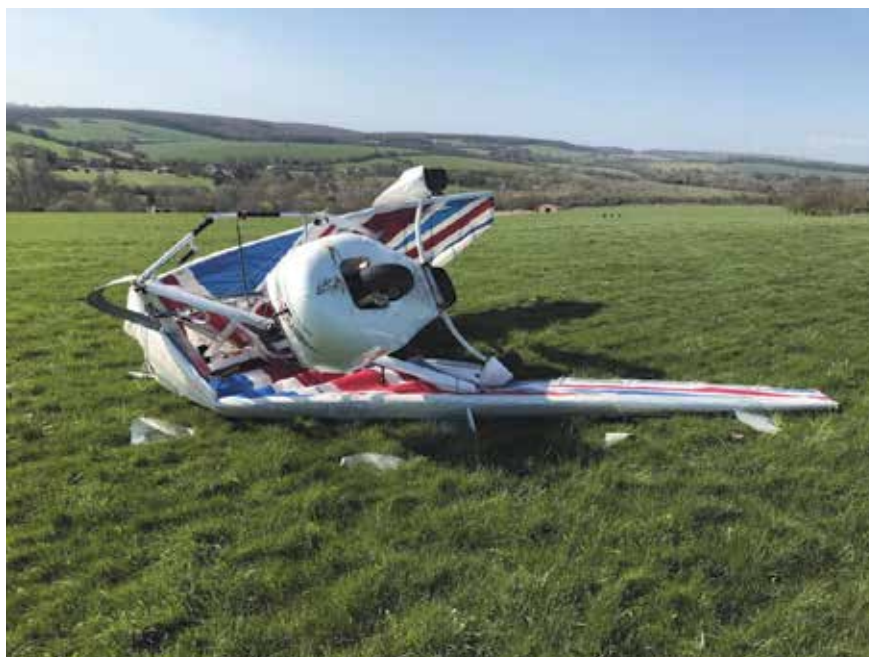
Figure 2
G-FFFA after landing

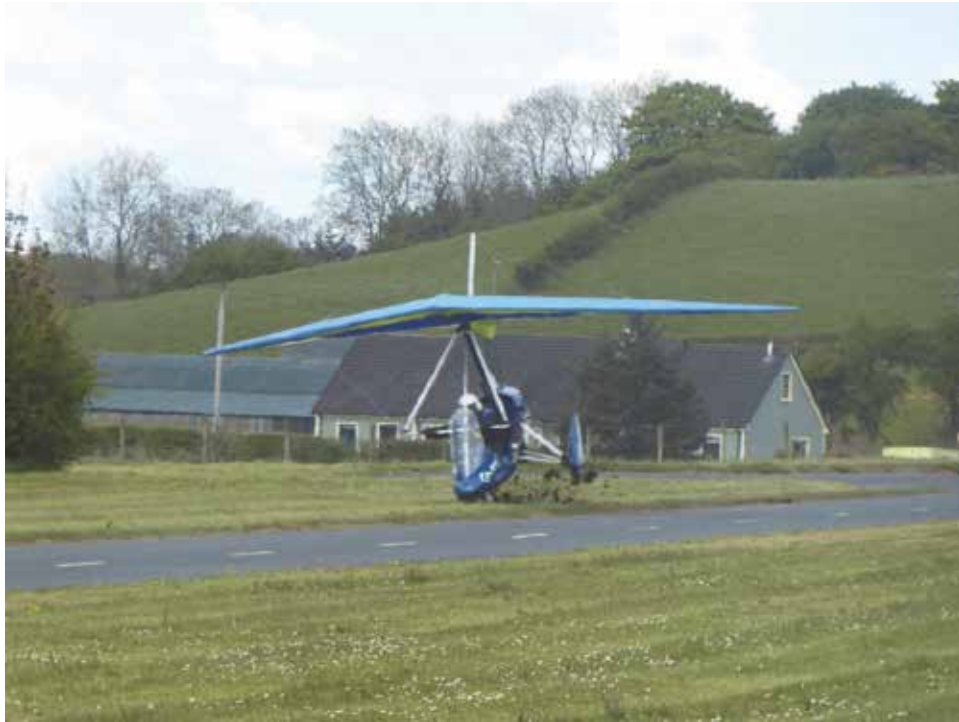
Figure 1

The pilot reported that being cold after the flight from Hunsdon may have affected his judgment. He also believed he was distracted by the departing aircraft, causing him to slow down to increase separation from them, and that consequently the aircraft had insufficient airspeed to flare properly and stalled onto the runway.

G-CEMZ landing on its nosewheel
