Derailment of a passenger train near Clogwyn y Gwin South foot crossing, Welsh Highland Railway, 10 June 2018

Summary of the accident

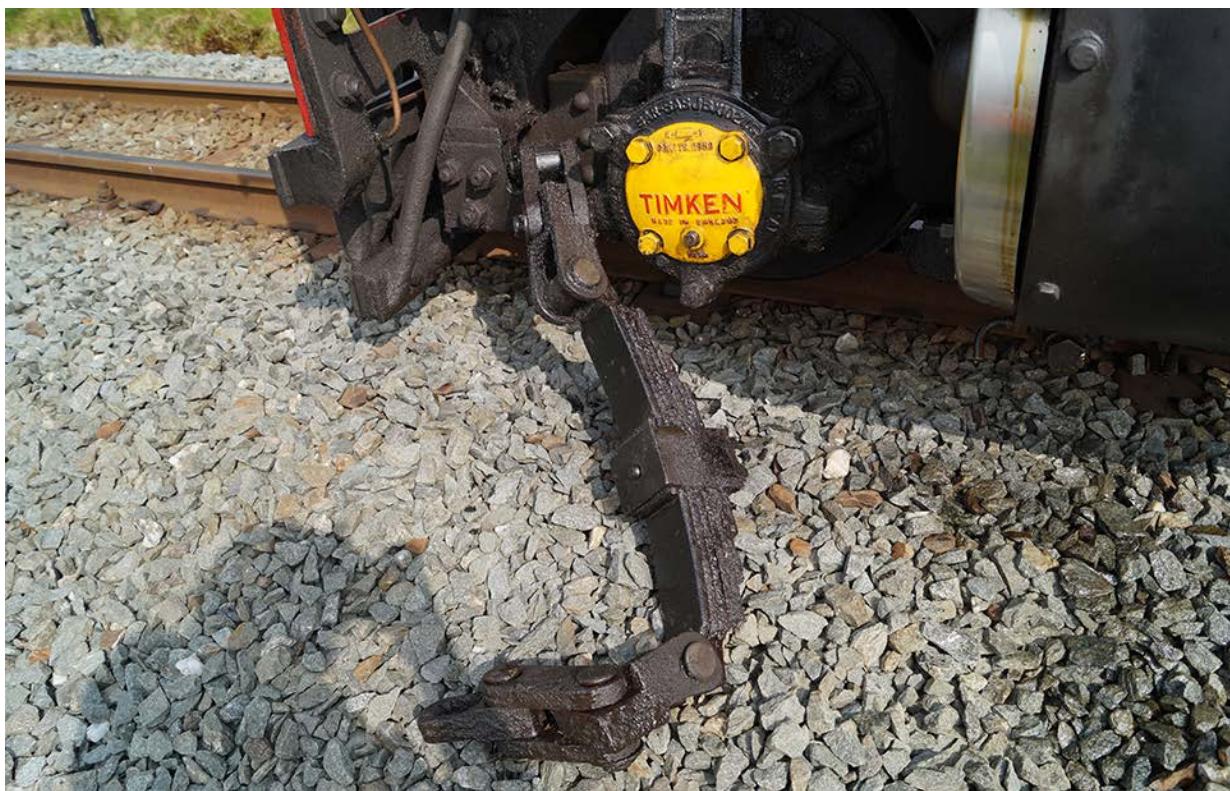
The accident occurred as a result of the failure of a suspension component on locomotive 143, resulting in the complete unloading of the left leading wheel.

The derailed leading wheelset. The leaf spring suspension and associated components had become disarranged as a consequence of the failure (photograph courtesy of Ffestiniog and Welsh Highland Railways).

When the hook failed, the leading left wheel lost vertical load. Because the train was traversing a right-hand curve at the time, the loss of vertical load allowed the flange of the left wheel to climb onto and across the left-hand rail into derailment.

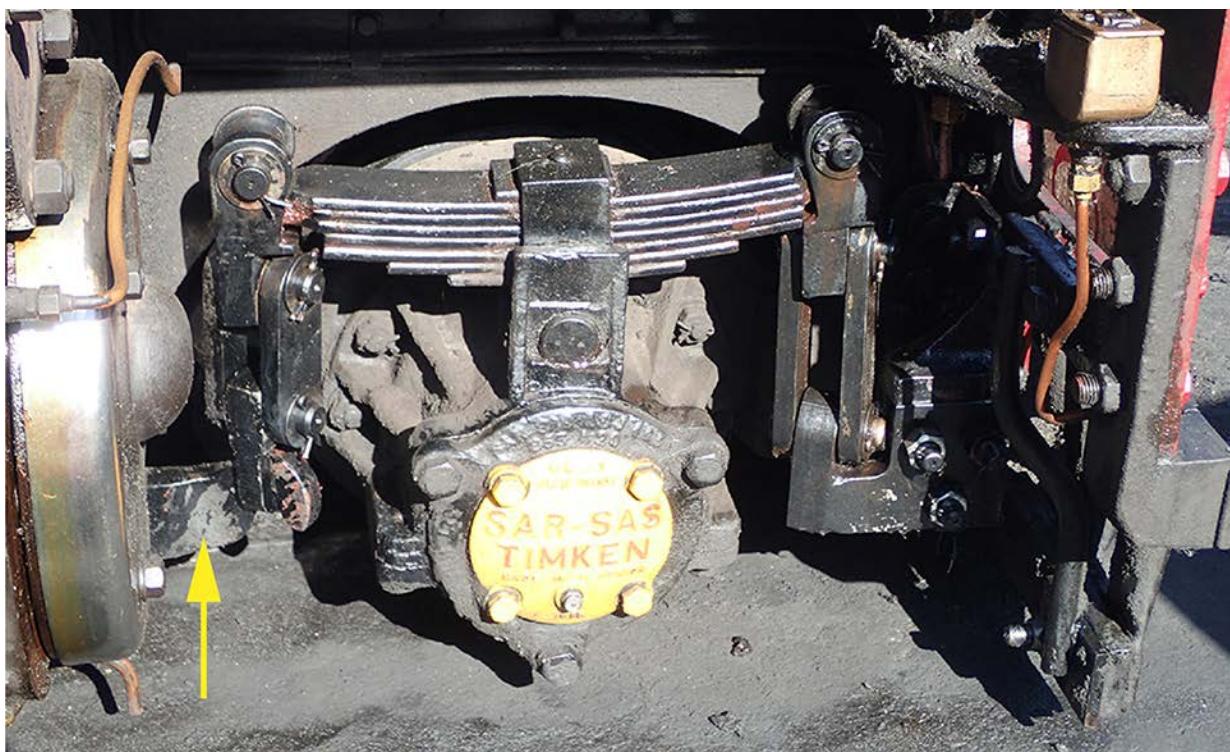
The undamaged opposite side of the leading wheelset on locomotive 143, taken after the locomotive had been recovered from the derailment site, showing the normal suspension arrangement. The undamaged equalising beam is arrowed.

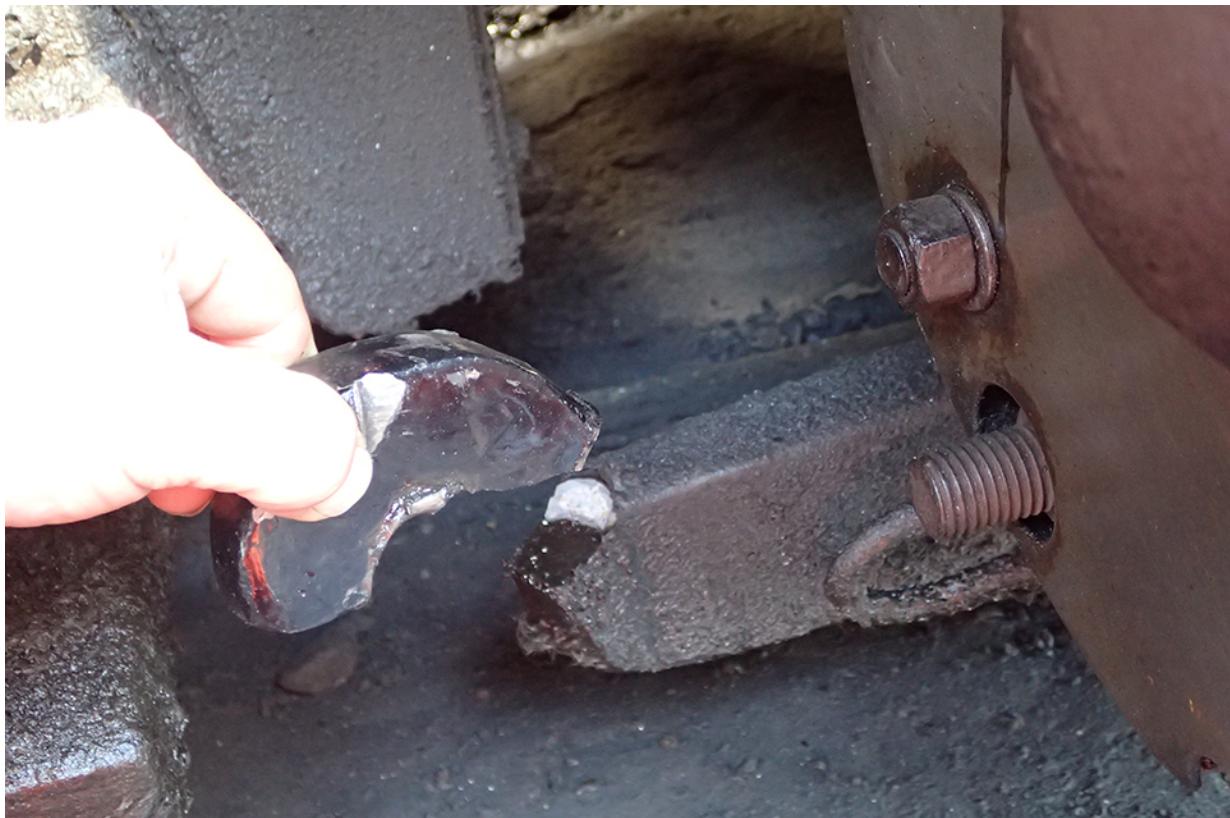
The component which failed was a hook which formed the end of a suspension equalising beam. This type of locomotive is fitted with equalising beams on each side which connect the springs on each wheelset. Such beams are designed to ensure that the weight carried by each wheelset in response to track irregularities is evenly distributed between a locomotive's wheels, as far as possible. The equalising beams are connected to each leaf spring by means of spring hangers.

The equalising beam with the detached hook end

The hook that failed had connected the equalising beam to a spring hanger. The spring hanger is connected to the leaf spring and transfers vertical load to the leading wheelset. There is one set of such suspension equipment on each side of the wheelset.

A visual examination of the failed component showed the presence of 'beach' marks on the fracture faces. These visible marks indicate progressive crack growth through a fatigue mechanism as a result of cyclic loads. The marks represent successive positions of the advancing crack front. A crack had grown until the remaining cross section of the hook was no longer able to carry the loading on it, at which point brittle fracture occurred. Although there is no means of knowing exactly when the cracking started, the 'beach' marks and the contamination of the fracture surface by oil and grease indicated that the crack could have been growing for a considerable period of time, possibly back to the last overhaul or even earlier.

The locomotive is subject to daily visual checks by the crew, and periodic examinations by workshop staff. However, the configuration of the hook and the spring hangers is such that it is difficult to observe any incipient cracks growing in situ.

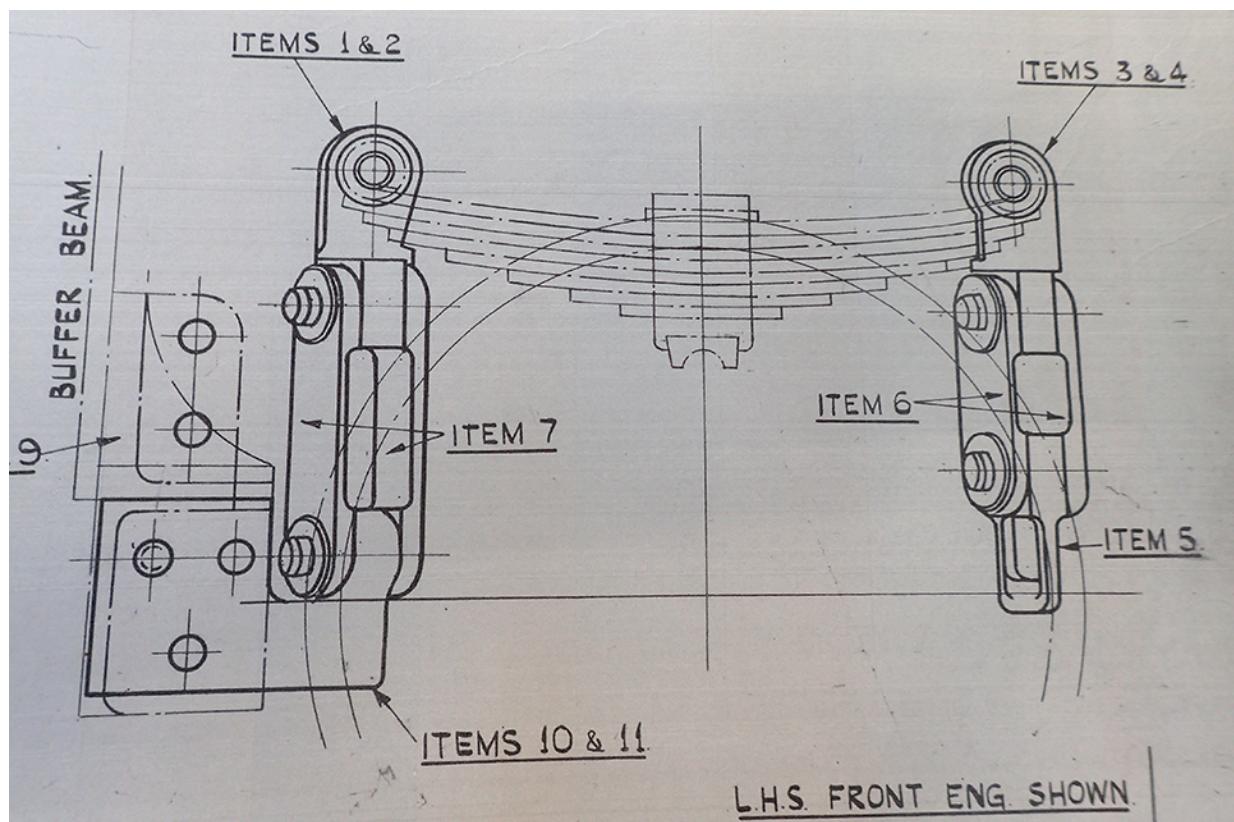
Examination of the locomotive post-derailment also found that two suspension components had been erroneously interchanged during the re-assembly of the locomotive during the 2015 overhaul.

Extract from a drawing of the locomotive leading wheel suspension arrangement. The equalising beam which failed is not shown; the equalising beam hook engages with item 5 in the drawing (drawing courtesy of the Ffestiniog and Welsh Highland Railway).

The locomotive left side (in the direction of travel at the time of the derailment) assembly uses items 1 and 3, as shown in the above drawing (items 2 and 4 are mirror images, and used on the right side of the locomotive). The hole accommodating the pin which secures items 1 and 3 to the drop links (items 6 and 7) is at different angle on item 1 compared to item 3. Locomotive 143 was found, during post-derailment examination, to have items 1 and 3 transposed at the location of the failure. The effect of this incorrect assembly would have been to impart additional loading to the end of the equalising beam in the area which failed. This may have contributed to the failure.
