Rail Accident Investigation Branch

Rail Accident Report

**Near miss with a group of track workers at
Egmanton level crossing, Nottinghamshire
5 October 2017**

Report 11/2018
August 2018

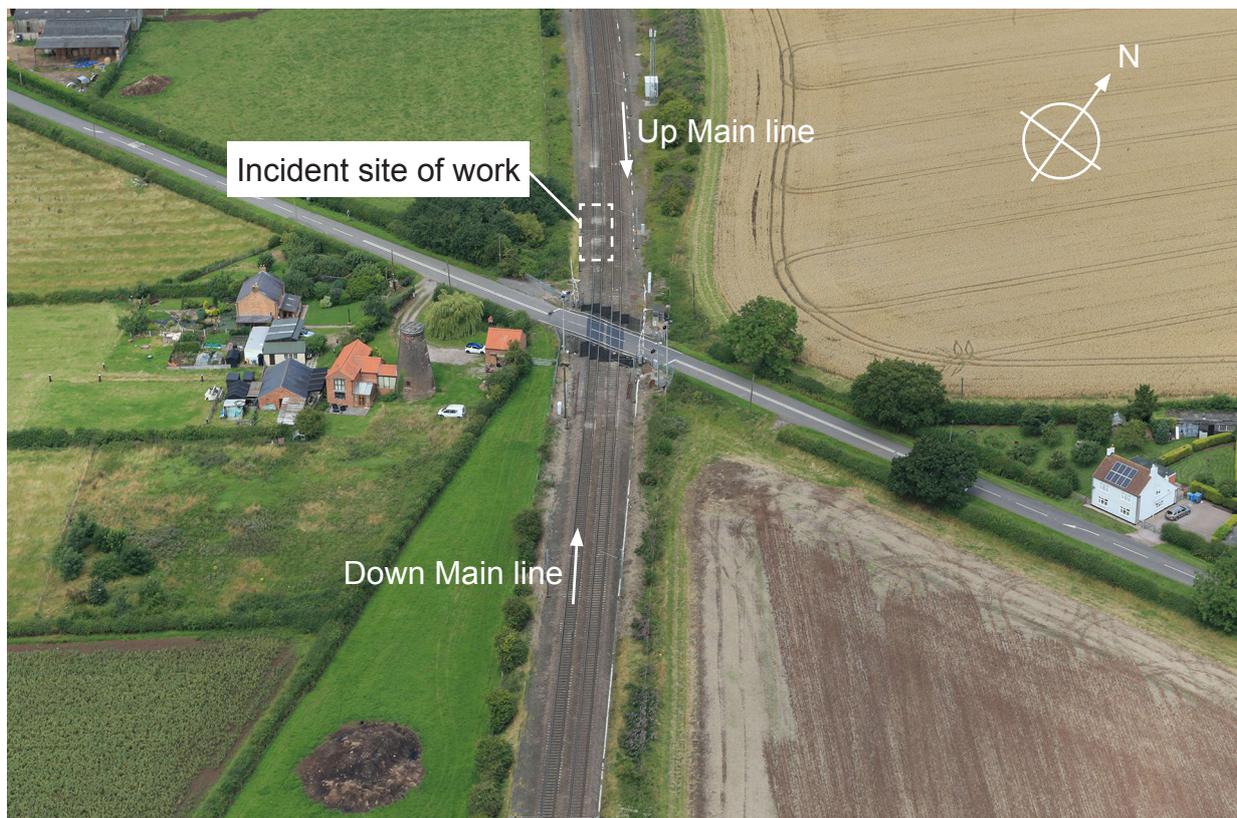
- 8 The incident occurred around 30 metres north-west of Egmonton level crossing (figure 2) which is located on the East Coast Main Line (ECML) at 130 miles 29 chains from London Kings Cross. The location is between Newark North Gate station to the south, and Retford station to the north.

Figure 2: The track layout and the incident site of work near Egmonton level crossing (image courtesy of Network Rail)

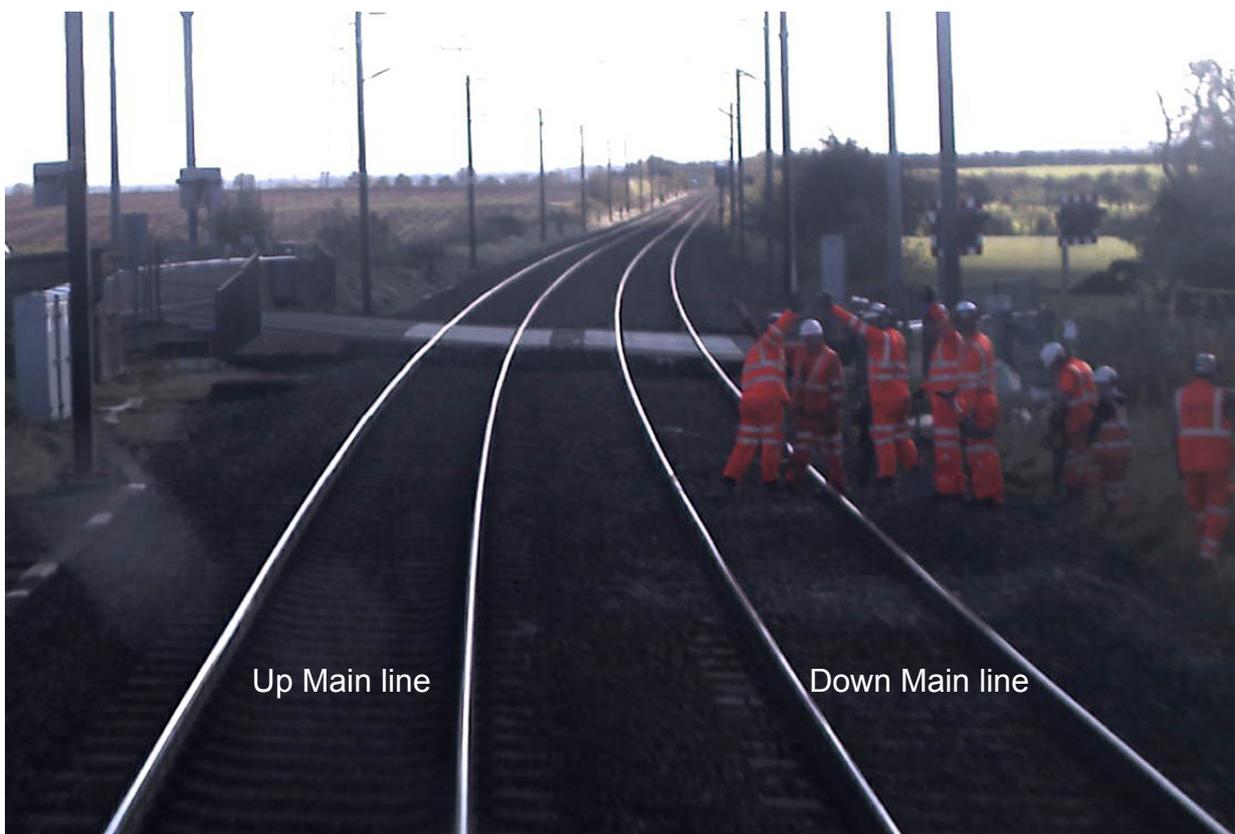
- 46 Around 20 seconds after the passage of this train, train 1E06 passed the group on the up line. The CCTV image from the front of train 1E06 shows that the group had recommenced work as soon as train 1S11 had passed (figure 4). At this time the TOWS warning tone would have continued to sound as both trains were present in the section.

Figure 4: Forward facing CCTV image from train 1E06 approaching the group on the Up Main line, captured 20 seconds after train 1S11 had passed them on the Down Main line (image courtesy of Virgin Trains East Coast)

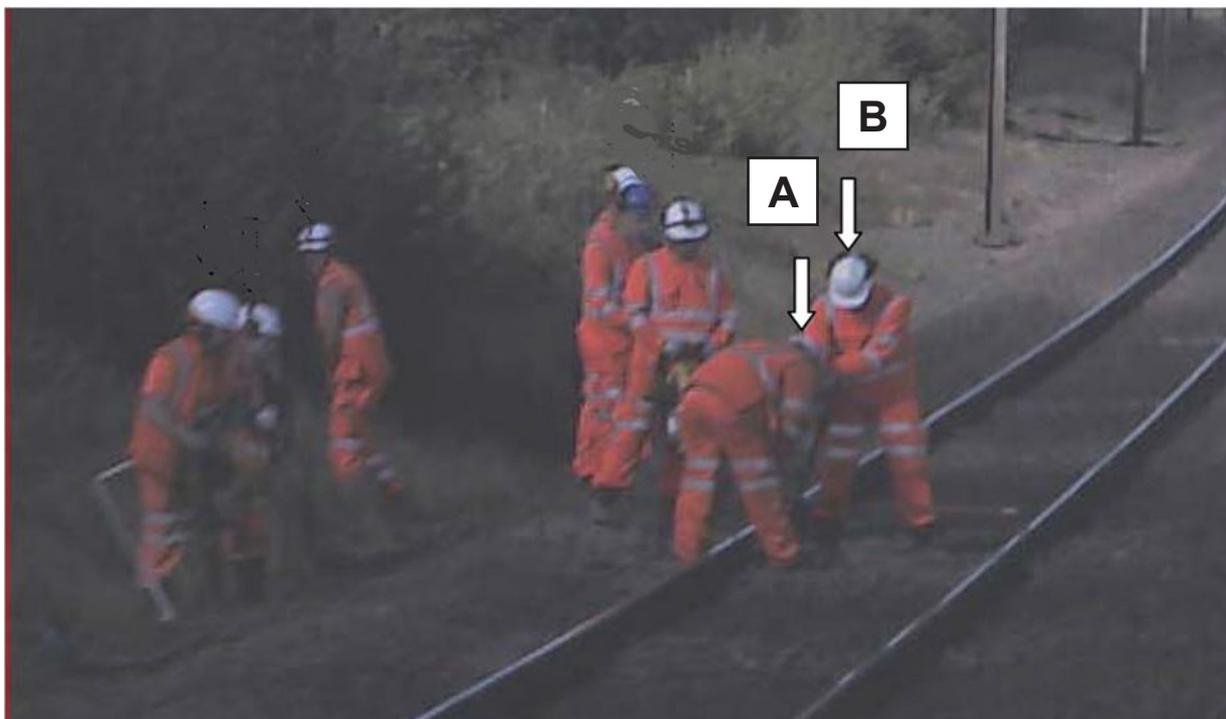
- 47 Train 1E06 was also fitted with a rear facing CCTV camera (figure 5). The RAIB has determined that the person marked 'A' in the image, is the PiC who is bending over to read a cross level gauge with his back to trains approaching in the down direction. The person marked 'B' is operating a track jack, and is the track worker whom the PiC appointed as the site lookout at the first site of work and who performed the lookout role later on at the second site of work (paragraph 41).

Figure 5: Rear facing CCTV image from train 1E06 passing the group on the Up Main line, showing the positions of the PiC ('A'), and the lookout ('B') (image courtesy of Virgin Trains East Coast)

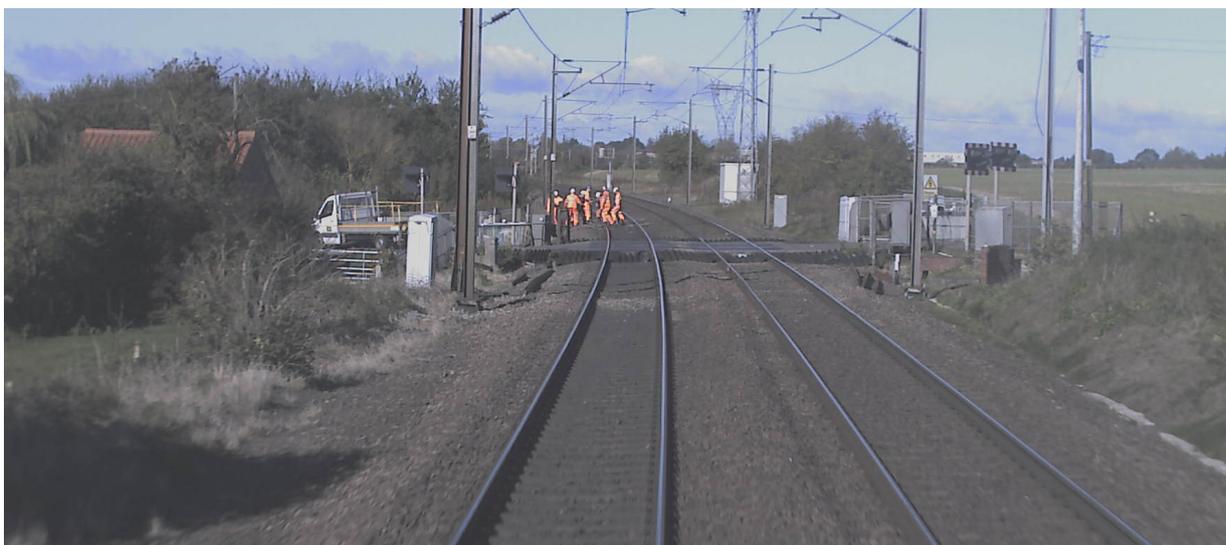
- 48 At around 11:22 hrs the work was nearly complete and TOWS began sounding the warning tone as train 1D09, the incident train, was approaching in the down direction (figure 6).

Figure 6: Forward facing CCTV image from train 1D09 showing three workers on the track as it approached the group on the Down Main line approximately 2 seconds before reaching the site of work (image courtesy of Virgin Trains East Coast)

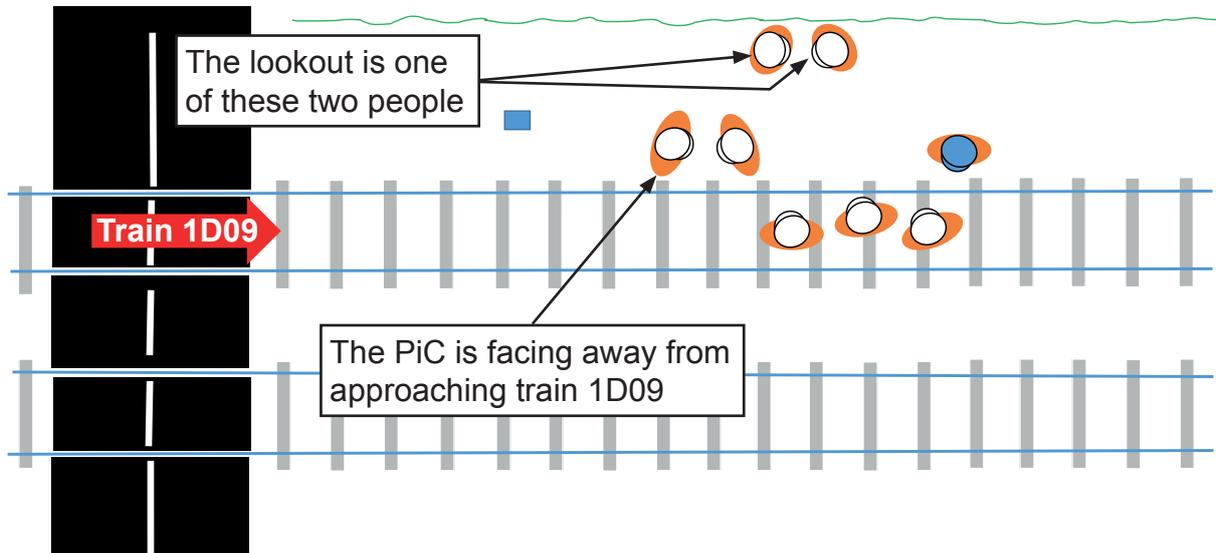
- 49 The approximate positions of the members of the group, and their actions immediately prior to the arrival of train 1D09, are based on witness evidence and forward facing CCTV images from this train (figure 7).

Figure 7: The approximate positions of the track workers immediately prior to the arrival of train 1D09

- 50 The PiC, who was standing close to the track with his back to the approaching train, told the RAIB that he was waiting for a down train to pass so that he could check that the track levelling work was satisfactory. Although accounts vary, it is likely that he was talking with one of the VHRL team who was facing the approaching train.

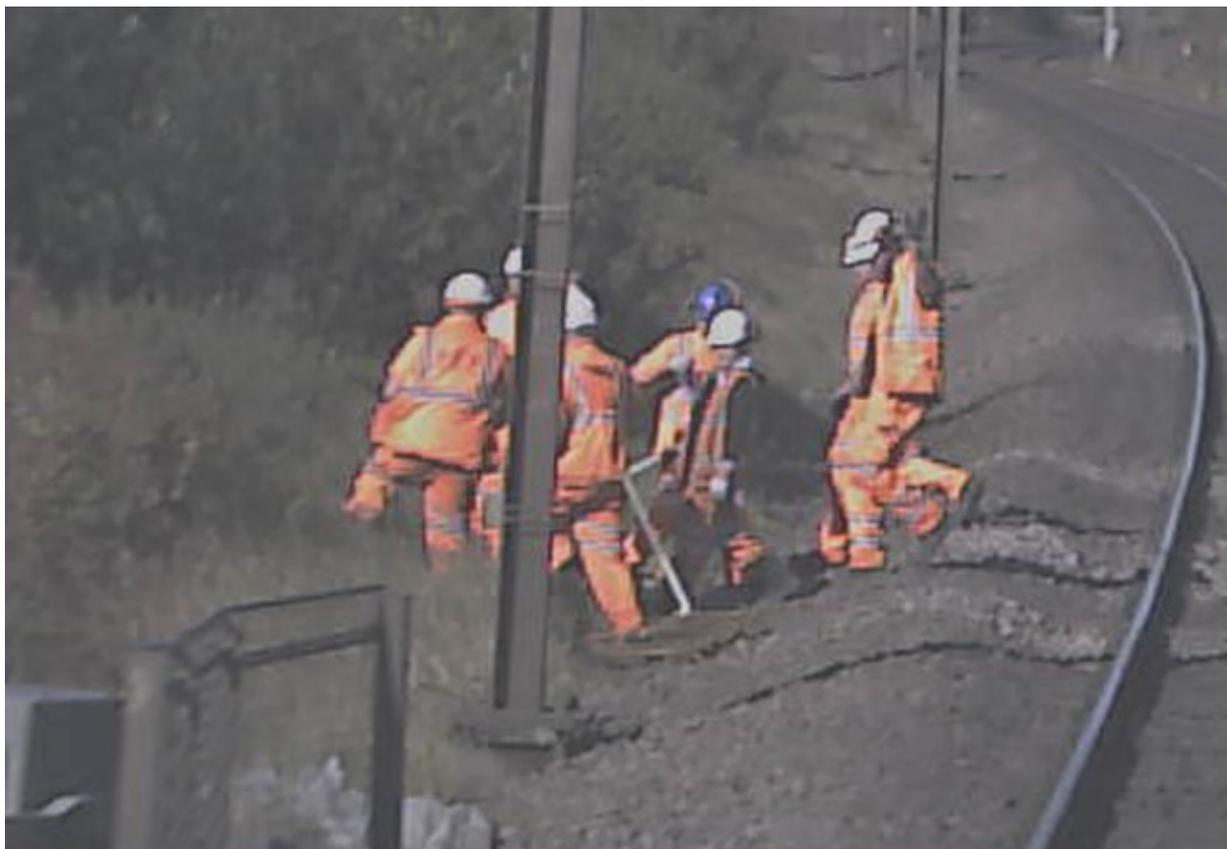
- 51 Four of the group had been on the track, clearing loose ballast from the top of the sleepers. One of them, who had been using a shovel, had moved clear leaving three on the track. The train's CCTV camera images indicate that around 5 seconds before the train arrived, one of them was crouching down, probably removing loose ballast with his hand. The track worker who was talking to the PiC and facing the approaching train shouted to the others when he saw it. This was around three seconds before the train arrived. The CCTV images show that the three workers on the track were clear of the track around one second before the train reached the site (figure 8).

- 52 Most of the group reported that they did not hear the train horn until a few seconds before the train reached the site of work. The driver told the RAIB that he sounded the horn twice on the approach, once when he first saw the group and then a continuous sounding of a series of short blasts from around nine seconds before reaching them. This is supported by evidence from the train's on-train data recorder (OTDR). The driver reported that after applying the emergency brake he closed his eyes as the train passed the site of work, expecting an impact.

- 53 It is likely that the track workers did not hear the horn earlier as, although the mechanised element of the work was complete, TOWS was sounding its warning, and some were still wearing ear defenders.

Figure 8: Forward facing CCTV image from train 1D09 showing the track workers moving clear of the train approximately one second before it passes them at 125 mph (201 km/h) (image courtesy of Virgin Trains East Coast)

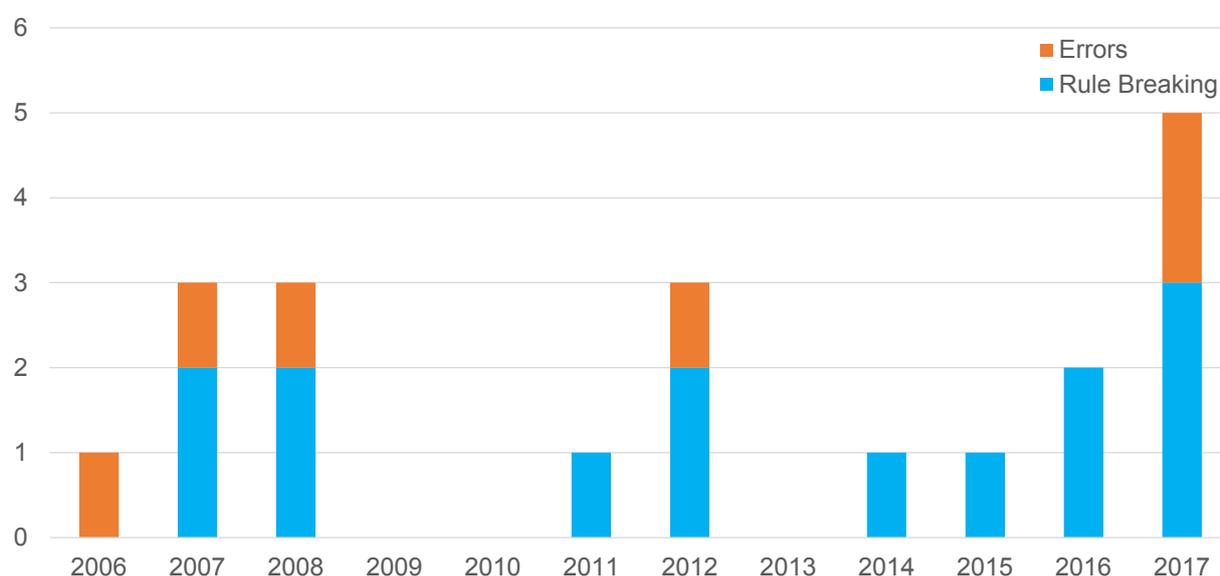
113 Figure 9 shows the number of RAIB investigations into serious track worker incidents and accidents for every year since 2006. This suggests a persistent problem with track safety behaviours and leadership.

Figure 9: Stacked bar chart showing RAIB investigations into serious track worker incidents and accidents with moving trains, from 2006 to 2017 inclusive, where a causal factor was either an error, or rule breaking behaviour, by the COSS
