Rail Accident Investigation Branch

# Rail Accident Report

## Collision at Frognal Farm User Worked Crossing 23 October 2017

Report 12/2018  
August 2018

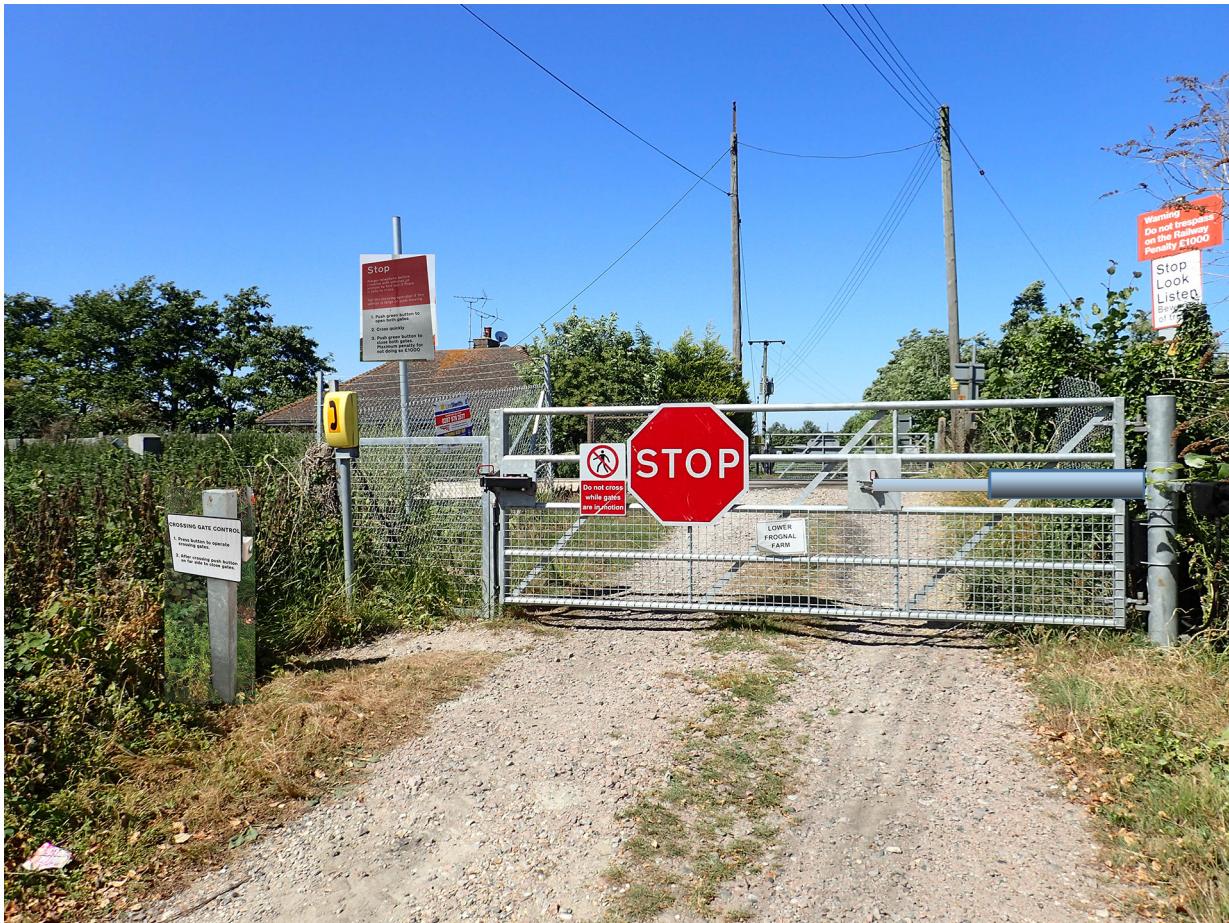
*Figure 3: Reconstruction of the van driver's view of the crossing. It was not possible for the RAIB to photograph the crossing in this state in the aftermath of the accident because of the presence of recovery vehicles, and the signs were altered a short time later to reflect changes made to the crossing after the accident.*

- 56 Users of Frognal Farm crossing were presented with nine signs of differing size and prominence on their approach to the crossing (figures 3 and 4). The van driver, having pulled onto the crossing's approach road and clear of Lower Road, had already passed the first sign. The level crossing manager (see paragraph 142) realised that users of the crossing would miss the first sign when they pulled clear of Lower Road, and so she asked for it to be repeated closer to the crossing, shortly after the POGO equipment was commissioned. An additional sign was installed on 13 April 2017.

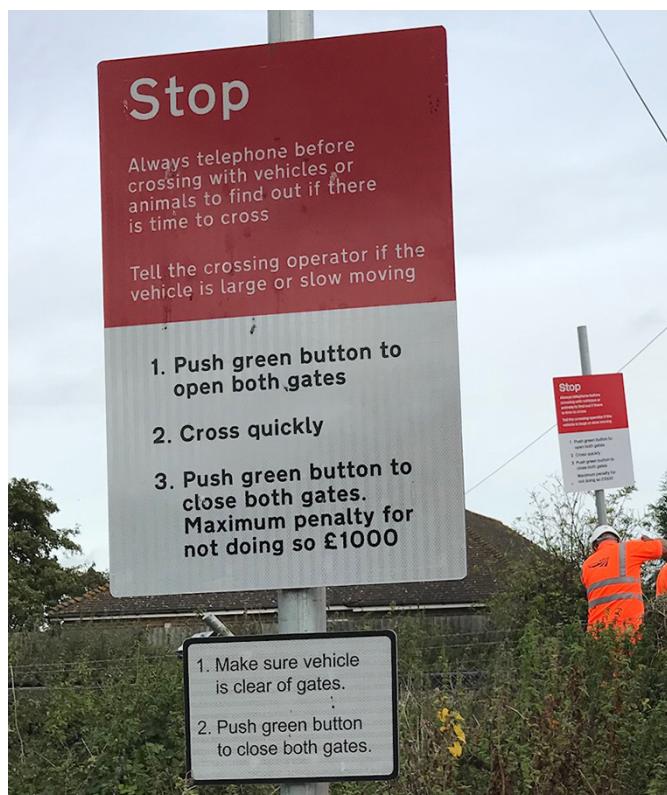
Figure 5: The duplicated signs explaining how to use the crossing

- 57 This sign (the sign on the right in figure 5, also visible above and to the left of the crossing gate in figure 3) explaining how to use the crossing correctly, was offset to the left of the road.
- 58 The van stopped on an incline clear of Lower Road. The signage to the driver's right, the bottom of which was partially obscured by vegetation, was the sign shown as sign D in figure 4.
- 59 There was a stop sign on the gate, and a sign warning people not to cross while the gates are in motion. These were mounted on the gate and so were immediately in front of a vehicle driver as they approached the crossing. There was a small sign on the button facing Lower Road, with two numbered instructions on it in small type.

- 83 Witness evidence indicates that the installers in March 2017 did their best to install the equipment in accordance with the intent of the 2014 design with the information that they had available, having collected all the signage required for POGO crossings from the central stores. Despite the error noted in paragraph 82, this included the instructional sign shown in figure 5.

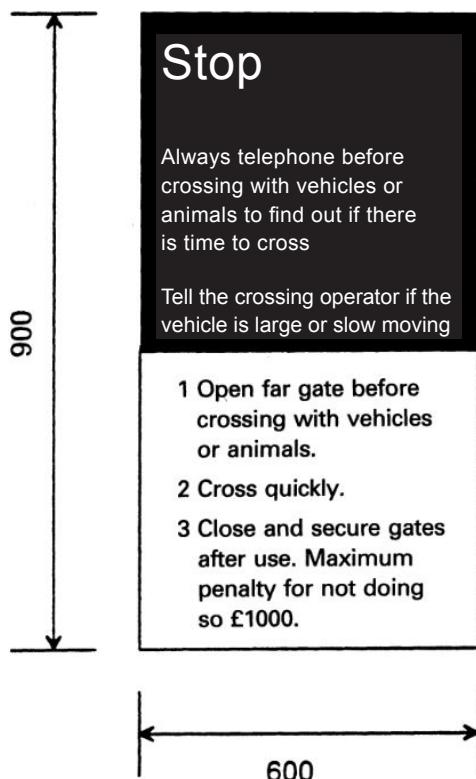
- 92 The signage was not clear, contained conflicting information and did not convey the most important action required to the crossing user.
- 93 The Private Crossings (Signs and Barriers) Regulations 1996<sup>6</sup> prescribe the signs to be used at a user worked crossing with and without telephones. POGO equipment had not been invented when these regulations were made, and so the sign that should be used at a crossing with telephones, shown at diagram 103 in the regulations (figure 6) does not explain how to use a POGO crossing. There are currently no appropriate signs in the regulations for crossings with new technology such as POGO equipment, and the signs used at Froginal Farm and other POGO crossings were designed by Network Rail for use in conjunction with other, legally specified, signs.

- 1) the signal word, 'stop' in this case, should be in upper case; and
  - 2) the signal word should be the only word in white-on-red – the rest of the text should be black-on-white.

As part of its support for the work identified in recommendation 1, the Department for Transport, in consultation with the Office of Rail and Road, should change the requirements for signs prescribed by law for use at private crossings, taking into account the need to convey information and instructions clearly and unambiguously to diverse users (paragraph 131a).

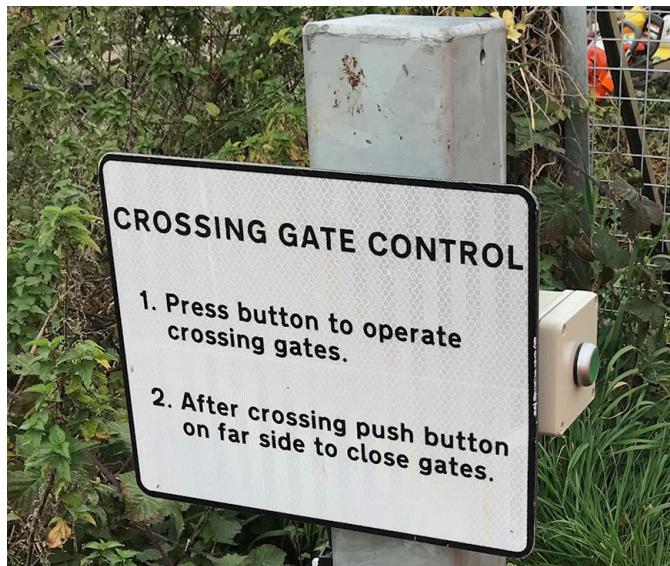
Figure 7: Sign and green push button

- 99 After he had walked around the van, the van driver would have approached the button from the railway side and therefore would not see the sign facing Lower Road on the other side of the button (figure 7). However, had he read this sign, he would not have seen an instruction to contact the signaller, as the sign merely instructed the user to push the button to operate the gates and to close the gates after crossing.

- 100 Of the nine signs (paragraph 56), seven did not convey the detail of how to use the crossing and contained conflicting information. One of the signs displayed information about the need to close the gates after the crossing had been used, and was on the same post as the first of the signs that explain how to use the crossing.

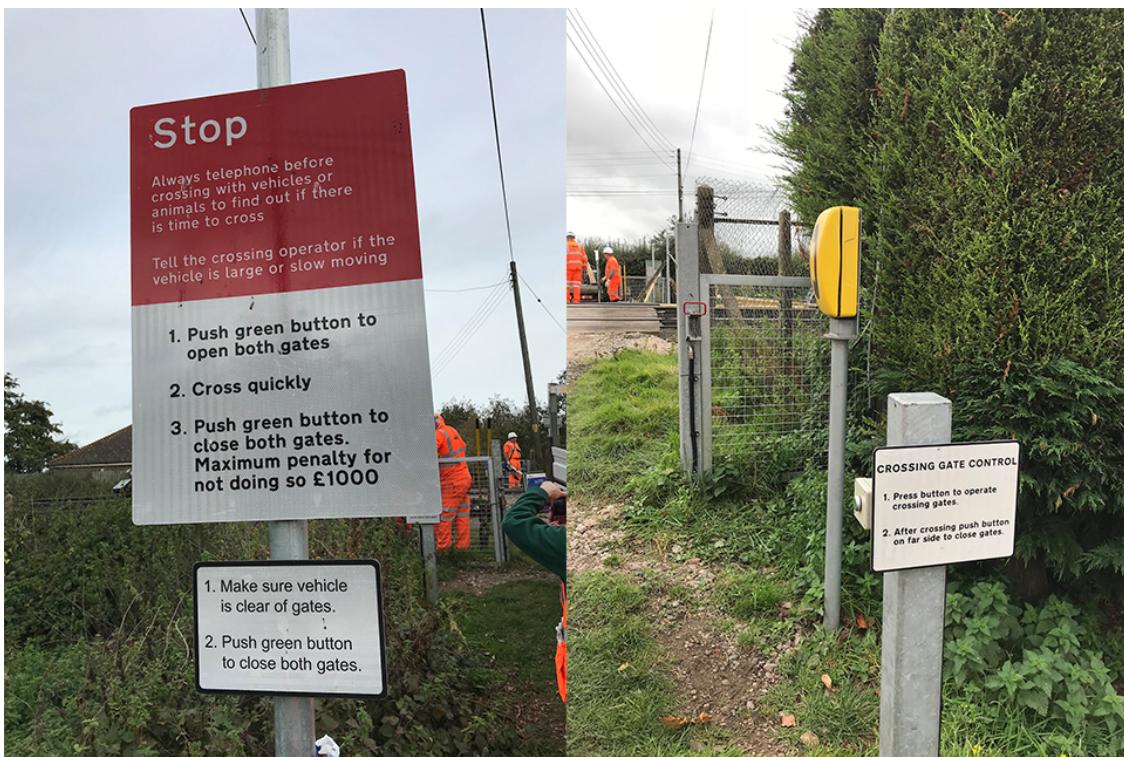
**The signs at Frognal Farm crossing, showing the instructions to vehicle users (left) and the telephone cabinet, gate operating button and subsidiary instruction sign (right)<sup>13</sup>**

Signs for user worked level crossings are defined in the Private Crossings (Signs & Barriers) Regulations 1996<sup>1</sup>. These regulations were made many years before POGO equipment came into use. There are currently no appropriate signs in the Regulations for crossings with new technology such as POGO equipment, and Network Rail has attempted to design its own signs to use in conjunction with the legally specified signs. Although the Office of Rail and Road (ORR) and the Department for Transport (DfT) are currently working on an updated and revised version of the Regulations, it is likely to be some time before this becomes law.
