Post-incident reporting for reservoirs
Annual report 2017

Over-pumping of service reservoirs

Bulletin No. 6 - December 2017

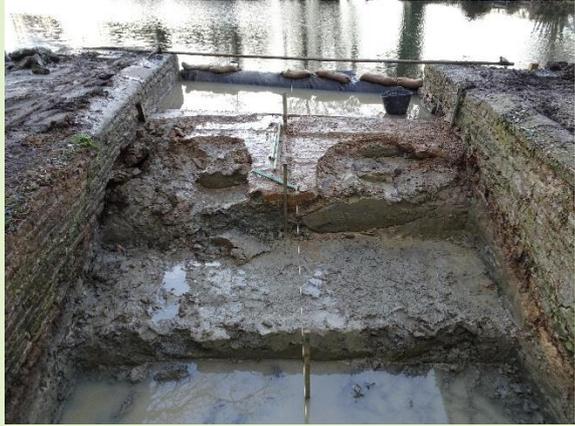
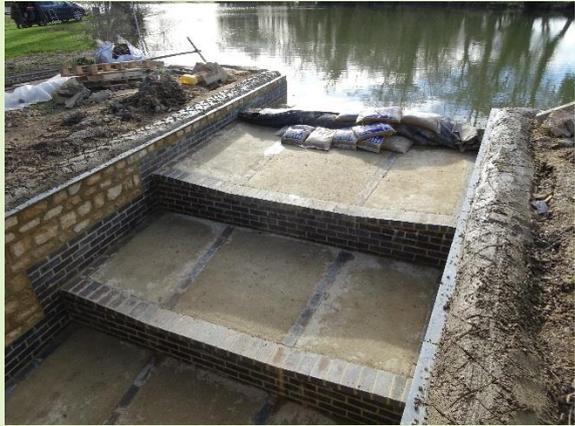
Incident 430	
Dam type	Earth embankment
Reservoir legal status	Statutory impounding reservoir
Dam height (m)	Unknown
Incident type	Internal erosion
Incident severity	3
<p>Description</p> <p>Leakage was noted past the right side of an overflow spillway at an old embankment dam. Water was observed to be passing close to the line of the right spillway wall and exiting on the spillway chute downstream of the overflow. An earth bund was placed in front of the point of leakage to allow investigations to be carried out. Excavations revealed large voids beneath the footings of the spillway side wall. Voids were also found beneath the floor of the spillway chute. Cracks had formed in the brickwork forming the side walls. The management of the incident was made challenging as no bottom outlet pipe was available to draw the reservoir water level down.</p> <p>Lessons learned</p> <p>Voiding below the spillway structure occurred as a result of an ineffective cutoff and an absence of filters to prevent the migration of soil particles. The incident demonstrates that internal erosion can occur at structures which have performed satisfactorily for a very long time. This underlines the need for vigilance and frequent surveillance at dam structures. The incident also shows the value of low level outlet facilities in managing such incidents.</p>

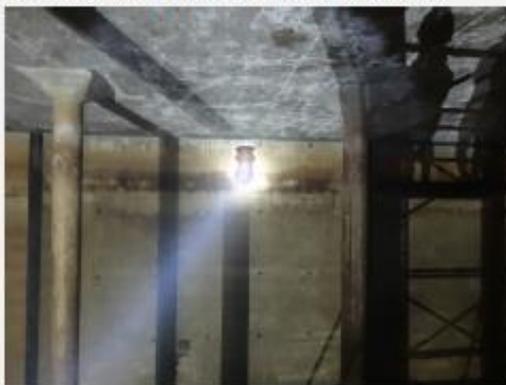
Normally, service reservoirs feature an overflow arrangement to prevent overflowing even if the water level control system fails. This reservoir features a high-level overflow pipe but the capacity of the pipe was insufficient to prevent the reservoir from overflowing.

Small overflow pipe within the reservoir

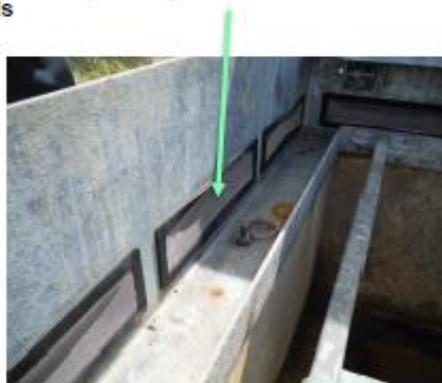
The overflow provisions at the site were inadequate to prevent the reservoir from being pressurised. Service reservoirs are not designed to be pressurised and damage to the structure can occur depending on the reinforced concrete design and the degree of pressurisation. The stability of service reservoir walls occasionally relies on the support provided by the perimeter embankments. If this

The reservoir over-spilled through air vents in the roof covers, causing the vents to distort outwards

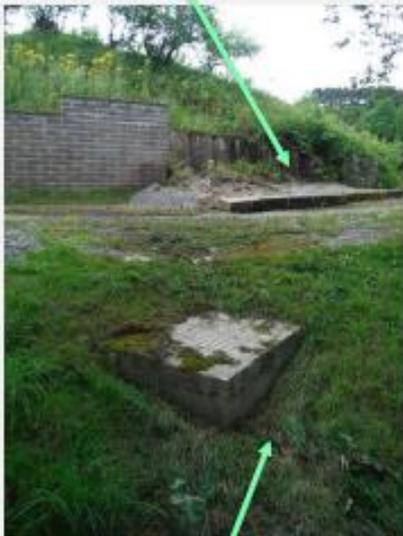
The water pressure caused the collapse of a retaining wall

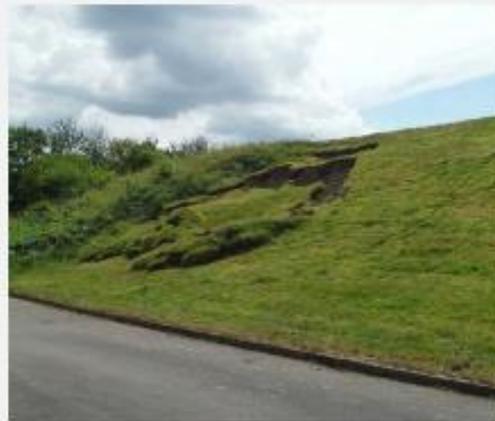
Grass flattened by the escaping water

Water spilled over the edge of the roof slab, saturated the perimeter embankment and destabilised the earthfill.

- Review the reliability of the water level and alarm systems in the event of a power outage at service reservoir sites
- Review the overflow capacity of their stock of service reservoirs in relation to the peak inflow rate
- Understand the importance of perimeter embankments with respect to the stability of the structure. This will inform decisions with respect to the monitoring, surveillance and maintenance of the reservoir.
- Keep well-maintained archives of existing structural record drawings/documentation.
