Passenger trapped in train doors and dragged at Bushey station, 26 March 2018

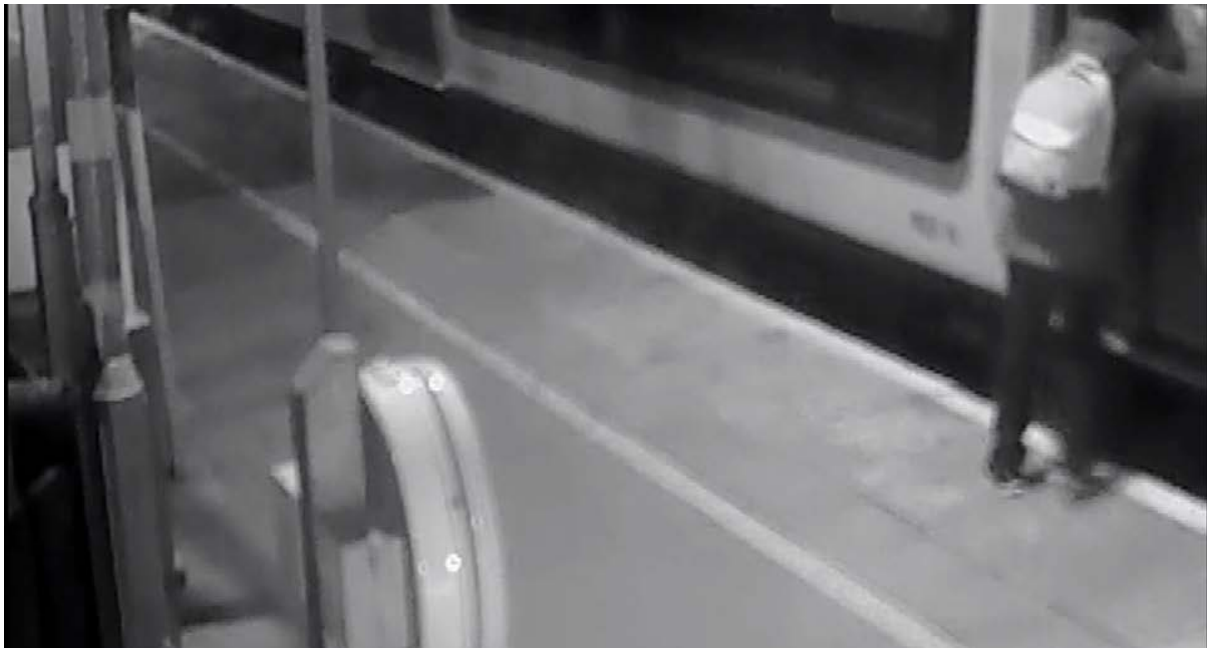
Platform CCTV images of the rear portion of the train showing the passenger in contact with the train (courtesy of West Midlands Trains)

Platform CCTV shows the passenger hurrying onto the platform and reaching the rearmost passenger doors of the train, approximately 75 metres from the conductor, just as the doors were closing. Shortly after departure, the conductor¹ heard the passenger shouting, sent a 'stop' message to the driver and then operated an emergency brake plunger. The passenger was dragged along the platform for around 13 seconds and, once the train had come to a stand, was able to free her forearm from the door. The passenger was given first-aid initially by the conductor and later by staff at London Euston station.

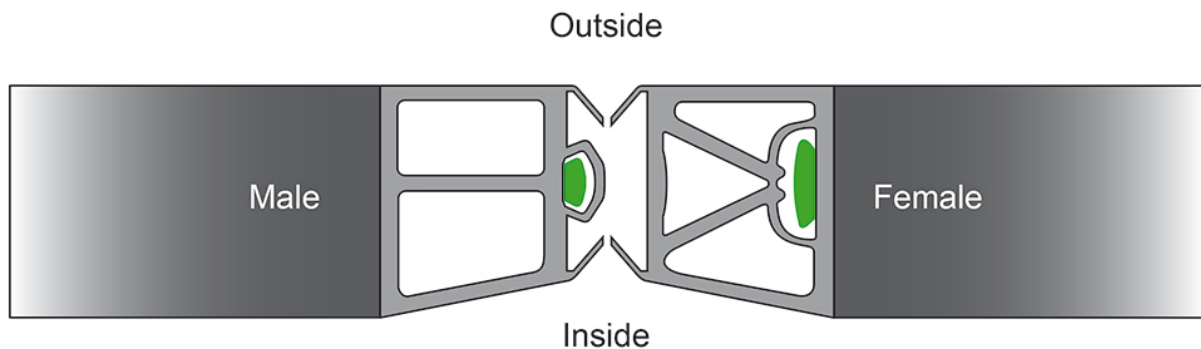
The class 350 train involved in this accident was fitted with a door system intended to detect the presence of obstructions trapped between closing or closed doors. If an obstruction of a size equal to or greater than defined dimensions is inserted between the door leaves, the system was designed to open the doors and prevent the doors being detected as closed². Objects are detected by sensitive edges which respond to pressure. These are incorporated in the rubber seals on the edges of the doors. One door includes a 'male' edge and the other a 'female' edge.

The design requires the female sensitive edge to be switched off shortly before the doors meet so it does not respond to the opposite male edge when they touch (which would cause the door to reopen). The male sensitive edge remains active until the door is closed and locked. The incident doors were tested after the accident by the train maintainer and found to reopen as required when an object of the defined dimensions was inserted between the closing doors.

Cross-section showing the door edge seals housing the electrical sensing elements (shown in green)

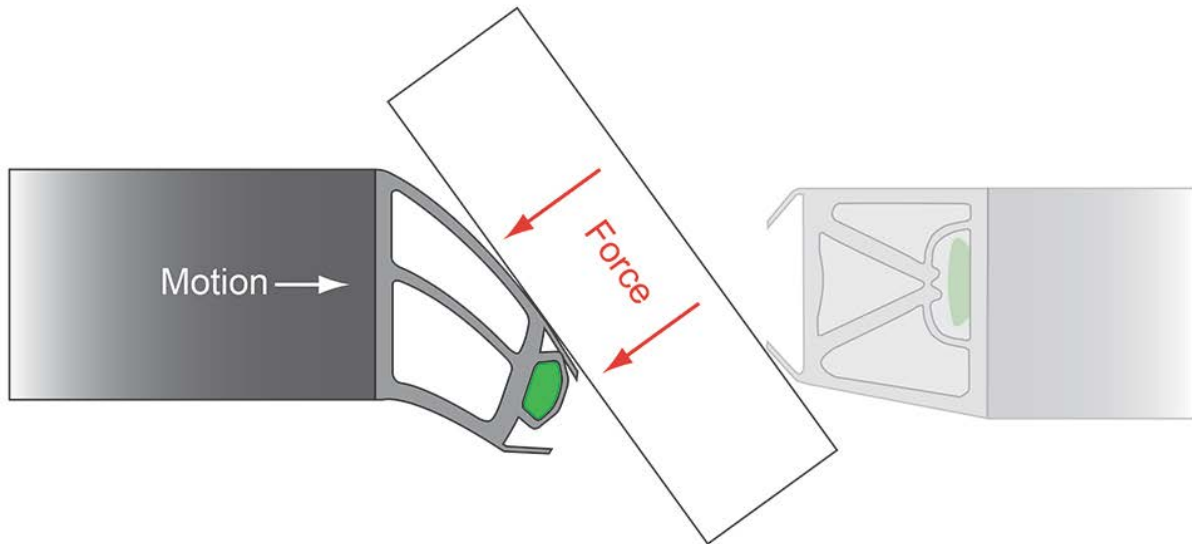
During the Newcastle Central investigation, RAIB tested the passenger doors of a class 185 train, another type of Desiro train fitted with the same design of sensitive door edge as the class 350. The testing found that if a force is applied to the male seal at an angle to the motion of the door, the male door seal can be deflected towards the inside of the coach. The male door edge seal will therefore not press against the female seal. Depending on its size, the object may not compress the female sensitive edge until after this has been switched off by the door detection control circuitry. The result can be a failure to detect a trapped object, such as a wrist or forearm.

Cross-section showing the door seals and the deflected male edge

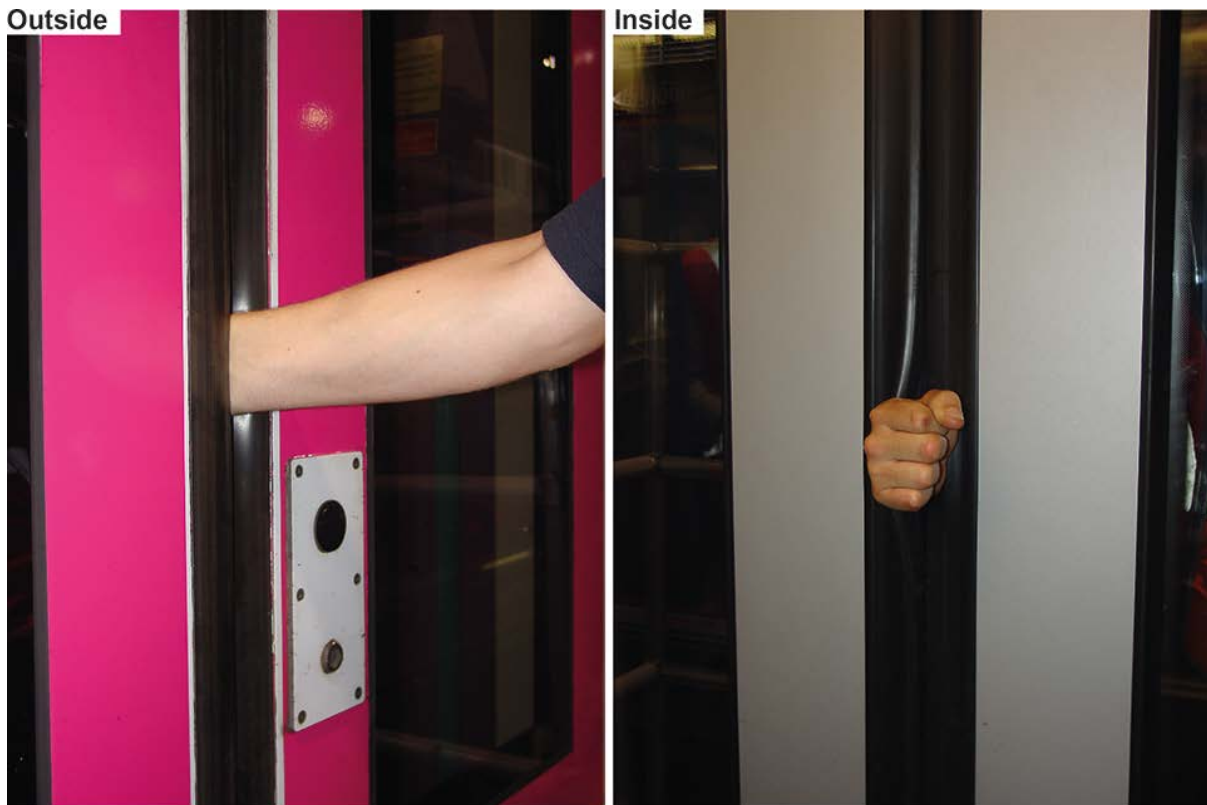
RAIB has previously found that door systems similar to those involved in the accident at Bushey can be detected as closed and locked with an object, such as a forearm or wrist, trapped between the doors (passenger trapped in train doors and dragged at Newcastle Central station, [RAIB Report 19/2014](#)).

Adult male wrist, approximately 45 mm by 70 mm, trapped in a class 185 door (of similar design to a class 350 door) detected as closed and locked

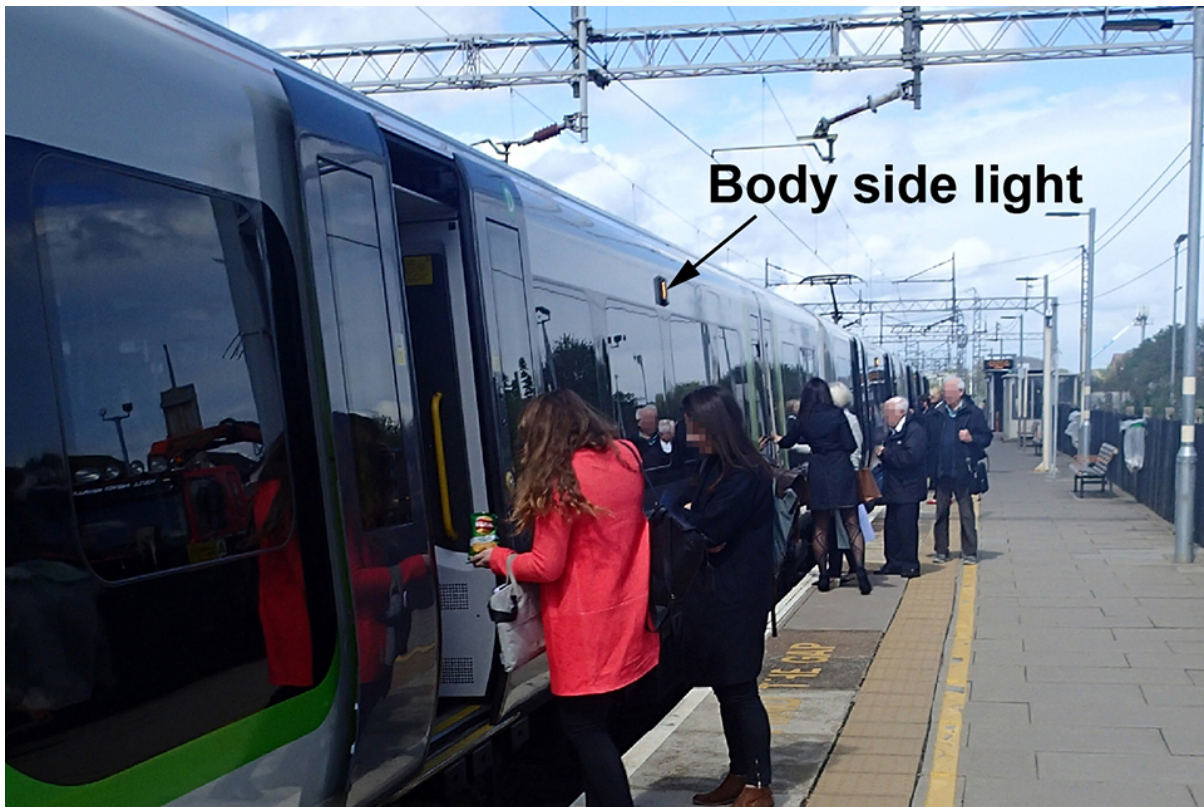
Body side light - not illuminated when doors are detected as closed and locked

The conductor then closed the door to his cab and the interlock light illuminated when this door was fully closed. The conductor stated he believed the extinguished body side lights and the illuminated interlock light in his cab showed that nothing was trapped in the closed doors. He therefore sent the driver a signal that the train could depart.
