Rail Accident Investigation Branch

Rail Accident Report

Pushchair trapped in tram doors and dragged, Nottingham 15 December 2017

Report 15/2018
September 2018

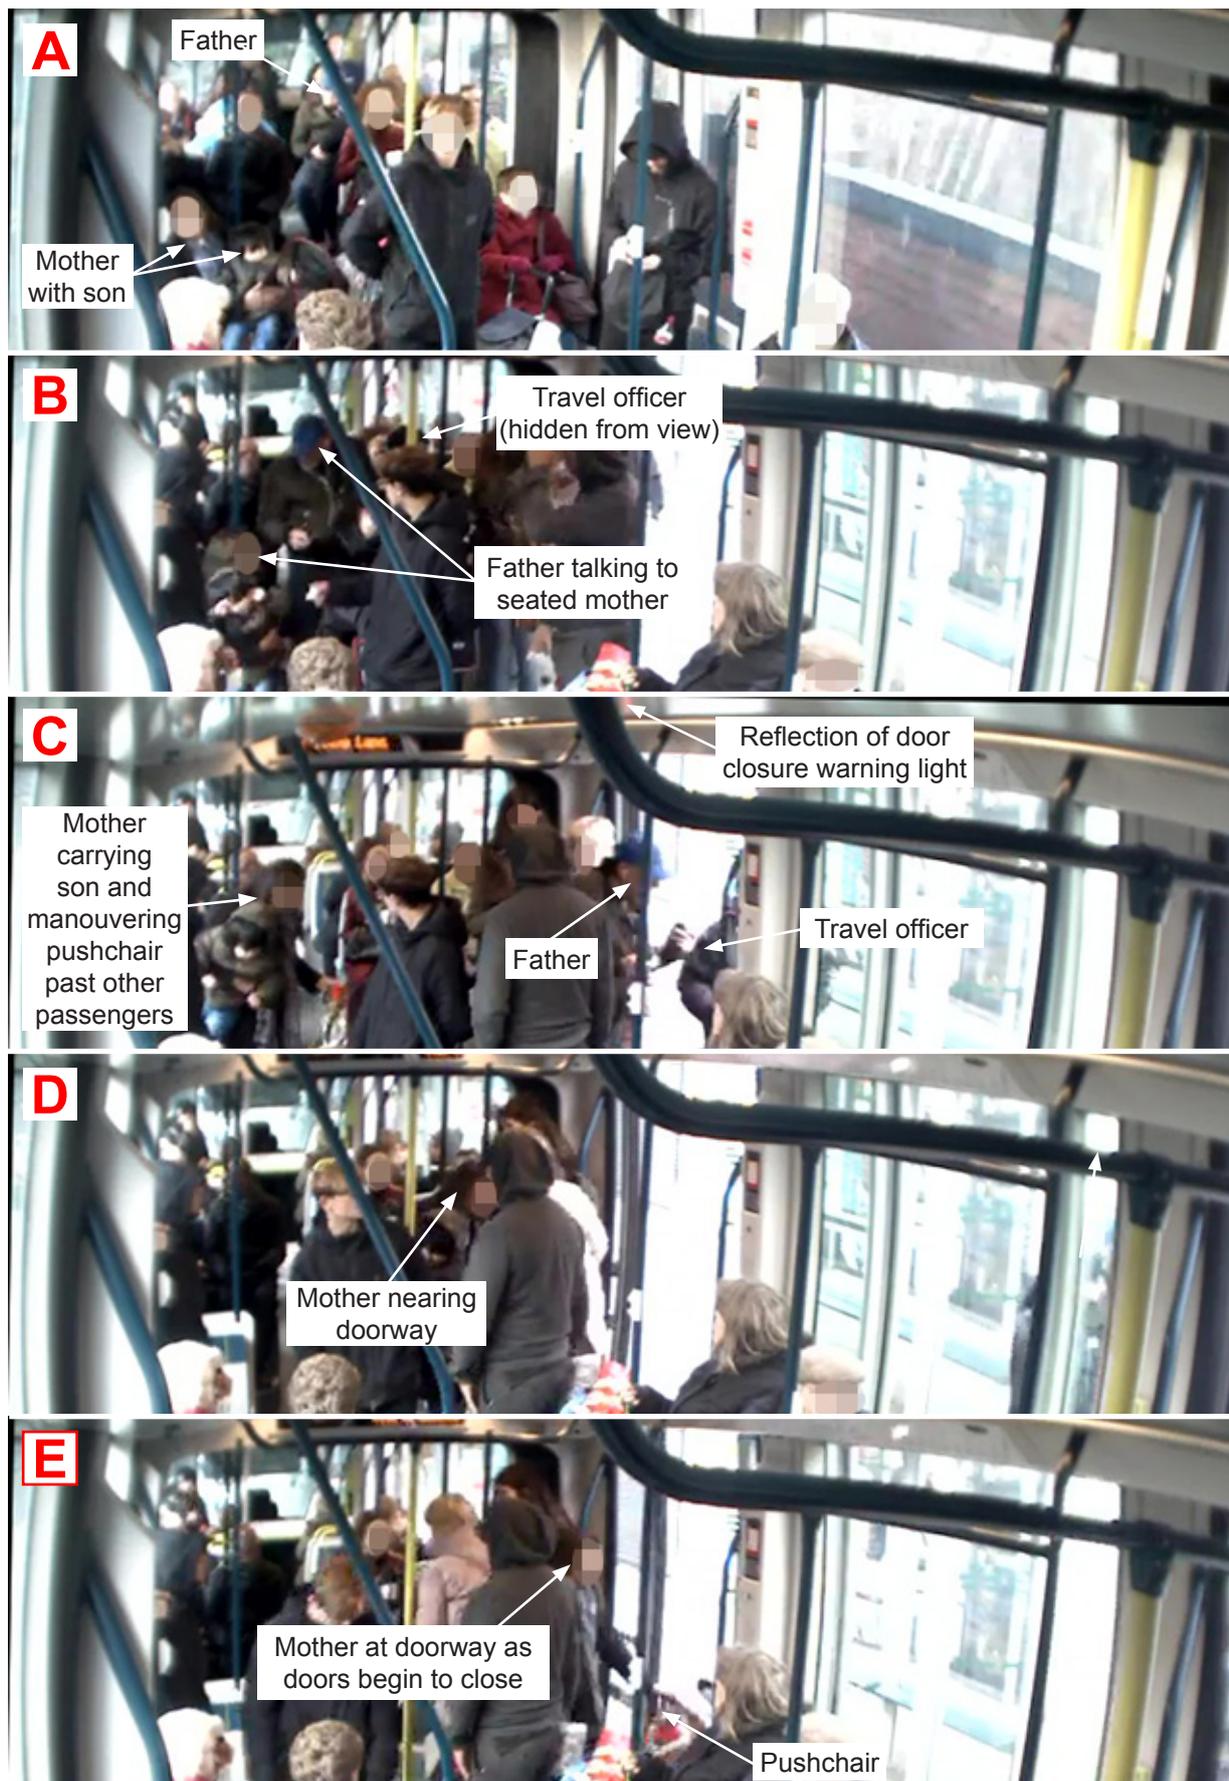
Figure 9: Passengers and travel officer movements (internal tram CCTV images courtesy of Nottingham Trams): a) Initial positions at tram stop; b) Father speaking to mother; c) Father and travel officer leaving tram; d) Mother nearing door; e) Mother at doorway

- 24 The family involved in the incident boarded tram 237 at Moor Bridge, seven stops from Radford Road, at around 13:15 hrs. Initially they sat adjacent to each other in the fourth module. The father gave up his seat to an elderly passenger at Bulwell, and found an empty seat in the rear (fifth) module as the tram travelled between David Lane and Basford. The mother remained where she was, holding her young son in her arms with their pushchair close by (figure 9a).

- 27 At the moment travel officer 1 arrived at the open doors, just ahead of the father, the driver, unaware of travel officer 1's intentions, pressed the doors close push-button in the driving cab. This initiated the three-second door closure warning comprising a flashing orange light above the doorway and an audible warning tone. Travel officer 1 and the father got off the tram as the mother, carrying their son, manoeuvred the pushchair past other passengers (figures 9c and 9d). Just as the mother arrived at the doors with the pushchair, the doors began to close (figure 9e). She pushed the pushchair onto the platform and pulled her arm back inside the tram before the doors fully closed. However, the plastic rain cover attached to the pushchair then became trapped in between the closed and locked doors.

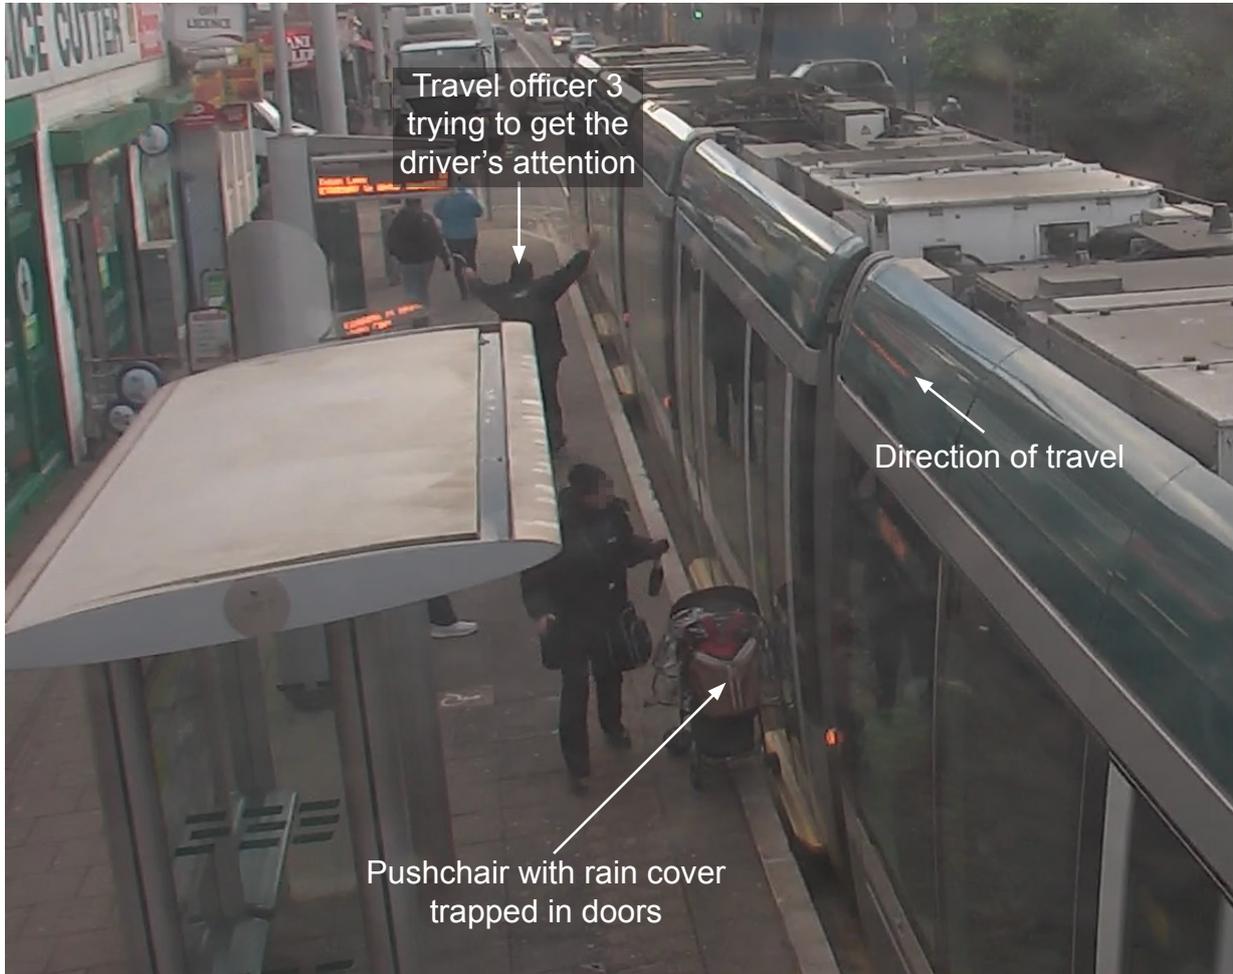
Figure 10: Travel officers trying to attract the tram driver's attention (tram stop CCTV image courtesy of Nottingham Trams)

- 28 When the tram doors had closed and locked, travel officer 3 saw the trapped pushchair (figure 10). He brought it to the attention of travel officer 1 who then tried to free the pushchair. At the same time, travel officer 3 and travel officer 2 turned to the front of the tram to try and get the drivers attention by waving their arms above their heads. As the tram began to move travel officer 1 grabbed hold of the pushchair but was not able to pull it free and the tram left the tram stop with the pushchair trapped in the doors.

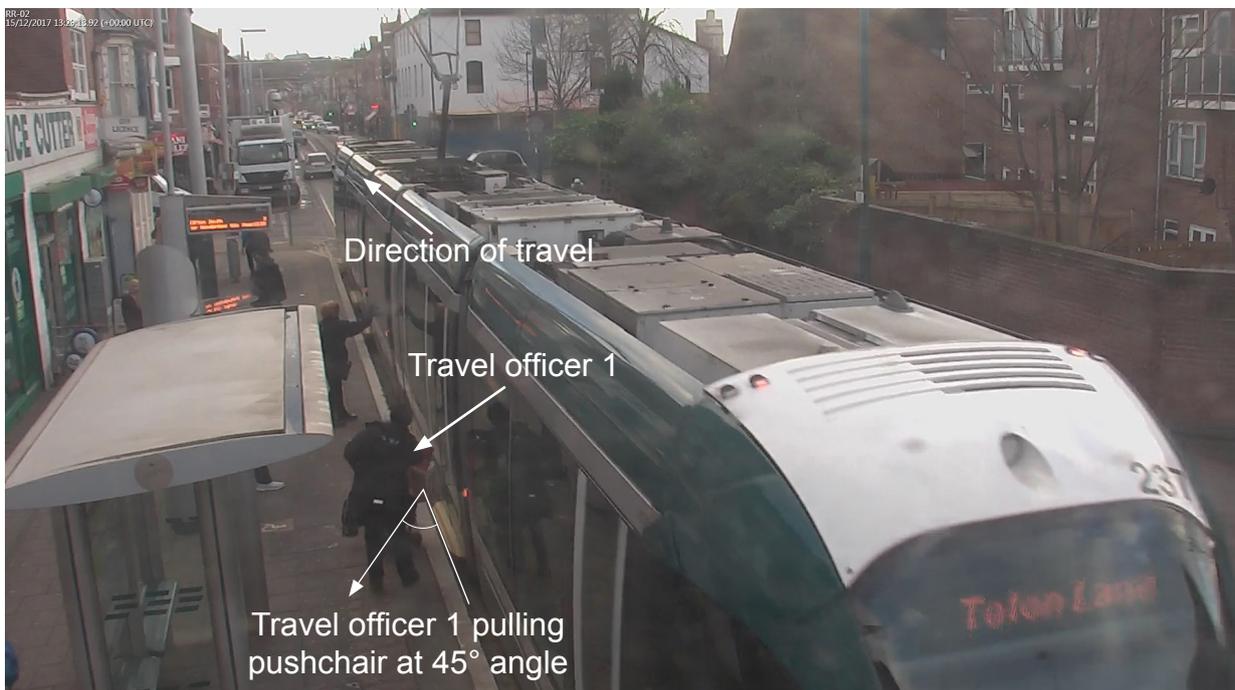
Figure 11: Travel officer 1 pulling pushchair (tram stop CCTV courtesy of Nottingham Trams)

- 48 Travel officer 1 made a grab for the trapped pushchair as the tram began to move but was not able to pull it free. Tram stop CCTV shows that she managed to get hold of one of the pushchair's handles but was not able to pull hard enough to release the pushchair. She was pulling it towards the rear of the tram at an angle of about 45° (figure 11).

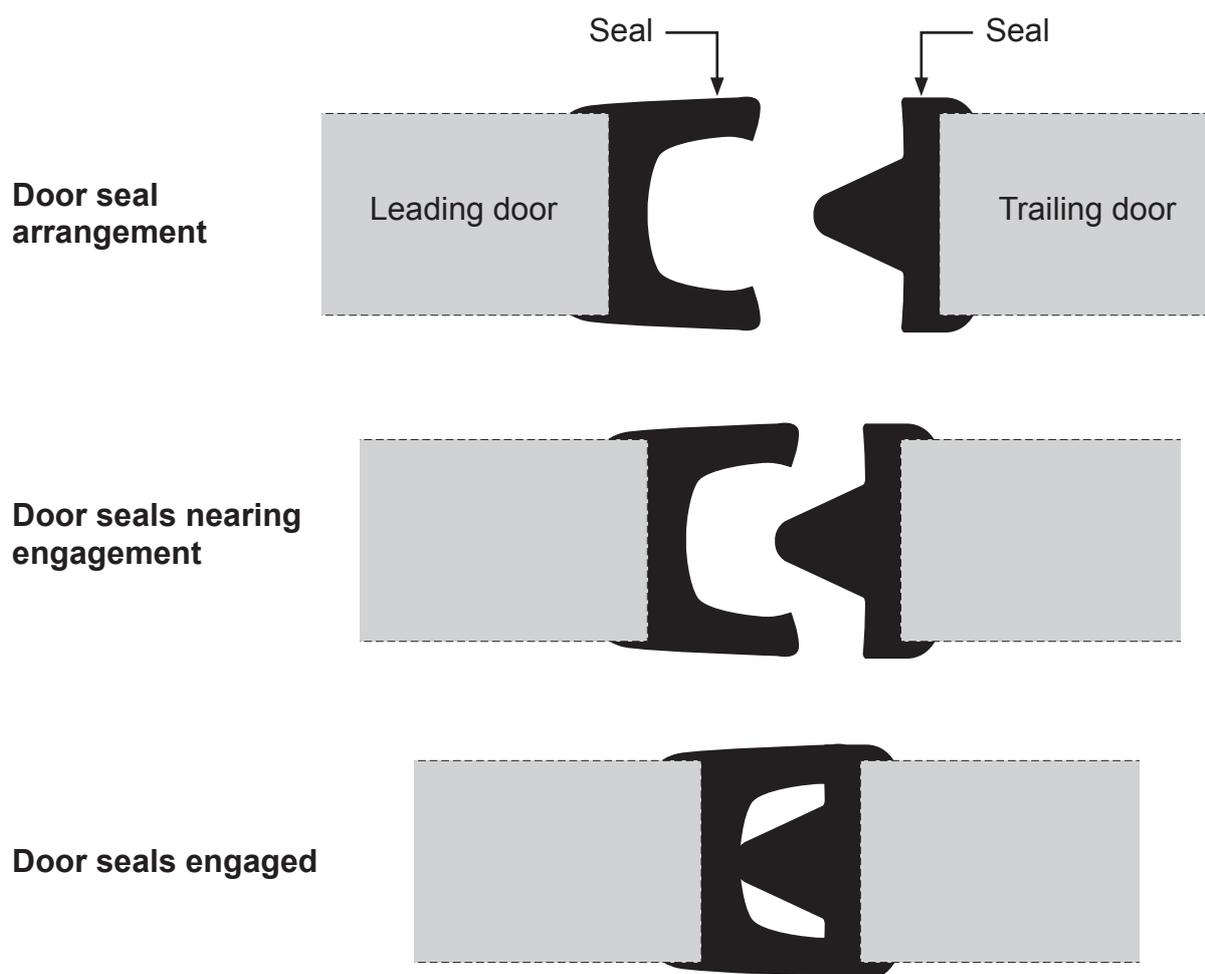
Figure 12: Door seals fitted to Nottingham Trams' fleet of Citadis trams (leading and trailing refer to direction of travel at time of incident)

- 52 The force required to pull the rain cover free was affected by the shape of the rubber seals fitted to the edges of the doors and the high level of friction between the rubber door seals and the plastic rain cover. The seal shape (figure 12) is intended to make a water tight seal between the door edges, but the shape of the seal edges means that thin flexible objects can be extremely difficult to pull free.

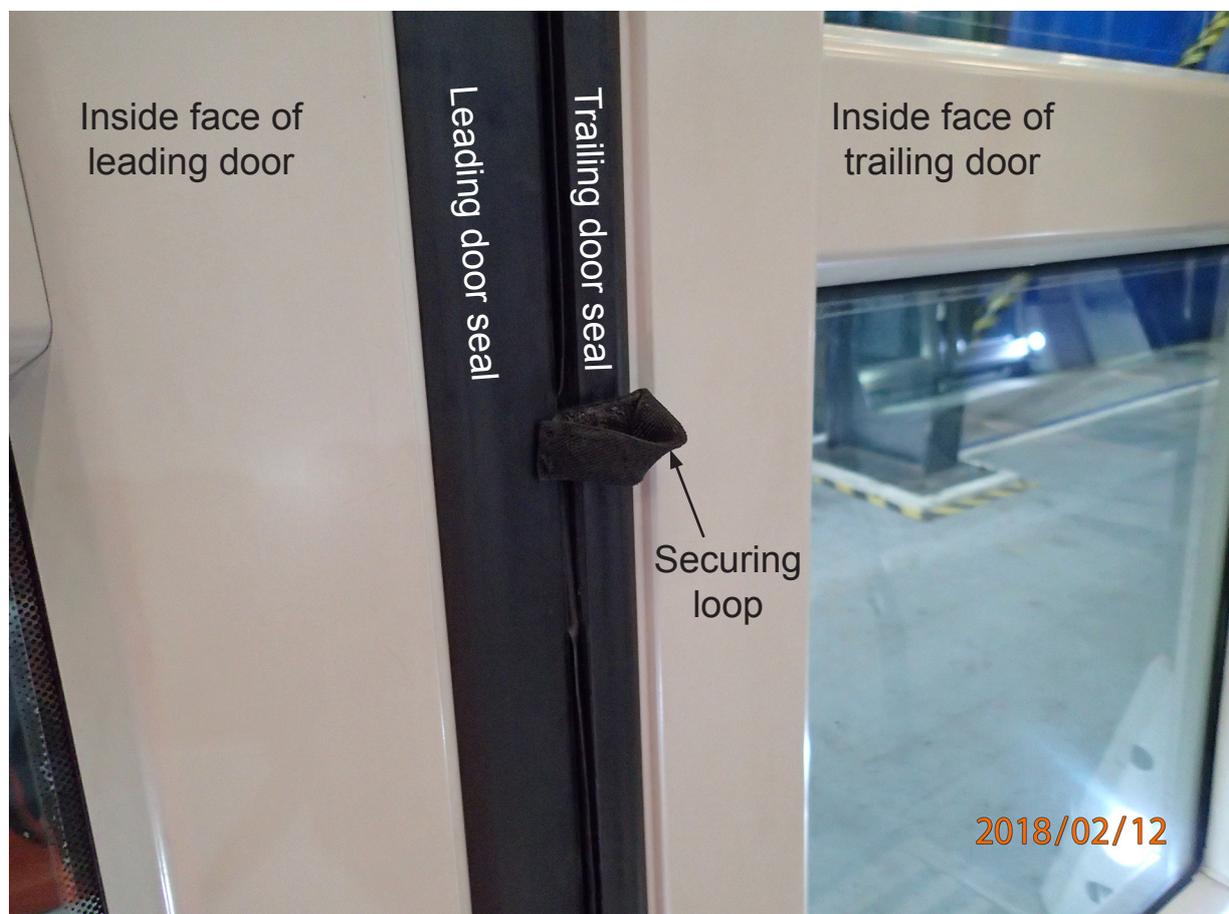
Figure 13: Securing loop trapped inside tram doors during RAIB testing (leading and trailing refer to direction of travel at time of incident)

- 53 In addition to the gripping effect of the door seals, it is possible that one of the securing loops (designed to keep the rain cover closed when it was not needed) was trapped on the inside face of the doors (figure 13). During two RAIB tests with the securing loop trapped inside the tram doors, the rain cover split apart and could not be pulled free in one piece. The pull forces, measured at right-angles to the doors immediately before the rain cover split apart, were 264 N (about 27 kg) and 289 N (about 29 kg).

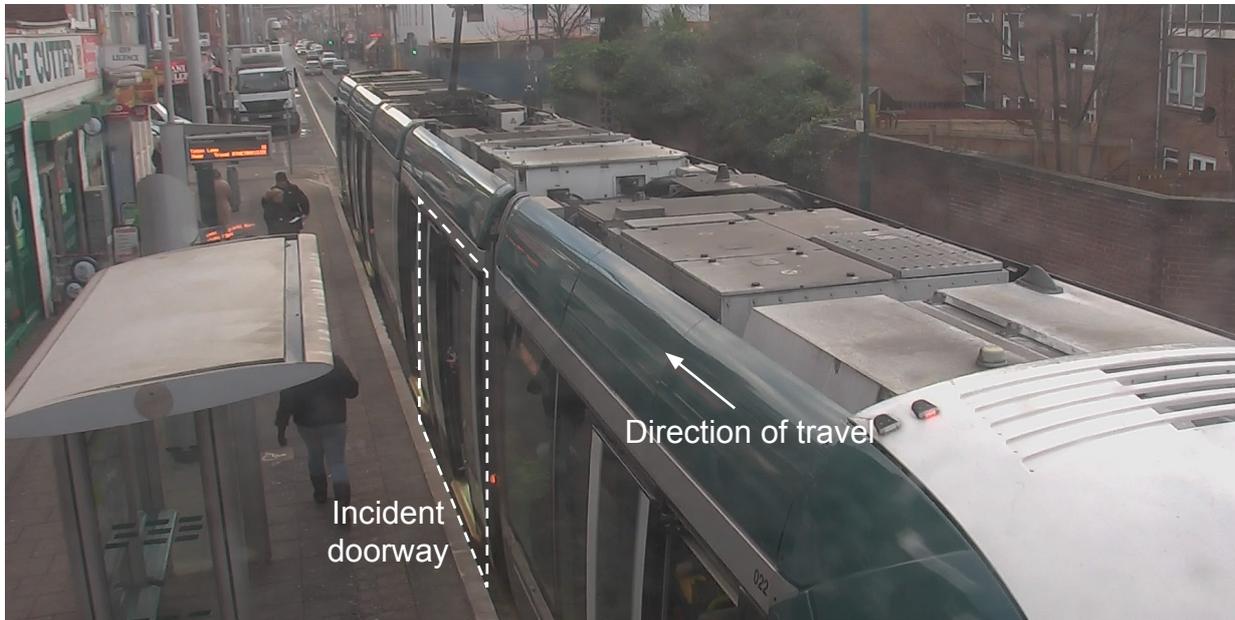
Figure 14: Tram stop when driver closed the tram doors (tram stop CCTV courtesy of Nottingham Trams)

- 56 The tram driver decided to close the tram doors at Radford Road tram stop when it appeared that people had stopped getting off and on the tram. Travel officer 1, the family, and the pushchair were still on the tram and so not visible to the driver (figure 14).

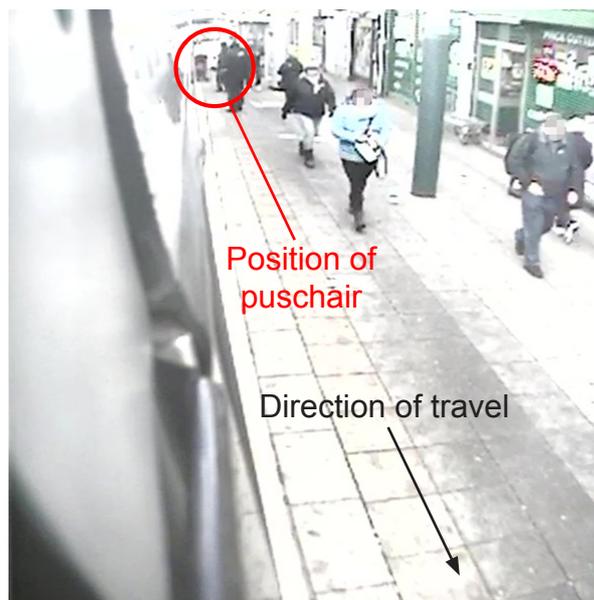
Figure 15: Driver's view of the side of the tram when doors detected closed and locked (tram CCTV courtesy of Nottingham Trams Ltd)

- 57 When the doors were detected closed and locked, the image on the right-hand monitor in the driving cab immediately changed from the rear CCTV on the tram stop (left) side of the tram, to the right-hand 'wing mirror' view (paragraph 14). The pushchair, trapped in the doors near the rear of the tram, was now only visible in the left-hand monitor. In this view the pushchair was near the far end of the tram and was small in size relative to the overall size of the image (figure 15).

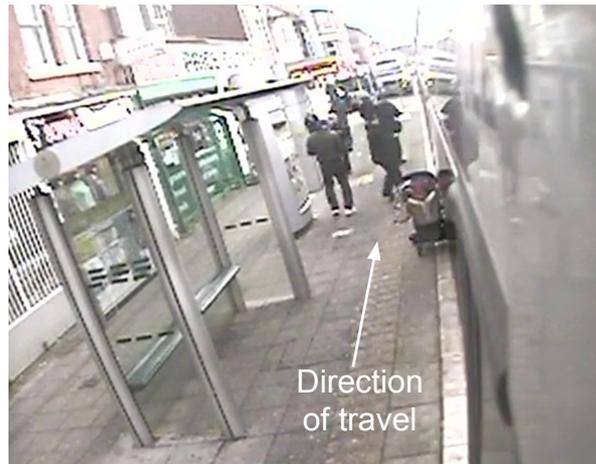
Figure 16: Driver's view of push chair if rear CCTV camera view available after doors closed and locked (tram CCTV courtesy of Nottingham Trams Ltd)

⁸ The RAIB is aware of another UK tramway operator whose trams’ CCTV system (a different type of tram to the one involved in this incident) allows the driver to keep the rear camera view until the driver has completed the final visual door check before starting the tram.

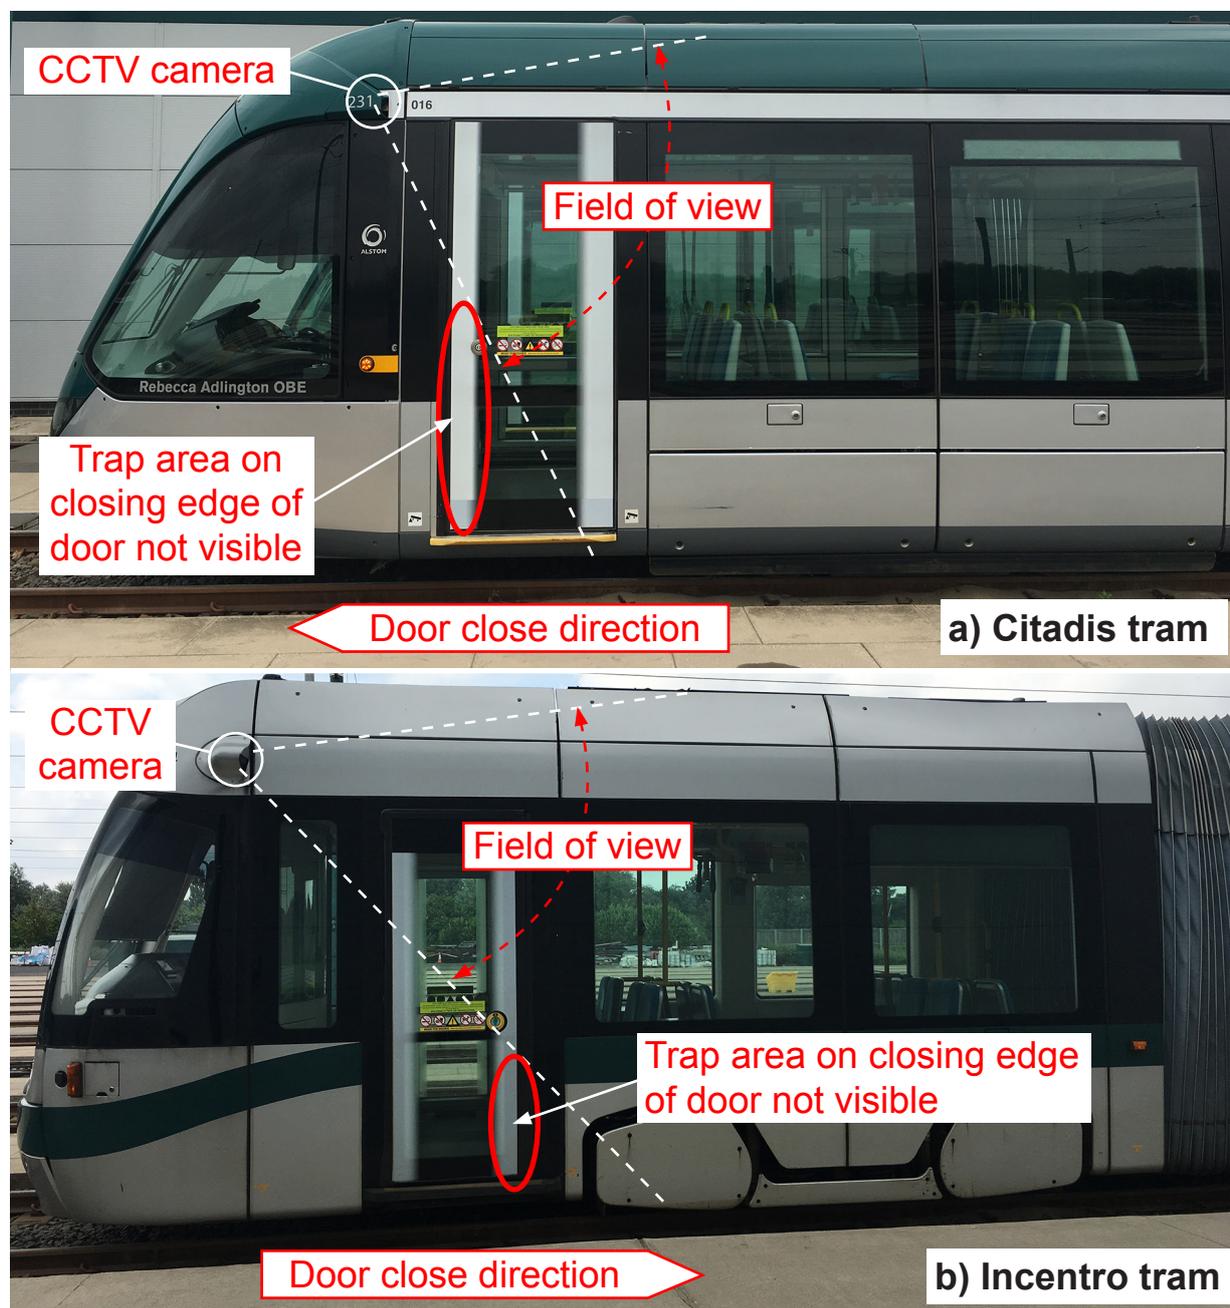
Figure 17: Door trap areas not covered by leading CCTV cameras: a) Citadis tram; b) Incentro tram

- 92 The field of view of the CCTV cameras fitted to the outside of the Citadis and Incentro trams does not cover the full height of the nearest door. RAIB testing found that these cameras did not show the lowest 1520 mm of the closed edge of the nearest door on the Citadis trams, and the lowest 880 mm of the closed edge of the nearest door on the Incentro trams (figure 17).
- 93 This means that a small person or an object could be trapped in the front door of a tram and not be seen by the front CCTV camera, the only camera view available when the driver is required to carry out the final visual door check after the doors are detected closed and locked.

- 94 The position of the front CCTV camera relative to the front door differed between the Incentro and Citadis trams, and the doors on the two types of tram open in opposite directions (figures 17a and 17b). This means that coverage of the front door by the CCTV systems was likely to be different so it was inappropriate to rely on an Incentro risk assessment when modifying the Citadis CCTV arrangement (paragraph 69).

101 The Citadis and Incentro trams bodyside cameras do not provide a full view of the nearest door, so do not allow drivers to check for objects trapped in the lower part of the forward most door before departing from a tram stop (paragraph 91, **Recommendations 1 and 2**).
