Near miss at Plain Moor user worked crossing, Barton-le-Willows, North Yorkshire, 7 July 2018

Summary of the incident

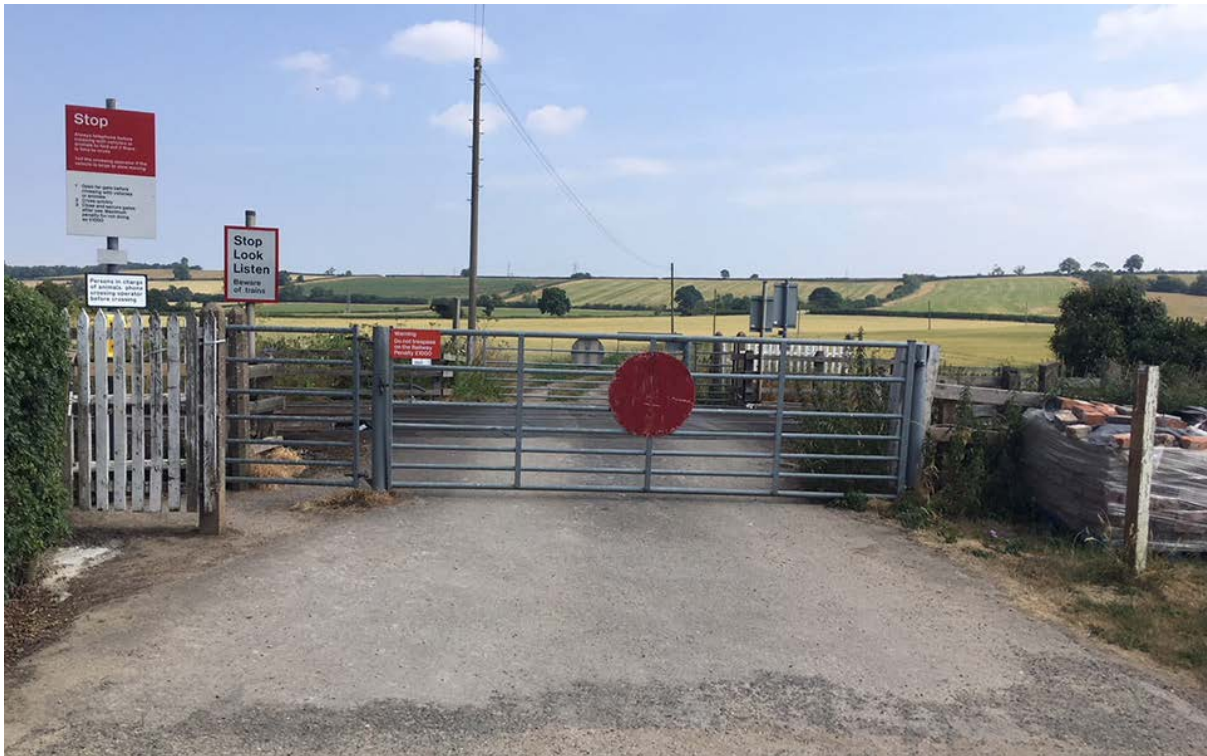
Plain Moor user worked crossing

At 09:37 hrs, a train narrowly avoided a collision with a car that was crossing the railway at Plain Moor user worked crossing, between York and Malton. The car driver had been given permission to cross by the signaller. The train was travelling at 61 mph (98 km/h) on approach to the crossing. A witness reported that the train passed the crossing 'seconds' after the car had cleared it.

The train involved, reporting number 1T85, was the 09:25 hrs TransPennine Express passenger service from York to Scarborough, formed of a 3-car class 185 diesel multiple unit. When it was about 400 metres from the crossing, the train driver saw a person on the crossing and sounded the horn. When it was about 200 metres from the crossing, the train driver saw a car passing over the crossing, and applied the train's emergency brake and sounded the horn again. The train came to a stand beyond the crossing.

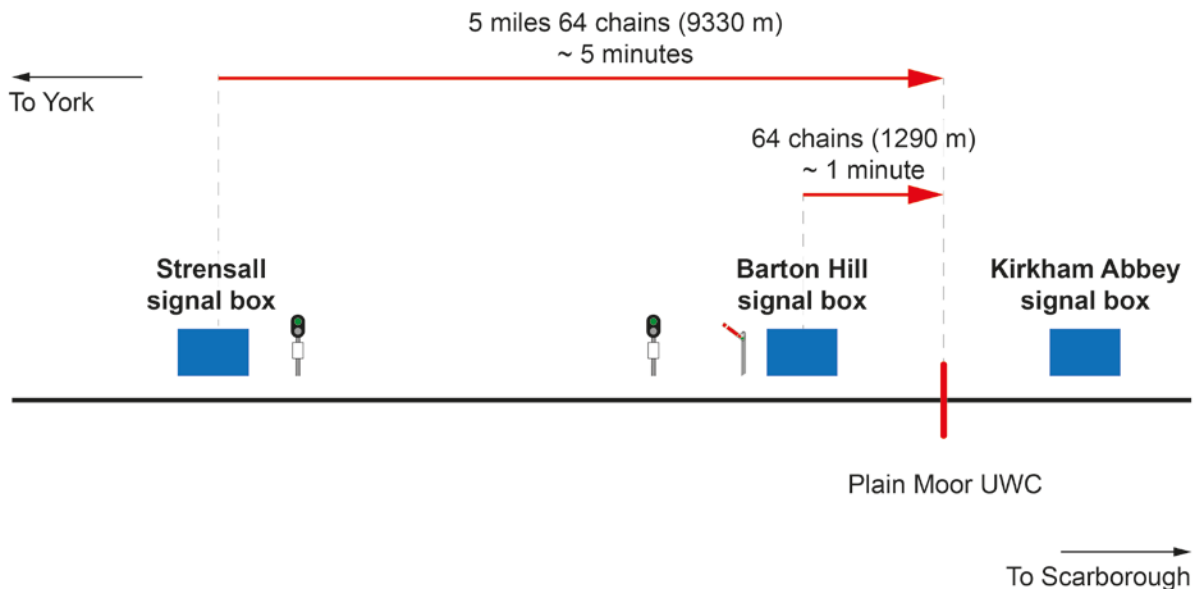
Simplified diagram of crossing location and signalling sequence

When a Scarborough-bound train passes the signal box at Strensall, the signaller there sends a bell-code to Barton Hill indicating that the train is entering the section. The signaller at Barton Hill then acknowledges the bell code and turns a switch on his block instrument to show 'Train On Line'. If the line ahead is clear he then offers the train to the signaller at Kirkham Abbey. At this time, a train is approximately five minutes away from Plain Moor user worked crossing.

When the train reaches the signal box at Barton Hill, the signaller sends a bell-code to Kirkham Abbey indicating that the train is entering the section. The signaller at Kirkham Abbey then acknowledges the bell code and turns a switch on his block instrument to show 'Train On Line'. At this time, a train is approximately one minute away from Plain Moor user worked crossing.

The only indications of train position that the Kirkham Abbey signaller receives for Scarborough bound trains are when he is offered the train and when the train enters the section from Barton Hill. For Plain Moor user worked crossing those indications occur approximately five minutes and one minute ahead of the train's arrival, although the five minute indication is dependent on prompt offering of the train by the Barton Hill signaller. Other crossings between Barton Hill and Kirkham Abbey signal boxes rely on the same indications, although the timings of the train's arrival will vary depending on the crossing location.

During the incident, the Kirkham Abbey signaller was offered, and accepted, the train at 09:32 hrs. The crossing user called at 09:35 hrs and asked for permission to cross with a car, requesting two minutes to do so. The signaller granted permission, asking the crossing user to cross immediately. The signaller received the 'train entering section' signal from Barton Hill at 09:36 hrs. The train driver made an emergency call on the GSM-R radio at 09:37 hrs, reporting a near miss with a road vehicle.

The signaller normally allowed crossing users two minutes to cross, but was aware that regular users could often cross in about one minute. He had calculated that the train would be expected at the crossing at or after 09:37 hrs, and that giving the user permission at 09:35 hrs would allow them to be clear before then. However, the train approached the crossing as the user was driving across.

In this case, the signaller misjudged the time available to the crossing user relative to the time the user needed to cross. If the signaller had been aware of the local instruction, and followed it, it is likely that he would not have given permission for the user to cross, and the near miss would have been avoided.
