Rail Accident Investigation Branch

Rail Accident Report

Detrainment of passengers onto electrically live track near Peckham Rye station 7 November 2017

Report 16/2018
October 2018

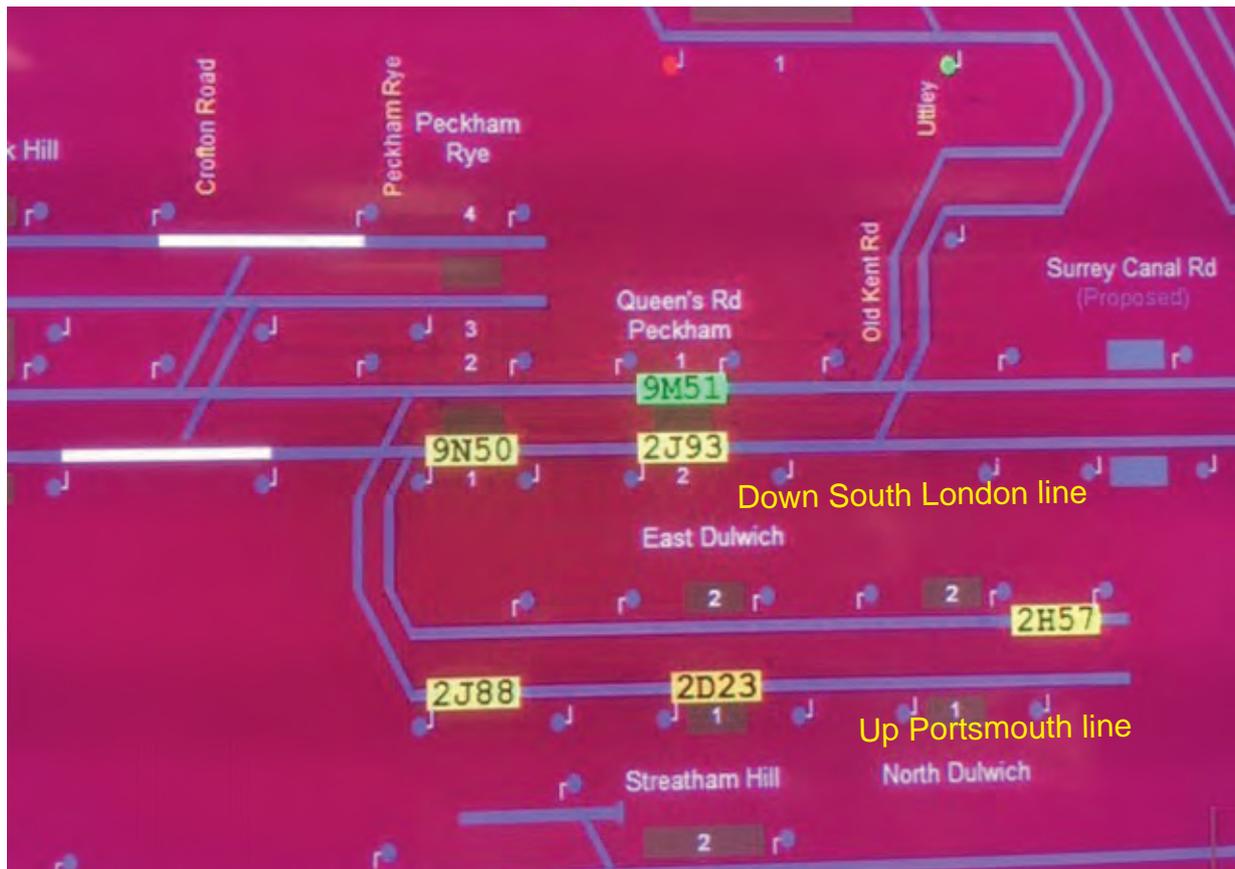
- 27 The IRC, having received brief details of the call from the TSC, checked the ARL train information management system on his control room monitor (figure 7) and observed that train 9N50 was shown on the screen as being at Peckham Rye station. The train was occupying the track circuit which includes the track in the platform at Peckham Rye, giving it the appearance of having reached the station. The IRC therefore assumed that the train was either fully or partially in the station platform. The IRC did not obtain any further details from the train driver, and immediately transferred the call to the Bombardier technician (ISST1) to work with the train driver to identify and rectify the train fault.

Figure 7: The ARL train information system screen

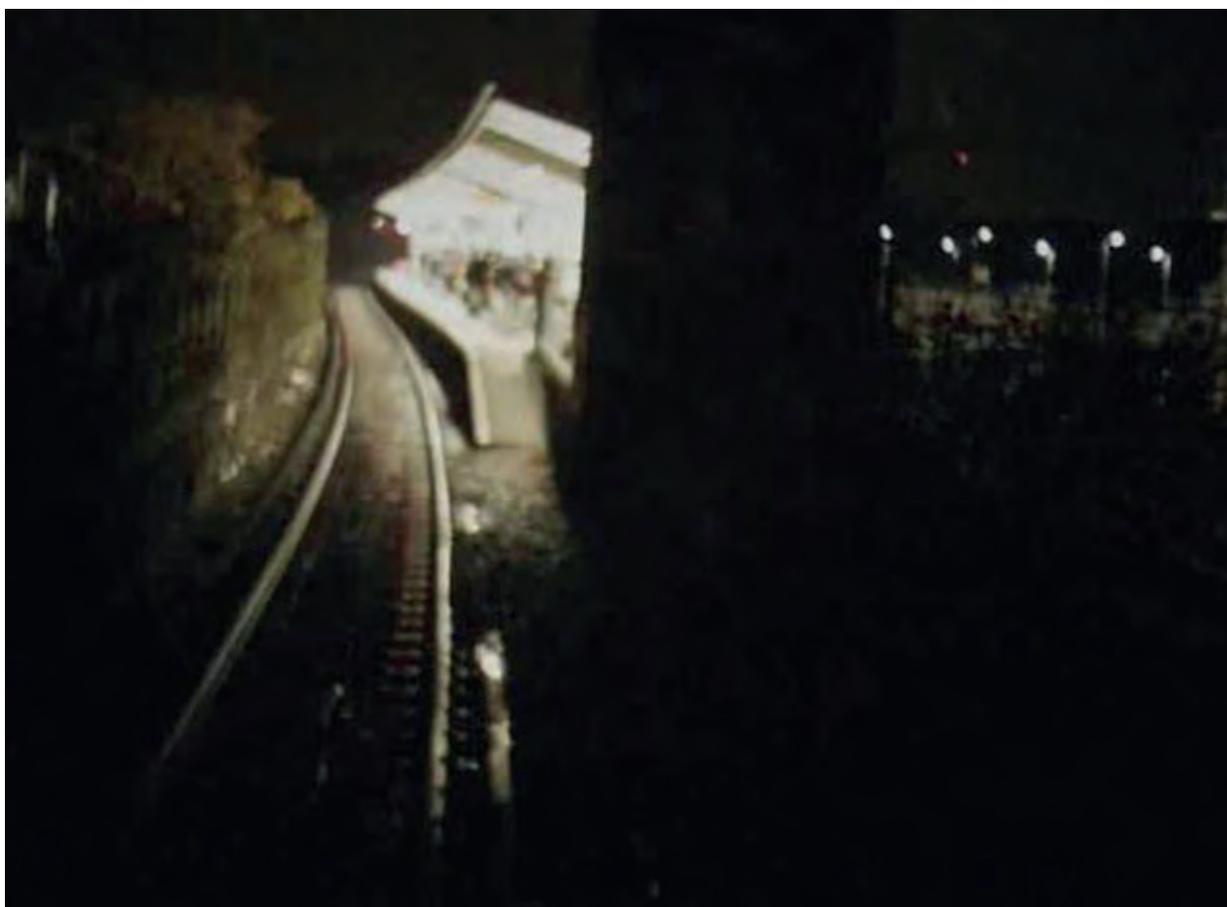
Figure 8: Image from train 9N50 forward facing camera (FFCCTV) showing the location of the train involved in the incident, and view towards Peckham Rye station

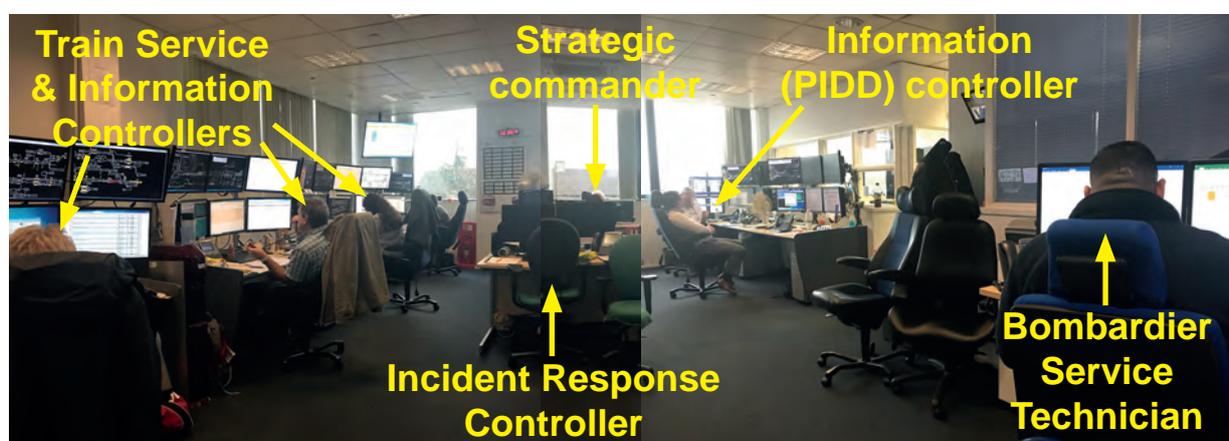
109 ARL strategic command were not adequately prepared to manage the incident, which led to prolonged delays, a confused response to resolving the situation and a failure to understand that the events were developing into a dangerous incident.

110 The restructuring of the ARL strategic command between April and October 2017 had led to changes in existing roles and the introduction of new roles. From May 2017, the strategic command development manager had started training staff. Witness evidence shows that the training was focused on individual training needs, rather than coordinated training through simulation or table top exercises with the object of equipping staff with the necessary skills to work as a team¹⁶, both in normal working and when coordinating incident response with external partners (Network Rail signalling staff and route control).

Figure 10: The position of the various roles within the ARL strategic command

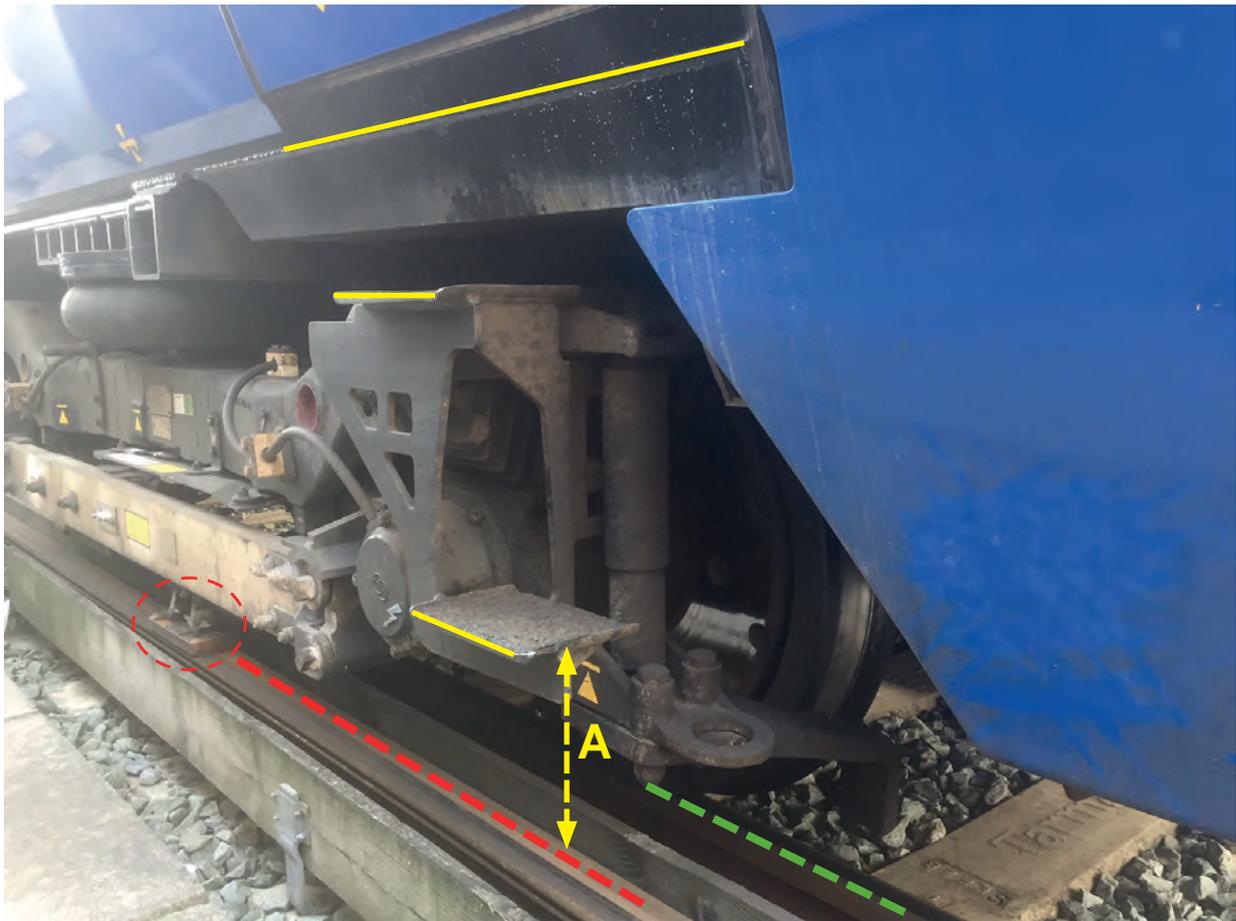
118 The detrainment on to the track side with passengers climbing down the steps and stepping over the live conductor rail and then walking on uneven underfoot conditions, in a dark and damp environment adjacent to the live rail, could have resulted in an injury or fatality. The desire of passengers to share information via social media was also potentially dangerous, as video evidence shows that at least one passenger, after leaving the train, was oblivious to the risk and crossed the live rail to obtain a better image.

Figure 11: Reconstruction showing the position of the steps from the train cab to the track side (yellow line), running rail (green line) and current collector shoe and energised live rail (red dotted line). The distance from the bottom step to the live conductor rail (A) is approximately 300 mm (image courtesy of Arriva Rail London). The wooden guard boarding shown in this photograph was not present at the location of the incident (see figure 12).

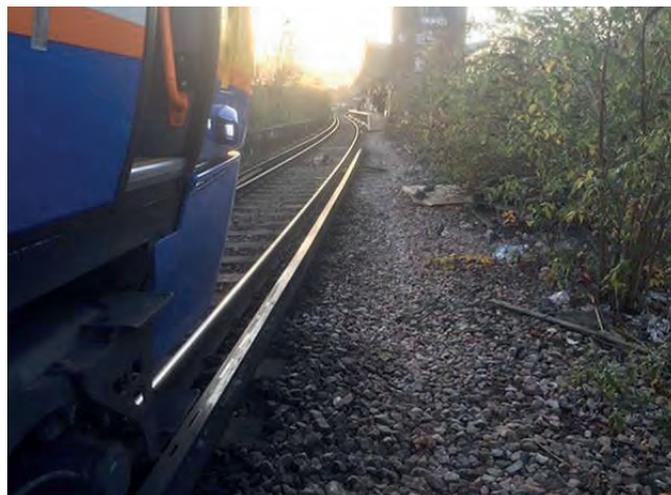
Figure 12: Reconstruction showing the position of train 9N50 relative to Peckham Rye station and the detrainment route (image courtesy of Arriva Rail London)
