Rail Accident Investigation Branch

Rail Accident Investigation: Interim Report

**Loss of speed restrictions on the Cambrian line
20 October 2017**

Report IR1/2018
October 2018

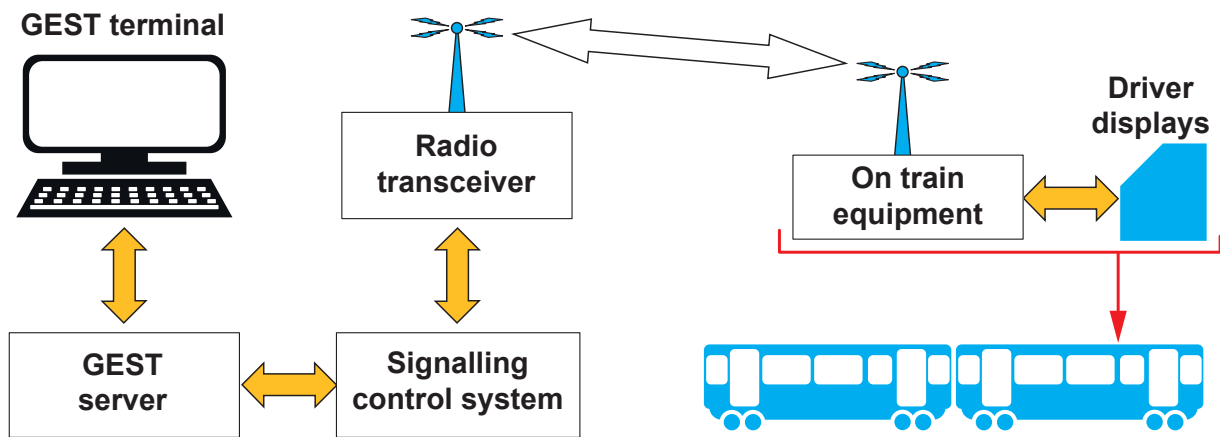
Figure 4: Simplified arrangement of GEST and signalling control system interface

- 30 Following the initial rollover shortly after 23:00 hrs on 19 October 2017, the automated process to upload temporary speed restrictions from the database in the GEST system failed. Such failures should have been revealed to the signallers by the signalling control system and trains should have been prevented from resuming service. However, on this occasion the failure to upload the temporary speed restriction database was not recognised by the signalling system.

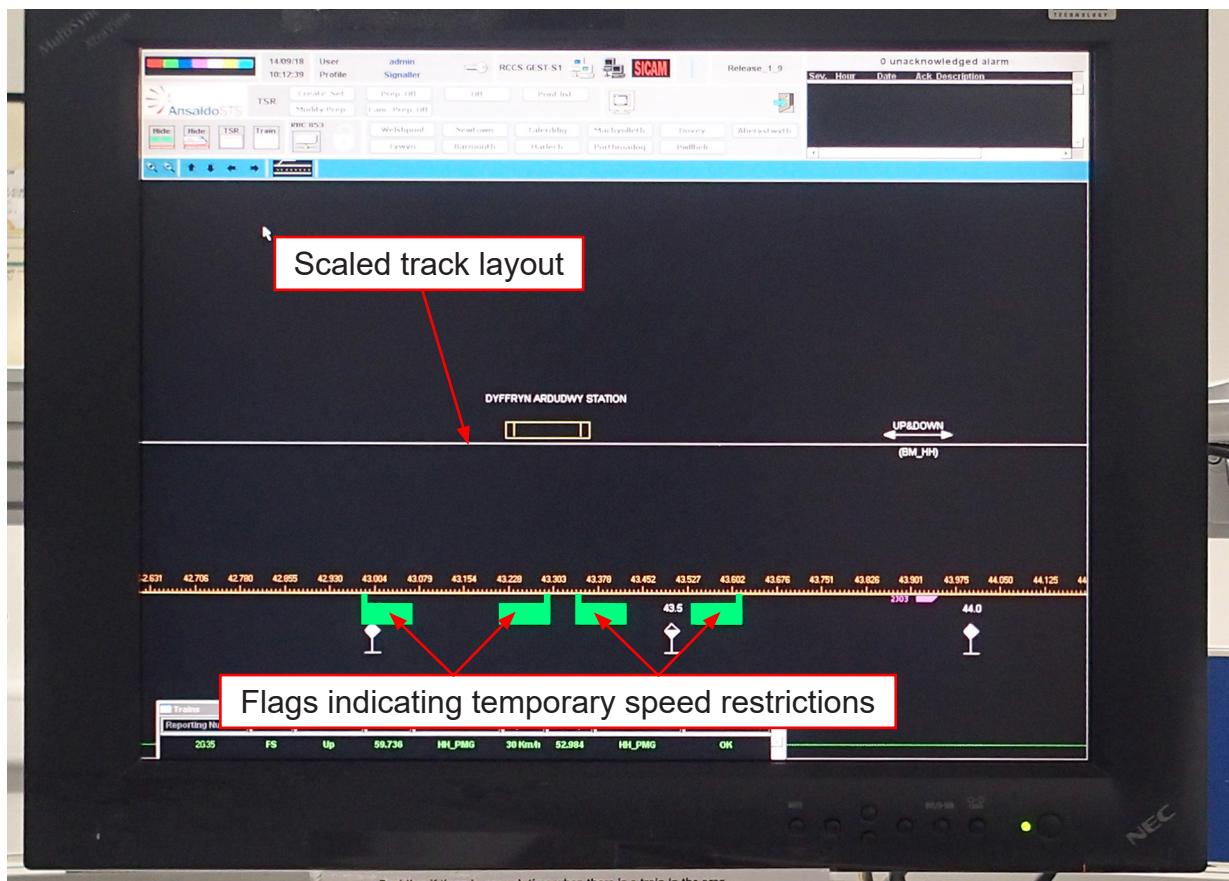
Figure 5: GEST terminal interface screen, here showing a single track with a station and flags at the beginning and end of two temporary speed restrictions

- 31 The signallers should have been alerted to the failure to transmit the restrictions by the restriction flags turning red on the GEST terminal interface screen. When asked by the Ansaldo STS engineer the following day, several members of staff at the control centre checked and confirmed that the restriction flags were green on the GEST terminal screen. Although this was several hours after the initial rollover had occurred, there is no evidence that the flags were any colour other than green since the rollover the previous evening.

- 32 The GEST system is an integral part of the overall signalling system and safety related decisions relating to the management and control of trains are made based on the information displayed by the GEST terminal screen. Checks within the safety critical system software should have prevented the incorrect displaying of the green restriction flags on the GEST terminal interface screen.
