Rail Accident Investigation Branch

# Rail Accident Report

## **Landslip and derailment at Loch Eilt, north-west Scotland 22 January 2018**

Report 10/2018  
August 2018

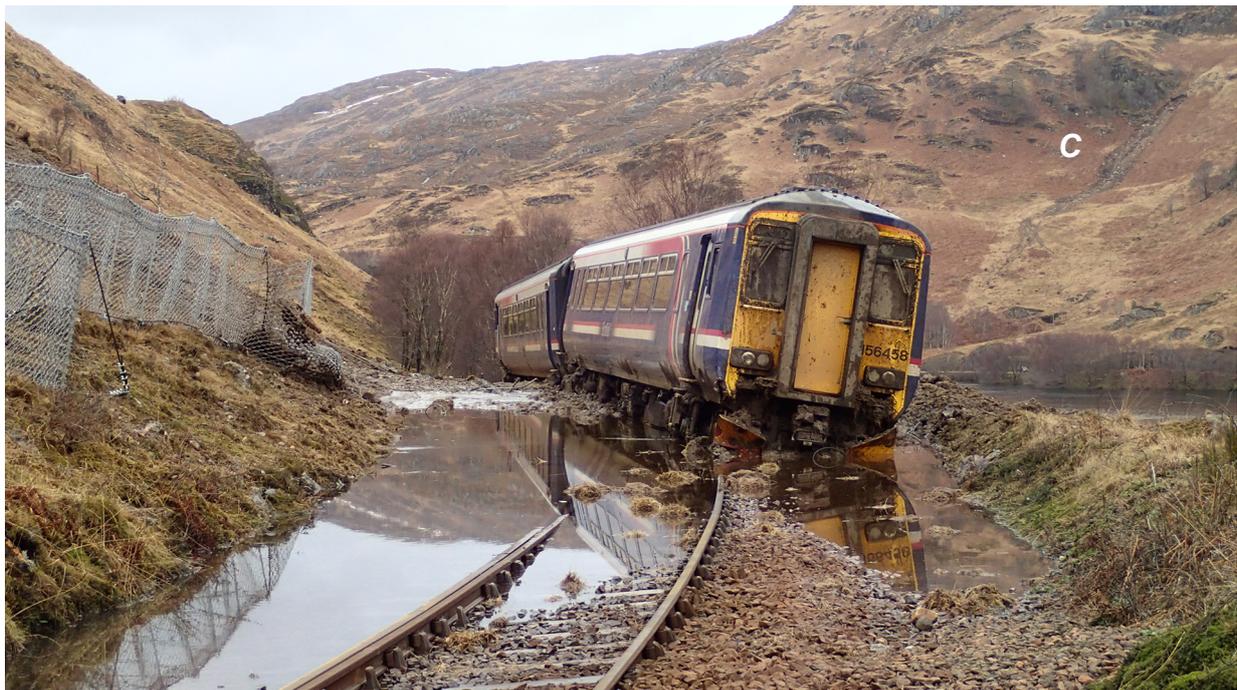
- 5 The train travelled through the debris for about 30 metres before coming to a stand with the leading vehicle derailed and tilted to the left (figures 3 and 4). After it stopped, the leading vehicle continued to shudder and was evacuated. There were no injuries to the traincrew or passengers.
- 6 The 2-carriage train was damaged and partly submerged in mud and flowing water. An estimated 700 litres of diesel fuel leaked from the damaged leading vehicle. Some diesel was carried by flowing water into the lineside drainage channel and entered Loch Eilt.

Figure 3: Front view of derailed train. Another recent landslip is visible in the distance on the opposite side of Loch Eilt (marked 'C').

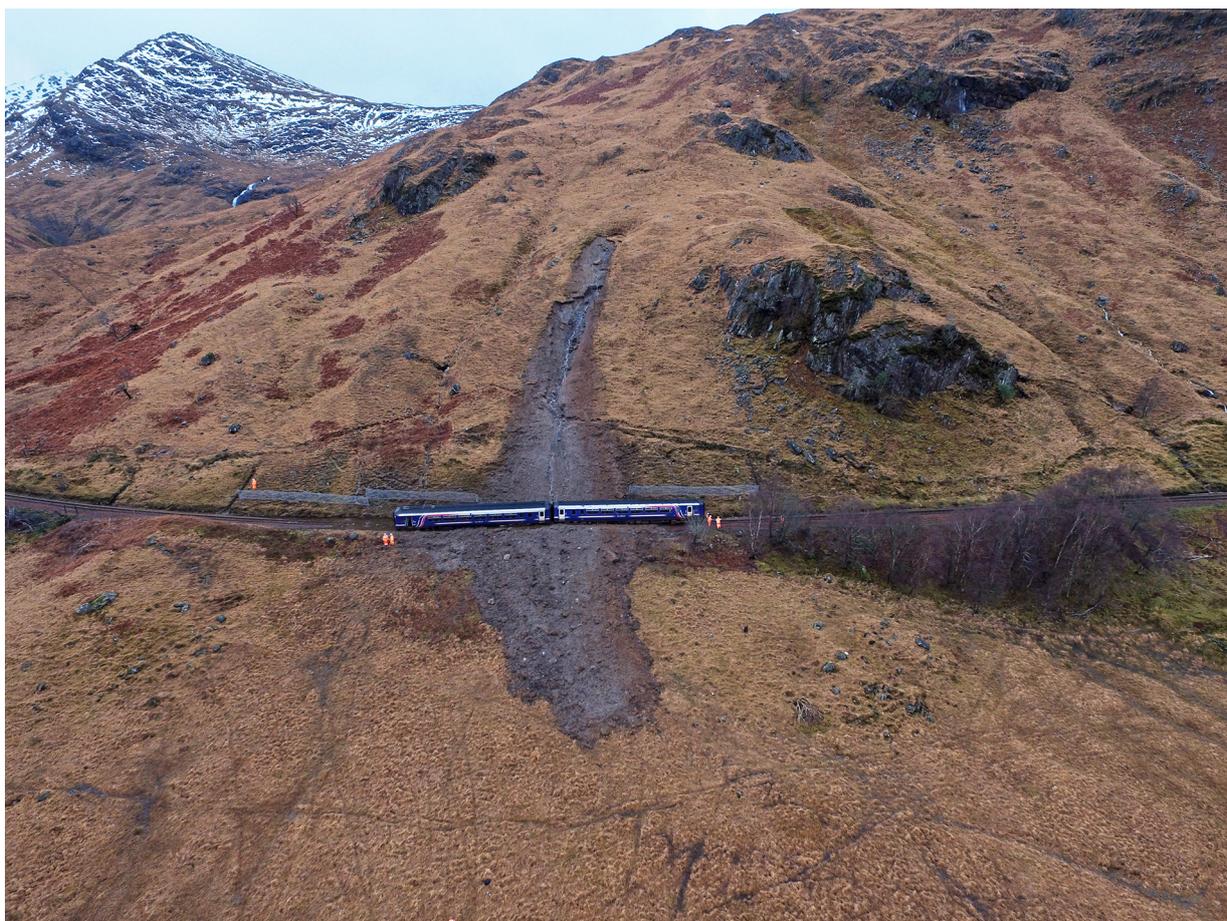
Figure 4: Aerial view of landslide

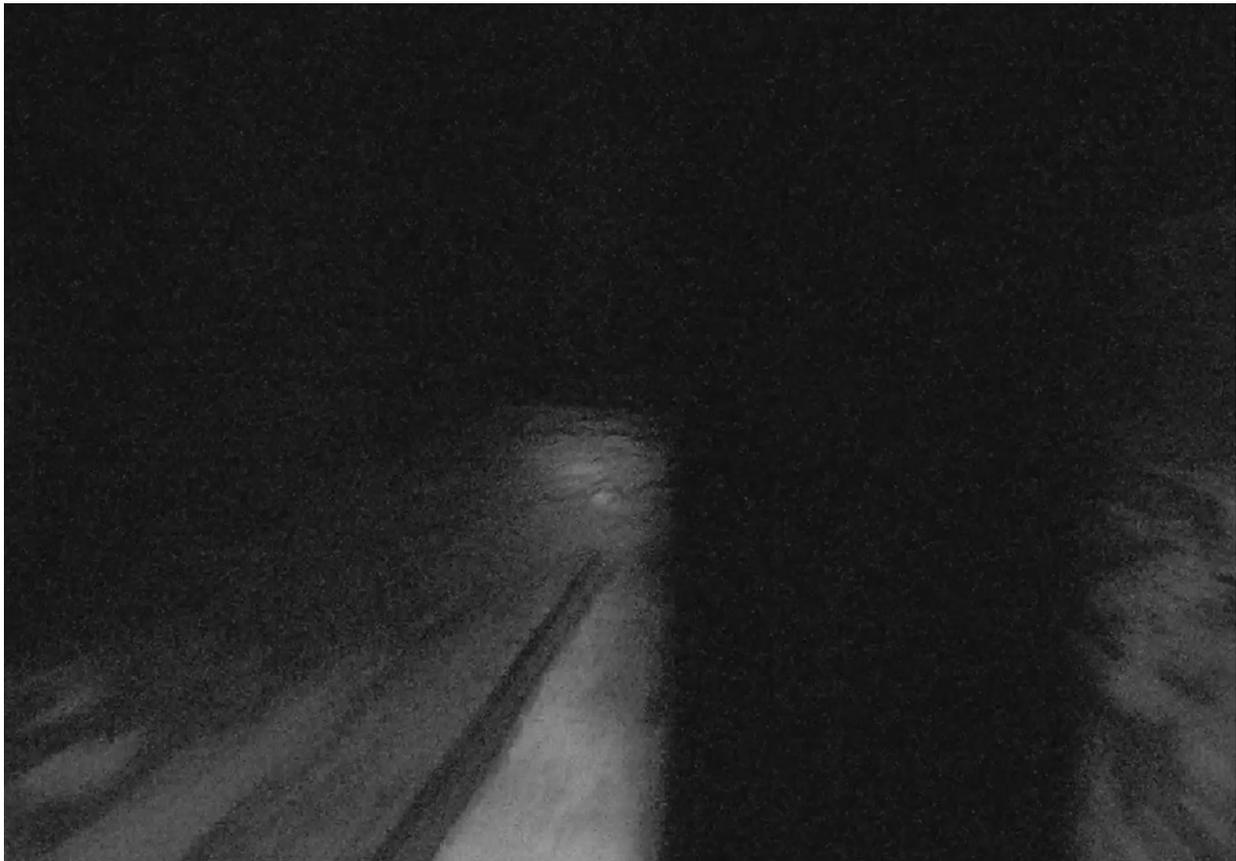
## Contents

*Figure 6: Image from forward-facing CCTV camera on train 1Y42 before the collision showing debris ahead and patches of snow at track level. The left-hand rail is visible, but the view of the right-hand rail is obstructed.*

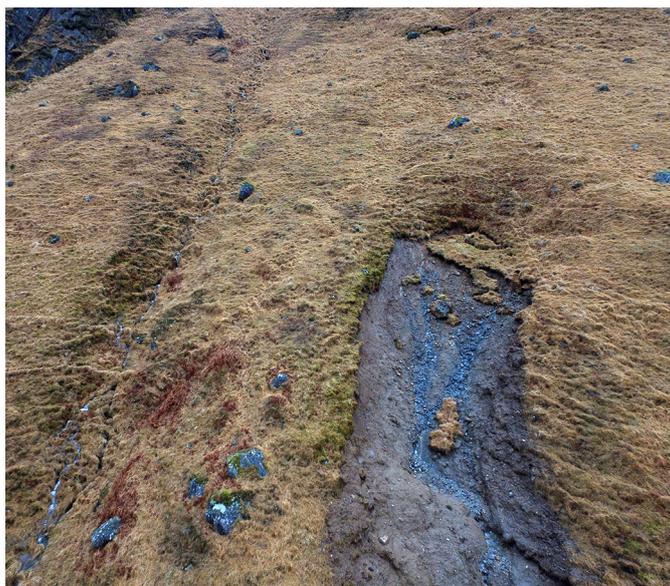
- 42 The gradient of the natural slope in the area of the landslip ranges between 25° and 30° with several streams flowing down the hillside and passing under the track into Loch Eilt.
- 43 The landslip involved an estimated 500 m<sup>3</sup> to 600 m<sup>3</sup> of material, weighing over 1000 tonnes. The top of the landslip started at a natural hollow about 80 metres outside the railway boundary fence, and 46 metres above track level (figure 9). The slip followed the path of an existing gully, enlarging it significantly down to the level of the underlying bedrock (figure 10).

Figure 9: Existing natural hollow at top of slip

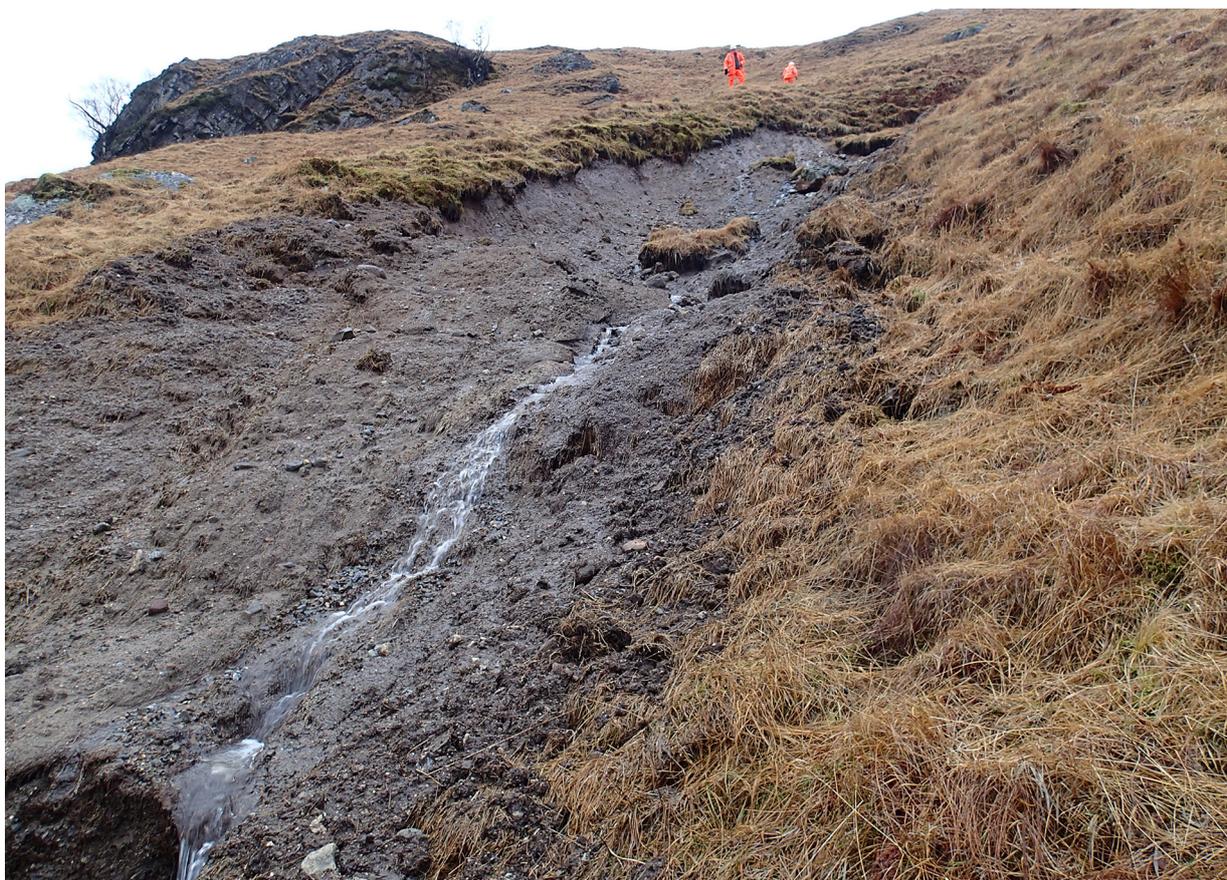
Figure 10: Side view of upper part of slip on natural slope

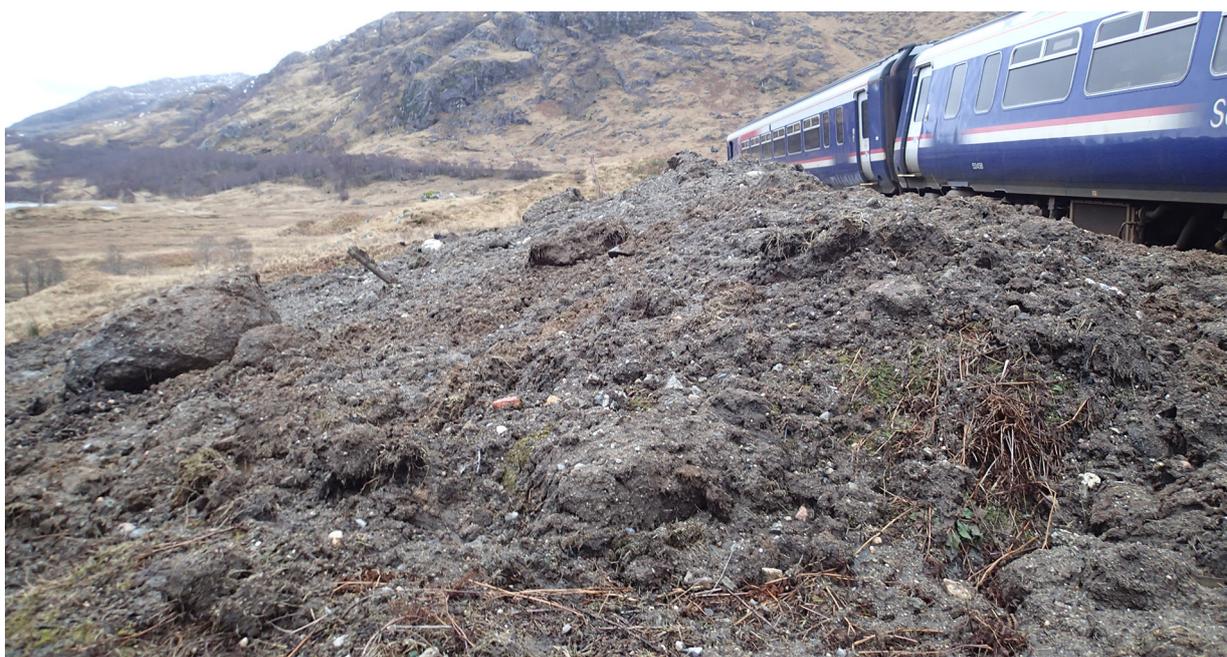
- 44 As the leading edge of the sliding debris approached the railway, it destroyed part of the catch-fence which had been installed in 2017 to trap falling rocks. It then spread out as a debris plume, 40 metres long below the level of the railway (figures 11 and 12). The displaced material included several large boulders, and a significant volume of water.

Figure 11: View showing nature of debris on downhill side of railway

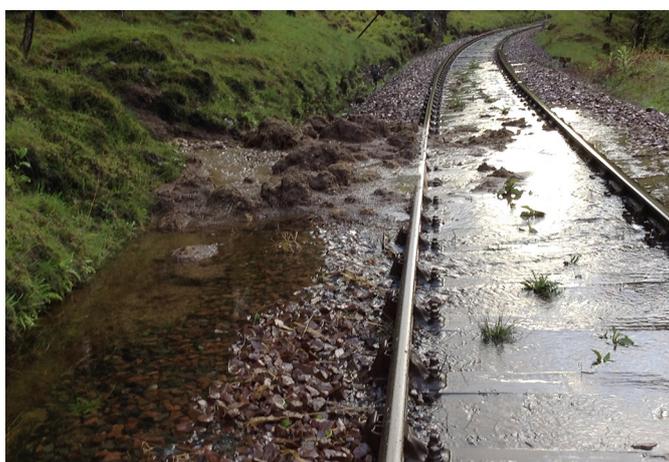
*Figure 13: view of minor landslip which occurred in June 2015 about 150 metres west of the 2018 accident landslip (photograph courtesy of Network Rail)*

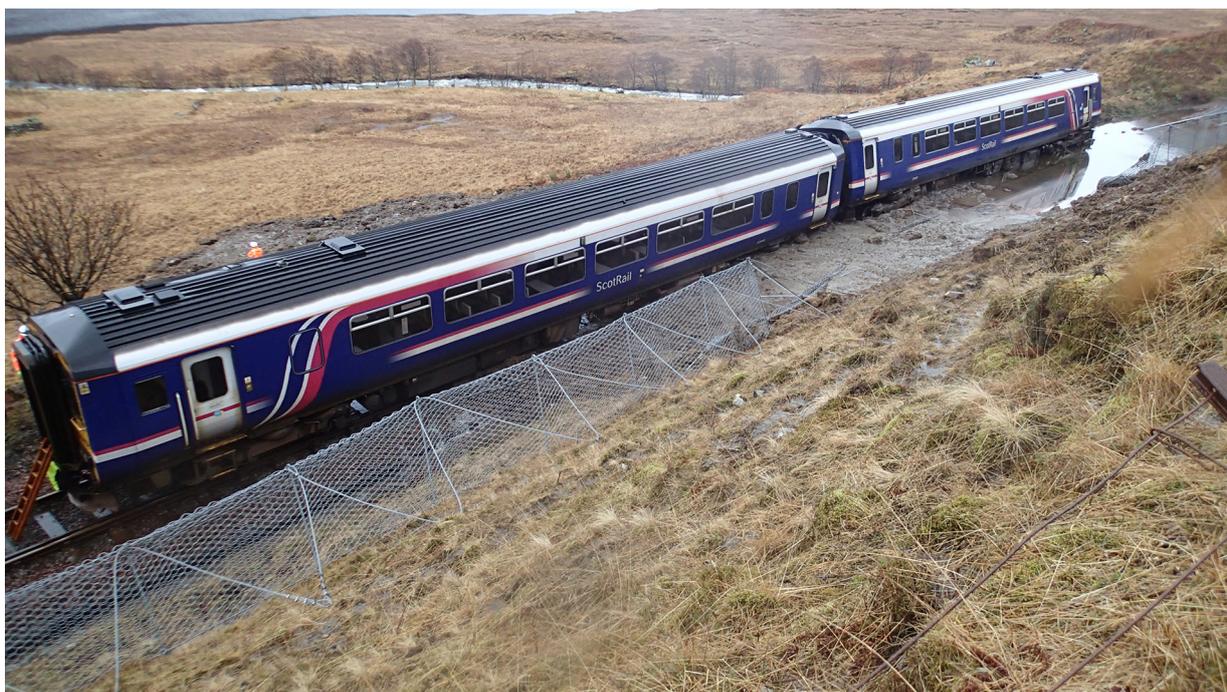
- 57 The catch-fence installed at the accident site was of a type used at other locations across Scotland route, and comprised a mesh fence supported by inclined wire ropes attached to ground anchors (figure 15). It was designed by Fairhurst, and was intended to be easy to install and maintain. The design was tested in a quarry in 2013, and found to be able to retain a 3 tonne boulder rolling down a slope 30 metres long with an angle of 35°.

Figure 14: Part of catch-fence installed in 2017 to trap falling rocks and boulders. The middle section was destroyed by the landslip. Part of the railway boundary fence is also visible in the foreground.

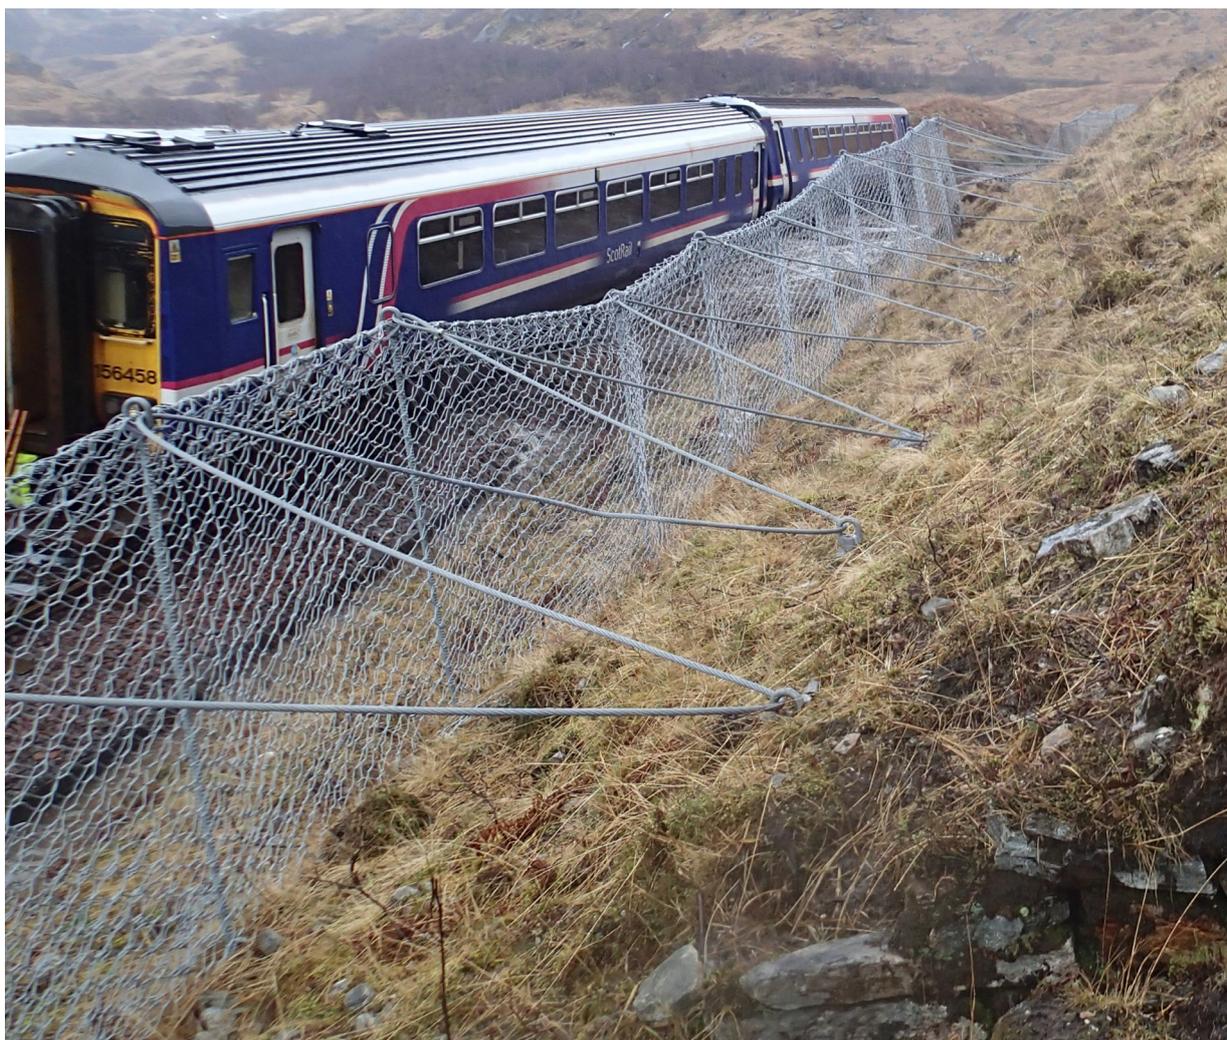
Figure 15: Detailed view of catch-fence supported by anchored cables
