**Department for
Communities and Local
Government Project
Report:**

Compartment sizes, resistance
to fire and fire safety project

Work stream 3 – Construction
details – roof voids, cavity
barriers and fire/smoke
dampers

Final publishable guidance

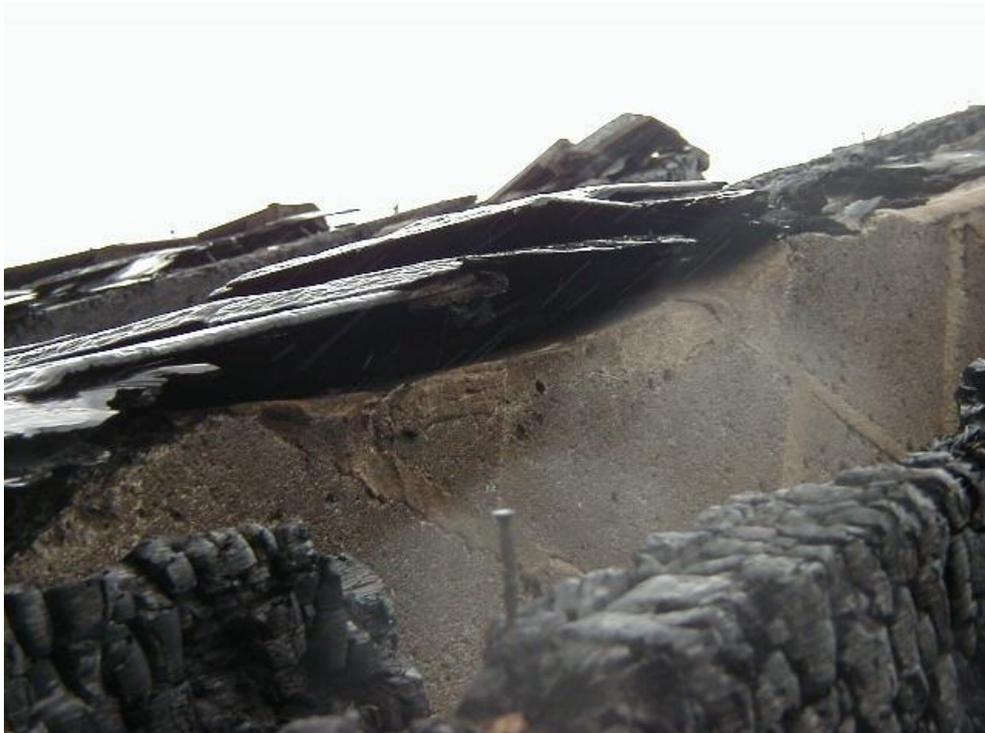
The fire started in a small section of a flat roof of one apartment block, ignited the sarking felt on the adjacent pitched roof and spread into the roof void. The fire spread within the roof space over three flats, bypassing two compartment walls. Eventually, the fire spread into the roof void of an adjacent block, again involving three apartments and bypassing two compartment walls. The compartment walls were constructed from concrete building blocks. However, it was clear from the scene that no attempt had been made to firestop the junction between the walls and the roof as detailed in AD B (see Figure 3).

Figure 3 - Lack of fire stopping between compartment wall and roof covering

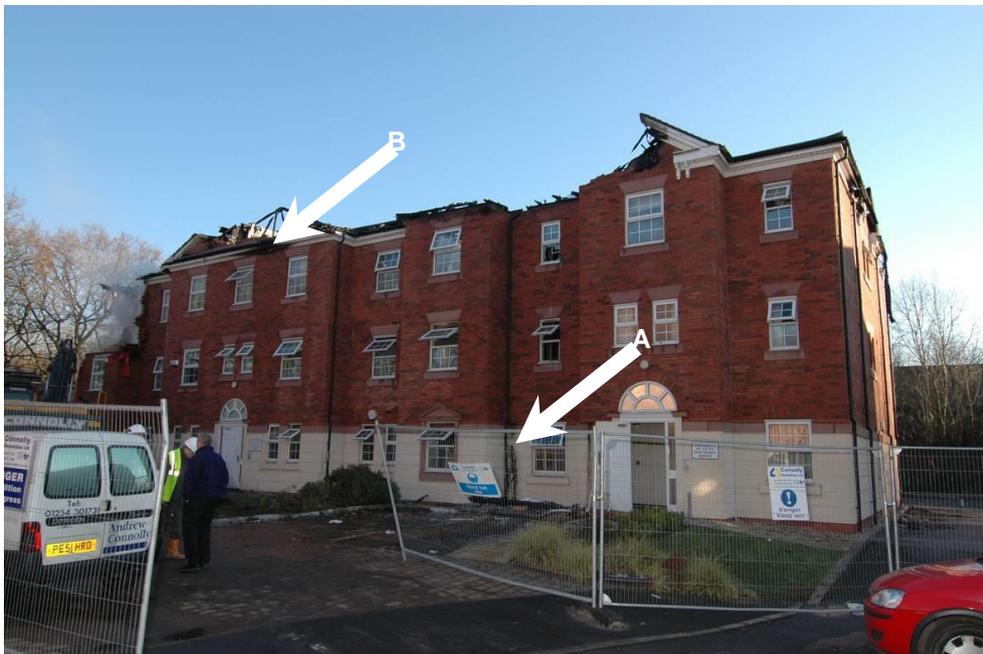
It is likely that the fire was initiated as a result of hot work being carried out on pipes penetrating the exterior wall of the three-storey block of flats. Initial fire spread was through the external wall cavity breaking out at roof level some distance from the point of origin. Once in the roof area, the fire spread rapidly, leading to collapse of the roof trusses and break out back into the floors below. It is clear from the speed and extent of the fire spread that compartmentation within the roof space was ineffective. Figure 4 shows the point of fire origin and the area where the fire broke out from the roof.

Figure 4 - Arrow A indicates point of fire origin. Arrow B indicates point of break out at roof level

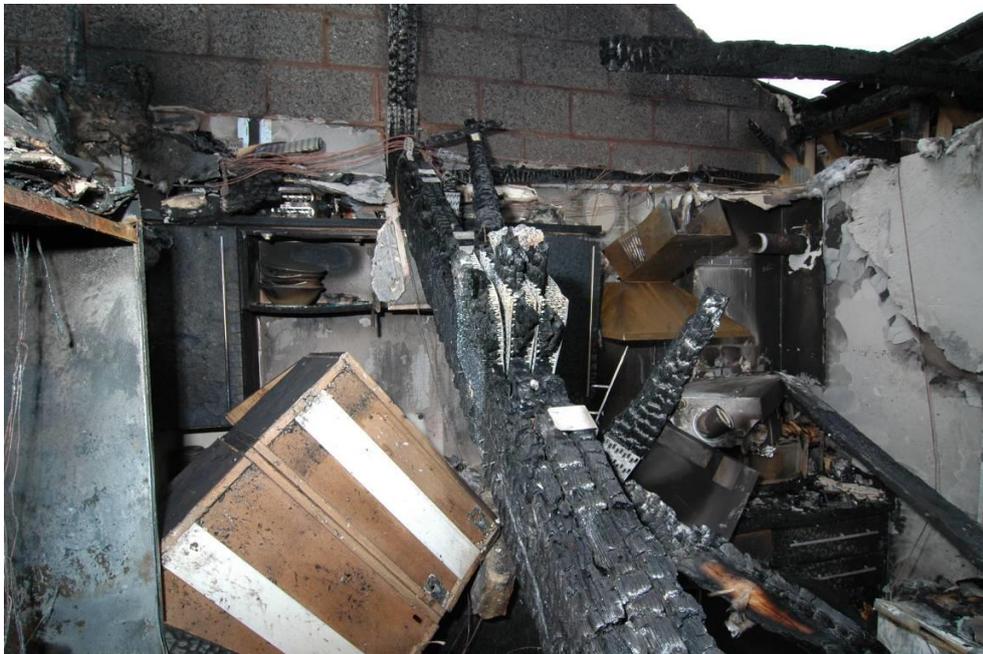
The fire is believed to have started on the landing of the second floor of a four-storey residential building. The fire spread from here to involve the third floor landing and ultimately, to the roof structure, most probably via an external wall cavity accessed through a window opening. Compartmentation was breached as the fire traversed the roof structure over a number of compartment walls. The compartment walls were constructed from concrete blocks clad in plasterboard with a plaster skim coat. The walls were continued up through the ceiling to the underside of the roof covering. The seal between the top of the wall and the roof covering seems to have been made from mineral wool. It is believed that the fire spread due to a combustible membrane between the tiles and the roof structure. Figure 5 shows the roof collapse into the apartment below.

Figure 5 - Roof collapse through ceiling into compartment below

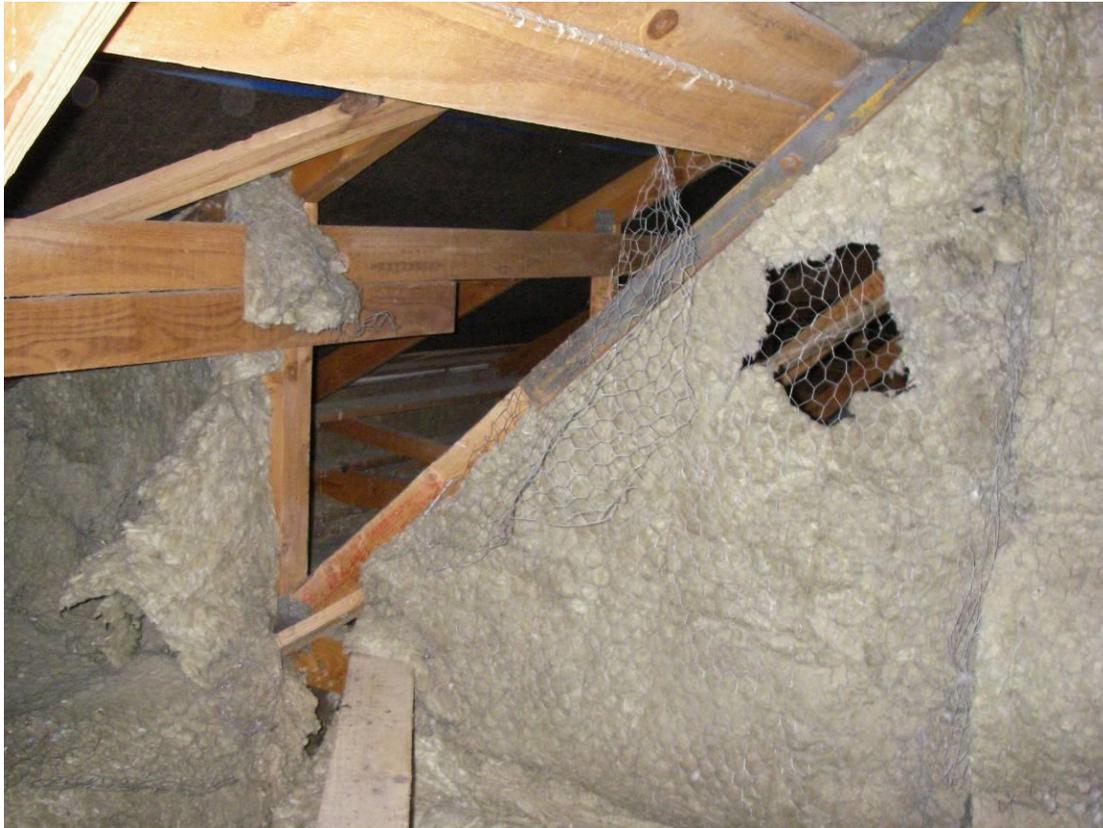
Fire broke out in one of the flats on the third floor of a four-storey apartment block. The fire broke out of the window and into the roof void through the roof eaves soffit and spread to destroy the entire roof area. The roof was a new pitched roof over an existing flat roof formed from a concrete slab. For this reason, the roof void could be considered to be a single compartment and separation would be necessary to maintain the maximum distances of cavities rather than specifically to maintain compartmentation. Separation was provided in the roof space at approximately 15m intervals, comprising mineral wool and chicken wire curtains held in place with metal bars fixed to the timber trusses. The separation in the roof space clearly did not perform as intended. The poor state of the compartmentation in the roof space had been highlighted in a previous report following a fire on the same estate. The condition of the fire stopping in the roof space in a similar block is illustrated in Figure 6.

Figure 6 - Fire stopping in poor condition (Image courtesy of London Fire Brigade)

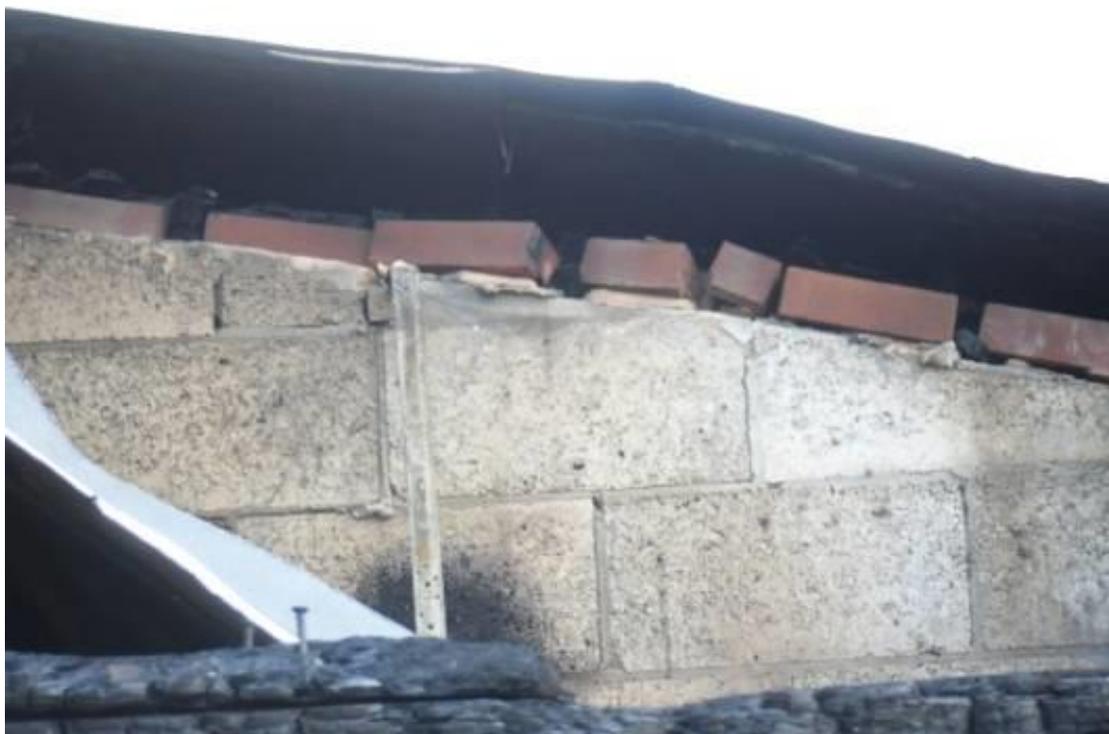
The fire occurred in a flat on the top floor of a three-storey block of flats and spread into the roof space. The fire developed to involve the roof space over all three flats on the top floor. Fire spread over the compartment walls in the roof area appears to have been due to a combination of poor fire stopping in the compartment walls above ceiling level, poor fire stopping where the curved sections of the roof crossed the compartment walls, and fire bridging the compartment walls due to the presence of combustibles materials within the make-up of the roof covering. Figure 7 shows the attempt made to provide fire stopping where the curved section of the roof crossed the compartment wall.

Figure 7 - Attempt to follow roof profile over compartment wall

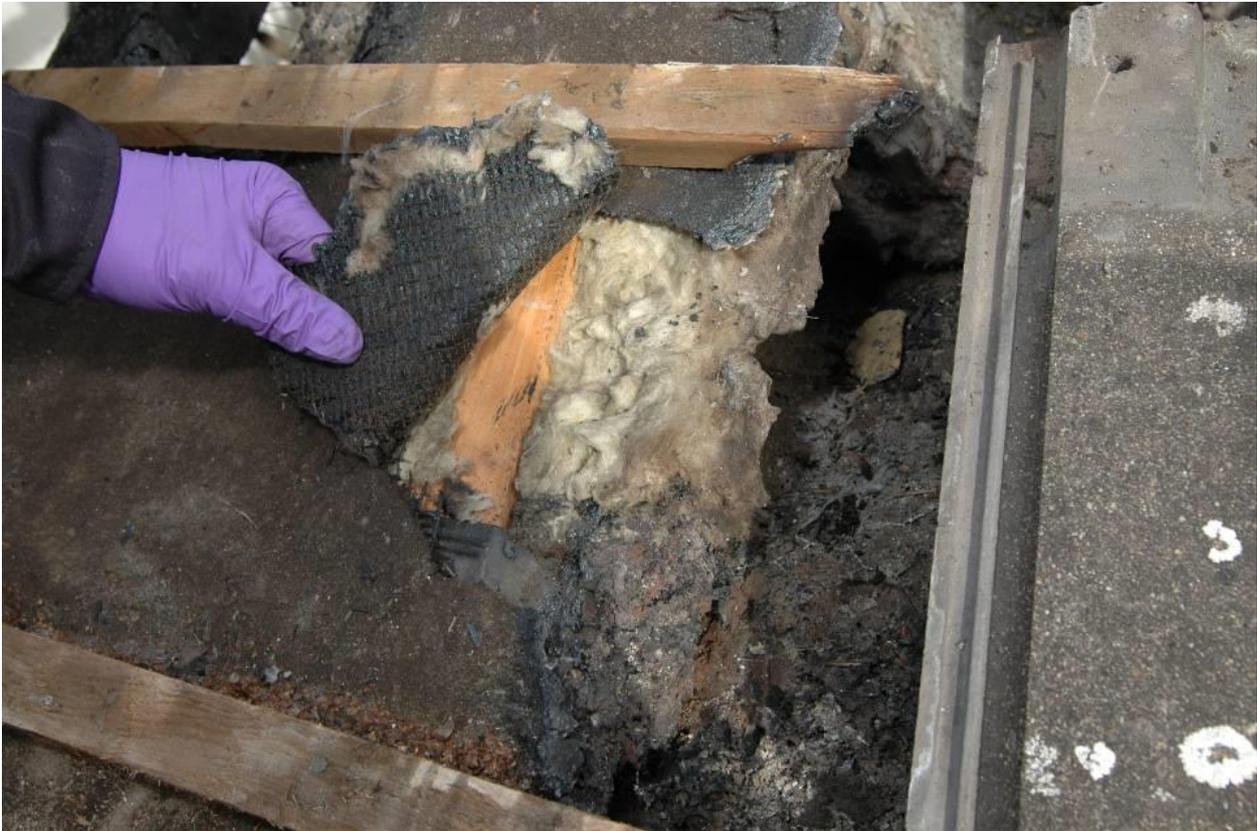
The fire started in a first floor flat of a block of flats, broke out of the room of origin through a window, and entered the roof through the eaves. Fire spread rapidly throughout the structure of the roof. The roof was constructed from lightweight timber truss rafters. The roof covering was ceramic tiles under which a bitumen impregnated sarking felt had been fixed. Fire separation within the roof space was completed using a mixture of blockwork and cavity barriers. The cavity barriers were constructed from mineral wool fixed to a wire mesh. The barriers were fixed to timber trusses using clamping plates. The fixing of the fire barrier to the timber trusses does not appear to have been in accordance with manufacturer's guidance since the barriers did not press up against the underside of the sarking felt so the fire was able to spread along the sarking felt over the top of the cavity barriers (see Figure 8).

Figure 8 - Fire stopping against underside of sarking felt but not pushed up against underside of roof tiles

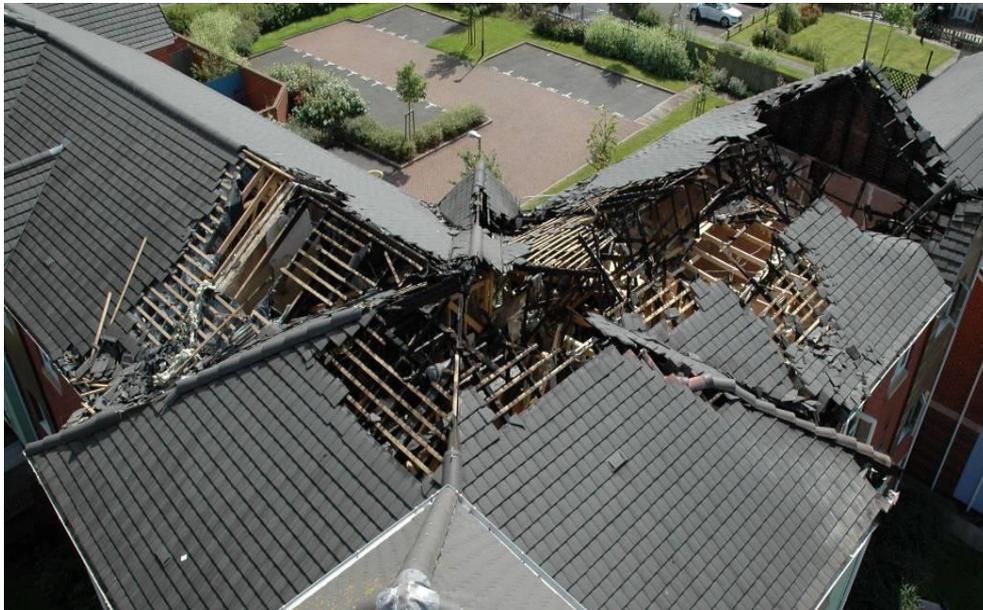
The fire is believed to have been started by a cigarette discarded in wood chippings in flower beds arranged around the outside of a three-storey block of flats and in contact with the external wall. The fire spread from the wood chippings into the cavity of the external wall via a plastic air brick providing ventilation to the cavity situated beneath the suspended ground floor. Cavity barriers in the external wall cavity were either missing or poorly fitted. The fire spread up the cavity to the roof of the building, causing significant structural damage to the roof and accommodation storeys. A combination of fire-fighting and effective compartmentation, both between compartments and within the roof space, prevented more extensive fire spread within the building. Figure 9 is an aerial view of the building showing the damage at roof level.

Figure 9 - Aerial view showing damage to roof structure

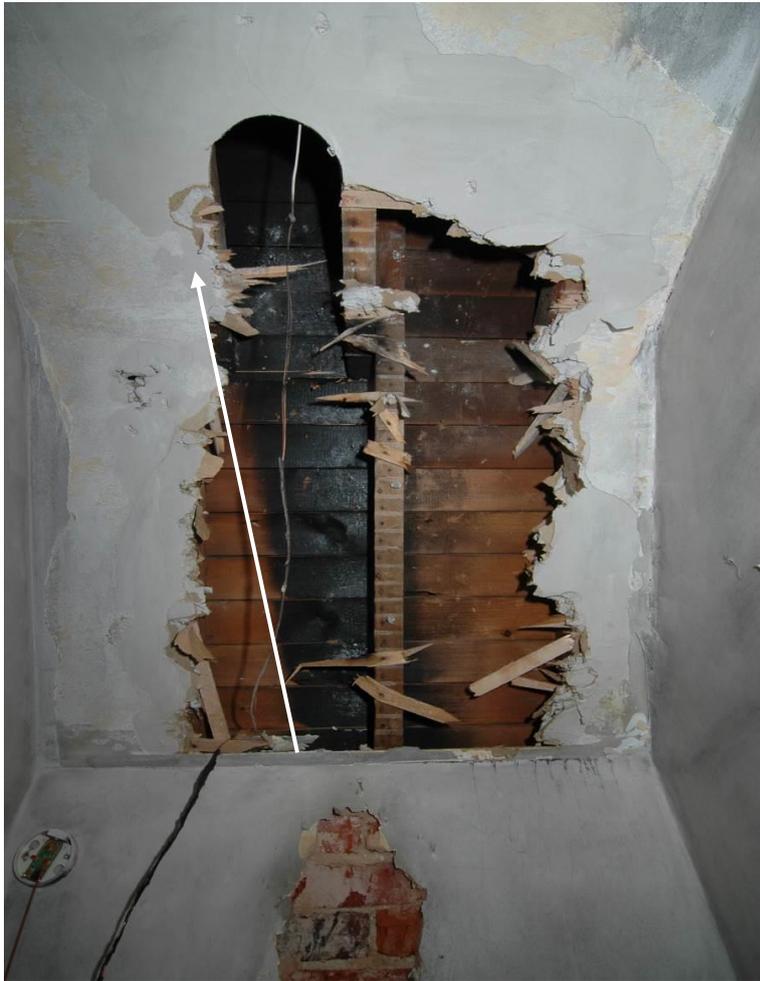
Fire started within a first floor bedroom of a two-storey residential care home. Smoke entered a wall cavity and found its way into the roof void where a detector was activated. Due to early activation and the prompt action of the Fire and Rescue Service, the fire was prevented from spreading into the roof void. However, there was inadequate separation within the roof space. The junction between the external wall cavity and the roof space is shown in Figure 10.

Figure 10 - Close up of fire damage to pitch roof (arrow showing direction of fire spread from wall cavity)

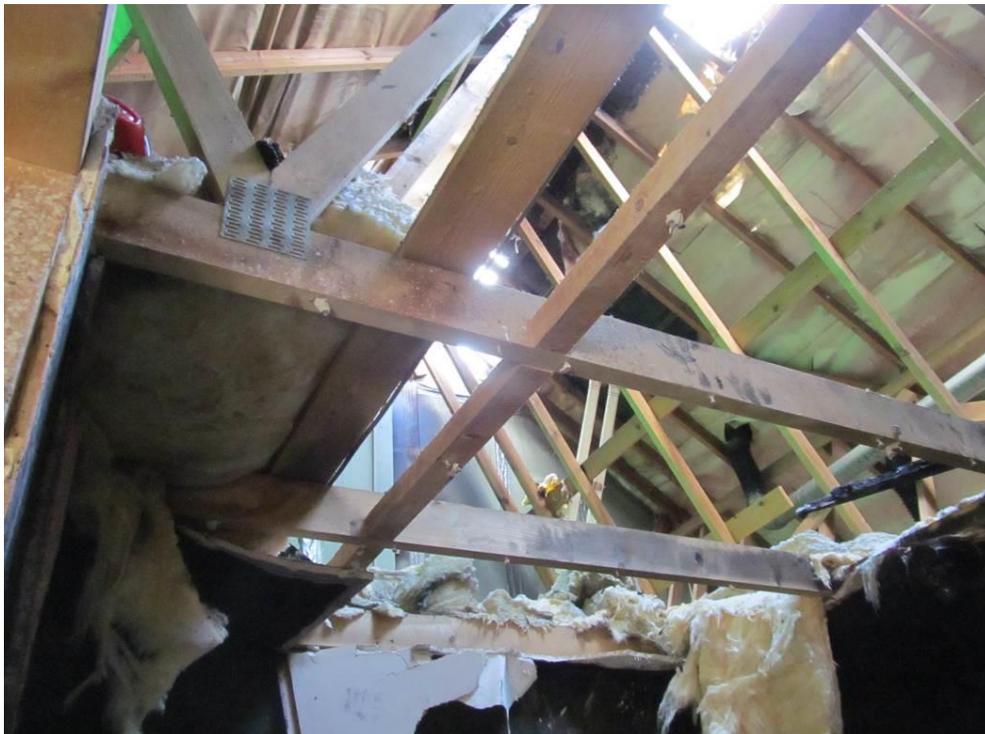
The fire was started within an upper floor bedroom of a three-storey timber-frame terraced house and flames spread into an external wall cavity through failure of a uPVC window frame. From there, it spread into a compartment wall separating dwellings. In this case, the quality of the compartmentation in the roof space prevented more widespread damage as can be seen from the undamaged roof trusses in figure 11. The compartmentation was formed from two layers of plasterboard either side of the timber frame compartment wall, with all joints fully taped and sealed.

Figure 11 - Undamaged roof trusses above seat of fire

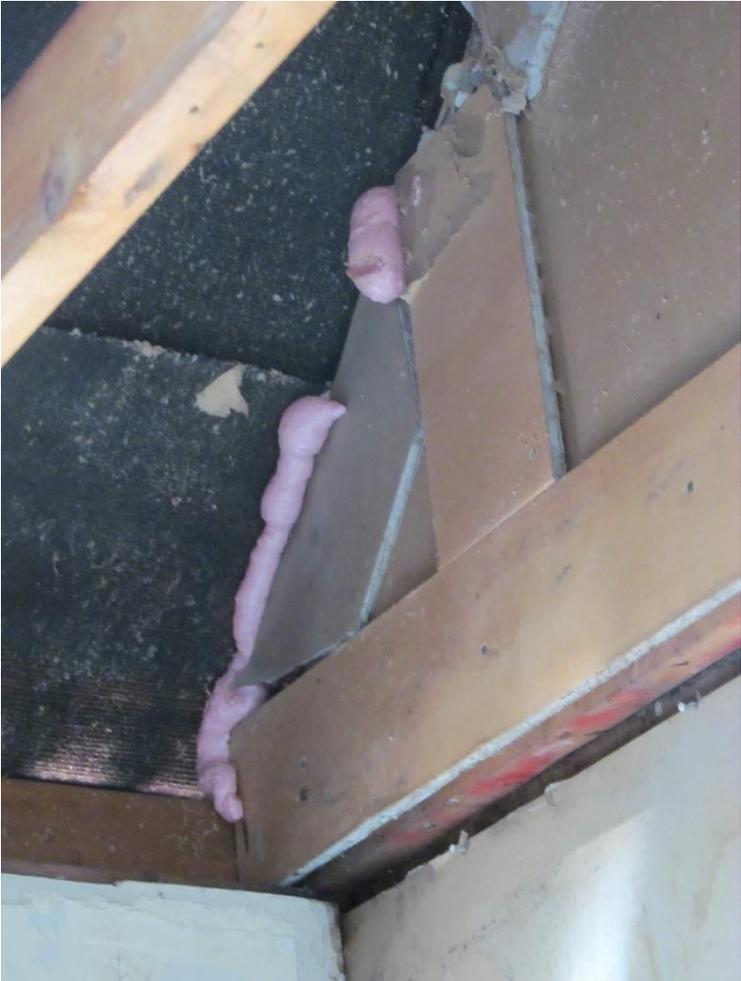
The fire started within a ground floor flat and spread via the external façade into the compartment wall between occupancies. As with the incident in case 9, the quality of compartmentation in the roof space, as shown in Figure 12, restricted the amount of damage from the fire.

Figure 12 - Sealing between compartment wall and roof construction

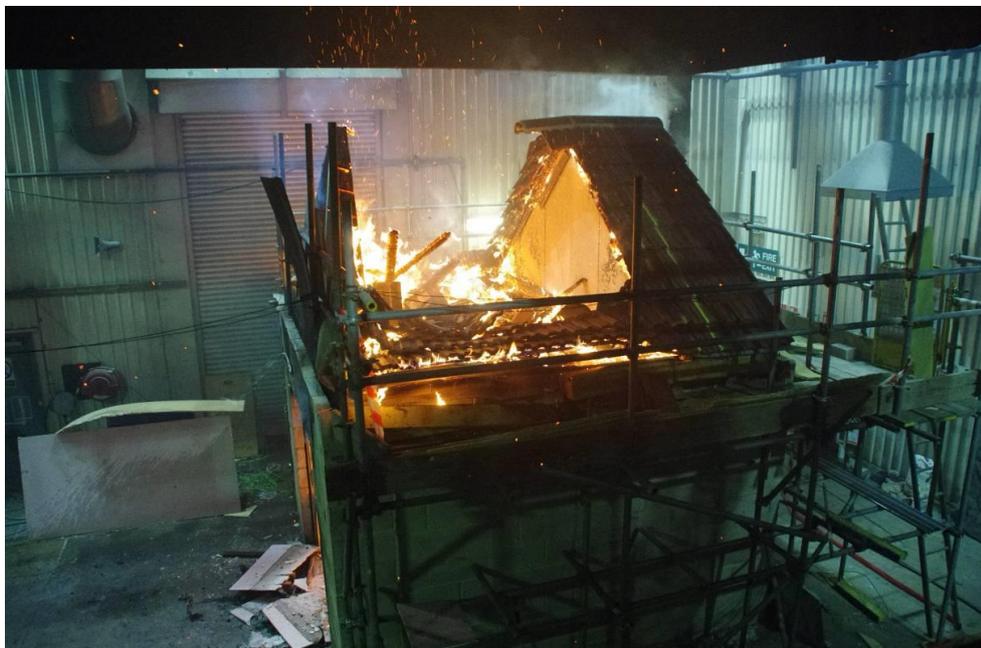
The results clearly indicate that the compartmentation has prevented any significant rise in temperature on the non-fire side of the roof space. The performance was clearly borne out through observations with the spandrel panel remaining intact despite a collapse of the roof structure on the fire side (see Figure 22).

Figure 22 - Collapse of roof structure with compartmentation intact

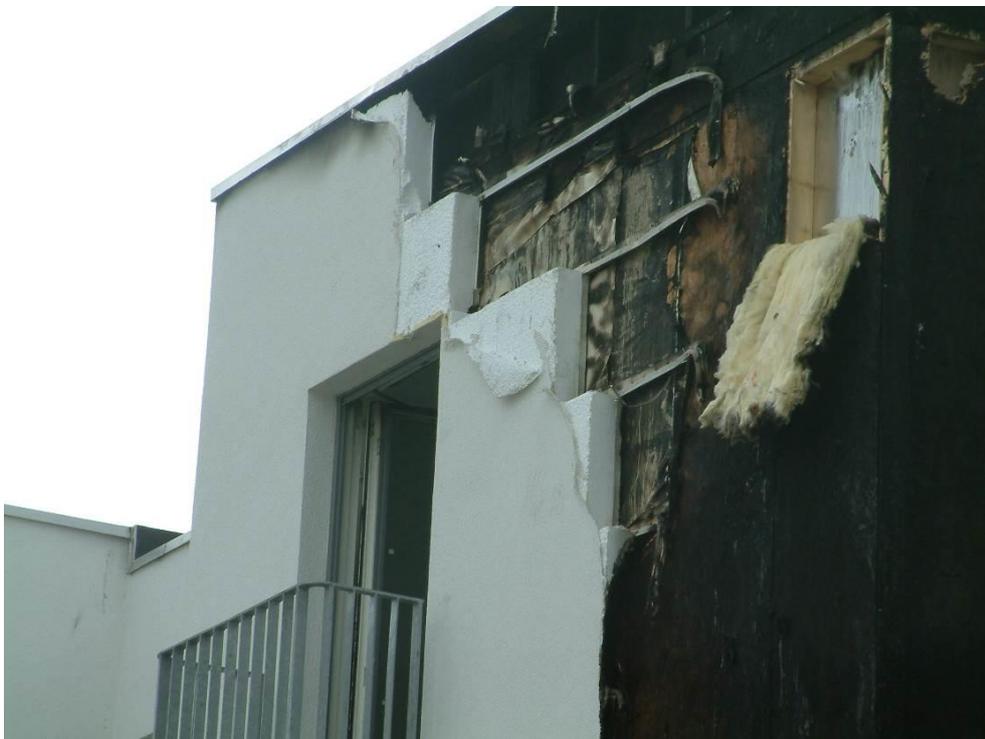
The fire started within the external wall void of a three-storey timber-framed residential building due to a nail penetrating a lighting cable. The external façade was an insulated cladding system. Fire spread up the building through the internal cavities and the external cladding. However, vertical cavity barriers were effective in limiting the extent of horizontal fire spread. The nature of the construction and the damage to the external façade is shown in Figure 27.

Figure 27 - Damage to front elevation of building

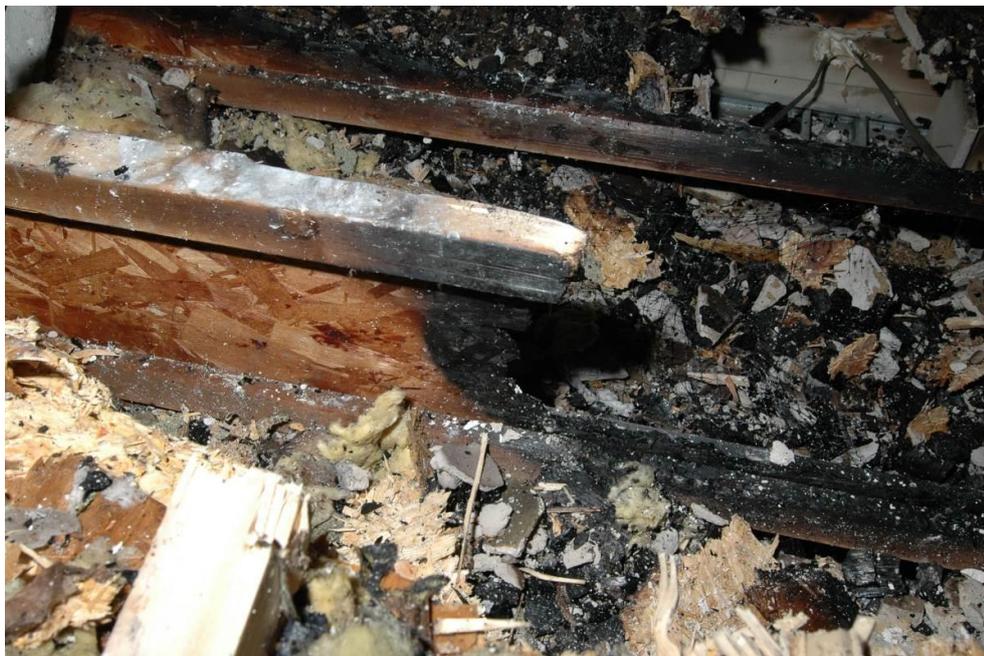
The fire spread through cavities in compartment walls resulting in fire damage within twelve different fire compartments (two flats and one corridor on four floors). The ignition source was an electrical fault and the fire did not involve any fuel load other than the fabric of the building itself. The external walls were not involved in the fire.

Figure 28 - Damage to engineered floor joists

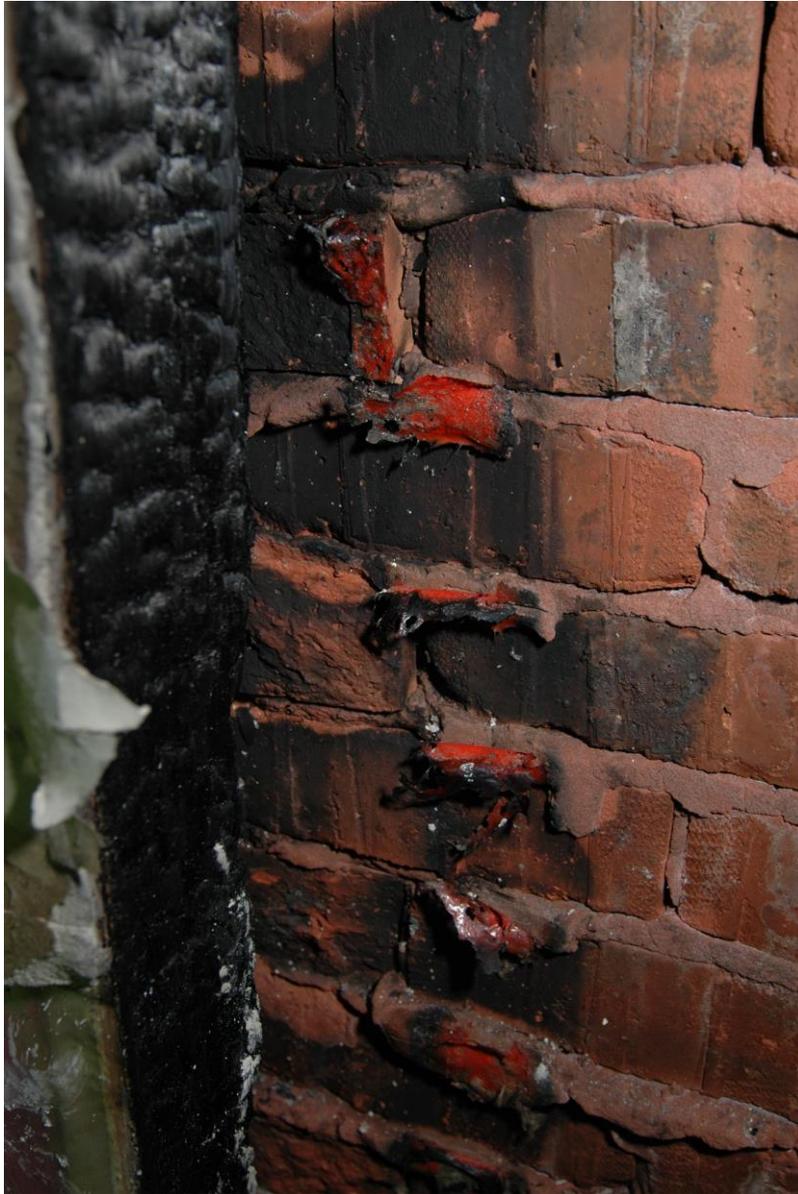
Cavity barriers within the external walls did not perform adequately. Figure 29 shows the remains of a vertical cavity barrier with the sheathing board completely burnt away. Observations and ad-hoc fire tests carried out by BRE indicated that the breather membrane and the plastic wrapping on the cavity barrier may have contributed to fire spread within the cavity in the early stages. Bituminous material spanning the roof beneath the tiles appears to have contributed to fire spread within the roof space.

Figure 29 Remains of cavity barrier on external wall

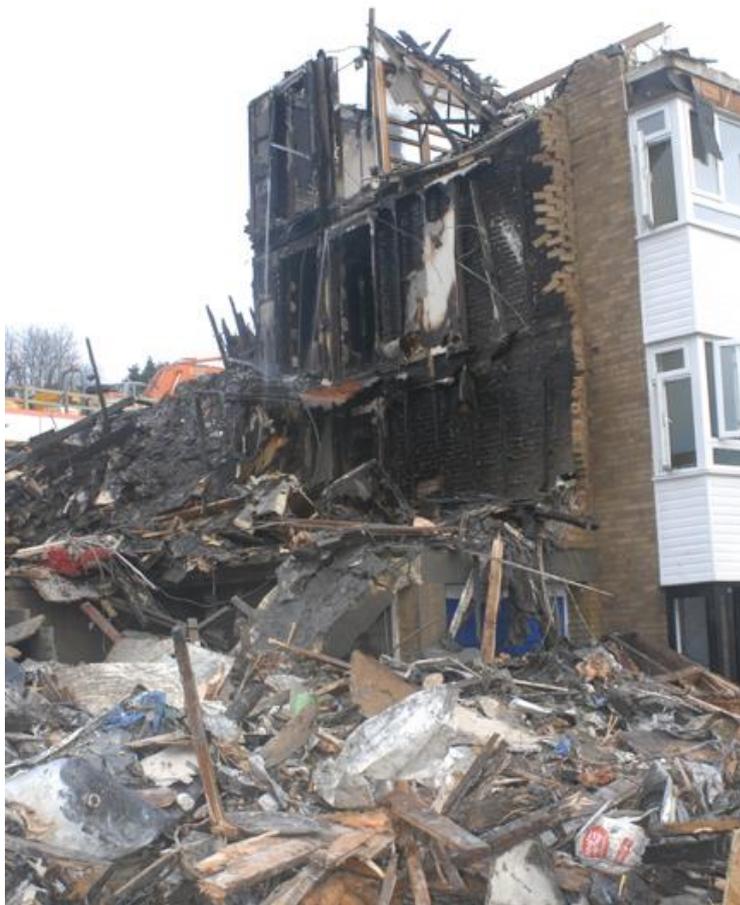
Timber battens were used to bridge the cavity in line with the compartment floor levels. These barriers were wrapped in a bituminous damp proof material to prevent moisture ingress. The sheathing layer appeared to be a low density bitumen impregnated fibre board similar to that identified as the worst performing product of those tested in the small flame test (BS EN ISO 11925-2²⁷) conducted as part of the collaborative 'Understanding fire risks in combustible cavities' research project²⁵.

Figure 30 - Structural collapse following fire spread through roof

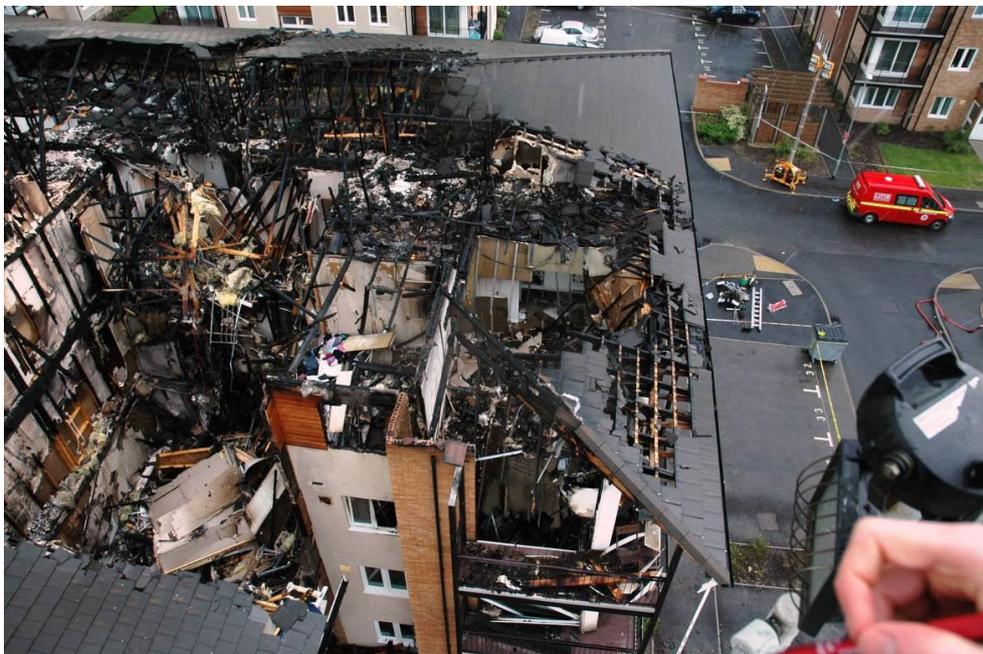
The fire is thought to have started by a carelessly discarded cigarette being thrown into a pile of wood/bark chippings laid in the flower beds in contact with the external wall of a timber-framed block of flats. A number of plastic openings were present at low level on the external wall and some were completely covered by the bark/wood chippings. An initial external fire was reported. Approximately 40 minutes later, the Fire and Rescue Service was called to attend as smoke could be seen issuing from the roof of the building and out of openings in the cavity at various levels. A decision was taken to evacuate the building and to adopt a defensive fire-fighting approach because of the extent of the fire spread and based on experience of similar fires. The fire led to the collapse of a large area of the development (see Figure 31).

Figure 31 - Partial collapse of development due to extent of fire spread

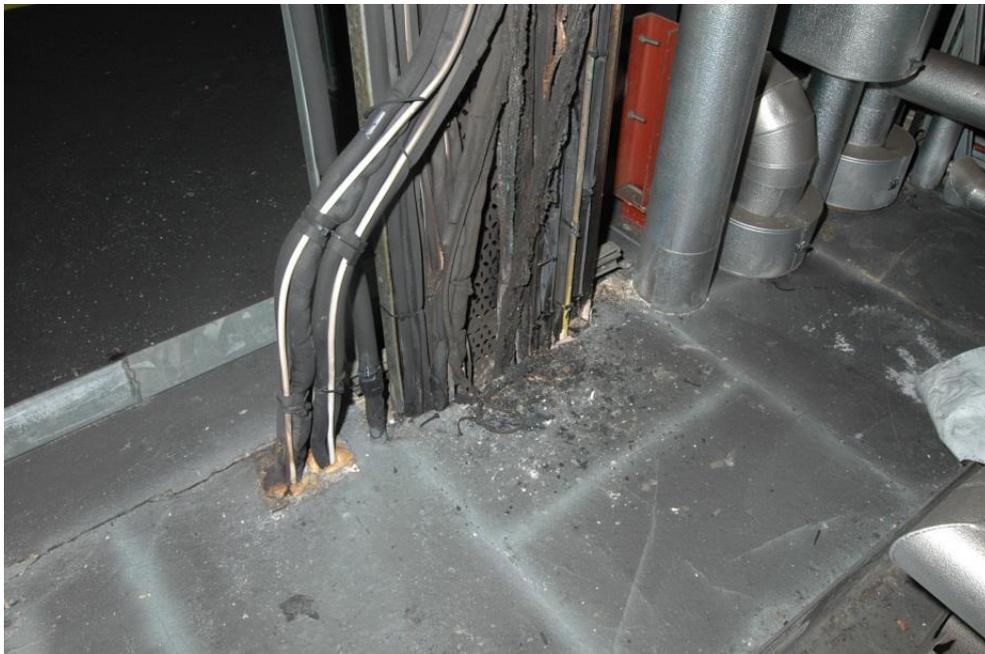
This incident did not directly involve fire rated ducts and dampers but is included here as an example of service penetrations through compartment floors. The fire started in a ground floor service riser and progressed up to the fourth floor of a multi-storey office block. The service riser was separated from the accommodation areas by fire resisting construction and accessed through fire rated doors. The existing fire precautions prevented fire spread away from the service riser and maintained tenability conditions within the occupied area of the building to enable safe evacuation. Fire stopping around services penetrating the fourth floor prevented more extensive fire and smoke damage above this level (see Figure 33).

Figure 33 - Effective fire stopping on floor above fire damaged floor

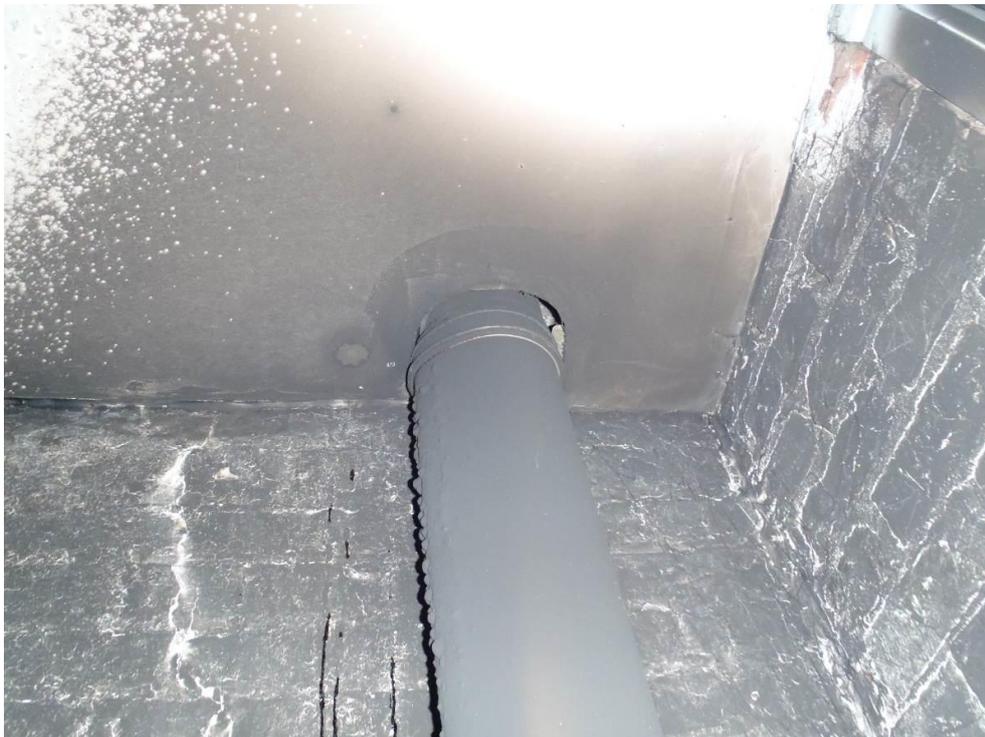
The fire originated in a bin/storage area on the ground floor. Although the fire did not break out of the area of origin, there was extensive smoke spread throughout the block with about 20 out of 40 flats affected. The area above the fire contained pipework and other services which penetrated compartment walls and floors. There was inadequate fire stopping in place leading to the problems with smoke spread during the incident (see Figure 34).

Figure 34 - Inadequate fire stopping around soil pipe penetrating compartment floor

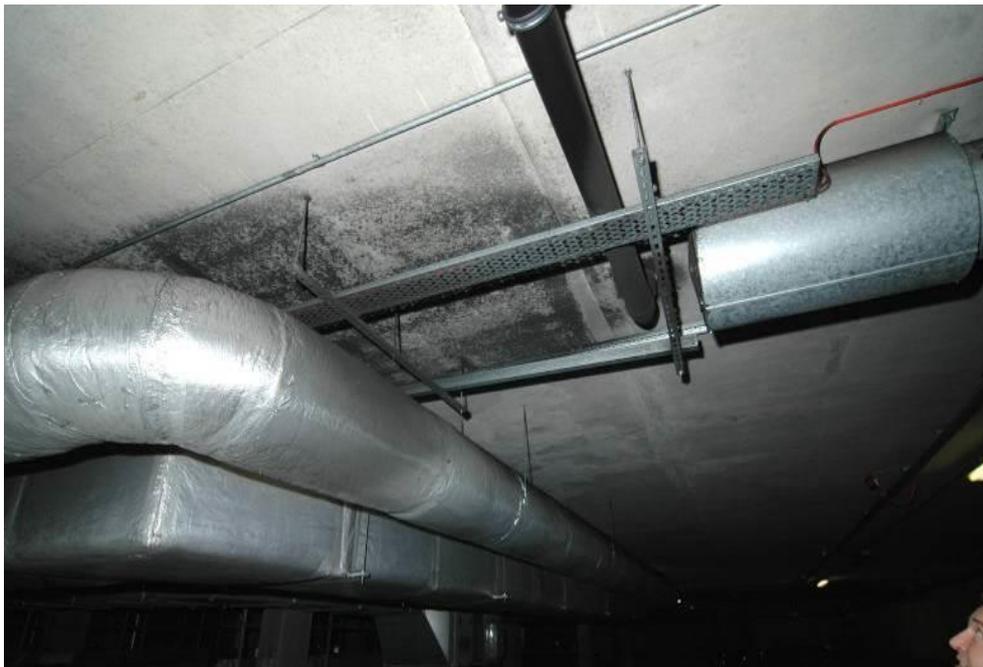
The fire occurred within an underground car park of a fifteen-storey mixed use building, spreading from the car of origin to involve the two cars parked either side. The car park was fitted with a detector operated impulse jet fan system designed to clear smoke away from the entrance to allow for emergency access and to direct the smoke towards an extraction point in a plenum space before passing up through the floor slab to the ground floor and then out to fresh air. However, since installation of the smoke extract system, a large amount of HVAC equipment including extensive ductwork had been installed. The new ductwork had blocked off much of the opening through the floor slab through which the smoke was to be extracted from the building. The fire rapidly overwhelmed the ventilation system, smoke logging the entire car park. The smoke impeded the actions of the emergency services and led to smoke spread into a number of staircases via leaky seals around doors and poor fire stopping around ducts and cables. The scene examination indicated that the HVAC ducting throughout the car park was obstructing the flow of smoke out of the jet fans (see Figure 35).

Figure 35 - Flow from impulse jet fan obstructed by HVAC ducting
