Rail Accident Report

Runaway of a road-rail vehicle at Bradford Interchange 8 June 2018

Report 01/2019
March 2019

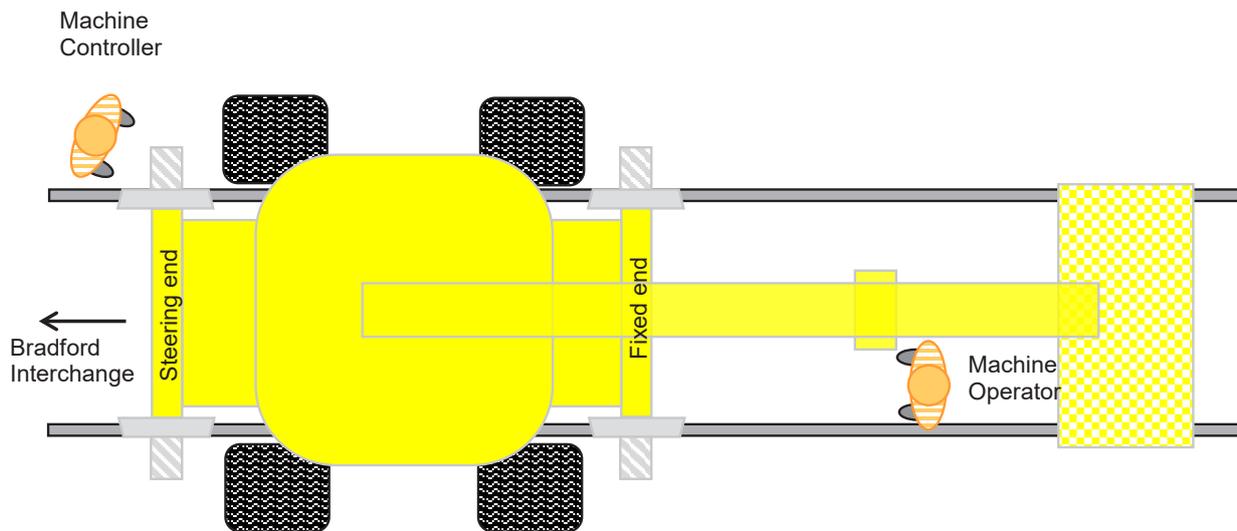
Figure 10: Position of machine operator and machine controller at time of runaway

- 28 Finding that he was unable to restart the engine, the machine operator jumped from the basket onto the track and, together with the machine controller, started running alongside the machine to warn others of the runaway. With the engine off, the machine was silent and with the emergency button pressed, it was also unlit. Witnesses described the machine increasing its speed from walking pace to a 'fast jog' as it ran away towards platform 1 of Bradford Interchange station.

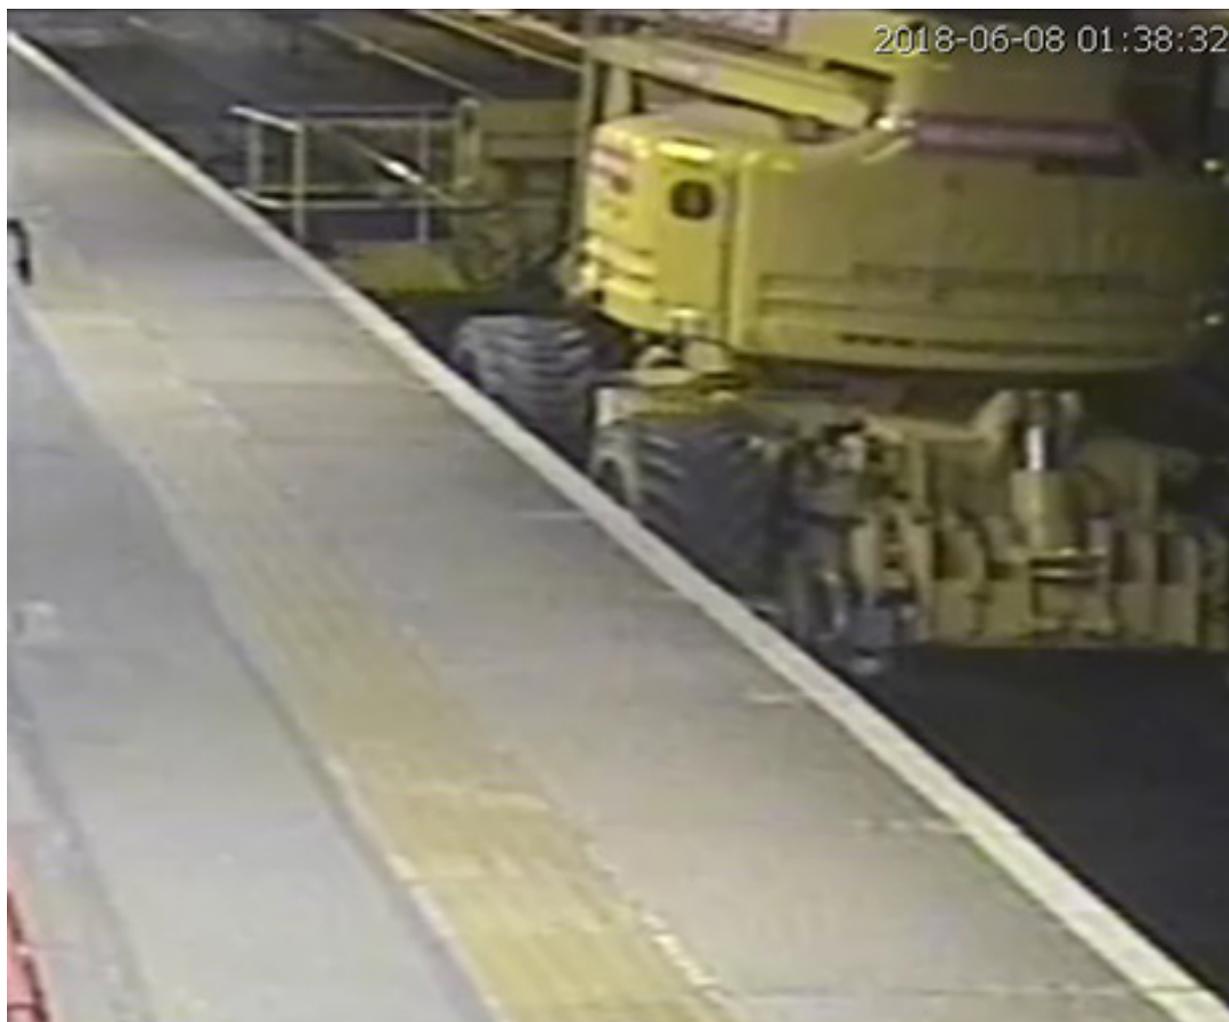
Figure 11: Incident MEWP at platform 1 immediately after the incident (courtesy Northern Rail)

- 29 Staff on the platform heard the commotion and quickly realised that there was a member of staff on the track alongside platform 1 in the path of the approaching machine. They warned him and helped him onto the platform approximately 5 to 8 seconds before the machine reached them. As the gradient levelled out and due to the action of the machine operator who pushed the basket against the platform, the machine came to a stop approximately 40 metres from the buffer stops located at the end of platform 1. The time was then 01:38 hrs (figure 11).

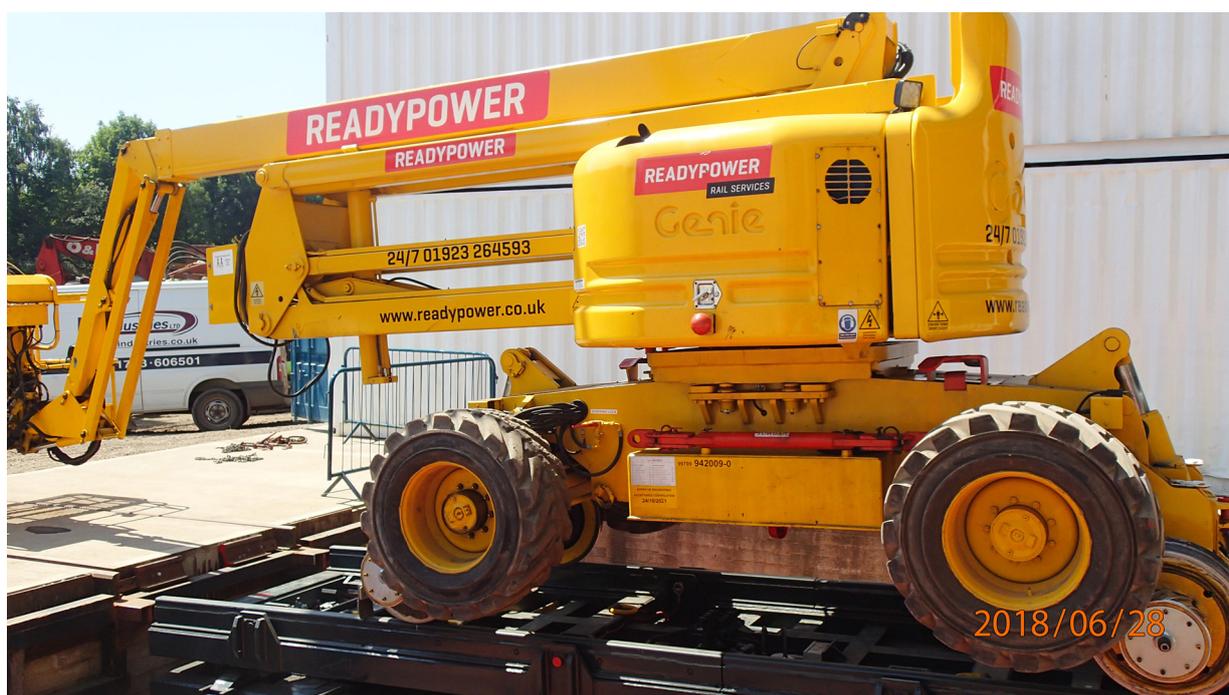
Figure 12: Incident MEWP during testing

- 37 The MEWP ran away on a gradient because only the rail wheel brakes were acting to prevent movement and these were unable to do so.
- 38 Following the incident at Bradford Interchange, the MEWP was taken to a testing site at EP Industries (Derbyshire) where the ability of its rail wheel brakes to hold the machine on gradients was explored (figure 12). In particular, the machine was placed with its rail wheels partially deployed, so that it was being held by its rail wheel brakes only, as it had been on the night. The machine was also tested with its rail wheels in a fully deployed configuration to establish whether it was able to meet the 1 in 25 gradient requirement in RIS-1530-PLT. Table 1 and table 2 show the results of the testing.

Incident condition: Rail wheels partially deployed (Road wheels not in contact with ground or rail wheel hubs)		
Test	Angle	Gradient
1	0.9°	1 in 64*
2	1.1°	1 in 52*
3	0.9°	1 in 64*

Incident condition: Rail wheels fully deployed (Road wheels in full contact with rail wheel hubs)		
Test	Angle	Gradient
1	2.3°	1 in 25**
2	2.7°	1 in 21**

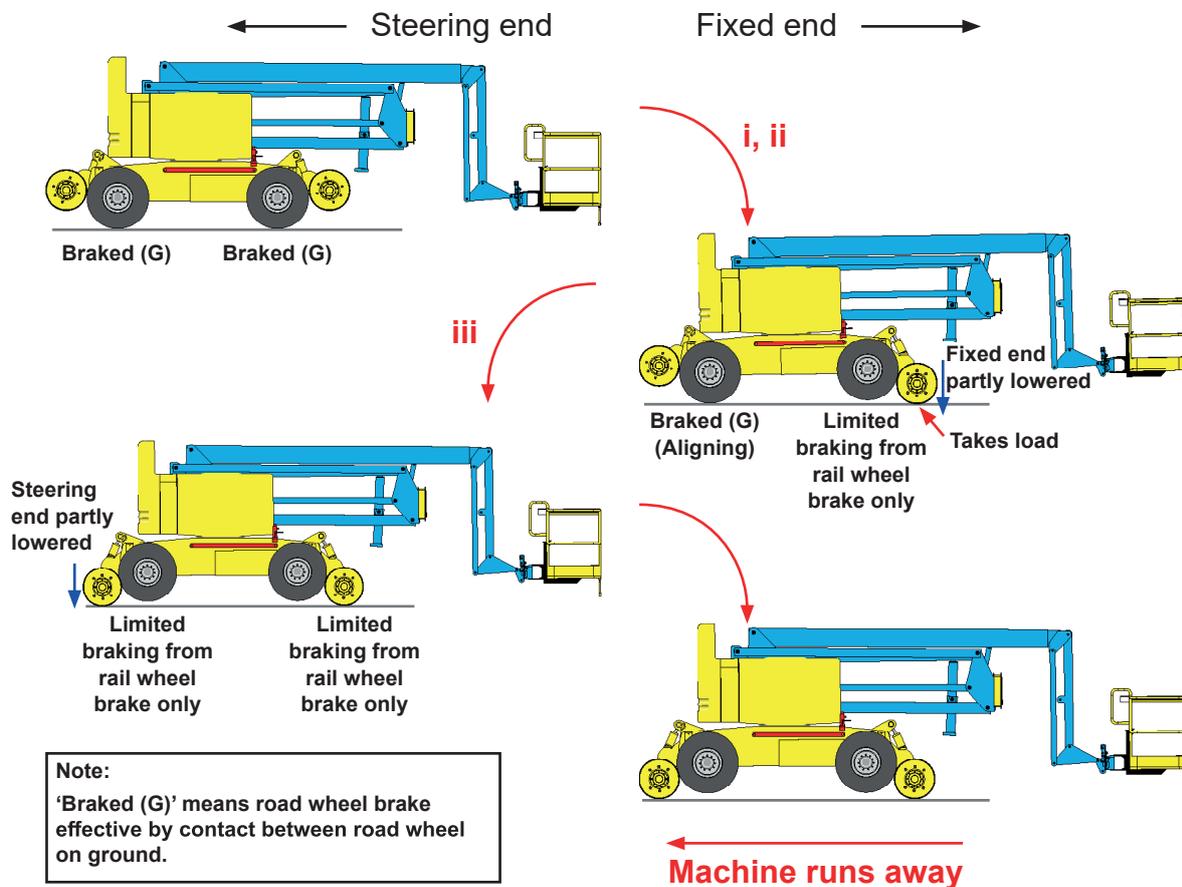
Figure 13: On-tracking sequence on the night

- 48 Since the introduction of the DRWB systems in 2014, interlocks of this type are no longer fitted to RRVs and the risk of runaway is mitigated by the presence of the DRWB system. As part of their training, machine operators are still warned about the risks of a runaway and taught not to start deploying the second rail axle until the first one is fully deployed. But there is now no interlock preventing a machine operator from deploying the rail wheels the way it was done on the night (figure 13).

- 49 The machine operator involved in the incident at Bradford Interchange had been trained in September 2016 on a Genie Z60. He demonstrated during his assessments that he understood the importance of following the on- and off-tracking procedure. He confirmed post-incident that he knew how to deploy a machine following the on- and off-tracking procedure (figure 14). He also stated that he deployed the rail wheels on the night in the same way as he had been routinely deploying the rail wheels on other machines. He was aware that the MEWP was fitted with a DRWB system which should have prevented a runaway situation and he stated that this may have affected his perception of the risk.

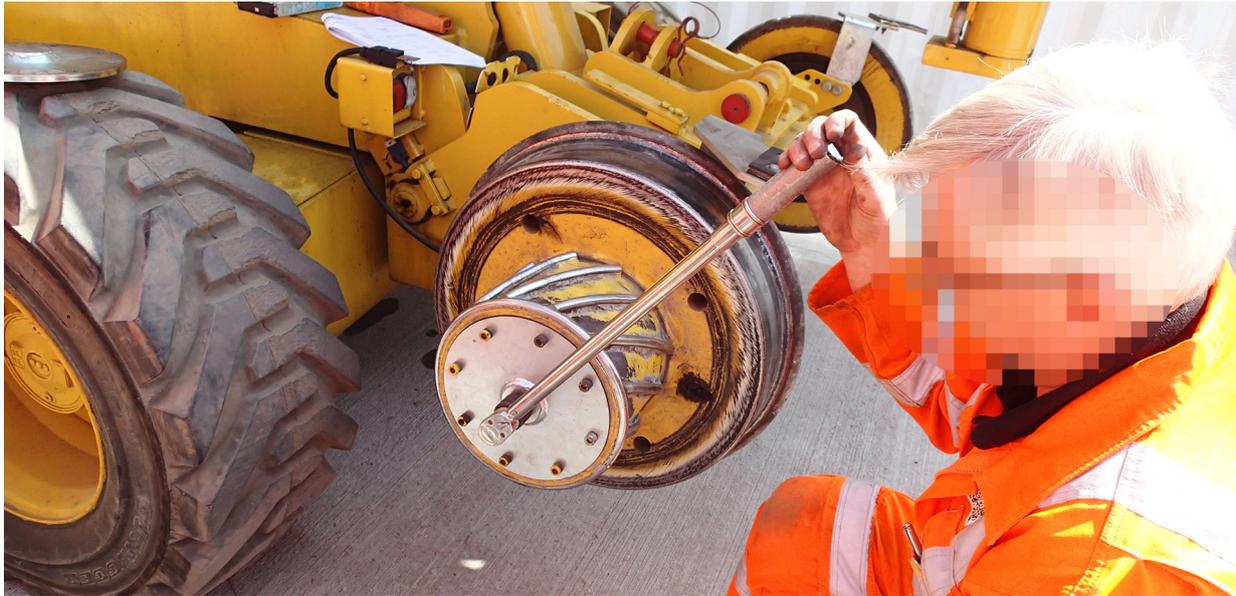
Figure 15: Torque testing of DRWB system

65 According to Hargreaves maintenance instruction AJH077⁹ issue 7, each rail wheel braking torque should have been a minimum of 950 Nm. The results of the torque tests show that the DRWB system was providing significantly less than the required torque. When converted to a brake force, the total resisting torque equates to a brake force of 220 kgf. The gradient at the RRAP (1 in 46) created a 380 kgf downhill force on the 17.5 tonne MEWP, which exceeded the brake force of 220 kgf. These tests further confirm (beyond the tests reported in paragraphs 38 and 39) that the MEWP rail wheel braking system was unable to provide enough brake force to prevent movement on a 1 in 46 gradient.

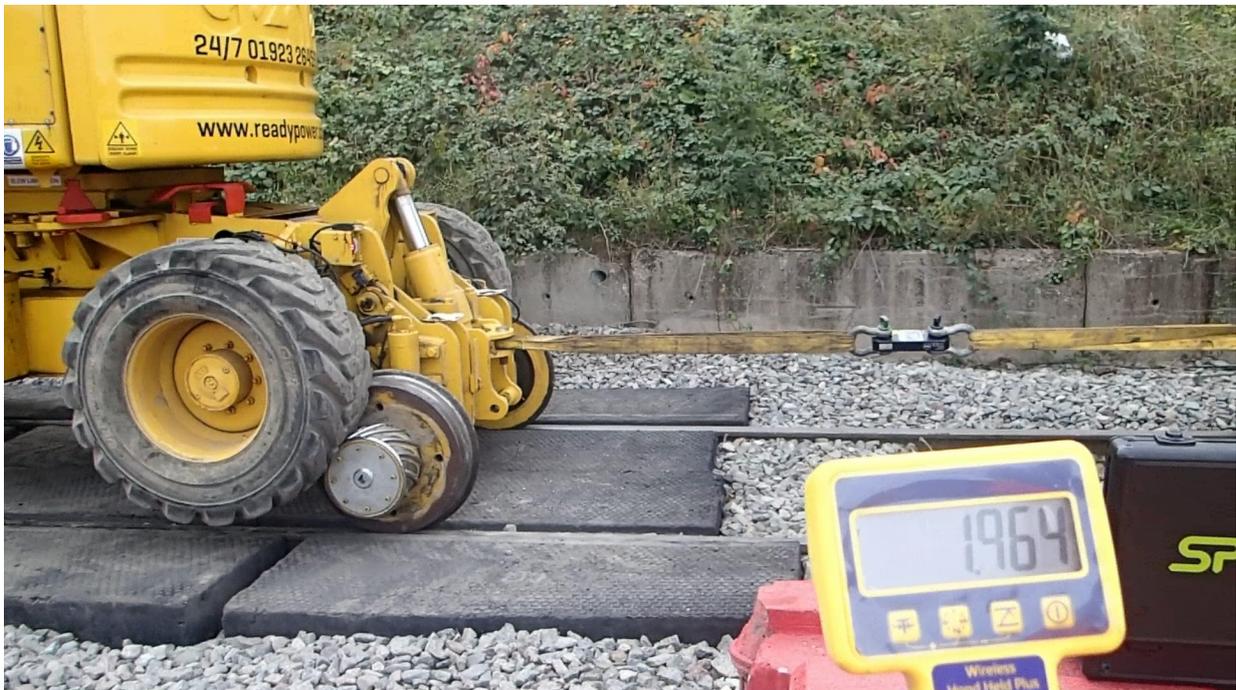
Figure 16: Pull-test when road wheels acting only (DRWB callipers removed)

Condition	Pull-force
As found #1	1750 kgf to 1950 kgf
As found #2	1850 kgf to 2000 kgf

- 92 Post-incident pull-tests on the incident MEWP showed that the road wheel brakes on their own provided somewhere between 1,750 and 2,000 kgf of brake force (table 4). A DRWB system which provided only 220 kgf of additional brake force (paragraph 65), would combine with the braking through the road wheels and achieve the target of 2,000 kgf. Therefore, a successful pull-test on the machine with fully deployed rail wheels may fail to reveal sub-standard performance of the DRWB system.

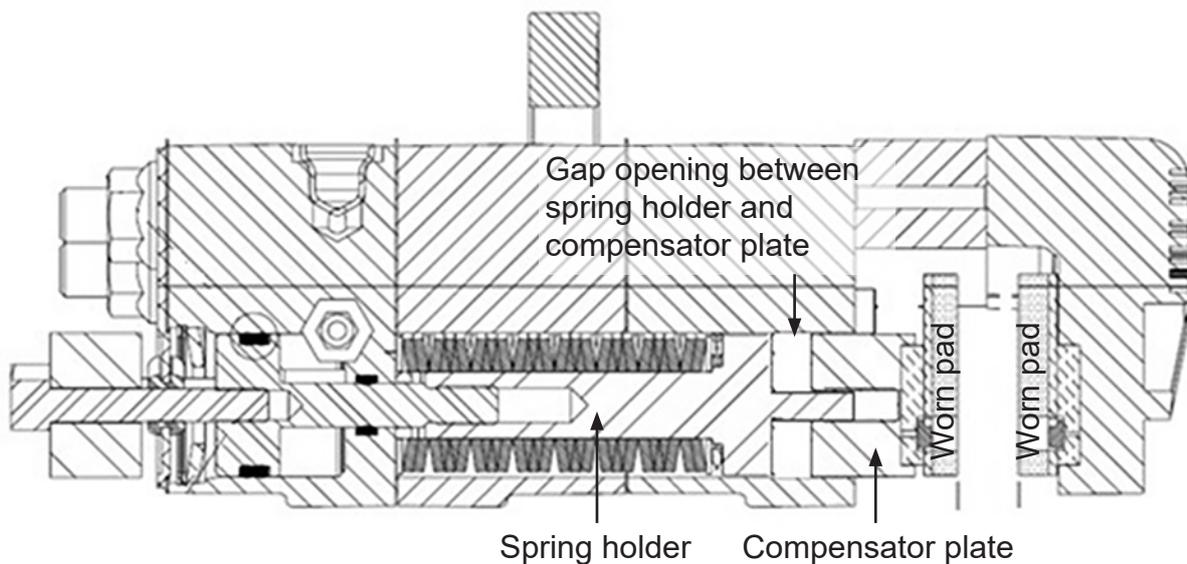
Figure 19: Calliper with worn pads, that has been adjusted

69 When the brakes are applied to slow a vehicle, the brake discs are clamped between the pads (inner and outer) and the pads wear as a result. This is a normal condition. As the pads wear, the load in the spring reduces which lowers the clamping load. In order to compensate for wear, the calliper needs to be manually adjusted by operating the adjustment bolts which results in a gap opening between the spring holder and the compensator plate (figure 19). This has the effect of compressing the spring which reinstates the required clamping load. If this operation is not carried out and the pads are allowed to wear, the clamping load will continue to decrease. According to the calliper manufacturer's datasheet, a combined wear of 11.7 mm on the pads, if unadjusted, will lead to all the clamping load being lost.

- 70 A detailed examination of the callipers fitted to the incident MEWP showed that the pads had worn to the extent that the callipers needed adjustment (combined pad wear ranging from 5 to 10 mm, across all four callipers). However, the examination also revealed that none of them had been adjusted.

- 73 The gaps at the four rail wheels on the incident MEWP were measured to be between 7.1 mm and 10.6 mm post-incident. This is consistent with the amount of wear measured on the pads, the low brake torque measured and a lack of adjustment.

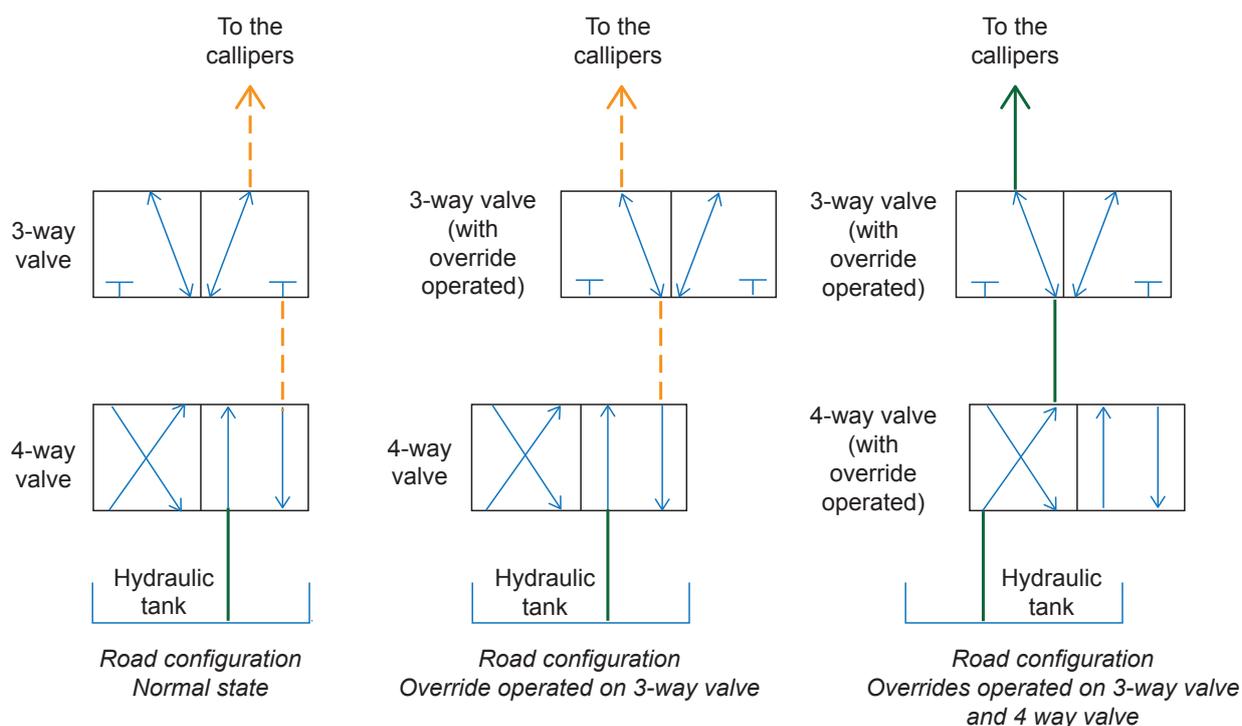
Figure 22: Hydraulic circuit for DRWB system (simplified)

- 112 Examination of the MEWP post-incident revealed that the operation of the override valve did not release the brakes when the machine was in its road configuration. This was because there was another valve in series with the three-way valve in the hydraulic circuitry detecting the position of the rail axles (figure 22). This second valve (a four-way valve) was only activated if it detected that the rail axles had been fully deployed at both ends. With the machine in its road configuration so its rail axles were off the ground, this four-way valve was not activated and did not allow hydraulic fluid to flow in the brake circuitry. As a result, operating the override on the three-way valve only had no effect. For the brakes to be released, the override on the four-way valve also needed to be operated (or the rail wheels fully deployed).

- 113 This error in maintenance instruction AJH077 was not causal to this incident as witness evidence indicated that Readypower fitters knew how to release the brakes, which was the purpose of the first step in the process. In accordance with Hargreaves' quality management system, AJH077 was checked by a competent person but he too did not identify the error in the maintenance instruction, possibly because this part of the instruction could not be validated by testing as the callipers did not need adjustment.

- 114 The three-way valve was part of the Hargreaves DRWB design but the four-way valve was not. It was part of the original design of rail wheel brakes that had been fitted to the Genie Z60 by the manufacturer (see footnote 5). When designing its DRWB system, Hargreaves retained some parts of the old braking system including the four-way valve.
