Defence
Infrastructure
Organisation

Safety Alert Part A, B, & C

Subject: Overheating of Electrical Fan Motors & Electrical Invertor Motor Drives

Number: SA 2018/07

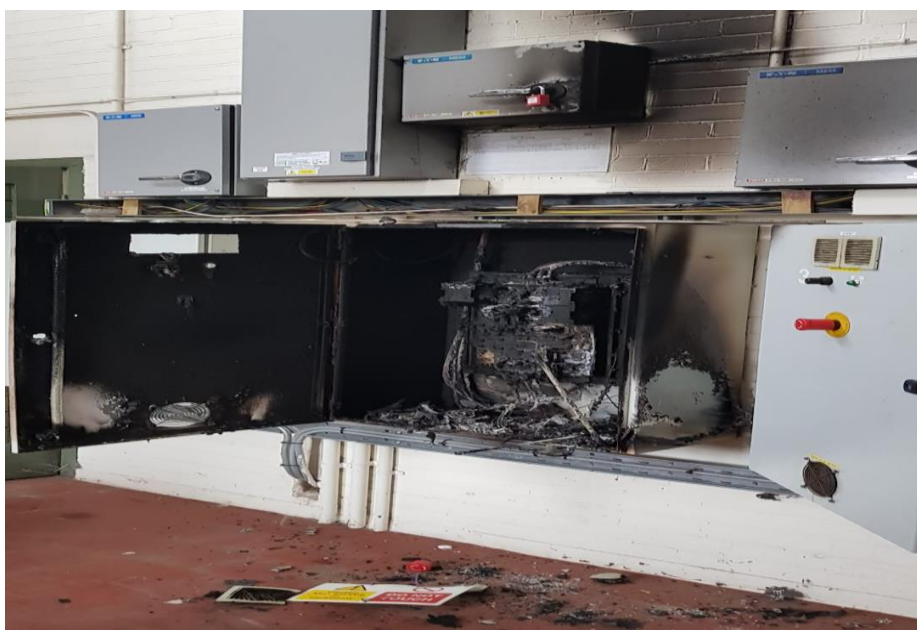
Background

Photograph 1 showing the damage resulting from the overheating of the electrical Inverter Drive Motor

8. All electrical motors and inverter drives used with in HEVAC systems, should be subject to PPM which will include as a minimum, electrical and mechanical inspection, testing and cleaning and any other manufactures requirements.
9. HEVAC systems must have the correct filtration installed and maintained to prevent dust build-up giving rise to environmental hazards.
10. During maintenance and inspection activities any non-standard components or unapproved modifications to the system should be identified.
11. Any work incurring expenditure of MOD funding requires appropriate authority from the MOD officer responsible for the establishment.

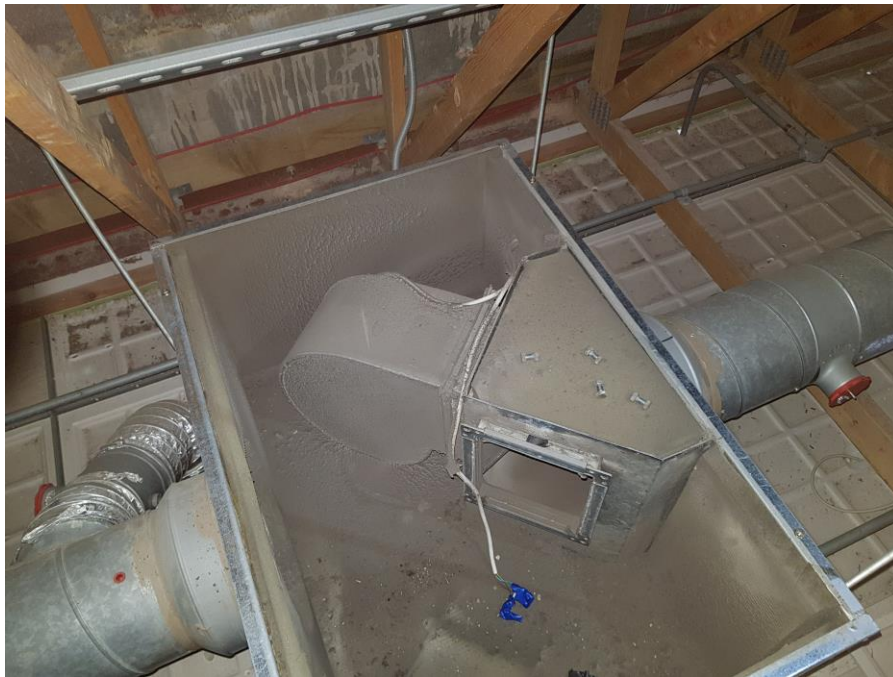
Photograph 2 showing dust build-up in the Air Handling Unit
