Derailment of a rail head treatment train near Dunkeld & Birnam, 29 October 2018

Summary of the accident

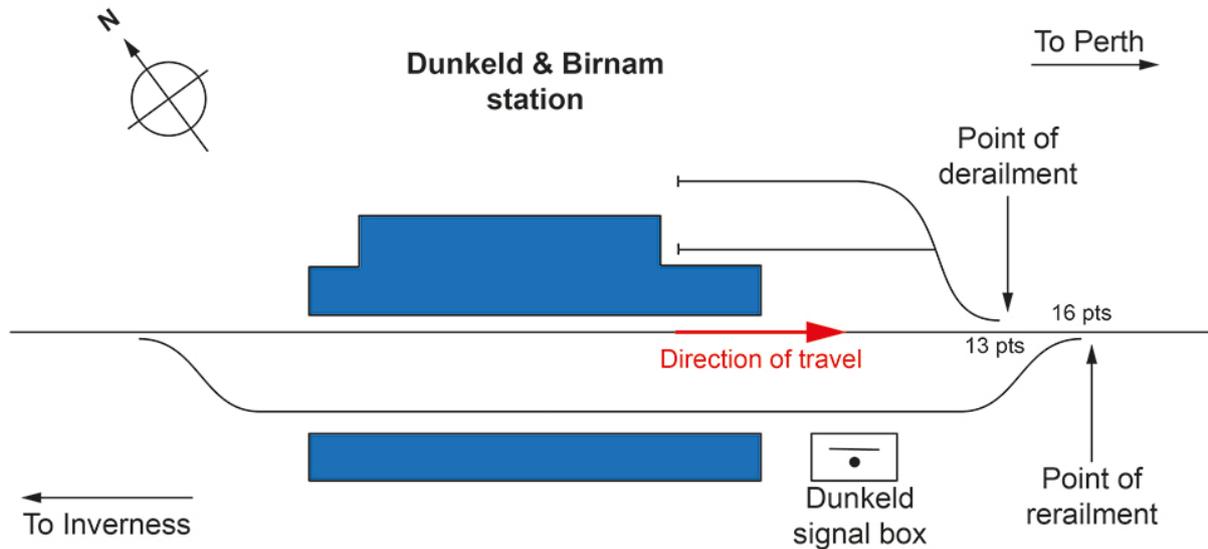
Simplified diagram of the track layout at Dunkeld and Birnam station

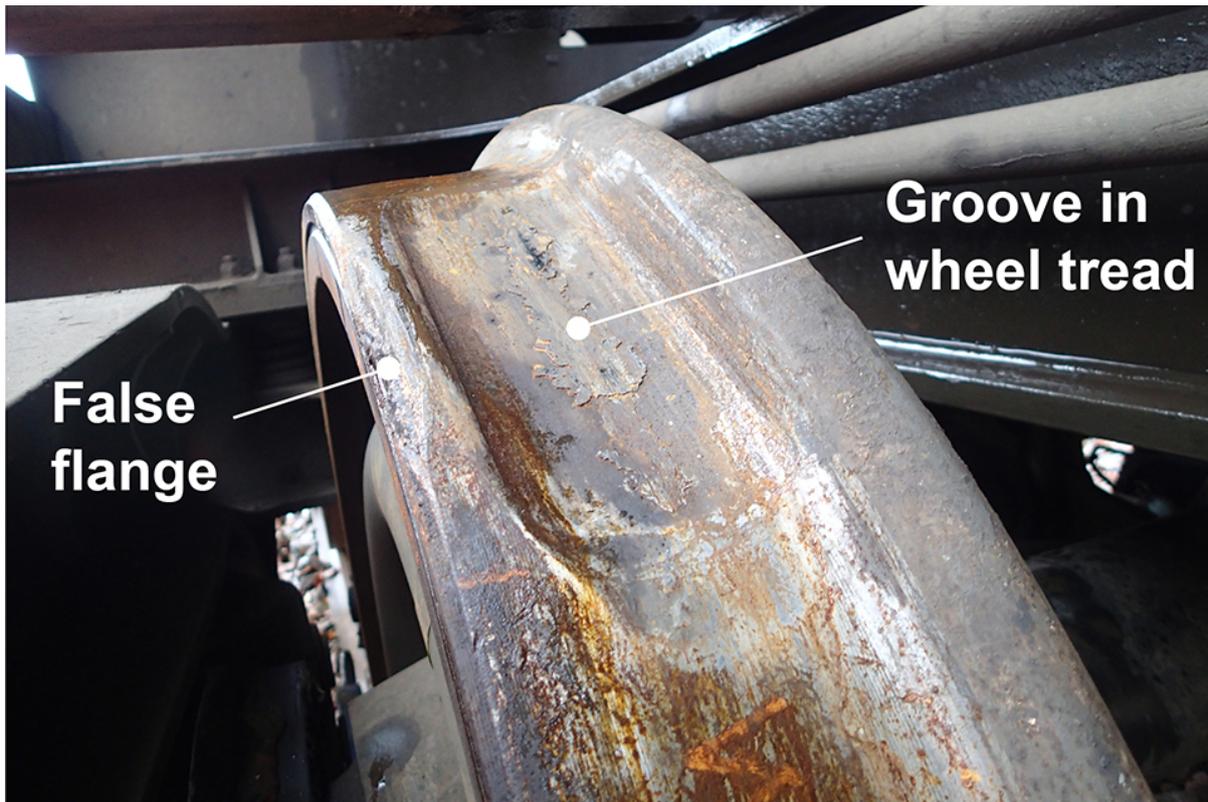
The RHTT was crewed by a driver, and an operative who operated the rail head treatment equipment in accordance with a pre-defined plan. At some point in the journey, the leading wheelset of the 4th bogie (the trailing bogie of the leading wagon) began to slide rather than rotate, resulting in the creation of a large wheel flat on both its wheels. As the train progressed on its journey, these flats developed, wearing a groove into the wheel treads and creating features on the outside edges of the wheels called 'false flanges'.

The large flat on the leading left-hand wheel of the 4th bogie and its associated false flange

It has not been possible to confirm the exact status of the handbrake during the journey. The brake blocks associated with the wheels which had the large flats showed signs of excessive heat being generated, consistent with the brake blocks rubbing against the wheels for a significant period of time. However, the other wheelset on the same bogie did not exhibit any wheel flats or heat marks indicating that its brake blocks had not been rubbing against the wheels and that the handbrake was not fully applied on this bogie. Although the RHTT operative stated that he performed handbrake checks, the condition of the inboard brake blocks indicates that they were rubbing against the wheels. If this was the case, the inboard wheels would have been susceptible to wheel flats in low adhesion conditions.

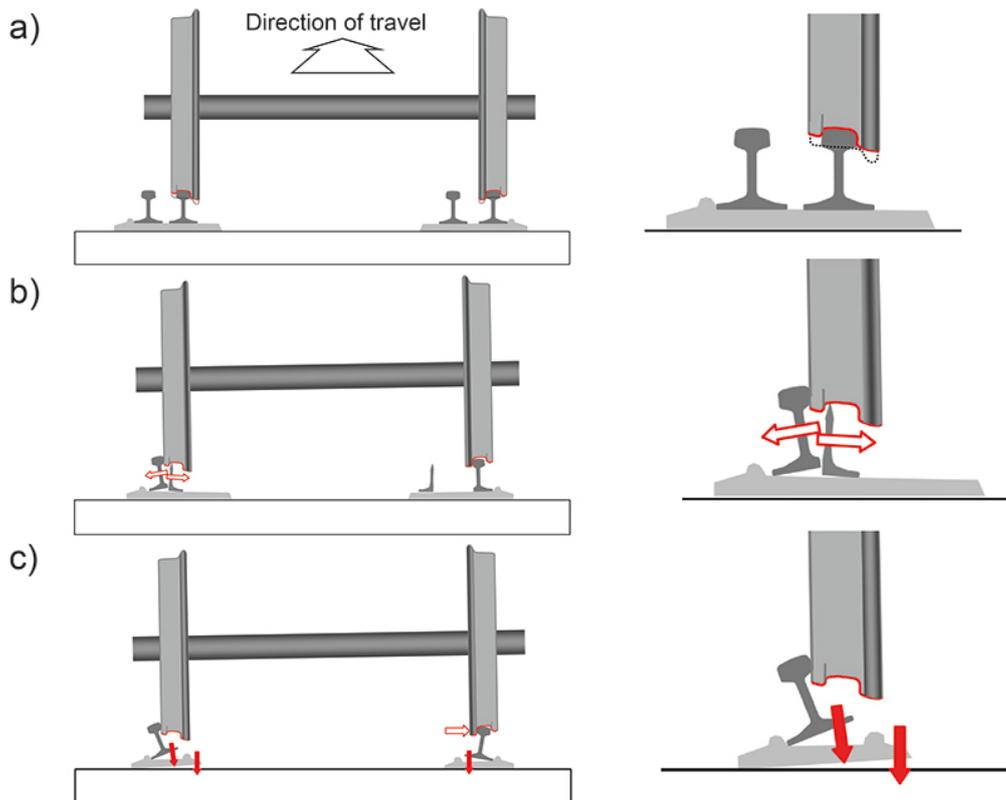
As the flatted wheelset passed over number 13 points, just south of Dunkeld and Birnam station, the false flange on the left wheel engaged with the converging switch and stock rails. Rather than the wheel tread transferring from the switch rail to the stock rail in the normal way, the false flange on the left-hand wheel became trapped between the stock and switch rail. This caused the outside face of the wheel to run along the gauge face of the stock rail, while the right-hand wheel was pushed up against the opposite stock rail. This led to the wheelset pushing the rails apart, resulting in high lateral forces on the stock rails which in turn overloaded the rail fastenings and in some places the wooden sleepers.

The derailment mechanism (and close up of the left wheel) showing: a) the false flange on the left wheel between the switch and stock rails, b) the false flange trapped between the rails and c) the resultant high lateral forces pushing the rails apart

This directly led to derailment of the leading wheelset of the 4th bogie, shortly followed by derailment of the bogie's trailing wheelset. They ran derailed for approximately 100 metres, before rereiling at 16 points, the next converging set of points. The derailment caused extensive track damage through this section, including broken rails, which resulted in a signalling fault.
