## **Service Inquiry**

Loss of Watchkeeper  
(WK042) Unmanned Air  
Vehicle over Cardigan Bay  
in West Wales

3 Feb 17

**SERVICE INQUIRY INTO AN ACCIDENT INVOLVING A WATCHKEEPER UNMANNED  
AIRCRAFT (UA) WK042 THAT OCCURRED NORTH OF WEST WALES AIRPORT ON 3 FEB 17**

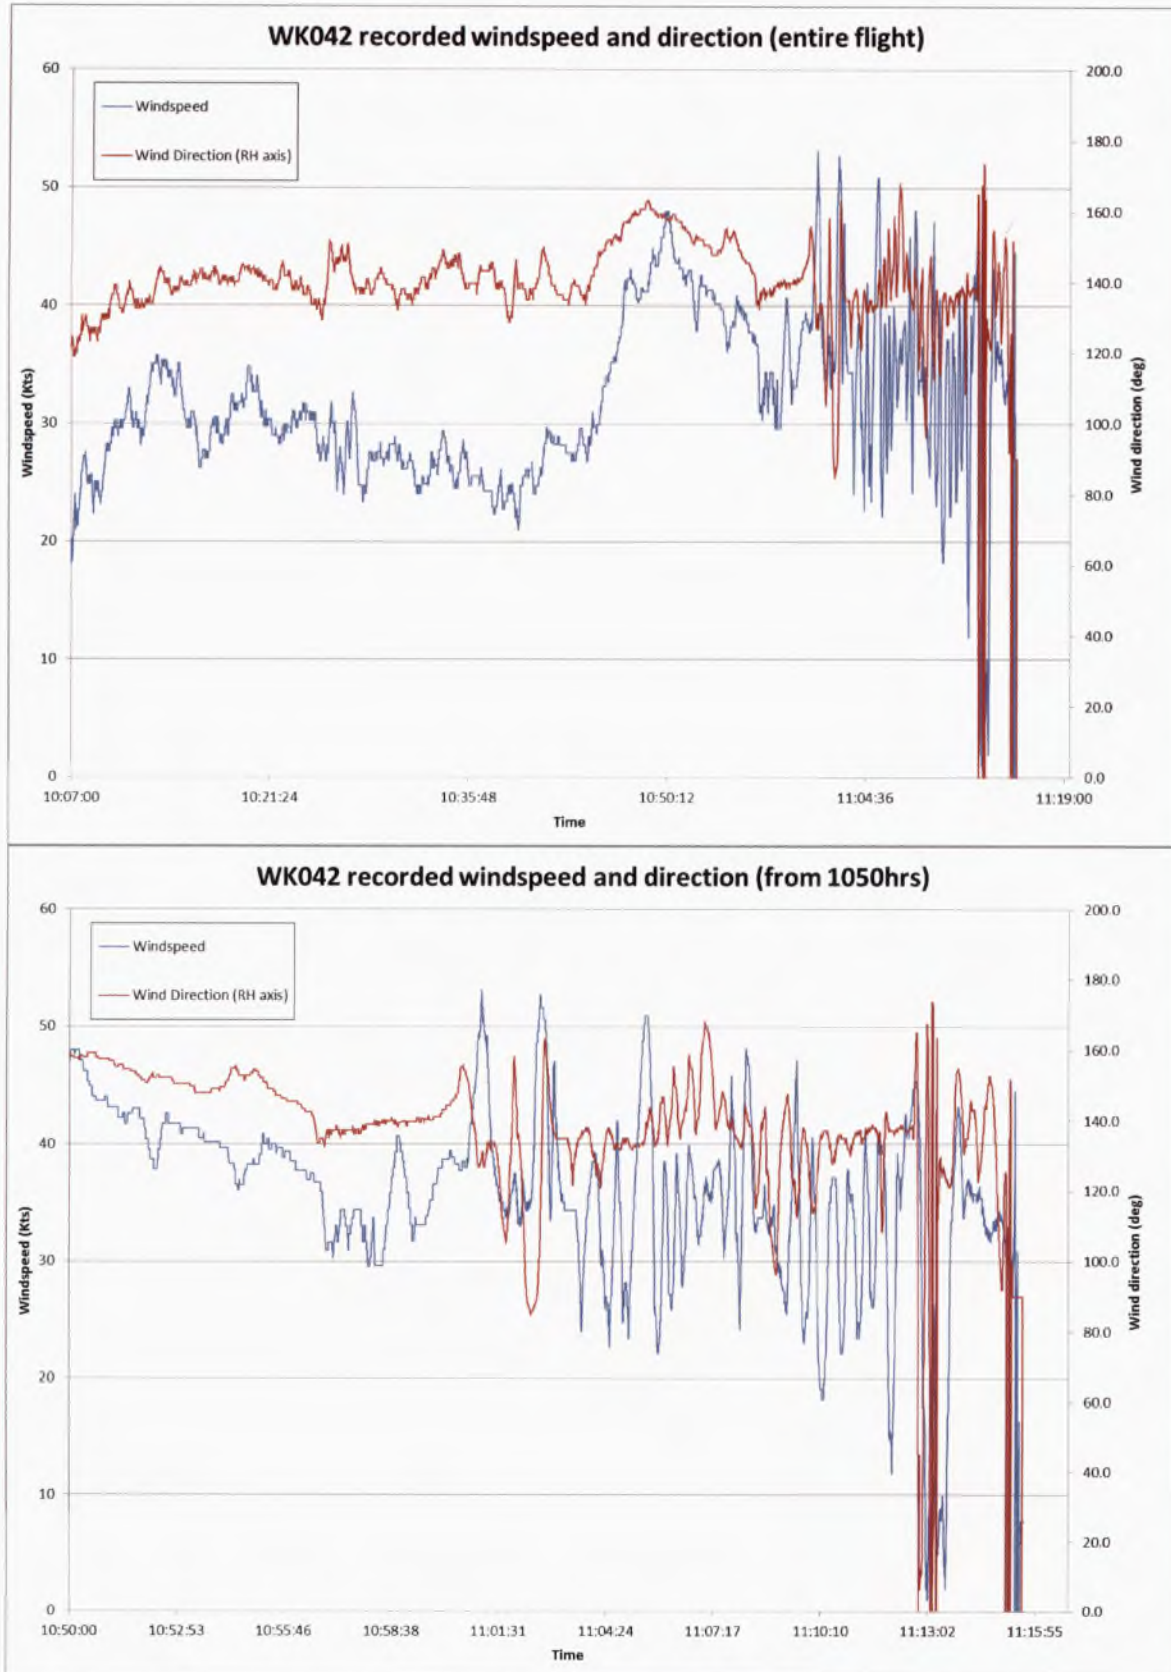
Figure 1.4.3.1 – Wind speed as measured by WK042

1.4.3.8. **Met analysis.** The Met Office produced a detailed aftercast for the 3 Feb 17, focusing on the time that WK042 was airborne and in particular from 1100hrs until it crashed at 1116hrs. The senior Met forecaster covering the MOD Aberporth range complex commented that in his experience, the conditions on the day were unlikely to have resulted in the wind vector change recorded by WK042 at the altitude that it was flying. He explained that such wind vector changes could only have been expected much closer to the surface in heavy showers, where the downdraught may have been deflected horizontally by the ground. He further commented that he believed that moderate turbulence due to mountain waves and the rainfall would have materialised as forecast, but doubted that the UA would have encountered any severe turbulence during its flight. Although no lee-wave aftercast was available, mountain waves of up to 500fpm were forecast for the end of the afternoon, however, there was no evidence that they were any greater than forecast during the flight. The Met forecaster suggested that mountain waves more in the region of 1000fpm vertical motion would have been required for the rapid descent recorded. Additionally, as WK042 was flying in precipitation during the end of its flight, the radial velocity of the precipitation had been captured at various points in time by a local Doppler weather radar. No evidence of such severe wind vector changes could be identified by the Panel when the resulting Doppler weather radar plots were analysed, although turbulence or very local wind vector changes would not be detected by the radar due to cell sizing<sup>15</sup>.

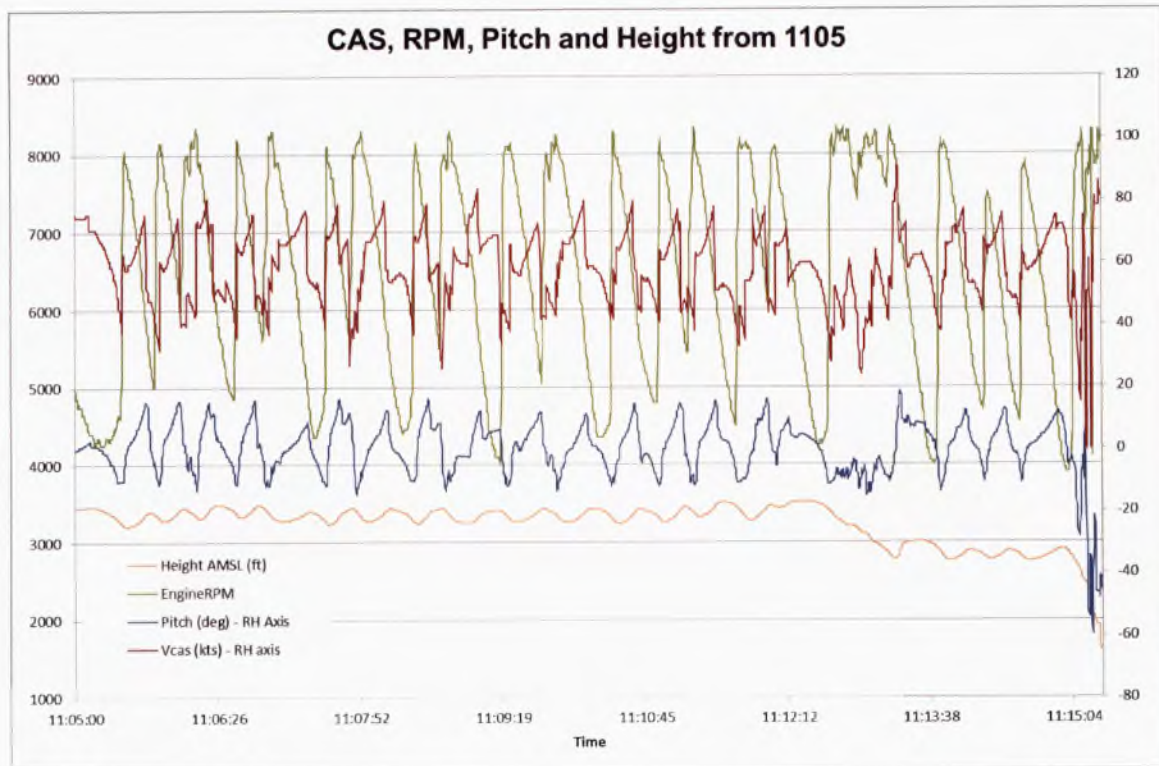
**Figure 1.4.3.3 – Recorded CAS, Pitch, Engine RPM and Height against time during pitching oscillations**

1.4.3.11. The UA has two Rockwell Collins Athena GS-411 Inertial Navigation System/Global Positioning System (INS/GPS) units fitted, which, along with other parameters, determine pitch. There were no WCAs indicating a mismatch between these units and a clear relationship between pitch and change in height can be seen in Figure 1.4.3.2, therefore, the Panel concluded that pitch was being reported correctly. Engine RPM is controlled by a mechanical throttle operated by a servo controlled by the VMSC. No throttle servo WCAs were recorded and there was no Engine Control Unit (ECU) throttle stuck warning that would indicate a mismatch between engine RPM and commanded power. The Panel therefore concluded that the engine RPM was being reported correctly. CAS is determined from total and static pressure measurements taken from the Kollsman and Space Age pitot probes<sup>16</sup>. The ADU velocity sensor redundancy lost cautions and the ADU velocity sensor fail warnings that were recorded are indicative of total pressure measurements deviating from each other and a reference value by more than defined limits. This can be due to either faulty pressure transducers or blockages in the pitot system. After analysing the data set available, the Panel concluded that the recorded CAS measurements became unreliable after 1056hrs. This supported the Panel's previous findings regarding wind speed and direction not being credible after approximately 1100hrs (paragraph 1.4.3.9) as air speed is an input into the VMSCs wind calculation.

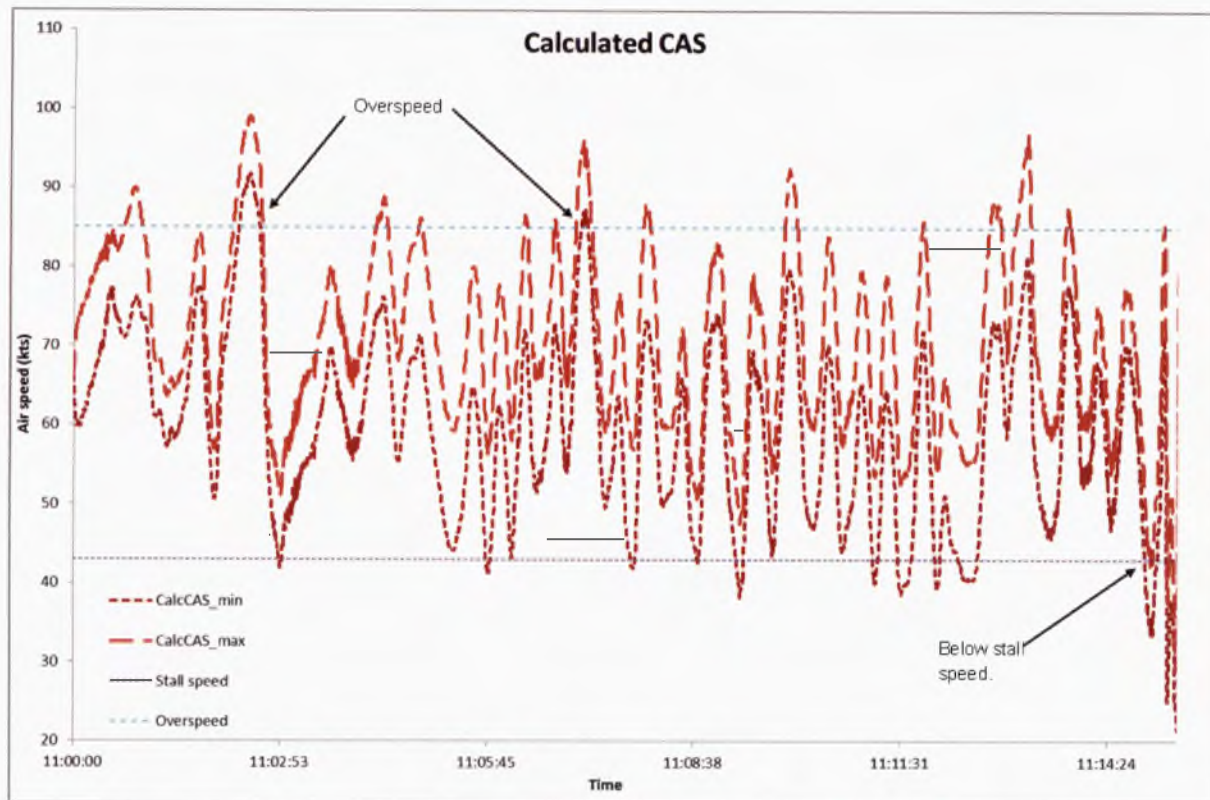
Figure 1.4.3.5 – Calculated CAS range from 1100hrs

1.4.3.14. At low speeds and altitudes, CAS can be calculated from TAS if the air density is known. Air density was found from pressure and temperature measurements in the air data recorded in the GCS. The Panel were able to calculate CAS based on the wind analysis from 1100hrs. The calculated CAS

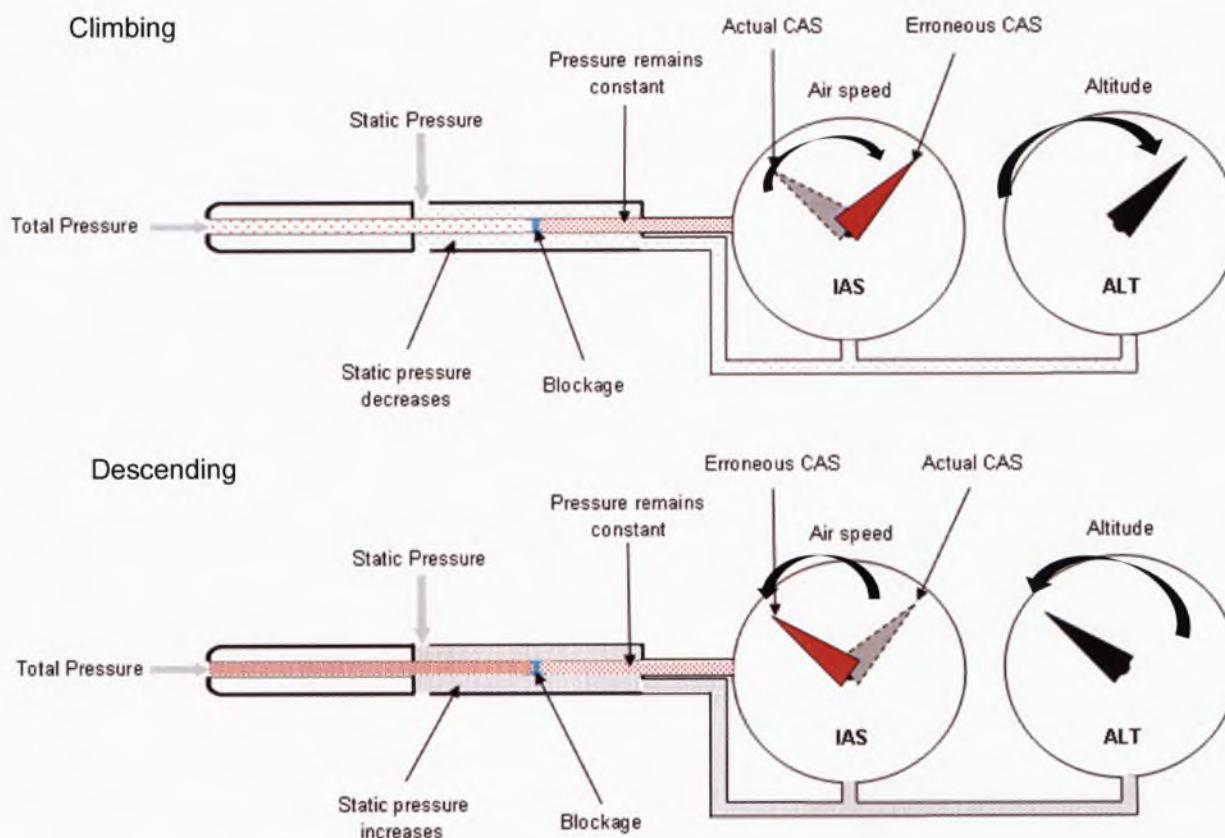
Figure 1.4.3.10 – Effect of pitot blockage on air speed with change in altitude

1.4.3.18. **Effect of pitot blockage.** As previously concluded, CAS was erroneous during the pitching oscillations, which the Panel determined is very likely to have been caused by moisture blocking the pitot tube total pressure feed. As CAS is based on the dynamic pressure, which is the total pressure minus the static pressure, relatively modest changes in altitude can have an effect on the CAS reading of a blocked total pressure feed. This is because static pressure reduces as altitude increases, increasing the relative pressure of air trapped behind a blockage on the total pressure side. The opposite is true when altitude decreases. A well-documented symptom<sup>25</sup> of a blocked pitot tube is an observed increase in instrumented airspeed in a climb and a decrease in a descent. This is illustrated in Figure 1.4.3.10. It is also possible that due to changes in AOA changing the total pressure ahead of the blockage, that pitch may also have an effect. Due to the pressure differential changing over the blockage, the weight and viscosity of the water, the blockage may temporarily clear, move and reform as illustrated in Figure 1.4.3.11. Changes in pitch are also often associated with changes in altitude and hence static pressure, will of course also change as illustrated.

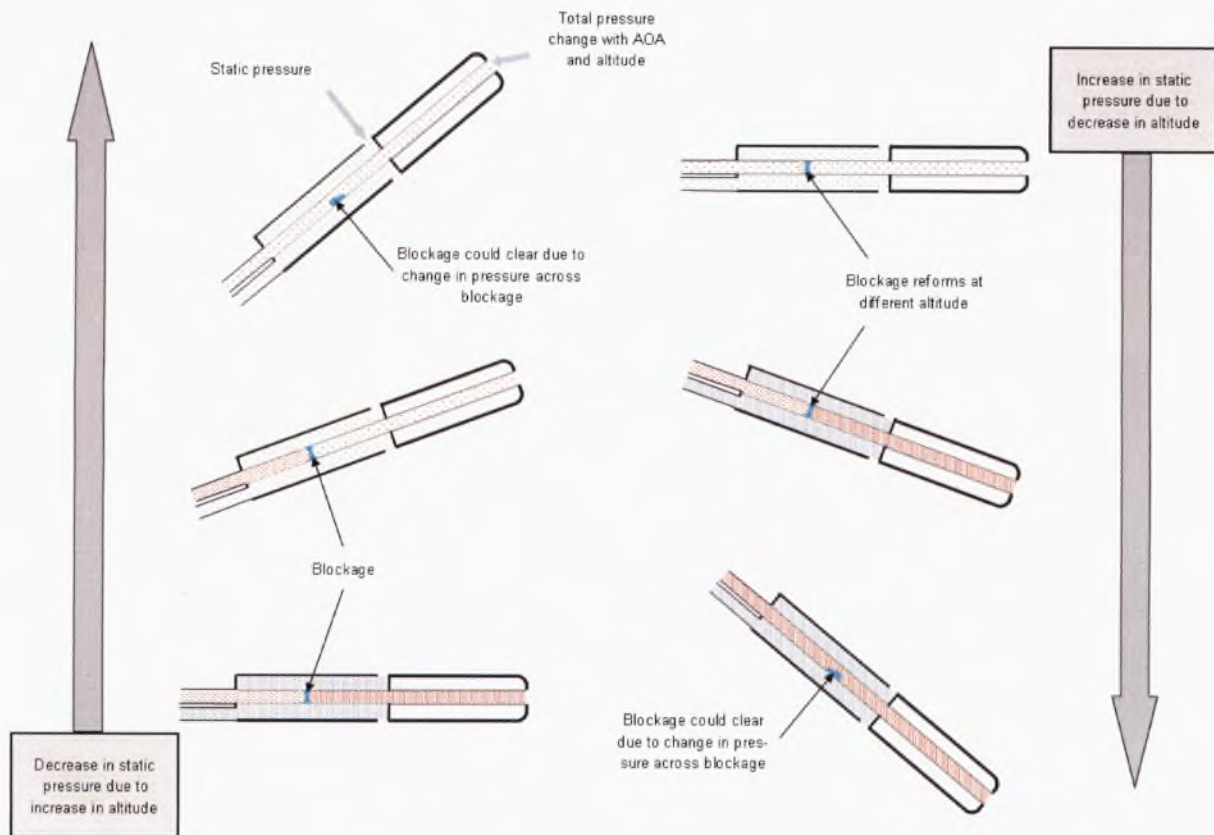
Figure 1.4.3.11 – Effect of pitch on pitot blockage

1.4.3.19. **Cause of pitching oscillations.** With CAS sensitive to pitch and changes in altitude, it is therefore possible that the FCS could respond unexpectedly to an erroneous change in CAS driven by a pitch or altitude change. For example, a high CAS input may trigger the FCS to command a reduced throttle setting or increase AOA. A corresponding increase in height would cause a reduction in static pressure and relative increase in total pressure in a blocked pitot, hence causing the erroneous CAS input to increase further. If the CAS reading then corrected due to the blockage clearing temporarily or the measurement being disqualified by the system, a low CAS input (from the reduced throttle setting and increased angle of attack) would result. This would trigger an increase in throttle and pitch down causing CAS to increase and restarting the cycle. This is illustrated in Figure 1.4.3.12. Further evidence supporting this hypothesis can be found in FRC Card E9, where it stated that *uncontrollable pitch oscillations* might be associated with ADU Velocity Sensor Fail Caution. The Panel were unable to positively determine the origin of this statement in the FRCs, but believe it to be a carry-over from the Quick Reference Handbook, which was based on Hermes 450<sup>26</sup> documentation and used by ESL during WK trials in [REDACTED] and at WWA before the FRCs had been developed. The Panel concluded that it was highly likely that blocked pitots caused the pitching oscillations seen at the end of the flight.

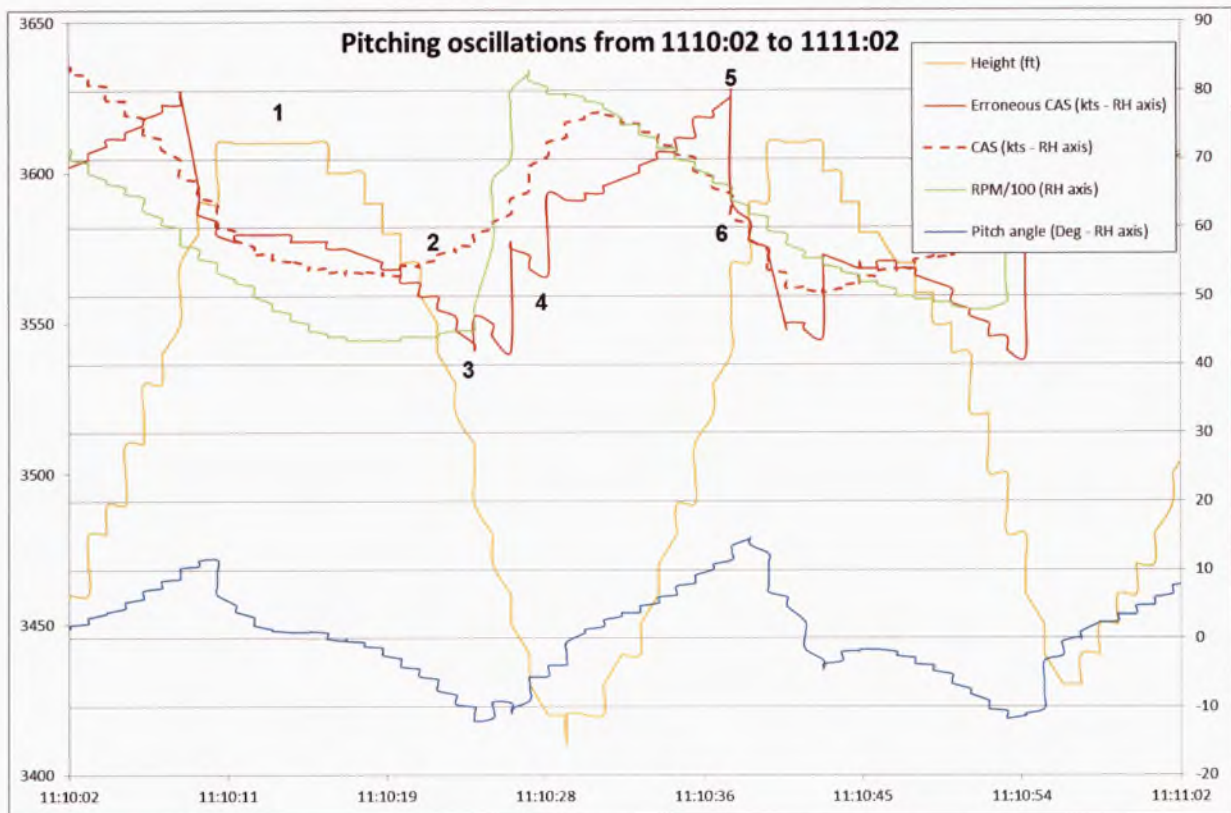
Period	Description
1 - 2	CAS diverges from the erroneous CAS value being used by FCS. The UA begins to fly slower than FCS believes, so RPM is set lower than required, which induces a slight reduction in height. This causes static pressure to increase slightly. The blocked pitot causes a relative reduction in total pressure in relation to static pressure, hence dynamic pressure decreases and CAS becomes erroneously low.
2 - 3	The UA continues to pitch down in an attempt to maintain CAS.
3 - 4	In response to low erroneous CAS, RPM increases in an attempt to maintain CAS, despite a -10 degrees nose down. This is followed by series of CAS corrections upwards (either due to pitot blockage clearing or pitot disqualification logic). FCS increases pitch in response to higher reported RPM value and CAS. As the UA pulls up the blockage reforms and CAS becomes erroneous again.
4-5	RPM reduces as reported CAS become satisfactory. The UA continues to pitch up in an attempt to reduce CAS, however, a reduction in static pressure with the increase in height, induces a relative increase in total pressure and CAS becomes erroneously high.

6	CAS corrects downwards (either due to pitot blockage clearing or pitot disqualification logic) and the cycle restarts.

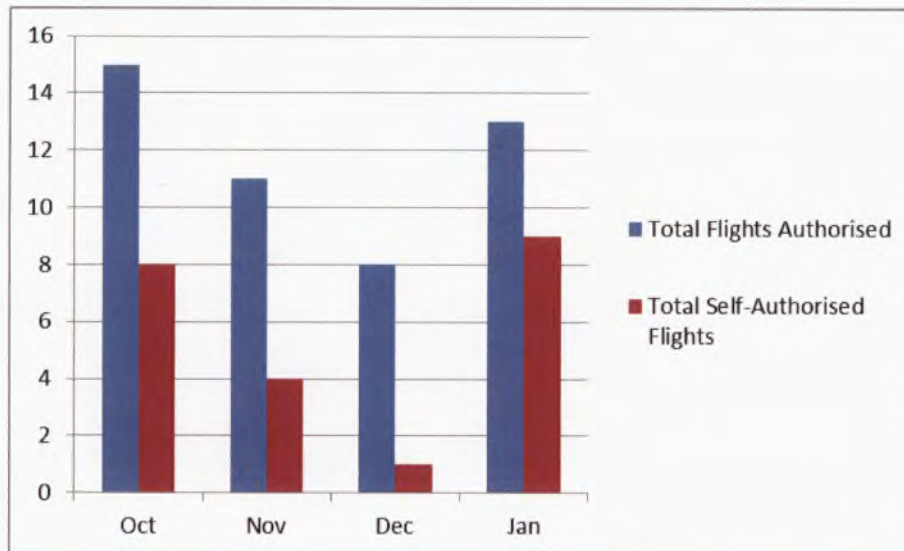
Figure 1.4.5.1– Self-authorisation over preceding 4 months

1.4.5.19 **Analysis of self-authorisation.** Although Thales FOB had stated self-authorisation should not be the "norm", Figure 1.4.5.1 shows that it had become regular practice, although the level of self-authorisation varied significantly from month to month. The RAFCAM HF report, discussed further in Section 1.4.7, noted that the process of self-authorisation has no form of independent assurance, which leaves room for error from the planning/preparation process, allowing undetected transfer into the sortie/flight. The Panel noted that no Met update was requested following the delayed take-off time (paragraph 1.4.2.9) and considered whether this was due to the crew being close to capacity with the task of crewing-in.

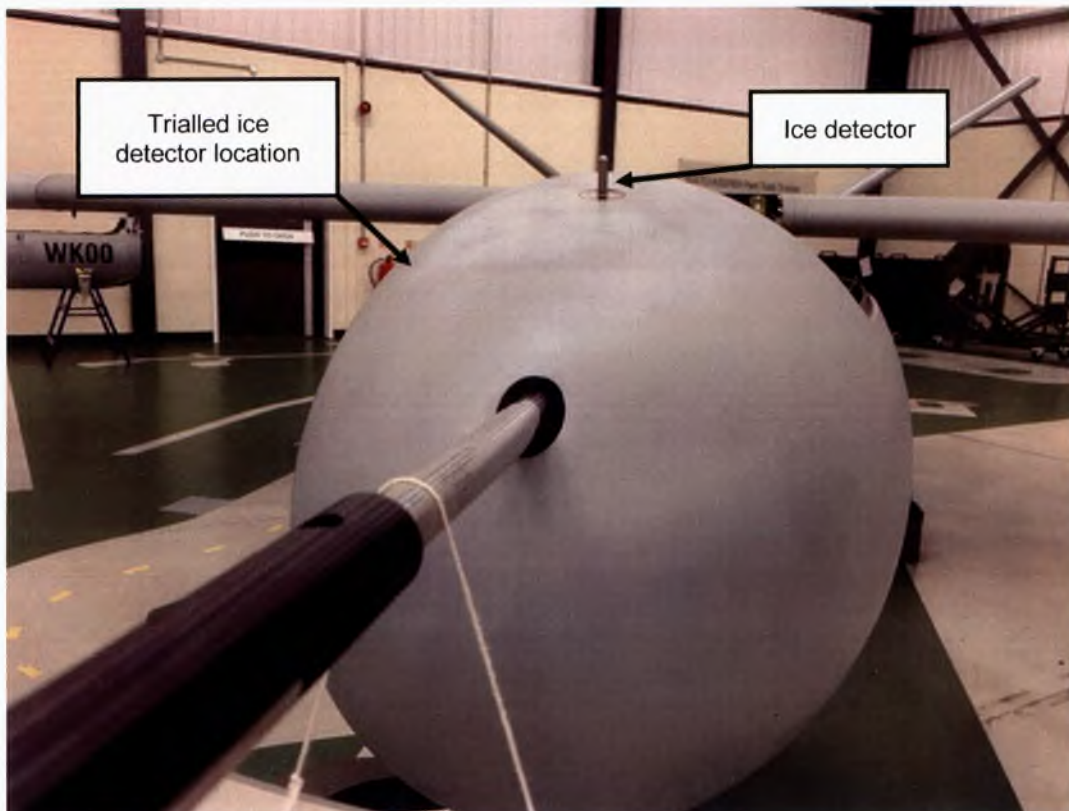
Figure 1.4.8.2 – Ice detector position

1.4.8.4. In the opinion of the Panel, the fact that response of the ice detector probe as fitted to WK is affected by residual heat from the Kollsman pitot heater is a **other factor** worthy of further investigation. This should be carried out in conjunction with any investigation concerning the suitability of the temperature and RH detectors and their integration with the VMS to consider the performance and reliability of the Ice Detection/Ice Protection system as a whole.

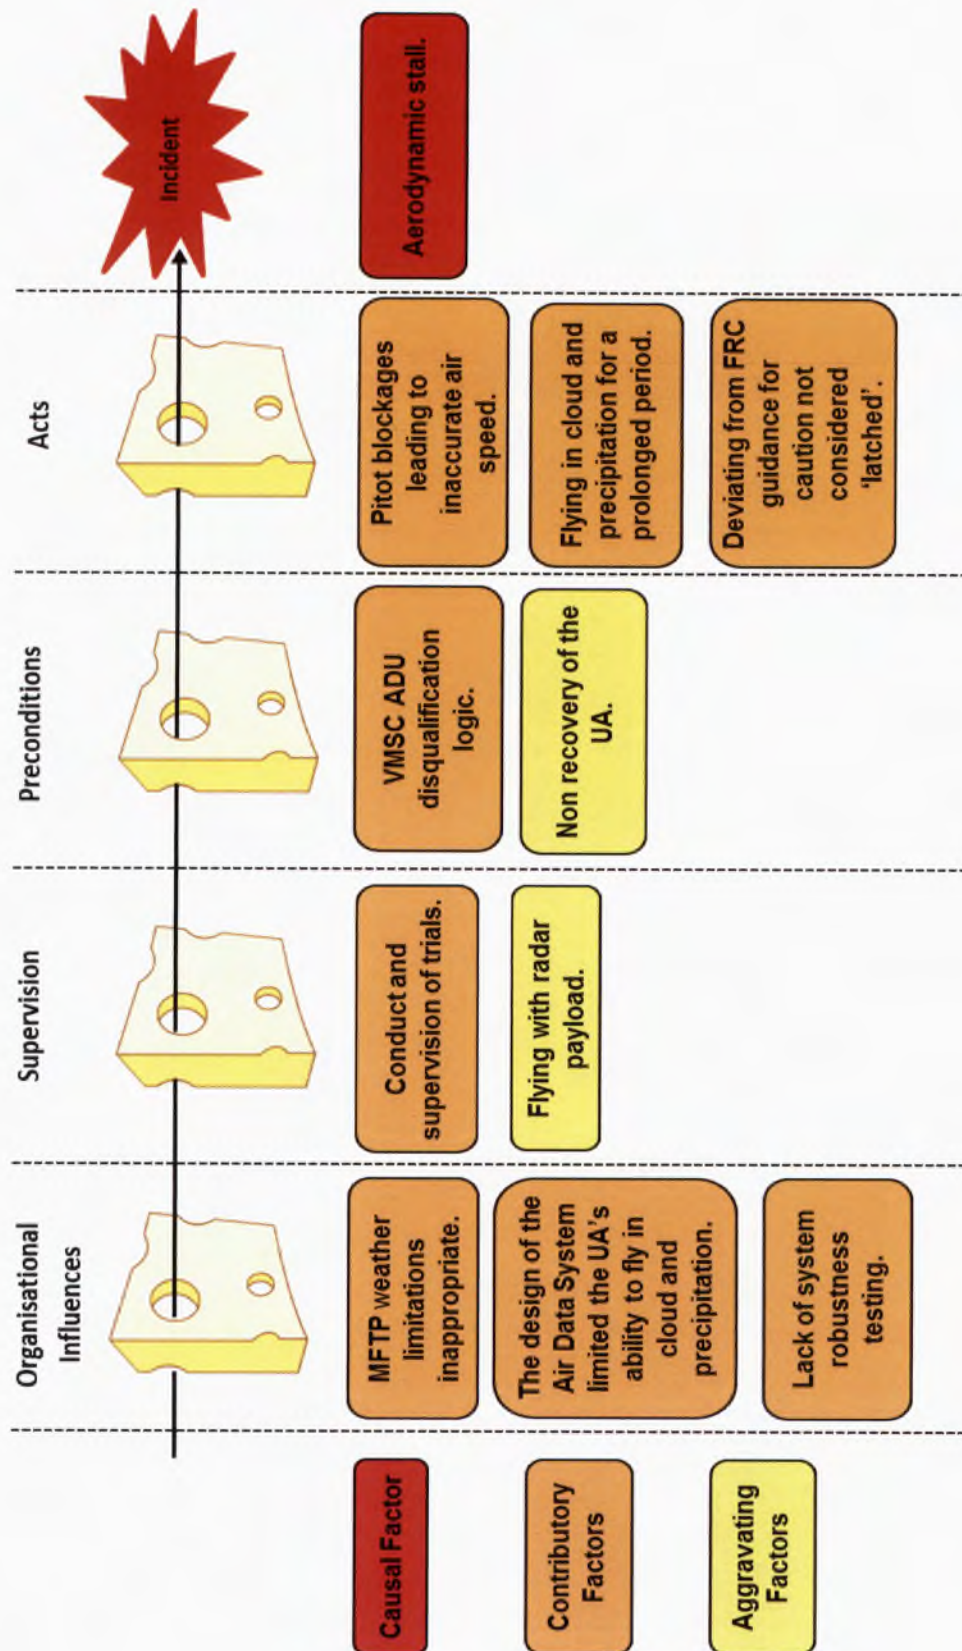
Figure 1.4.9.1 – Reason's Swiss Cheese analysis of the accident

1.4.9.2. **Causal factors.** A causal factor is a factor, which, in isolation or combination with other causal or contributory factors and contextual details, led directly to the accident. The Panel identified the following causal factor:
