Defence
Safety
Authority

Service Inquiry

Loss of Watchkeeper
(WK043) Unmanned Air
Vehicle over Cardigan Bay
in West Wales

24 Mar 17

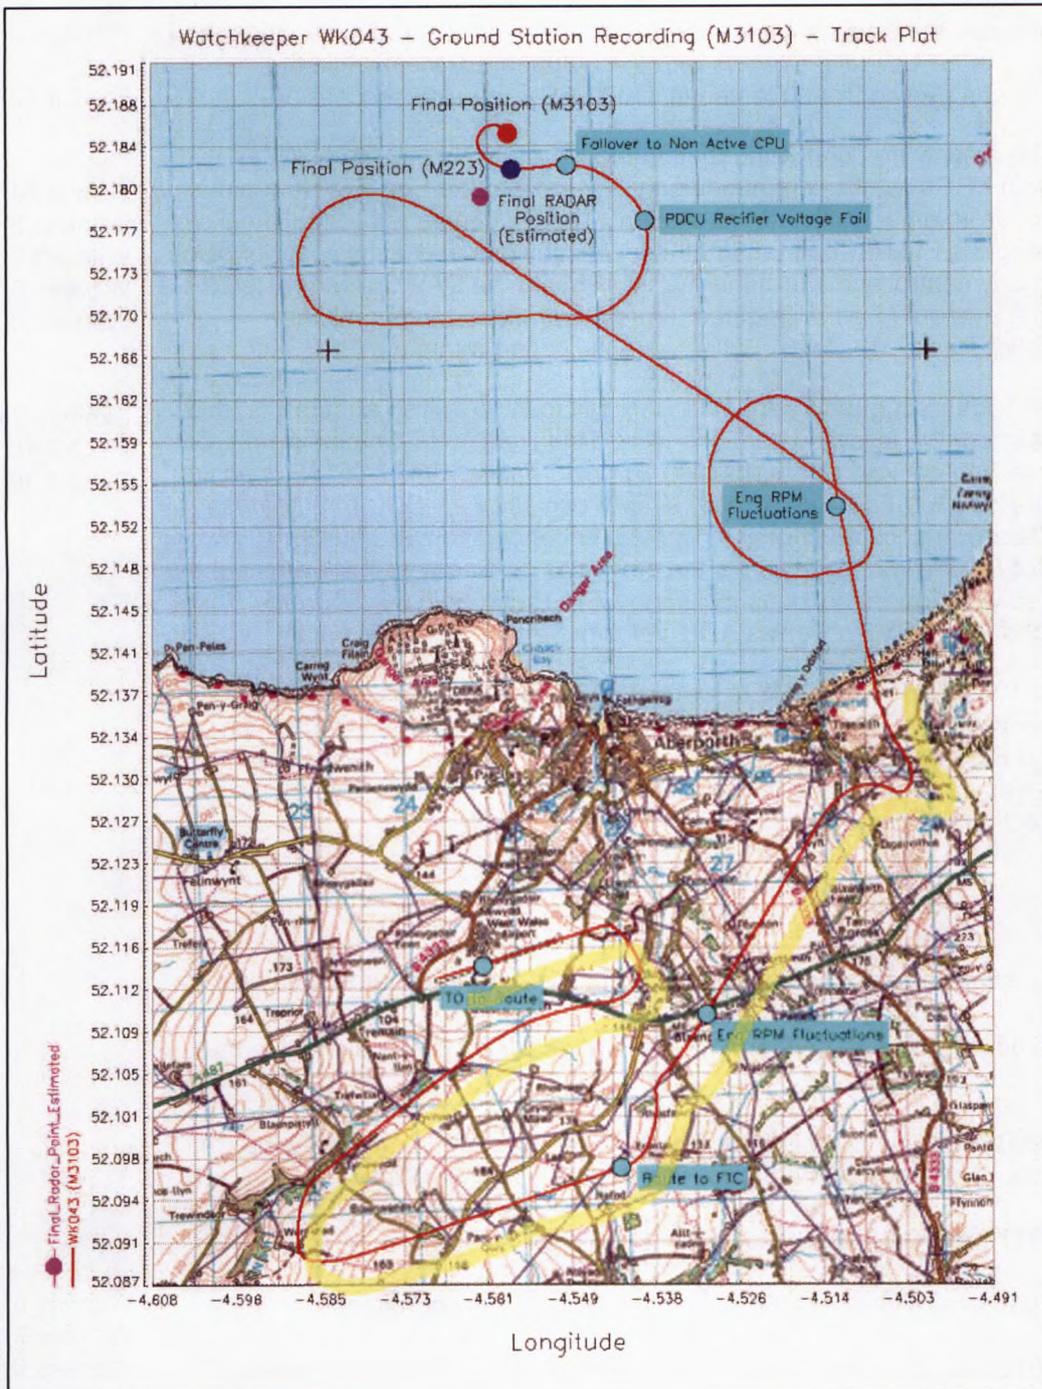
Figure 11 – VMSK flight data trace of WK043 from take-off to crash.

1.3.10. At 1043hrs and during the initial climb the P2 noticed that the reported payload footprint on the AV was inaccurate compared to the true heading, the P2 also noted that the FMV window displayed the opposite report of the payload mode; when Port was commanded, it displayed Starboard. The P2 and the UAV Cdr worked through the payload issues referring to Flight Reference Cards (FRCs) where required. Whilst climbing through 4000ft AMSL³, an *ECU Throttle Posn Difference* message was displayed. The FRCs stated that this caution may result in degraded engine performance, and that controllability checks should be conducted and the AV should land ASAP. Before the crew could conduct controllability checks, the caution cleared. The same caution was repeated 1 minute later and cleared in seconds. The next caution that appeared was *ECU Tacho Fail*, which the FRCs stated indicated that RPM was above 9000RPM or below 2000RPM, which may be the result of a RPM sensor failure or invalid reading. Concurrently the RPM displayed in the HCI was seen to fluctuate and the AV appeared to be unable to climb satisfactorily.

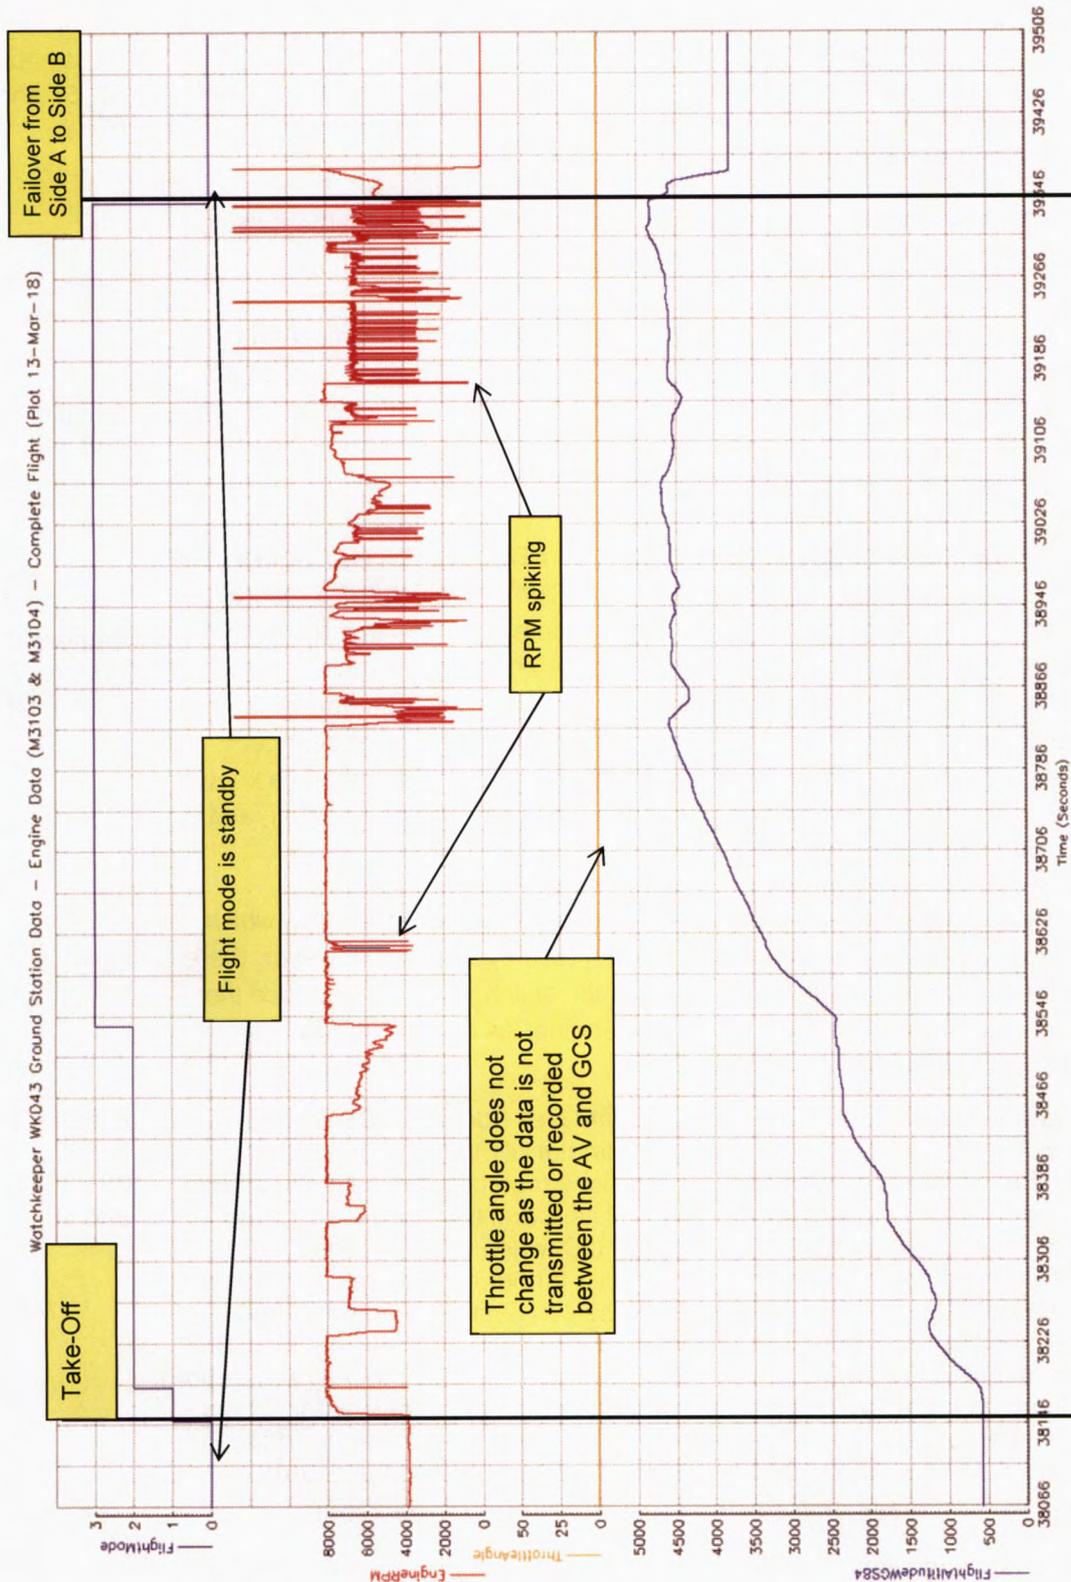
Figure 14 - General parameters plot.

1.4.26. **Flight Mode.** Figure 14 shows the flight mode, which changed during the various stages of the flight from standby, to take off, to fly to coordinate. At the time the VMSC Side A failed over to Side B, the flight data recorded that the flight mode

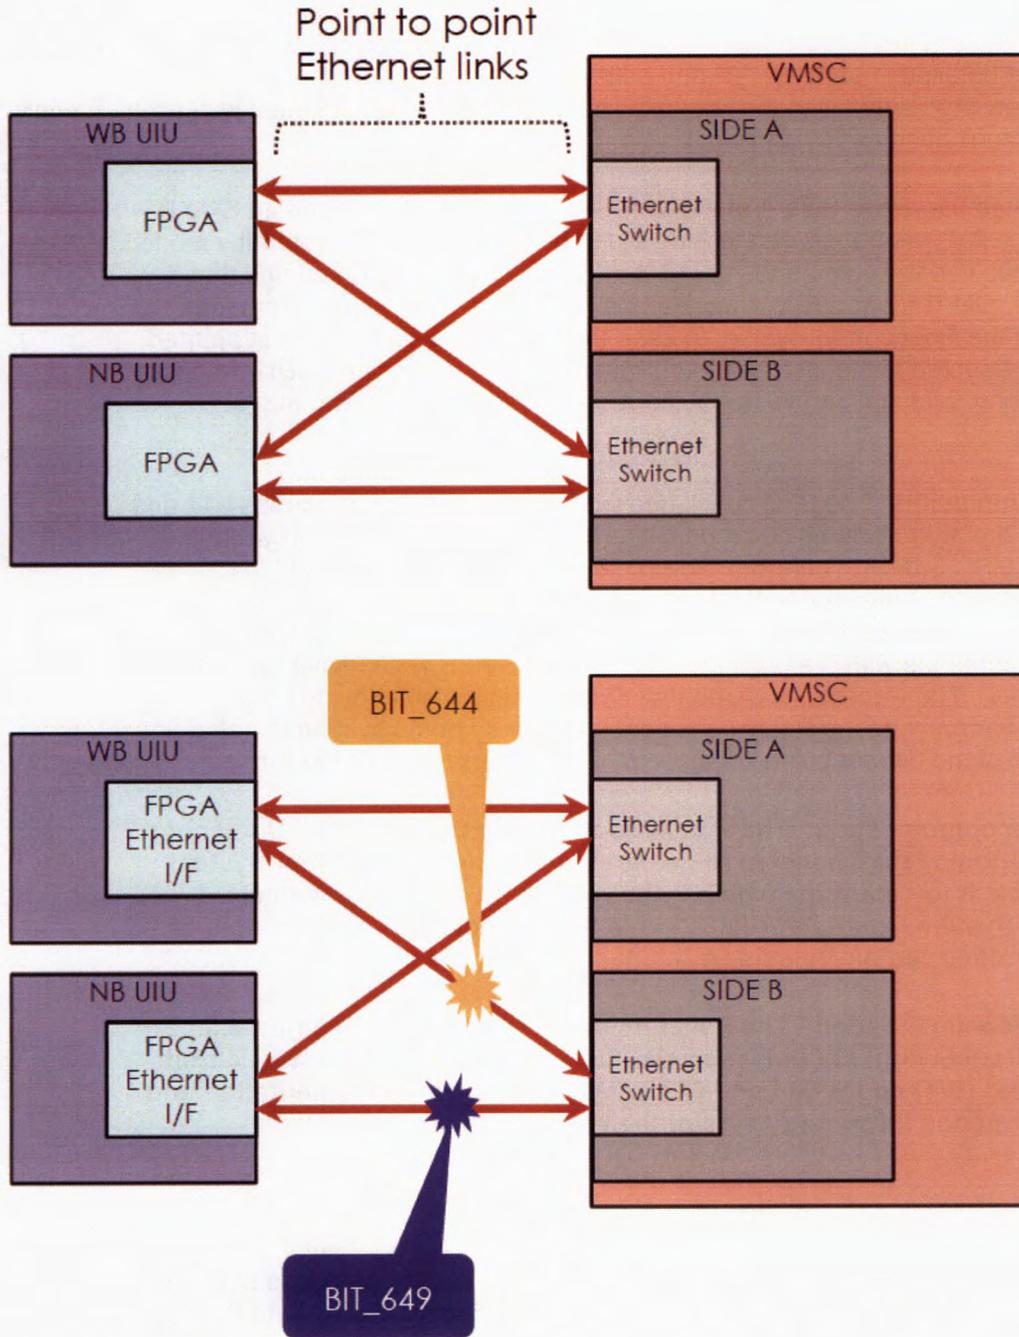
Figure – 15 Diagram of Ethernet connections between VMSC and data-links (UIUs).

1.4.44. Figure 15 is a diagram representing the Ethernet connections in the AV between the VMSC and the data-link interface, the User Inter-face Units (UIUs) . The WB and NB UIUs, housed in the Air Data Terminal, are independent and both use Ethernet Field Programmable Gate Arrays (FPGA) to connect to the independent sides of the VMSC; a total of four connections. The BIT codes 644 and 649 mean no Ethernet connection to the data-link UIU has been established to one side of the VMSC, Side B as illustrated.

1.4.45. **No Data Link Communication.** The data links between the GCS and the VMSC are established as part of the BFS. This is an automated connection and check carried out by test computers in the PATE. Any failure of the data-link is reported as a warning BIT code to the PATE Operator at the conclusion of the test. There are 2 BIT codes that relay this information: BIT_644 (DL_WB_NO_COMM) and BIT_649 (DL_NB_NO_COMM).

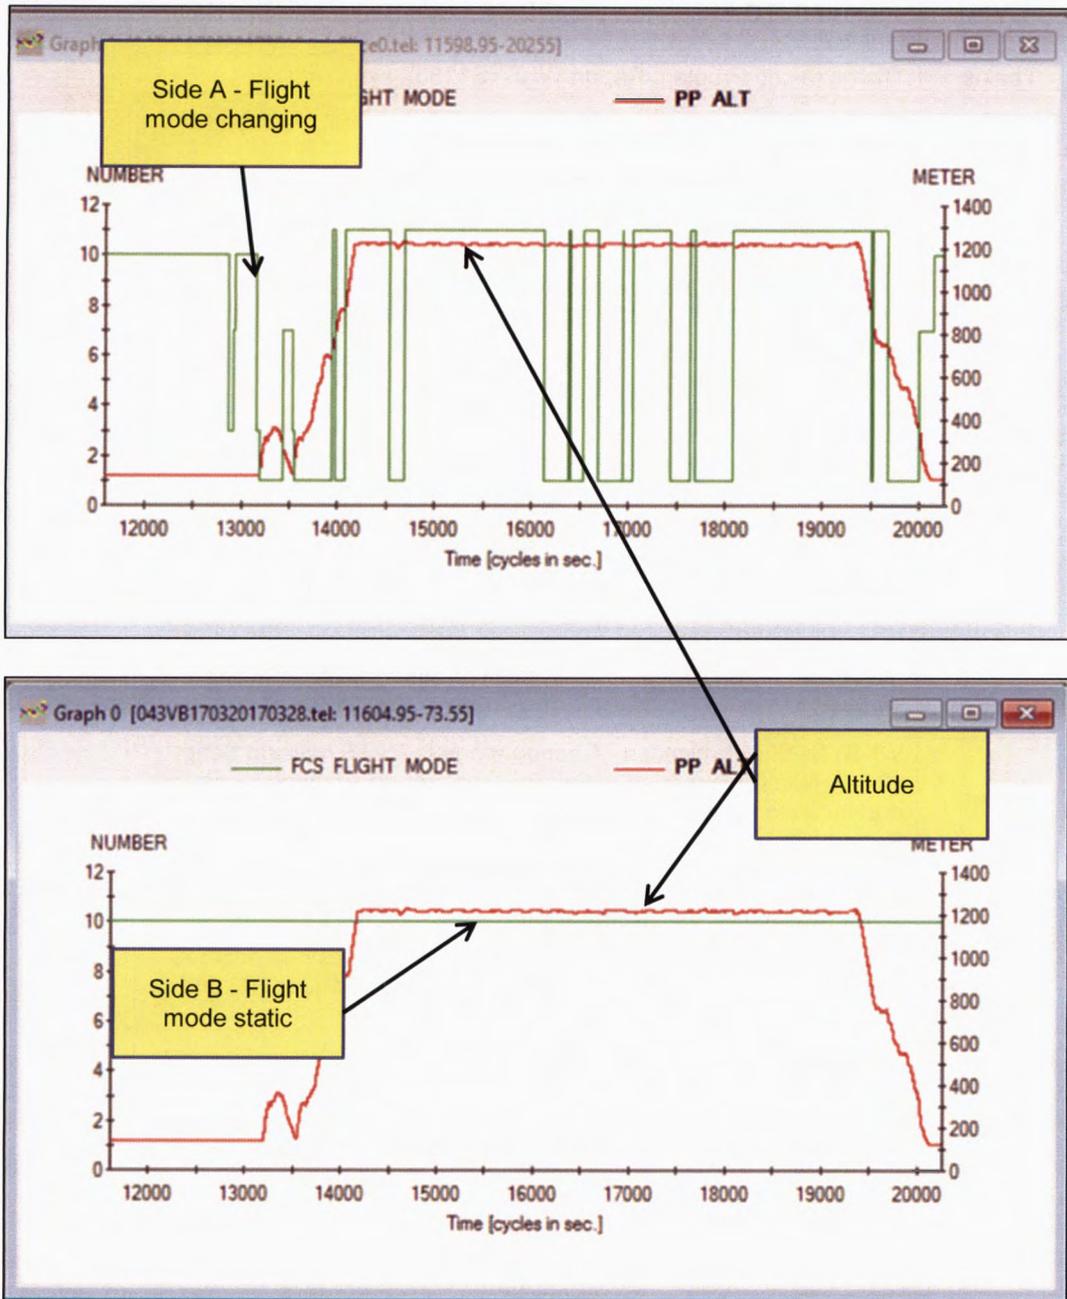
Figure 17 – VMSC Mode and Altitude against time from WK043 Flight 607.

altitude profile recorded is identical, but Side B does not change mode for the duration of the flight.

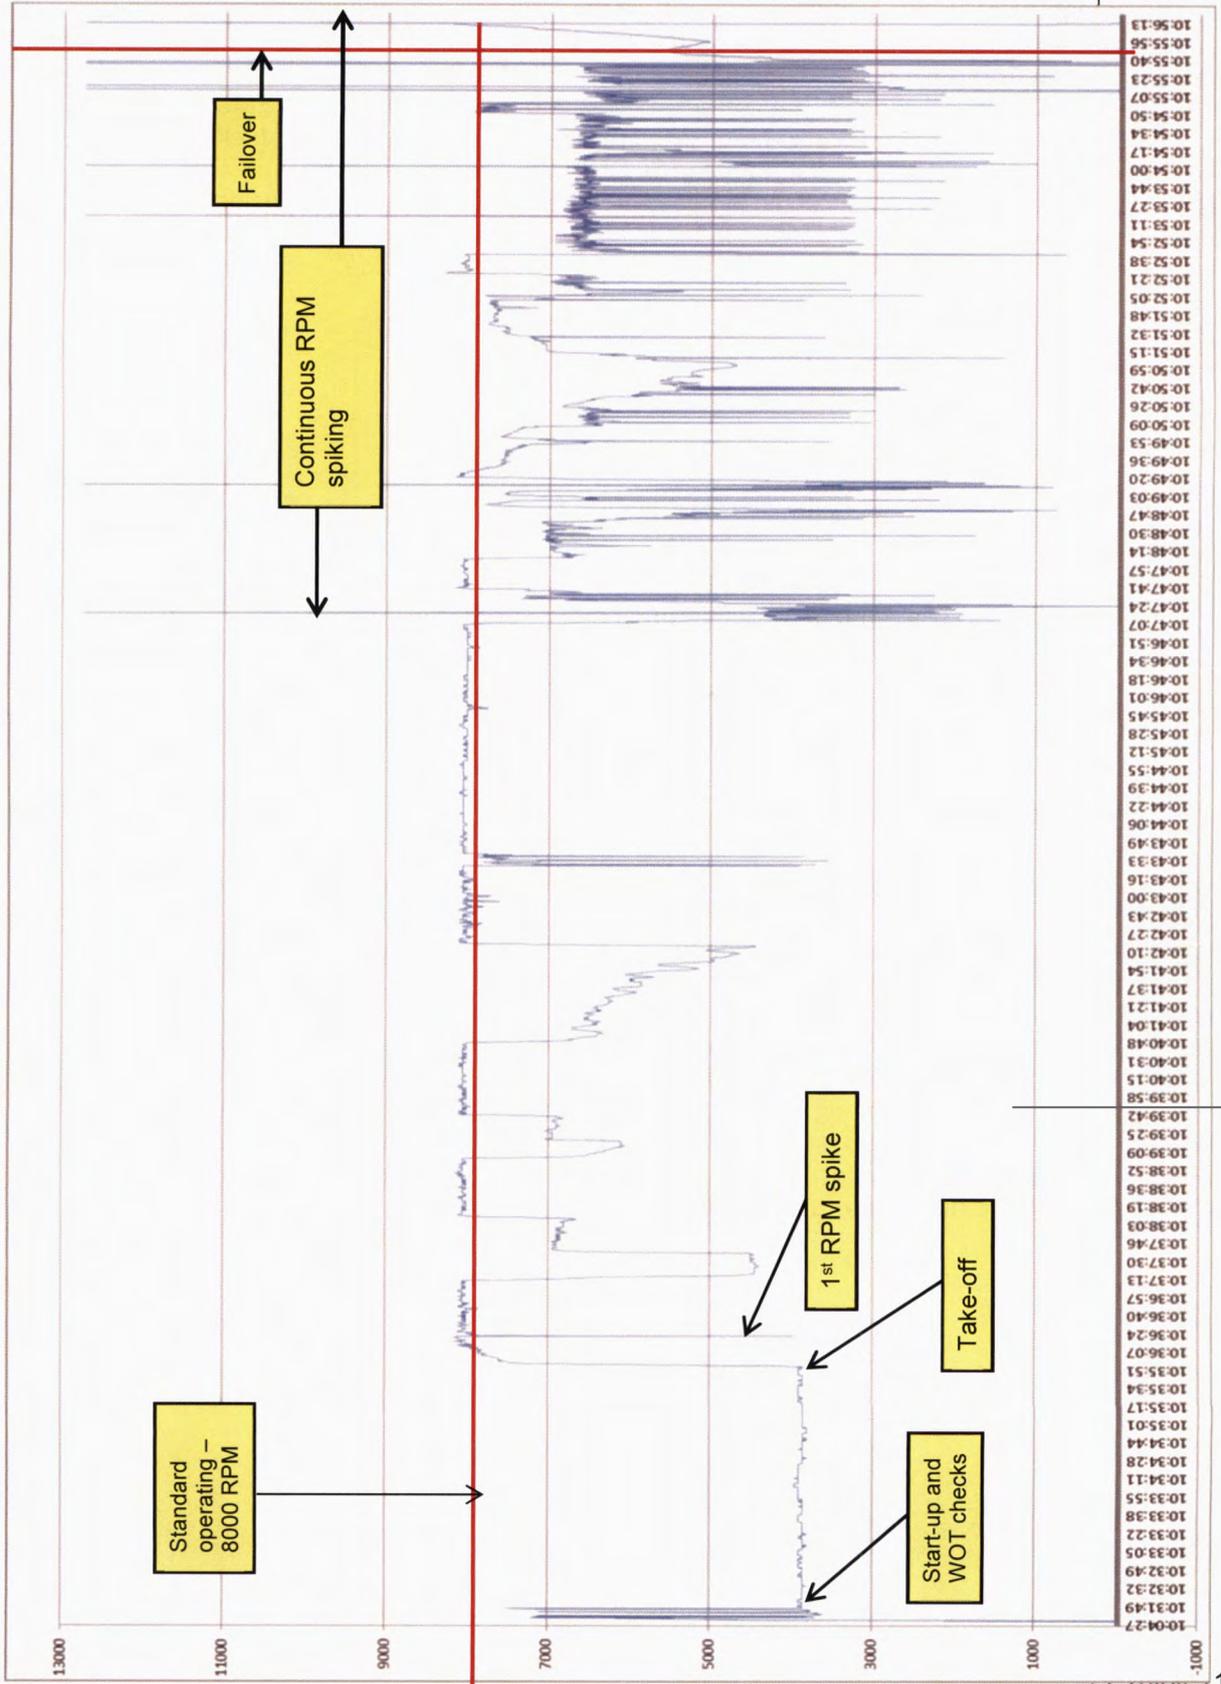
Figure – 19 Full RPM plot from Flight 611 on 24 Mar 2017.

1.4.77. The majority of other WK flights with RPM spikes were limited to only a few spikes per flight. For WK043 the majority of the RPM spikes over its operational history were not sufficient to generate a caution in the GCS to alert the crew; only RPM above 9000 or less than 2000 will generate a caution. As there was no historical indication of a fault, there was no investigation and no trend analysis. The RPM data from 24 Mar 2017 (Figure 19) clearly shows that some of the spikes are high (over 9000) or low (under 2000) enough to cause a WCA, which were subsequently displayed to the GCS crew during Flight 611 and recorded in the flight data. Figure 20 shows the engine from start-up and WOT checks, to idle during towed taxi, to take-off. The first RPM spikes are seen at 1036hrs, shortly after take-off and again at 1043hrs before becoming the main feature of the RPM profile from 1047hrs.

1.4.78. In depth analysis of the flight data from the GCS shows continued abnormal behaviour of the RPM from approximately 12 minutes into the flight. Some of the reported spikes' amplitude and frequency are outside of normal engine operating parameters; it is not physically possible for the engine to go from 0 to over 12000 RPM in milliseconds. It is impossible for the engine or propeller speed to match the reported RPM spikes. The video captured by the EOP does not have the frame rate or resolution to confirm propeller RPM.

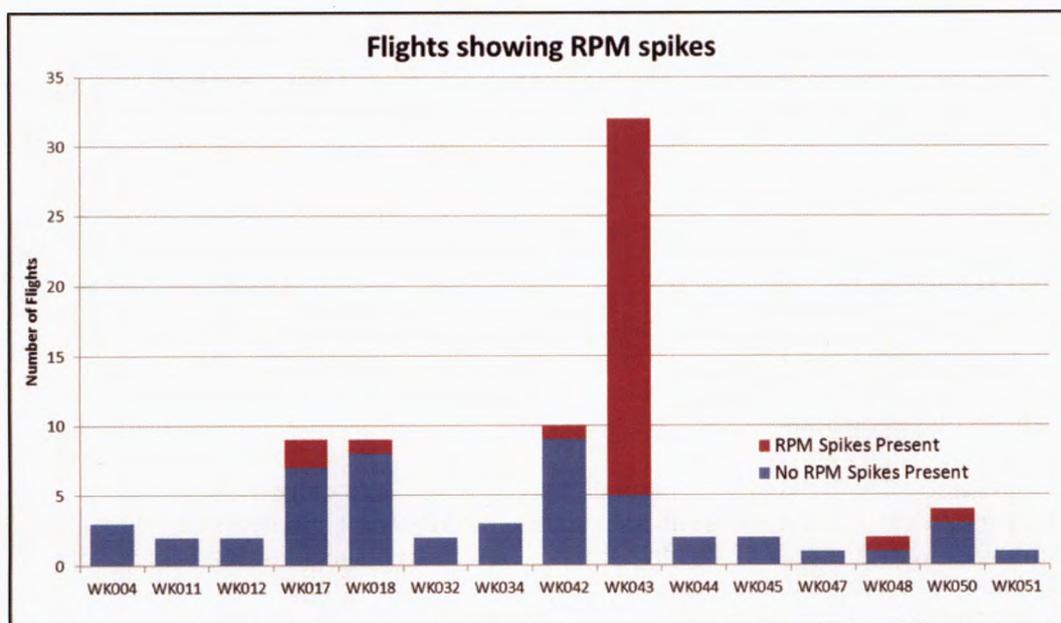
Figure 20 – Comparison of WK043 RPM spiking events with other tail numbers.

1.4.80. The RPM spiking, whilst not unique to WK043 was most prevalent on that airframe. Analysis of data from 83 flights of 15 different AVs provided by Thales shows 6 flights with single spikes on either Side A or Side B. By comparison, WK043 had 27 of 32 flights with RPM spikes recorded (see Figure 20). Half of the single incidents of spiking seen on other airframes were seen 0, 1/2 and 1/3 of the standard RPM range. The remaining 3 flights had momentary spikes of RPM above the maximum value of 8500 RPM.

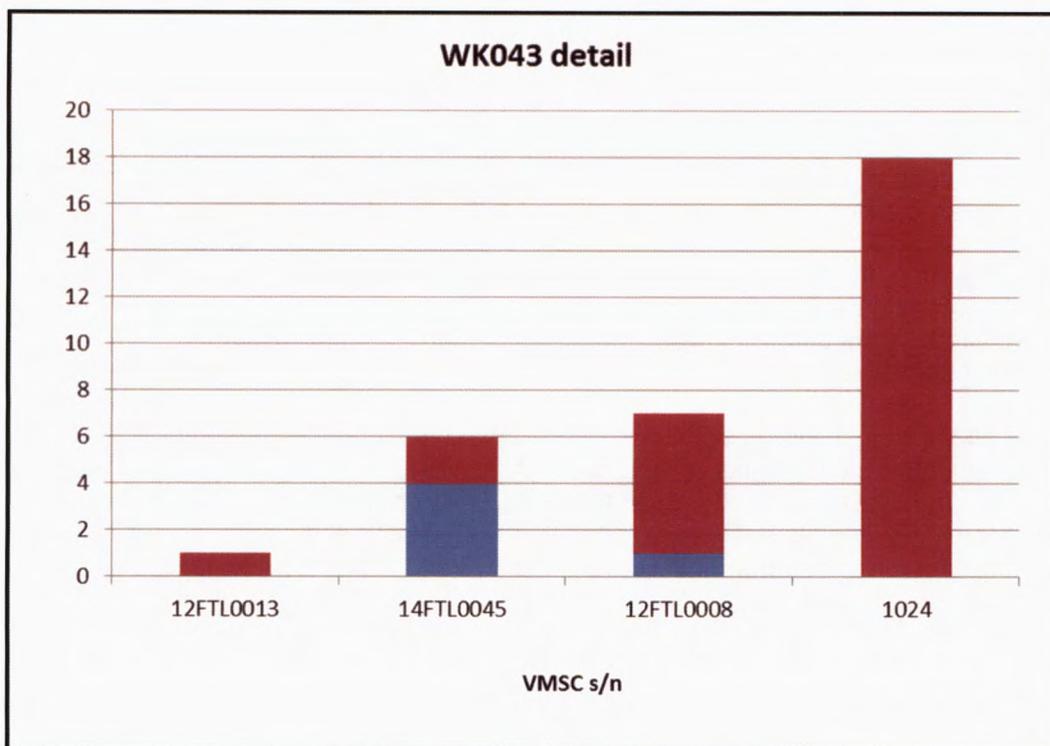
Figure 21 –The VMS computers that had been fitted to WK043 with the number of flights with RPM spiking.

1.4.81. WK043 experienced RPM spiking from its production flight through to the crash on 24 Mar 2017; the magnitude and frequency of spiking worsening over time. The first WK043 RPM spike was recorded on 16 Jun 2016, and the AV continued to have single occurrences of RPM spiking until 1 Nov 2016. There was a short gap in flying, and the next WK043 flight on 24 Jan 2017 showed 3 RPM spikes; the following flight on 31 Jan 2017 had multiple spikes. There was another VMSC change from serial number 12FLT0008 to serial number 1024 on 9 Jan 2017; the same serial

number of the VMSC that was the subject of the original F760 in 2013. However, there was no correlation between a single VMSC or build standard; the RPM spiking was seen on all four VMSCs fitted to WK043 at both OCU and ES2 builds (see Figure 21).

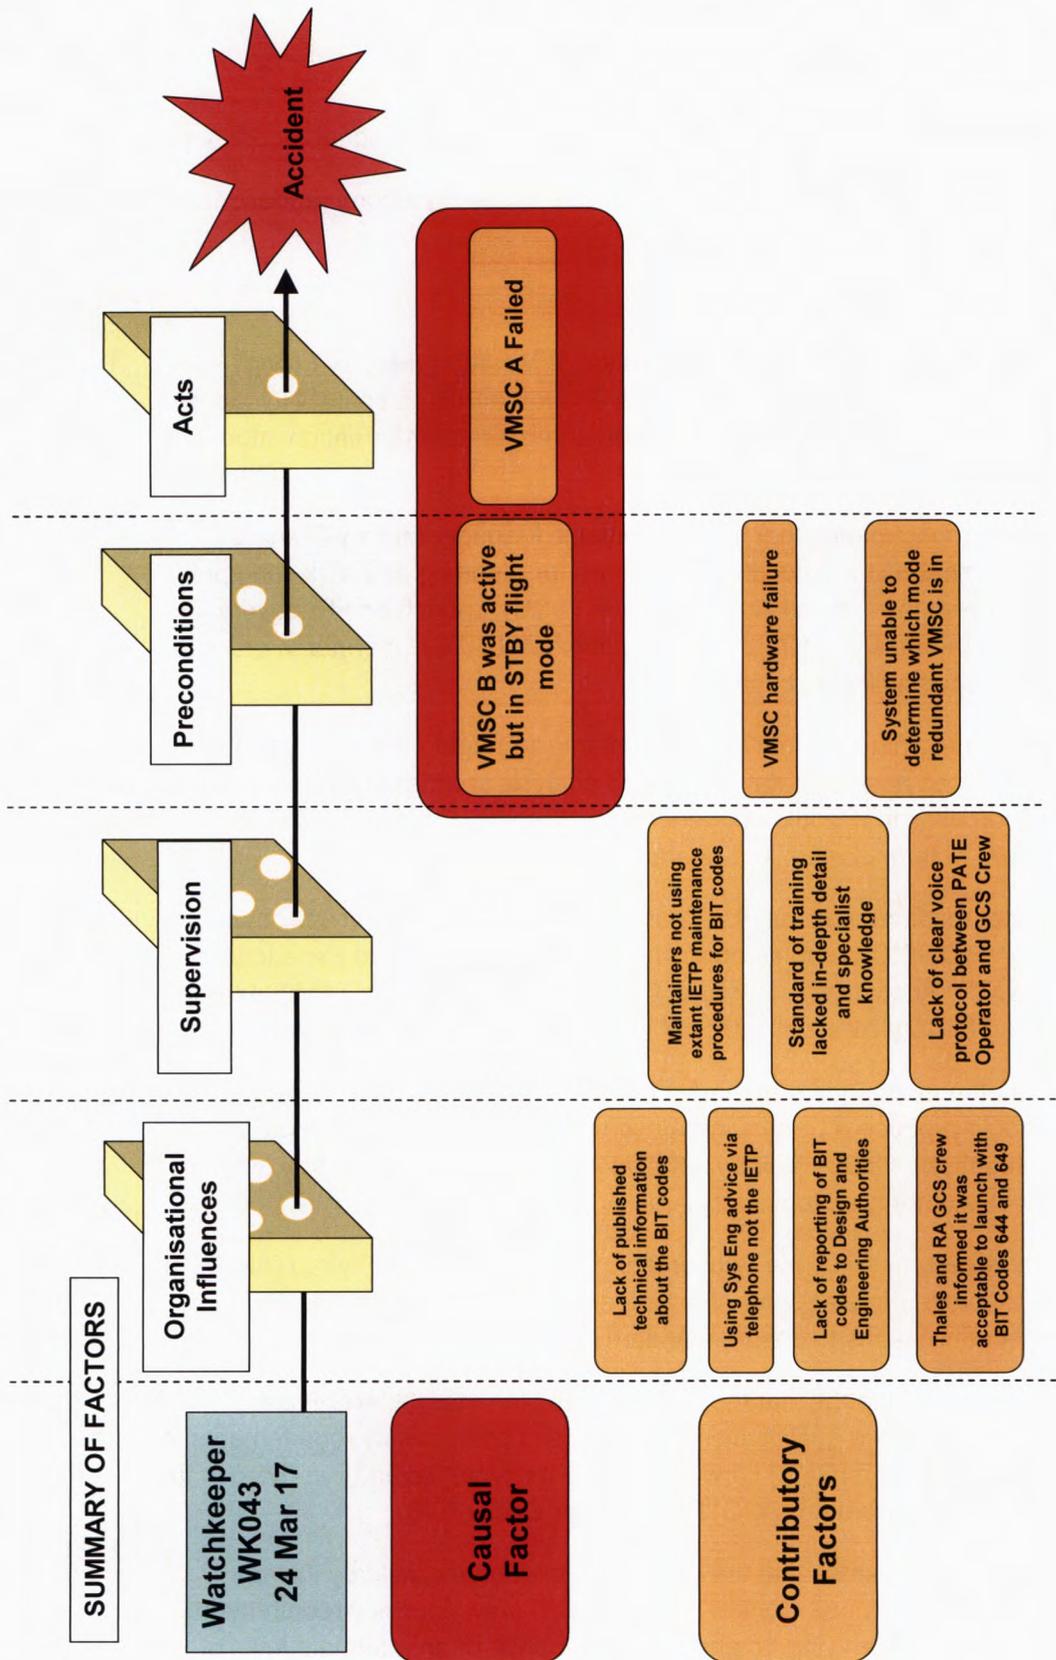
Figure 27 – Swiss Cheese Analysis of WK043 crash.

1.4.277. Reason's Swiss Cheese Analysis is a model used for risk management, based on the principle of layered defences. The layers of Swiss cheese represent the controls, mitigations and defences employed at various levels of an organisation that are in place to prevent accidents. The holes in the slices represent the weaknesses in each layer; when the holes line up there is an opportunity for an accident to occur.

1.4.278. In this instance, the levels are organisation, supervisions, preconditions and acts. The key point is normalising the acceptance of BIT codes with no auditable procedure or reference, which led to the VMSC Side B being in STBY flight mode. Although VMSC Side A failed over, the redundant Side B should have been available to take active control and it was not; this is why the AV crashed.
