Passenger train derailment at Penryn, 28 January 2019

Summary of the accident

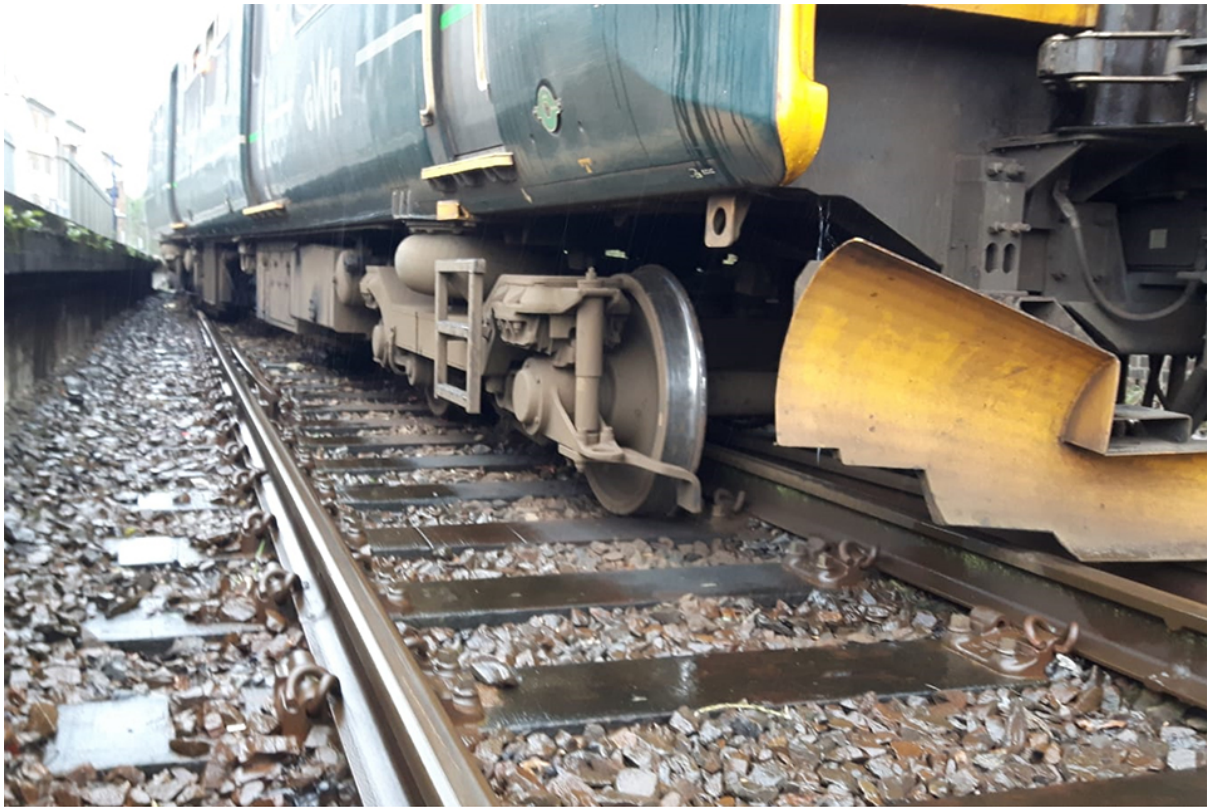
The train driver repeated back the instructions that the signaller had given him, and drove the train towards the station. Points 27 were not in the correct position, and the leading wheels of the train passed either side of the switch rails, leading to immediate derailment (figures 2 and 3).

Figure 2: The derailed train 2T76

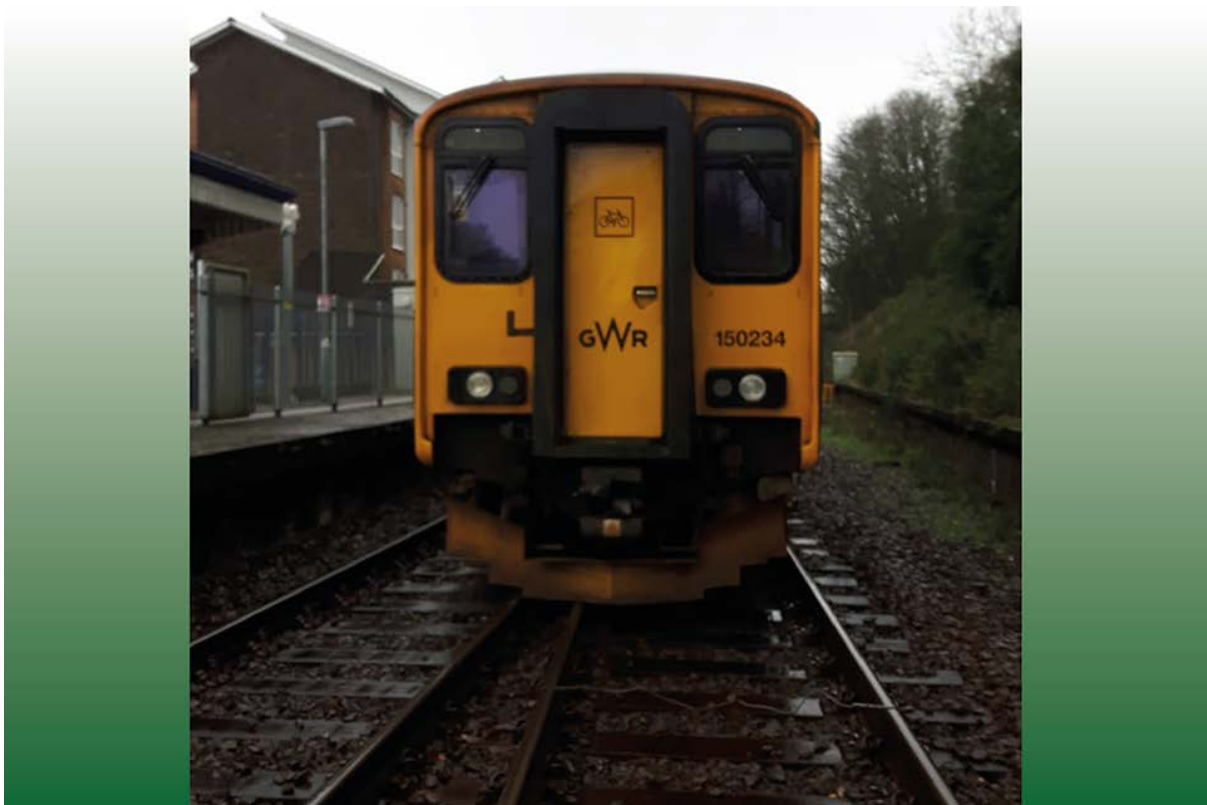
Figure 3: The front of train 2T76 at Penryn station

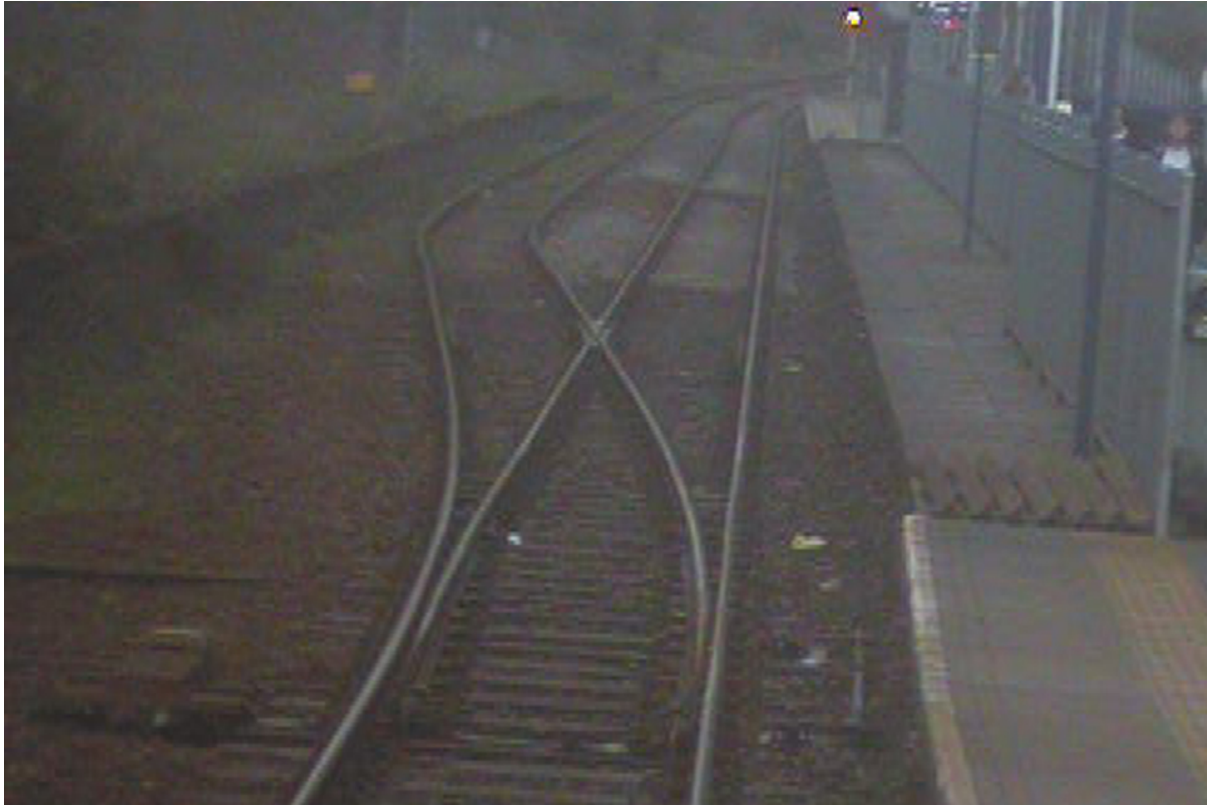
The driver reported that he was concentrating on controlling the speed of the train as it entered the station, and did not observe that the points were not in the correct position (figure 4). Evidence from the forward-facing CCTV fitted to the train shows that the points were lying in mid-position as the train approached.

Figure 4: Forward Facing CCTV image from train 2T76 showing points 27 lying in the mid-position at Penryn station

After the accident, Network Rail carried out a technical investigation. Records from the data logger fitted to the installation showed that points 27 had been operated to the normal position about fifteen minutes before the accident, and were detected in this position, but a few seconds later moved, uncommanded, to an intermediate position, causing detection to be lost. At the time the points moved, the signal lever was normal in the frame.

Signalling failure investigation was also carried out on the electrical cables and the point machine at Penryn. These tests found very low insulation resistance values between some of the cable cores, and in the points motor itself.

Network Rail's technical investigation was still in progress at the time of publication of this digest. Initial indications are that the points machine was energised, and consequently moved the points, when no command was present, although the testers were unable to recreate conditions that may have led to this. The faults that were found were not associated with the indication circuits to Truro signal box.

The point motor and cables were replaced. As a precautionary measure, various relays and contacts at Truro signal box were also replaced, although no faults had been found with them.
