Maritime &  
Coastguard  
Agency

## SS Richard Montgomery Survey Report 2017

Maritime and Coastguard Agency  
January 2019

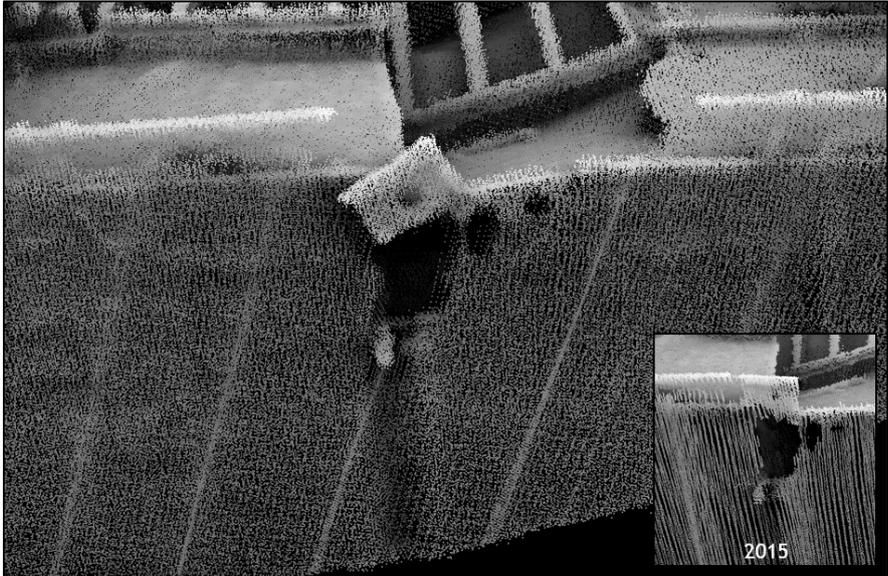
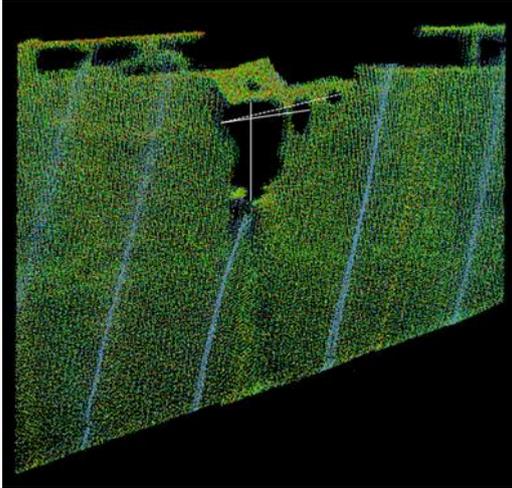
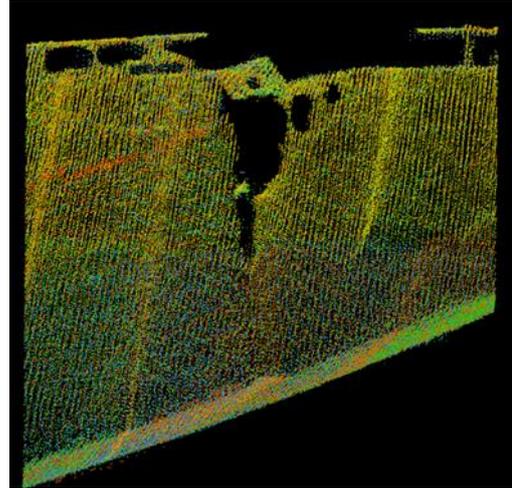
4.2 Key Area 1 – Crack in the hull on the port side of Hold 2

4.2.1 The crack in the hull on the port side of Hold 2 has been evidenced in surveys since at least the 1970s and is likely to have occurred when the vessel went aground in 1944. This crack was well defined in the 2017. Between the 2015 and 2016 surveys the position of the broken section of gunnel over the top of the crack moved and this has created an acoustic shadow around the upper parts of the crack. Added to which, although there are three holes visible in the data, it is not possible to determine whether the soundings are from existing pieces of hull plate or elements of the vessel frame onto which the hull plate, now missing, was originally attached. As a result, the measurements recorded in the 2017 survey suggest that the crack is slightly smaller than was measured in the 2016 but, as outlined above, this is due to acoustic shadows cast by protruding debris rather than actual change.

Fig. 3 – Crack on the port side of hold 2, 2017 data with insert of 2015 data.

Fig. 4 – 2017 data showing the crack at Hold 2

Fig. 5 – 2016 data showing the crack at Hold 2

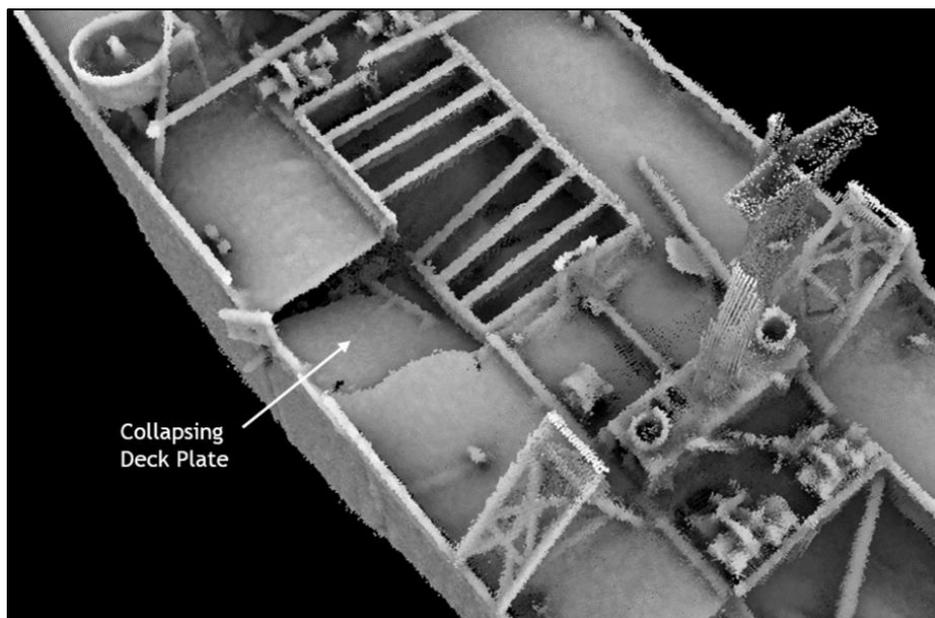
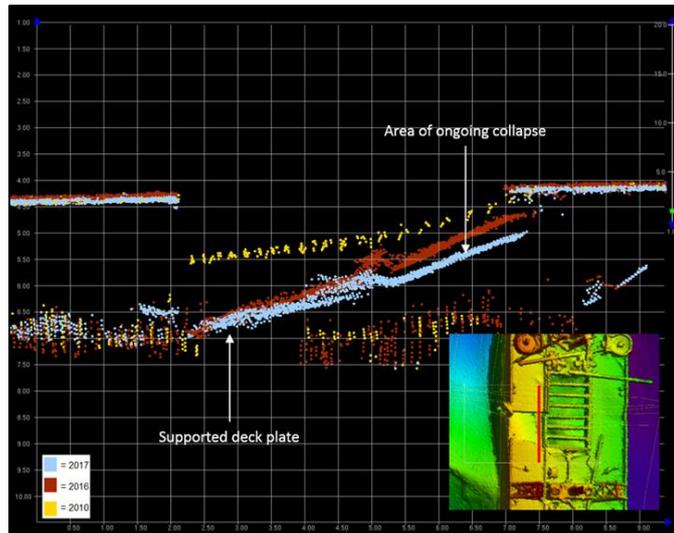
### 4.3 Key Area 2 – Collapse of deck plating at Hold 2

4.3.2 In previous reports the magnitude of collapse has been measured at the leading edge of the deck plate. However, the focus of change in 2017 has shifted to a point that makes this measurement irrelevant. The surface difference indicates that the collapsing region of the deck has subsided by up to 60cm since the 2016 survey. The data suggests that the collapsed section of deck has broken free from the deck to the aft. In previous surveys this has appeared to be distorted but attached. Measurements taken in cross-sections show that the magnitude of collapse between 2016 and 2017 is 40cm at both locations. In addition, the three aft-most Hold 2 hatch cover supports, which are connected to the collapsing section of deck, also show evidence of collapse from 2016.

Fig. 6 – 2017 data, collapsed deck plate at Hold 2

Fig. 7 – Cross section of data showing gradual collapse from 2010

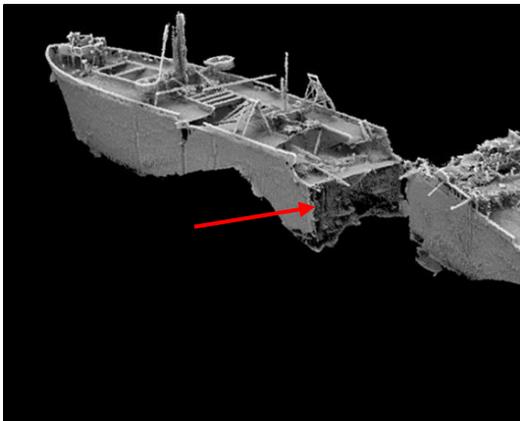
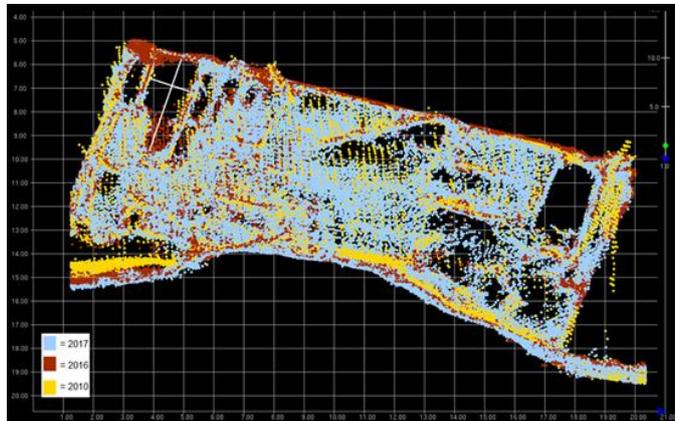
#### 4.4 Key Area 3 – Aperture in the Aft end of the Forward Section

4.4.1 The bulkhead at the aft end of the forward section (at Hold 3) is one of the Key Areas for two reasons. Firstly, the bulkhead is containing the munitions in Hold 3 and, secondly, there are apertures in the bulkhead, one in particular which is identified as one of the Key Areas of focus. It has been well-defined in the 2017 survey data and measurements taken of the aperture and compared with the previous survey and with survey data from 2010 show that there has been no change in the dimensions. Figure 9 below shows the 2017 data (in blue) overlaid with survey data from 2016 (red) and 2010 (yellow).

Fig. 8 bulkhead, aft end of Hold 3

Fig. 9 Surface difference using 2017, 2016 & 2010 data

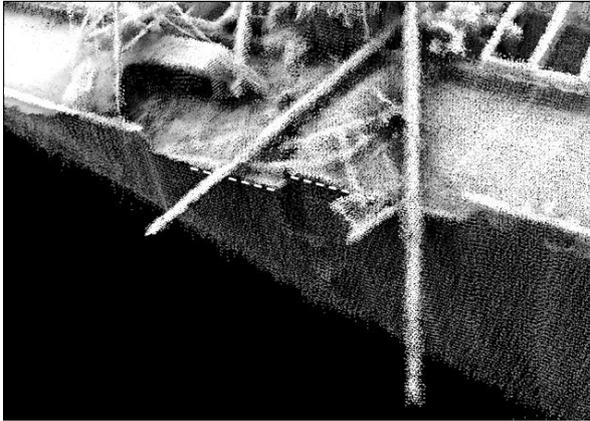
4.5.2 Key Area 5 is a split in the deck and hull plating at this same area of the wreck on the port side. These features are clearly visible in the 2017 dataset and surface difference results highlight the ongoing subsidence of the deck plating. Measurements taken in Caris indicate that up to 0.3m of movement has occurred since the 2016 survey. However, cross-sections taken through the data to examine the split in the hull show that the split reaches from deck level to near the seabed but that it is not demonstrating any change since the 2016 survey.

Fig. 10 Key Area 4 showing discontinuity of deck

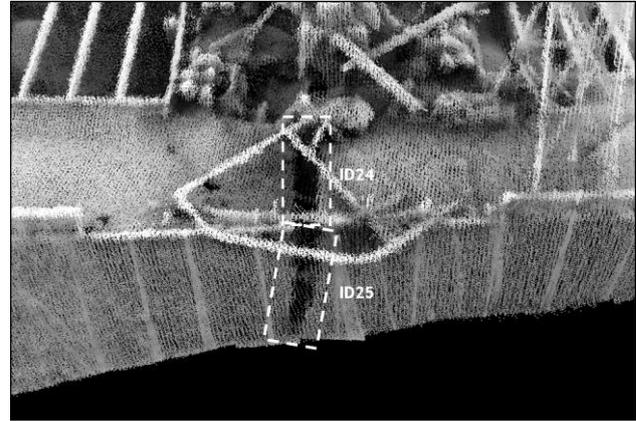
Fig. 11 Key Area 5 showing crack in deck and hull

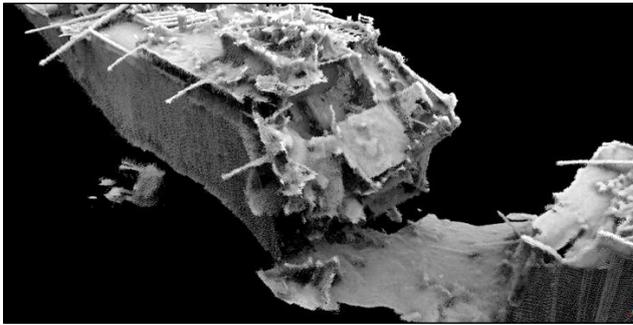
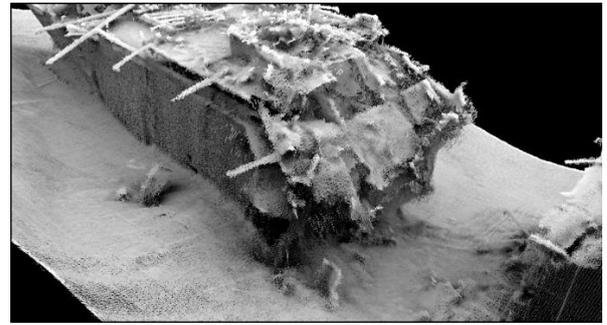
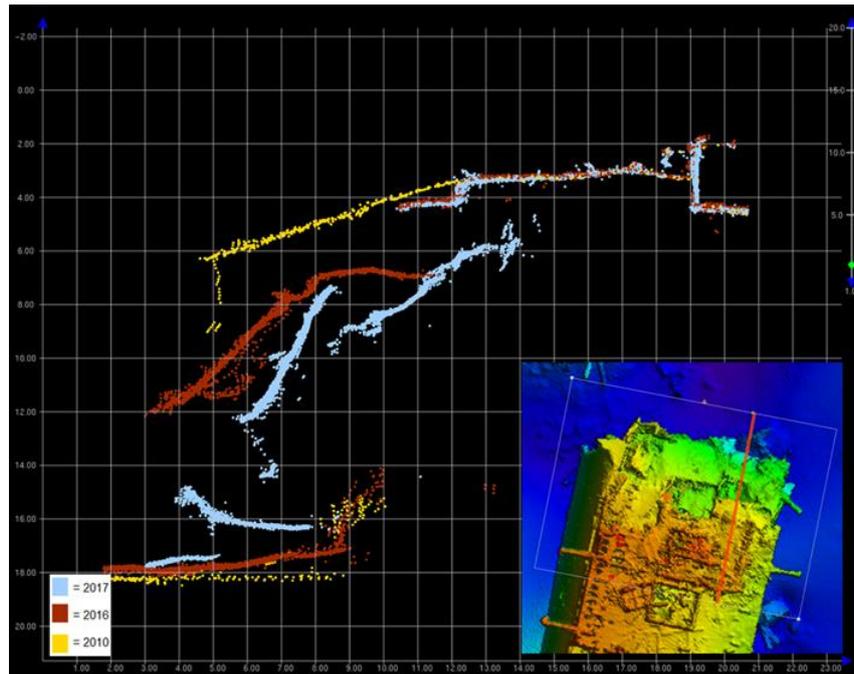
#### 4.6 Key Area 6 – Collapsing Bridge Deck Area

4.6.1 This feature was added to the Key Area list in the 2015 survey report after a collapse of the overhanging bridge deck was noted. The subsidence of the bridge deck has continued since the 2016 survey with the inclined sections tilting more steeply into the gap between the two sections of the wreck. The collapse is most notable towards the starboard side and it appears that part of the leading edge has detached and fallen to the seabed. This is most clearly shown by an increase in size of the mound of debris directly beneath this side of the wreck. Inspection of the point cloud data shows that there are changes to the extent of the inclined section of wreck.

4.6.2 The changes and deterioration of the remains of the ship's superstructure in this area of the wreck include the region on the starboard side of the boiler room casing which has collapsed by approximately 1.5m at the aft end and has become detached and dropped to the seabed (6m) at the forward edge. Although the greatest changes are focussed on the starboard side, there is also evidence of collapse along the full width of the overhanging bridge deck. Cross-sections taken through the data at this part of the wreck shows subsidence across the area of between 20cm to 30cm. The cross-sections and surface difference analysis show that the wreck aft of the boiler room casing has remained stable with the above noted changes occurring in the poorly supported/overhanging structures.

Fig. 12 Collapsing superstructure 2017

Fig. 13 Collapsing superstructure 2016

Fig. 14 Shows a cross-section through the combined 2017, 2016 and 2010 datasets demonstrating the largest area of collapse over this seven-year period.

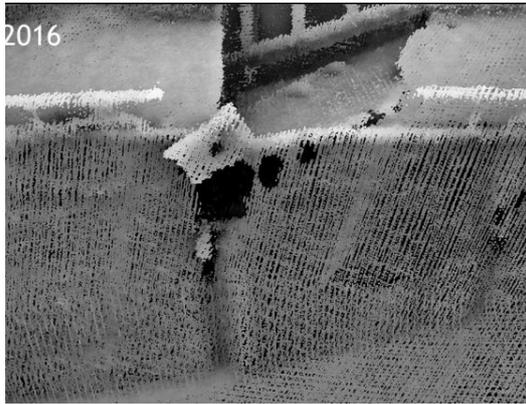
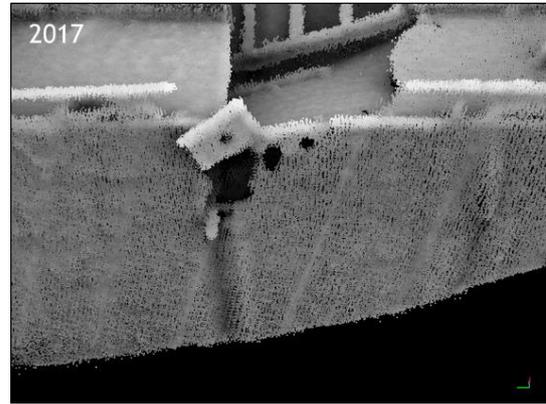
The displaced section of gunnel on the port side of Hold 2 has tilted slightly, the maximum amount of change being c.15cm. It is possible that this is a small positional misalignment of the data rather than an actual change.

Fig. 15 Gunnel at port side Hold 2, 2016

Fig. 16 Gunnel at port side Hold 2, 2017

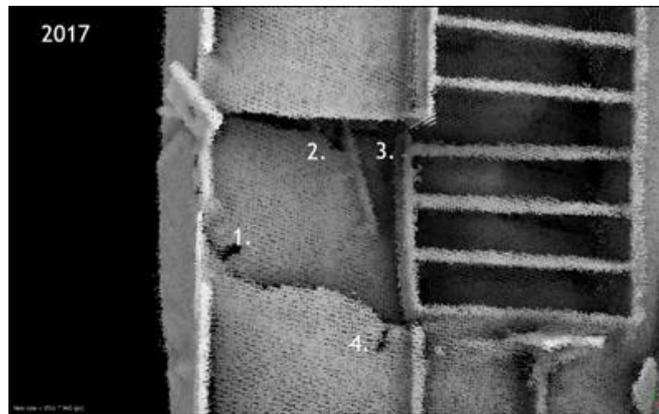
#### 4.7.3 Holes in the Deck Plating, Port Side, Hold 2 – ID13

These four holes are in the collapsed deck plating at ID08. One hole is now so deep in the hold space that it could not be seen in the data. Of the other three holes, one shows some expansion since 2016, c.20cm.

Fig.17 ID13, holes in deck plating at Hold 2

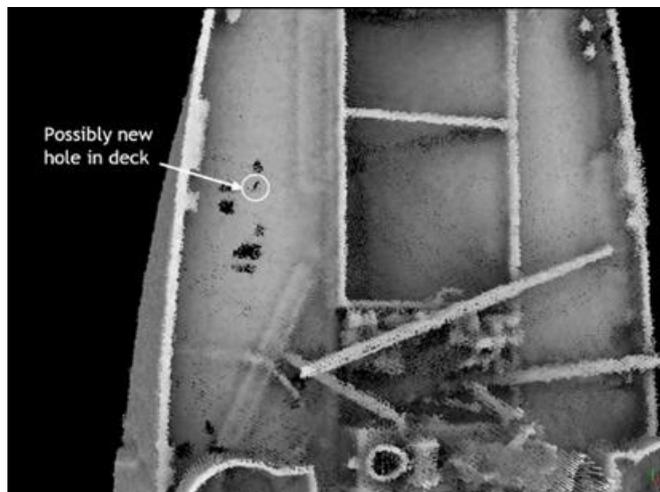
#### 4.7.4 Holes in the Deck Plating, Port Side, Hold 1 – ID14

The 2017 data was compared to previous survey datasets and the results of this showed that a small hole towards the northern end of this cluster of holes may have opened up since the last survey.

Fig. 18 ID14, holes in deck, port side, Hold 1

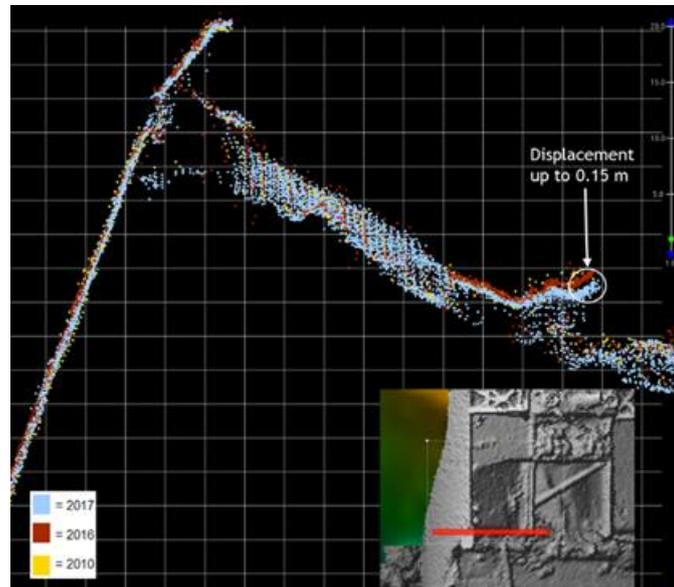
#### 4.7.5 Collapse of Deck and Hatch Coaming, Port Side, Hold 3 – ID15

Both Surface difference analysis and cross-sections through the data were used to assess this area of the wreck. The results of this suggest that up to 15cm of subsidence has occurred since 2016. The image below shows a cross-section through the data from 2017 (blue), 2016 (red) and 2010 (yellow).

Fig. 19 Cross-section through three datasets on the port side of Hold 3

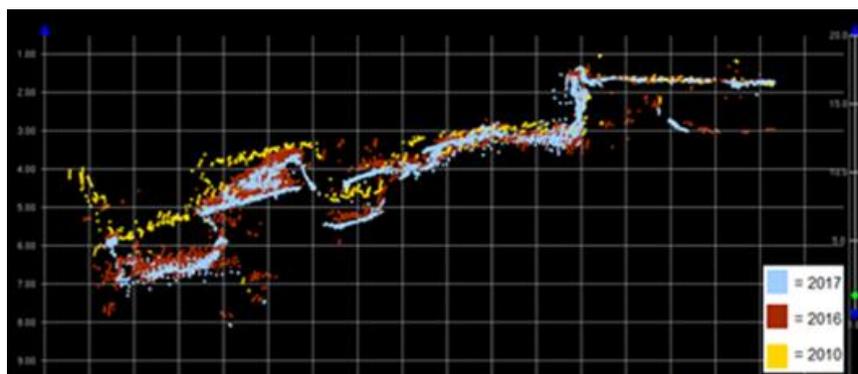
#### 4.7.6 Collapsed Boat Deck, Port Side, Aft Section – ID28

This is part of the central superstructure along with the bridge deck (Key Area 6) and is a complex area of features and structures. Surface difference analysis at this area of the wreck shows an overall trend of subsidence with some localised uplift resulting from horizontal translocations of smaller features. Cross-sections through the data show the degree of subsidence is small, with measurements indicating up to 20cm of collapse. The image below shows a cross-section through data from 2017, 2016 and 2010 which demonstrates this gradual subsidence.

Fig. 20 Collapsed Boat Deck, showing cross-section through three datasets.

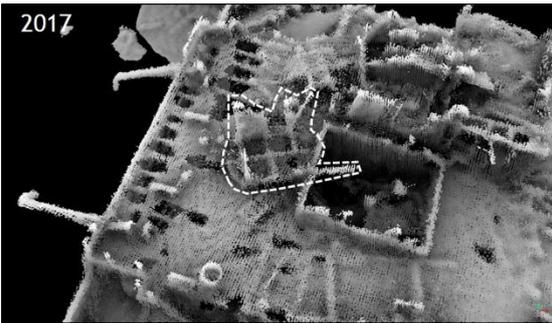
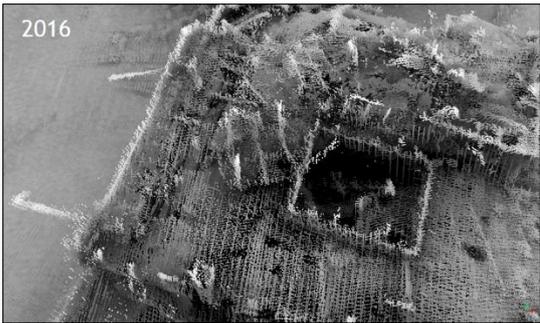
The SSRM was well armed, with bow and stern guns and a number of 20mm guns on circular platforms (gun tubs) along the length of the hull on both the port and starboard side. ID57 is a gun tub on the port side of the superstructure/bridge deck area. This feature has remained generally stable, but the easternmost leg has fallen from its 2016 position and can now be seen lying at a more acute angle across the deck area.

Fig. 21 Gun tub on port side of central superstructure - 2017

Fig. 22 Gun tub on port side of central superstructure - 2016

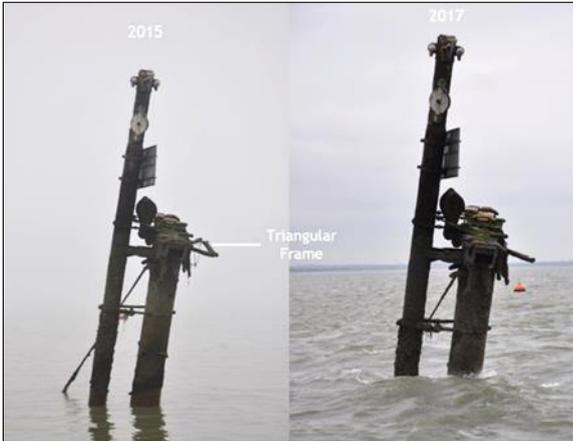
#### 4.7.10 Fore Mast and Mast House, Forward Section, Aft of Hold 1 – ID60

Whilst the main structure of the fore mast and mast house has remained stable since the previous survey, it was noticed in the laser and photographic element of the survey that a small piece of triangular metal frame that protruded from the mast has fallen away since the 2016 survey.

Fig. 23 Fore mast, showing small section of missing frame

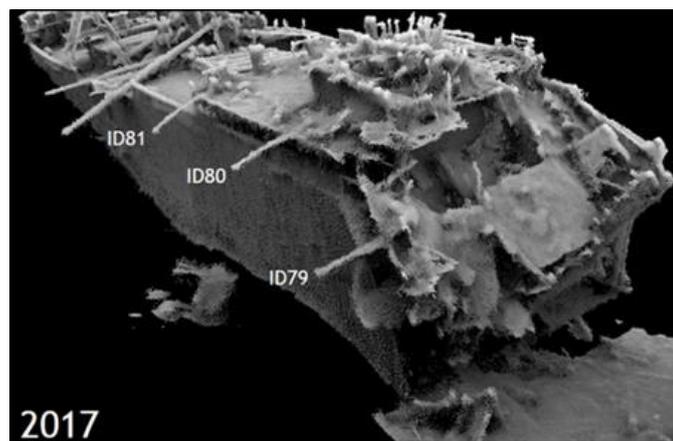
The 2017 dataset shows that the lifeboat davit at ID79 on the starboard side of the aft section of the wreck has subsided by 0.1m since the 2016 survey. Measurements of the depth of the distal end of the davit show that, in the years between the 2010 and 2017 surveys, it has moved from a depth of 7.5m in 2010 to 10.4m.

Fig. 24 Subsidence of ID79.

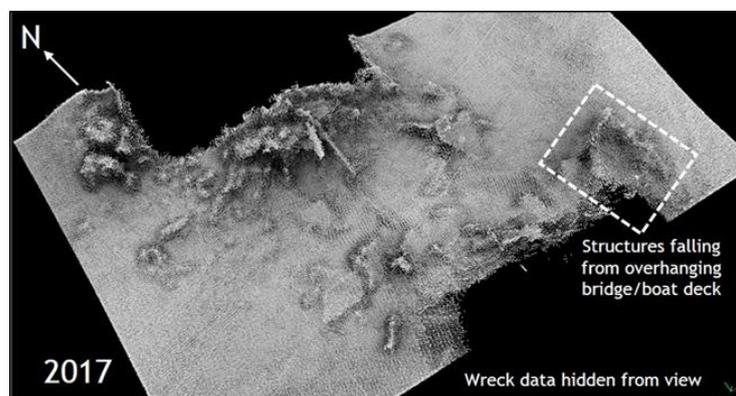
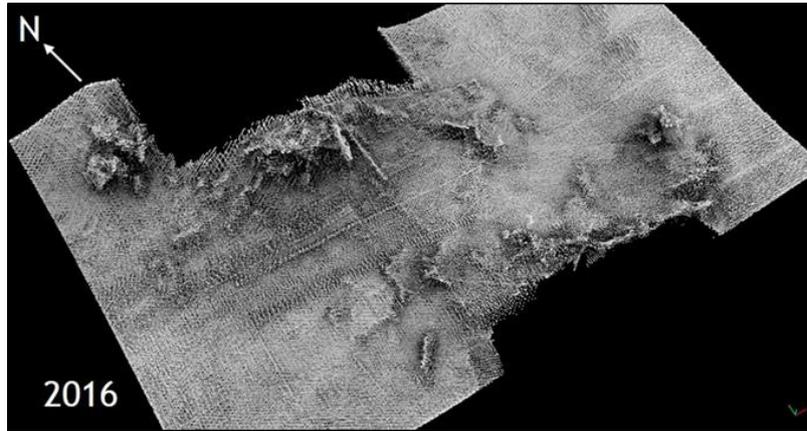
#### 4.7.13 Debris on the Seabed Between the Two Sections of the Wreck – ID85

When it sank in 1944, the SSRM broke into two sections. This created a debris field between the two sections of the wreck, in particular, at the foot of the bulkhead at the aft end of Hold 3. The debris has generally remained stable since 2016. The main exception to this is at the foot of the stern section of the wreck on the starboard side below the overhanging Bridge/Boat deck area. Here it can be seen in the data that sections of debris have fallen to the seabed at this location creating a new pile of debris 3.0m higher than in 2016. Another exception is the eastern linear feature extending from the midships region of the forward section of the wreck which appears to have tilted down by up to 0.15m at the tip since 2016.

Fig. 25 Debris field from the 2017 survey data

Fig. 26 Debris field from the 2016 survey data

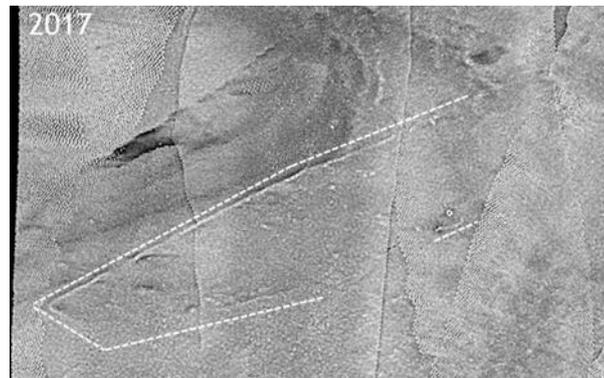
#### 4.7.14 Towing Cable – ID89

ID89 is a feature on the seabed within the survey area. In the 2017 data it has been identified as possibly a towing cable related to the salvage operation. It is a curving linear feature which shows in the 2017 data to have a definite angular structure, suggesting that it is not just part of the sedimentary structure but a piece of debris.

Fig. 27 ID89, possibly a towing cable

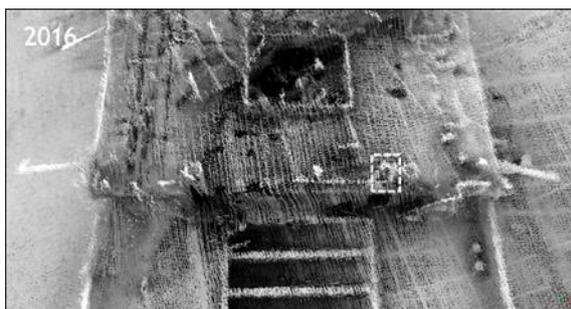
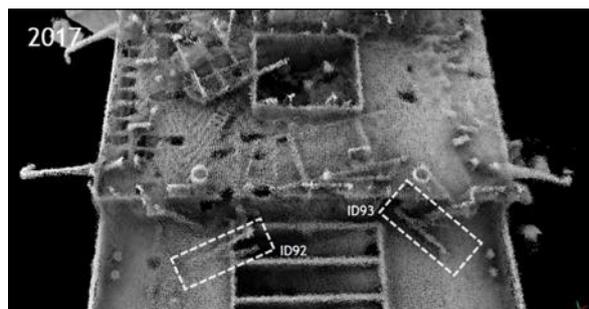
#### 4.7.15 Starboard Lighting Tower, Aft of Central Superstructure – ID93

Analysis of the surface difference results from the 2017 survey data shows that there has been a structural change on the starboard side of the wreck at the aft end of the central superstructure. Close inspection of the 2016 and 2017 data shows that the structure identified as the starboard lighting tower has collapsed towards the south and now lies over the Hold 4 deck at the foot of the stairs to the boat deck level. Improvements in the density of soundings over the aft end of the central superstructure area reveals some of the fine detail of the complex structures strewn across the deck.

Fig. 28 Starboard lighting tower in 2016 data

Fig. 29 Starboard lighting tower in 2017 data

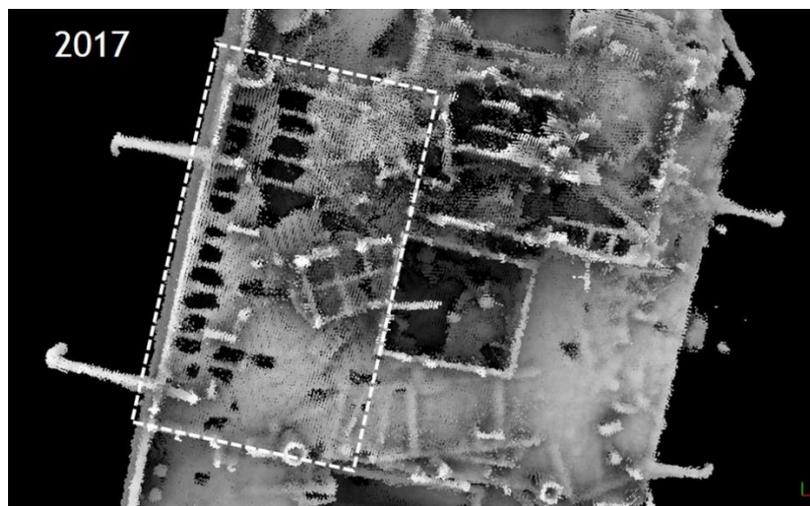
4.10.3 Coverage over the boat deck is improved in the 2017 dataset and this has led to better definition of the holes in the boat deck and the structures between them. This shows the port side boat deck plate is perforated with an abundance of holes. In parts, the collapsed deck plate is visible within the wreck. Switching between overlaid point clouds shows that the 2017 data defines pre-existing holes in the deck that are also visible in the 2010 survey, suggesting that there has been no change since 2010, but that the holes are much clearer to see in the higher definition of the 2017 dataset.

Fig. 32 Holes in the boat deck, aft section of the wreck

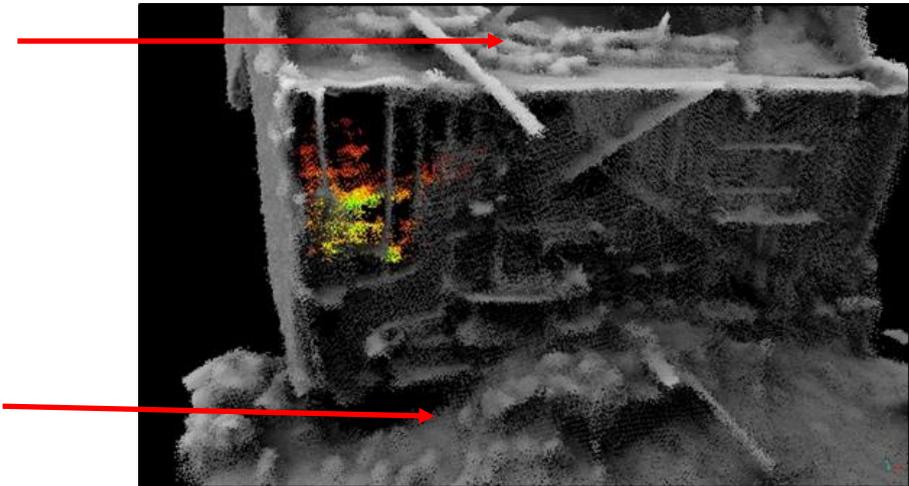
4.11.3 Cargo material is also visible through the hole in the bulkhead at the aft end of Hold 3. This can be seen in the image below. Cross-sections taken in Caris to observe the hold contents show that the comparison of the shoalest data is not possible with the 2016 dataset due to a lack of density at similar shoal depths. Although generally sparse, the 2010 dataset shows soundings at the same levels as the 2017 dataset and this suggests that there has been little or no change in the positions of the contents of this hold since at least 2010.

Fig. 34 Yellow/red data showing cargo inside of Hold 3 and arrows indicating debris in the remains of the 'tween deck and debris pile.

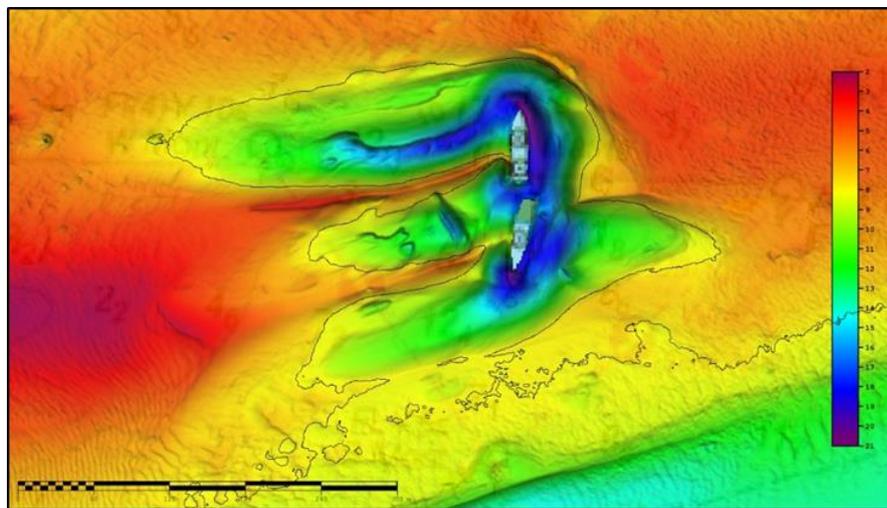
5.7.3 The long, northwestern scour has increased in depth along its southern slope by between -0.2m and -0.6m. This relates to a slight southward shift in the position of the apex of the ridge separating the northern and central scours on the western side of the wreck. This shift is small; between 1.0m and 2.0m. The deep channel at the base of this scour shows some larger changes in depth caused by repositioning of the steep northern wall and a small expansion of the "bowl" at the western end of this channel.

5.7.4 The central scour on the western side of the wreck shows the largest differences from the 2016 survey. At the eastern end of this scour is a depression with a pronounced groove on its eastern edge. The development of this groove feature is shown as a region of deposition (maximum +1.0m) and region of erosion (maximum -3.1m). On the western edge of this depression are two bowls and both of these show evidence of expansion.

Fig. 41 Overview of the scoured area around the wreck, the black line is the 8m contour which is used here to highlight the form of the scours
