Rail Accident Investigation Branch

Rail Accident Report

Near miss between a train and a track worker at Peterborough 20 July 2018

Report 04/2019
June 2019

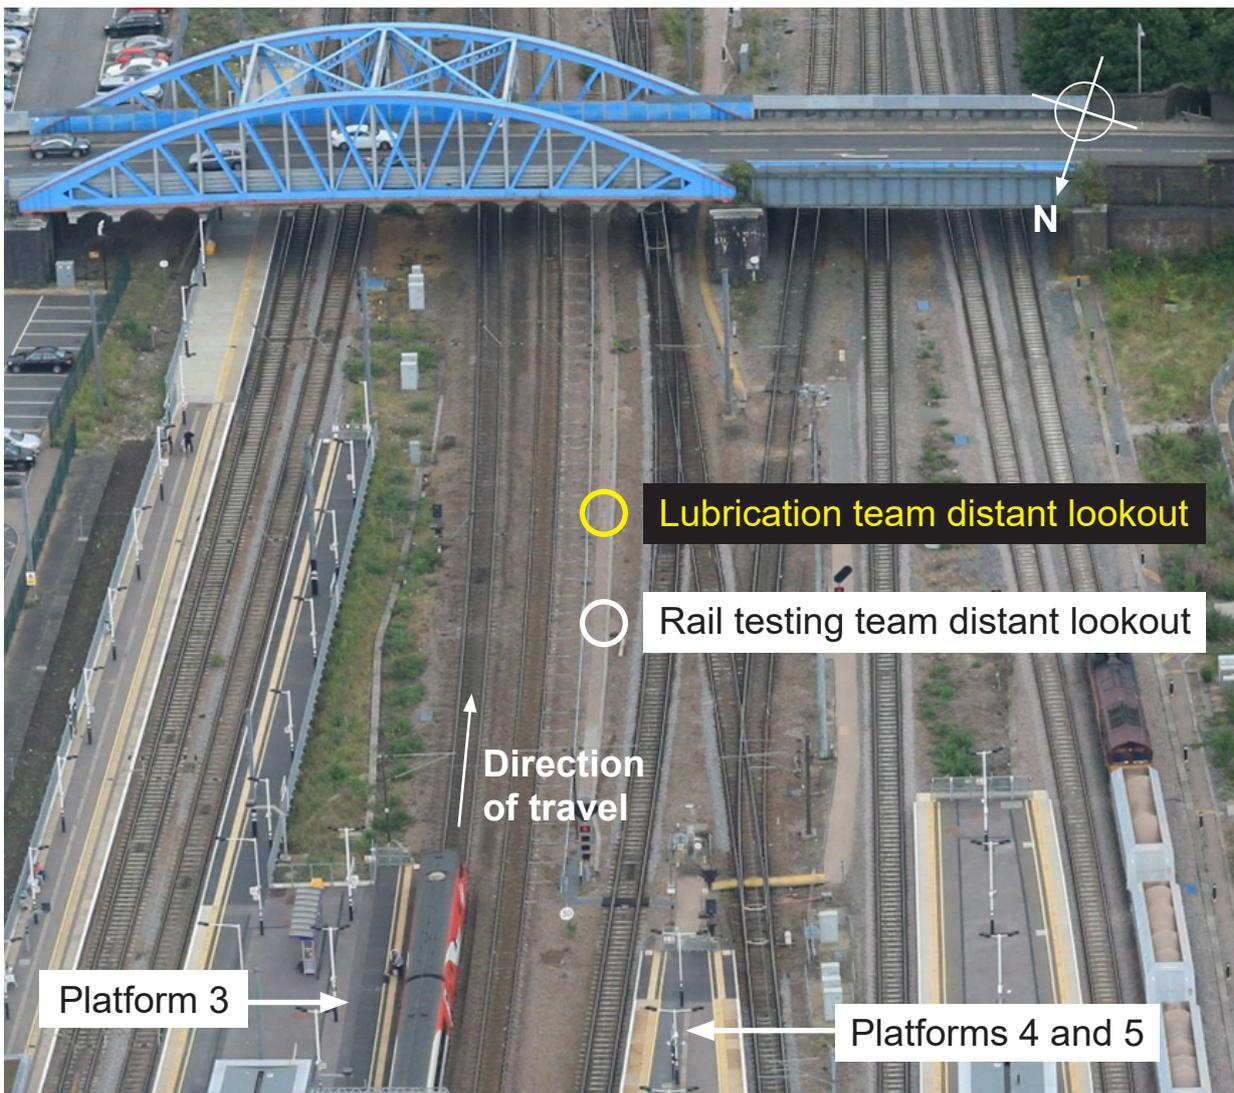
Figure 6: The locations of the distant lookouts

- 26 When track worker B arrived at the end of platforms 4 and 5, he found another distant lookout was already standing where he planned to look out from. This was a distant lookout for a rail testing team, though he was not looking out at the time as his team had just moved to work to the north of the station. Track worker B positioned himself about 10 metres to the south of the other distant lookout (figure 6).

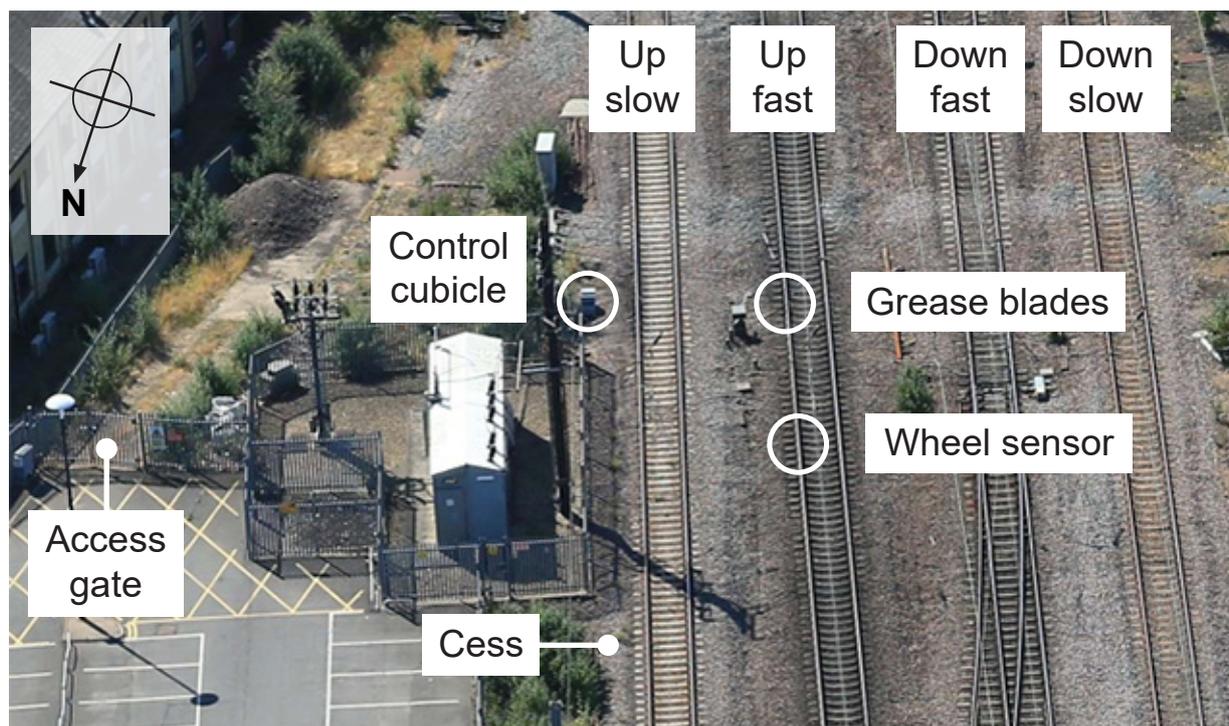
Figure 7: Location of the lubrication equipment to be inspected

- 27 In the meantime, the team leader and track worker A had driven through the station car park to a vehicle access point at the south end. After going through the gate, the team leader gave a further COSS briefing to track worker A who was going to be the site lookout for the inspection at this location. The planned work was to carry out a routine inspection on the lubrication equipment located on both the up slow and up fast lines (figure 7).

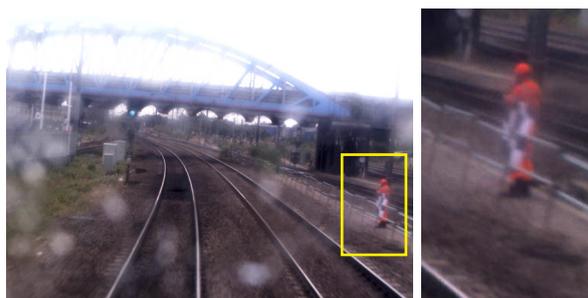
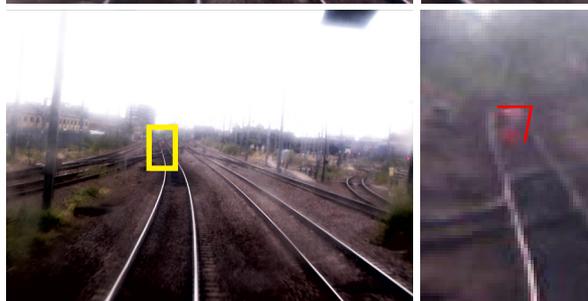
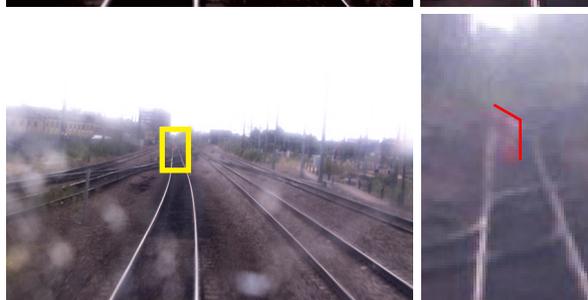
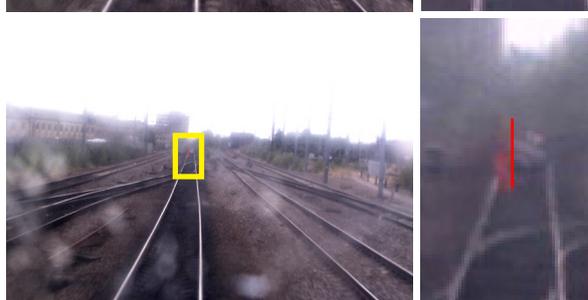
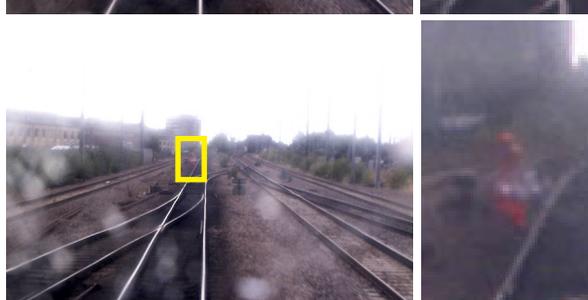
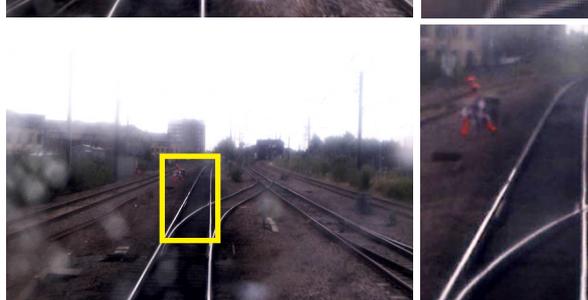
Figure 8: The sequence of events

Event: Driver started sounding train horn when she saw track worker A ahead on the up fast line. The distant lookout for the track maintenance team was standing to the right.

Event: As train passed under bridge, track worker A was bent over on the up fast line.

Event: Driver applied train's brakes just as track worker A started to straighten up.

Event: Track worker A started to move and wave his lookout flag.

Event: Driver stopped sounding train horn and track worker A stepped out of the up fast line.

Event: Track worker A has now moved more than 2 metres from the up fast line.

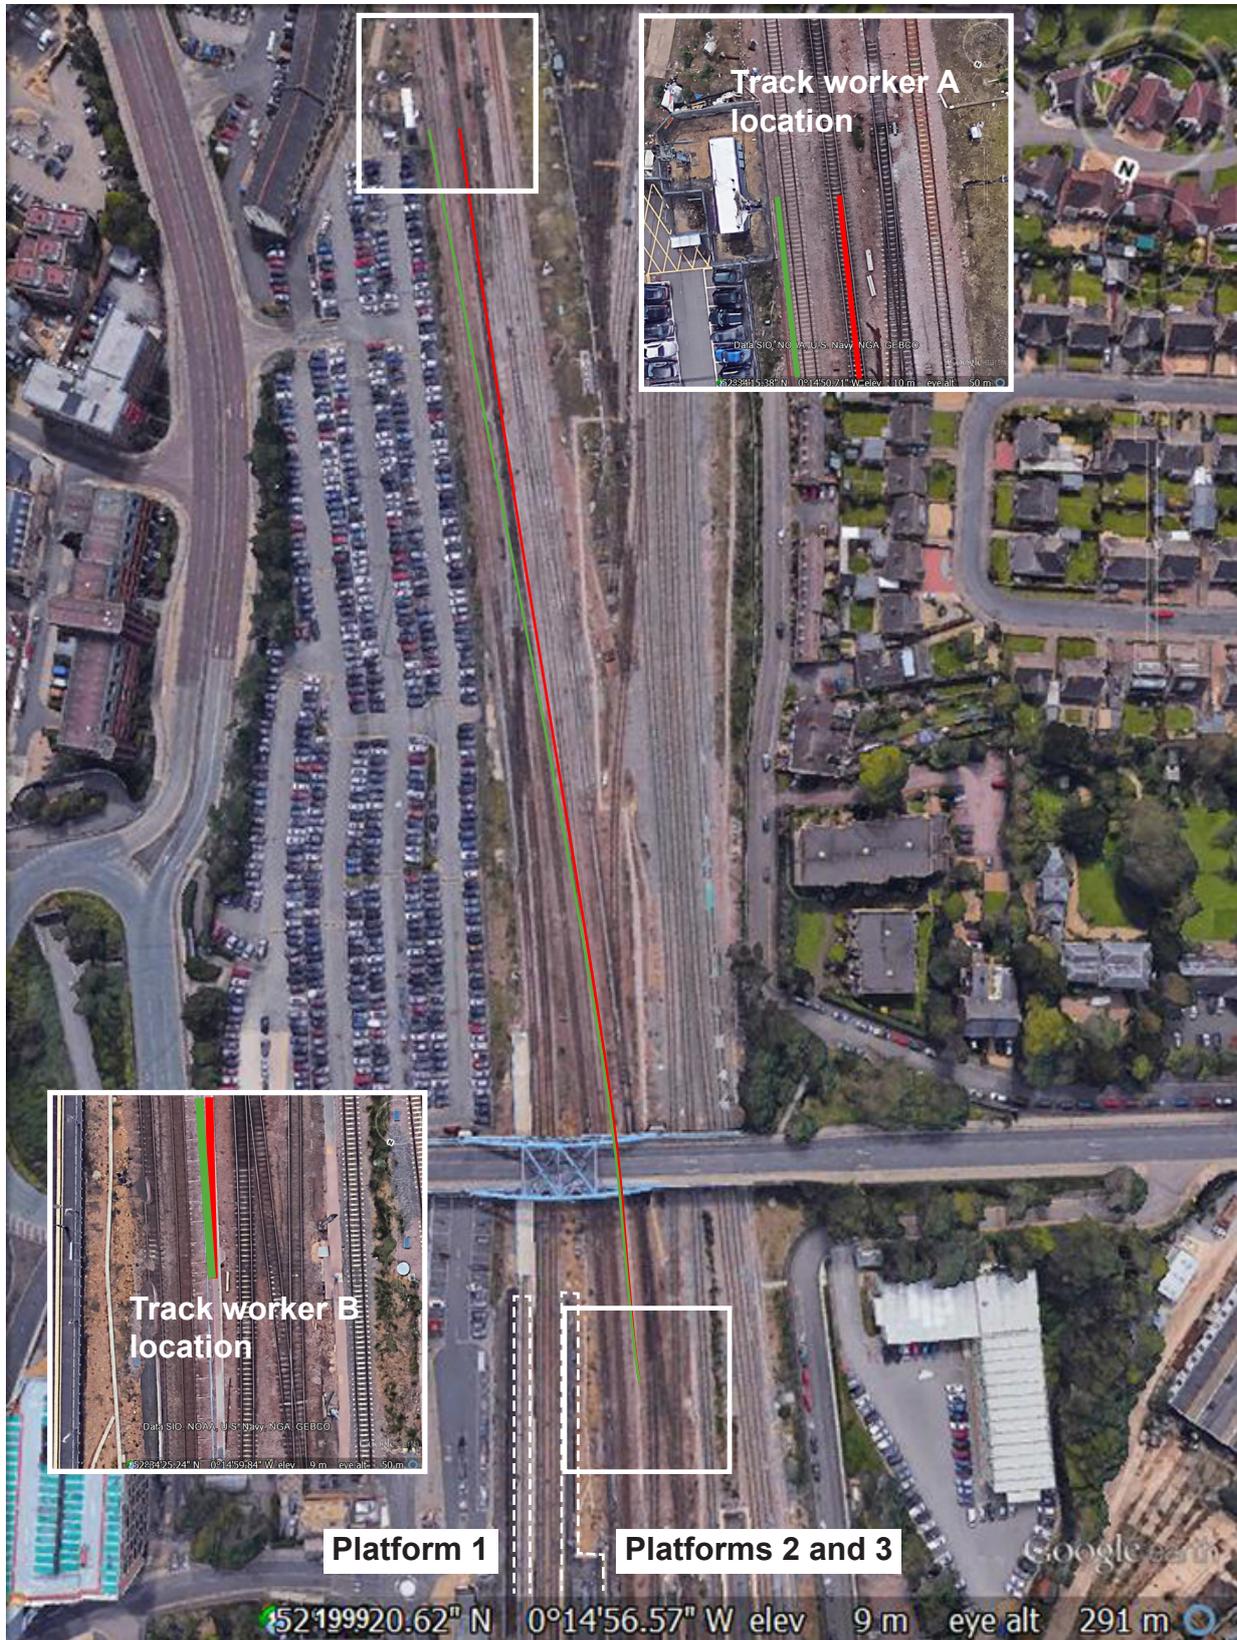
Figure 9: Sighting of the distant lookout by the site lookout

56 Track worker A also reported that he thought standing on the up fast line gave him a better view of his distant lookout. Figure 9 shows that the difference in the angle for sighting the distant lookout from the up fast line and from the cess is very slight. The increased personal risk is, however, significant.

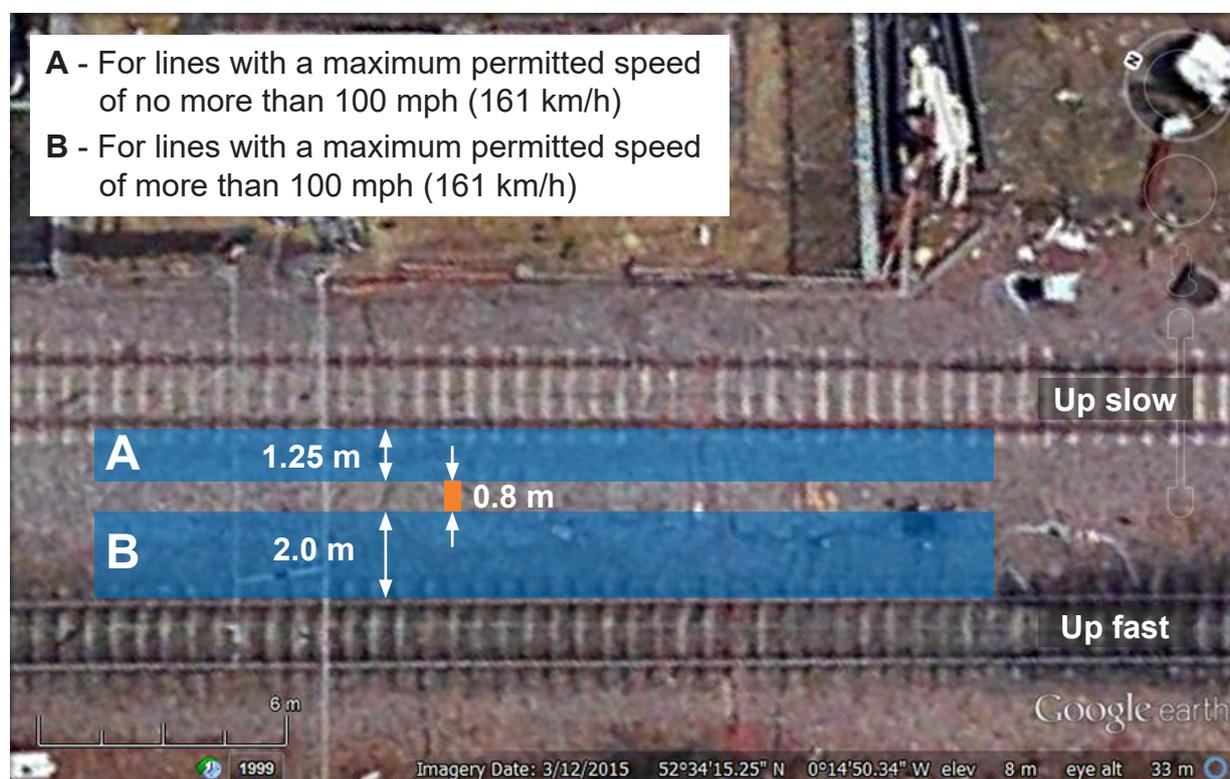
Figure 10: The space between the up slow and up fast lines

- 57 Other Network Rail staff who were familiar with carrying out site lookout duties at this location, reported to the RAIB that they did not stand on the up fast line. They indicated that they could see a distant lookout just as well from the cess or from the space between the up fast and slow lines. Figure 10 shows that the latter is just wide enough for a site lookout to stand between the up slow and up fast lines and still be in a position of safety.

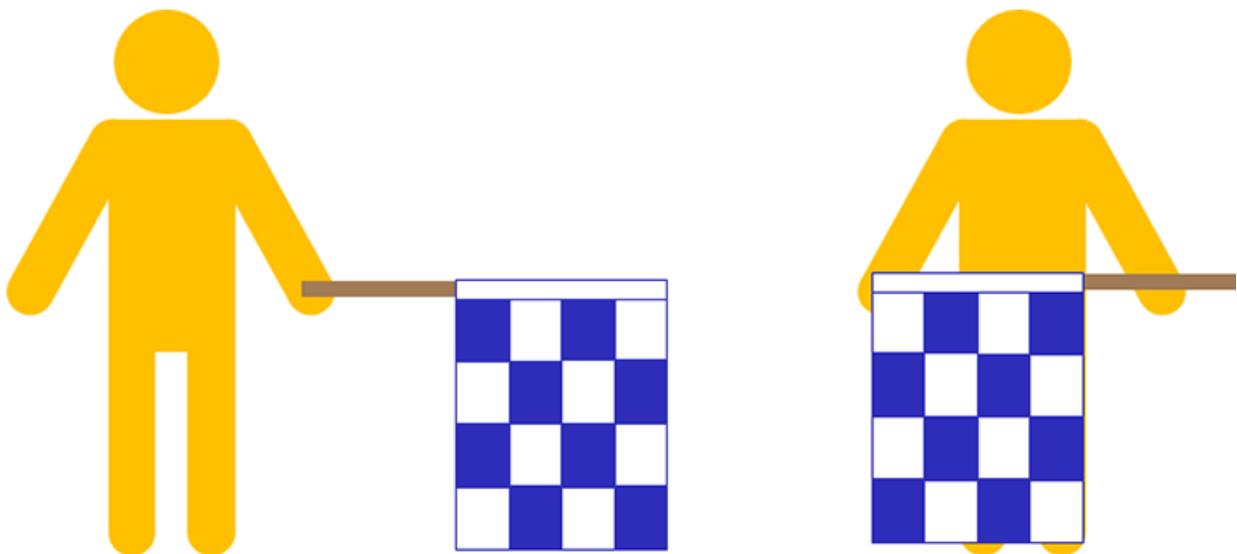
Figure 12: Unofficial lookout flag signals used to communicate 'all clear'

- 73 The first unofficial flag signal is used by lookouts to communicate that it is 'all clear', meaning that no trains are approaching, so that work can start or resume. The RAIB found that some distant lookouts hold their lookout flag out briefly and then, once acknowledged by the site lookout, both lookouts gather their flag up and hold it in against the flag pole. Other site and distant lookouts were found to hold the flag out all the time, either to the side or across their body, to give a continuous all clear signal to each other (figure 12).

- 74 Before the team leader and track worker A went onto the track south of Peterborough station, track worker B, as the distant lookout, held his flag out briefly to give an all clear at the start of the work. Track worker A acknowledged this by holding his flag out but then kept his flag held out. He did this because on previous occasions when he had worked with the track maintenance team based at Peterborough depot, he had seen that their lookouts hold their flags out all of the time to give an 'all clear' signal. A previous manager there had instructed the track maintenance team to do this and the practice had continued. Track worker A had assumed that as the lubrication team was based at the same depot as this track maintenance team, both teams followed the same practice. Therefore, he held his flag out all the time as he thought that this would fit in with common practice in his new team. However, the lookouts in the rail testing and lubrication section did not follow this practice because they only held their flags out briefly to give an 'all clear' signal.

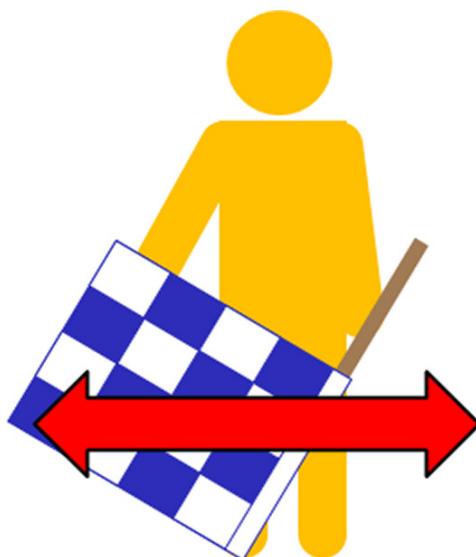
Figure 13: Unofficial lookout flag signal used to communicate that work is complete

- 75 A second unofficial flag signal is used by lookouts to communicate that work is complete so they can stand down the safe system of work and leave their post. When the safe system of work can be stood down, the COSS tells the site lookout who then waves their lookout flag low across their knees. This is known as an 'under wave' (figure 13). When a distant lookout sees an under wave flag signal, he acknowledges by doing the same. Both lookouts then stop waving and know they can stop looking out for trains and leave their position.

- 76 On the day of the incident, track worker B believed he saw an under wave, albeit 'flimsy', from track worker A. Track worker B reported that he gave an under wave in response, packed up and left his position. However, just before this happened, track worker A had been moving about a lot as he was following the team leader around (paragraphs 53 and 54). Track worker A was still holding the flag out across his body while he did this as the COSS had not told him to do otherwise. It is probable that track worker B mistook a movement by track worker A and his flag as the under wave signal. By that time, track worker B was expecting the inspection to end soon as it had already gone on for much longer than planned; the timing of the apparent under wave fitted in with his expectation.
