Rail Accident Investigation Branch

Rail Accident Report

**Train travelling with doors open on the Jubilee line
1 September 2018**

Report 06/2019
July 2019

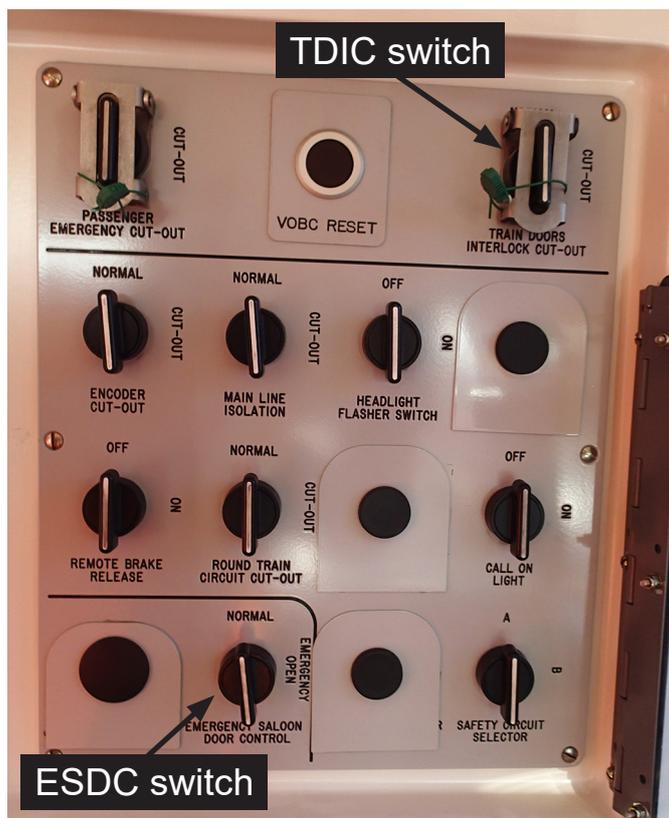
Figure 10: TDIC and ESDC switches on driving cab panel (location of panel shown on figure 5)

- 61 Both the ESDC and TDIC switches are part of the cut-out switch bank on the back wall of the driving cab, near the cab door which was adjacent to the platform (figures 5 and 10). However, there are significant differences between these switches; the TDIC switch is at a higher level and nearer the cab door than the ESDC switch. The TDIC switch is fitted with a flap and a seal in the form of a plastic tag which must be broken before the switch can be operated. The flap covers only the TDIC switch and must be lifted before the switch can be turned. The ESDC has no seal or individual flap. However, it can only be operated after opening a plastic door which covers most of the switch bank, but not the TDIC switch. This plastic door opens towards the driving cab door, which makes operating the ESDC switch from the doorway difficult.

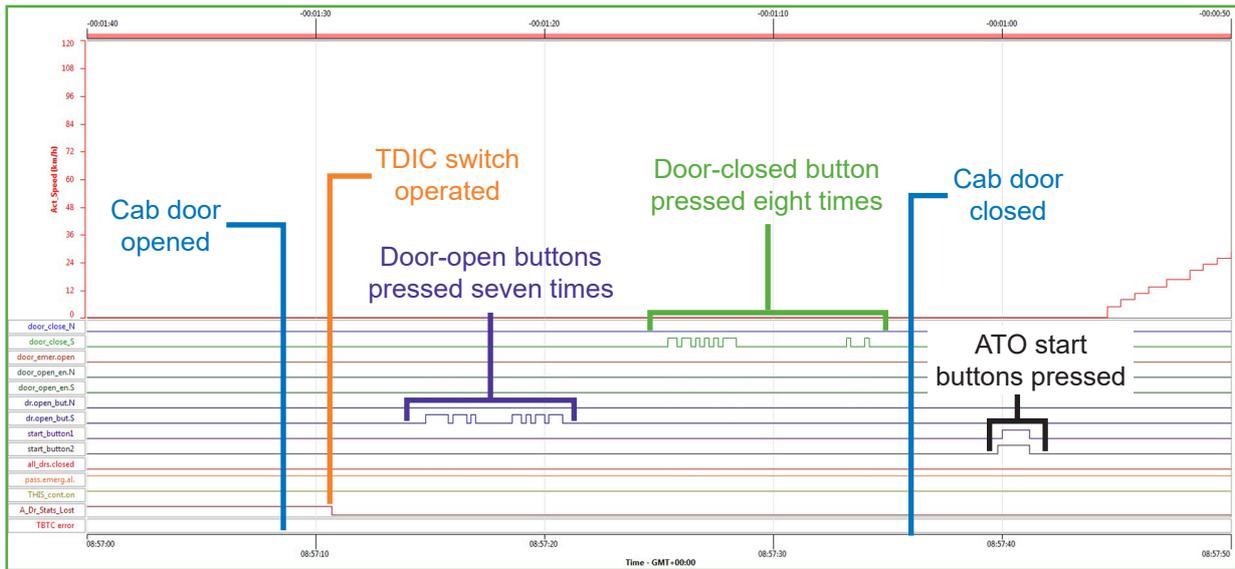
- 28 The train operator stated that he then stood up, opened the driving cab door adjacent to the platform, put one leg out onto the platform, looked along the side of the train and saw that some other passenger doors had not opened. The on-train data recorder (OTDR) fitted to the train shows the cab door started to open 1 minute and 21 seconds after the train stopped at Finchley Road and that, about 2 seconds later, the train operator bypassed the door interlock circuit by operating the TDIC switch.

- 29 The OTDR then recorded several operations of the passenger door-open and close buttons by the train operator while the cab door was open (figure 11). The OTDR does not indicate which buttons were used (console or back wall) but it is likely that the train operator remained at the cab door and so used the back wall buttons. The train operator stated that, between opening and closing the cab door, he looked through the peephole in the door leading from the driving cab into the saloon of the first car and saw that no passengers were standing at closed doors waiting to get off the train in the leading car (when looking through the peephole, only the interior of the leading car can be seen).

Figure 11: Annotated OTDR graphic showing TDIC switch operated, cab door operation, and operation of door-open and close buttons

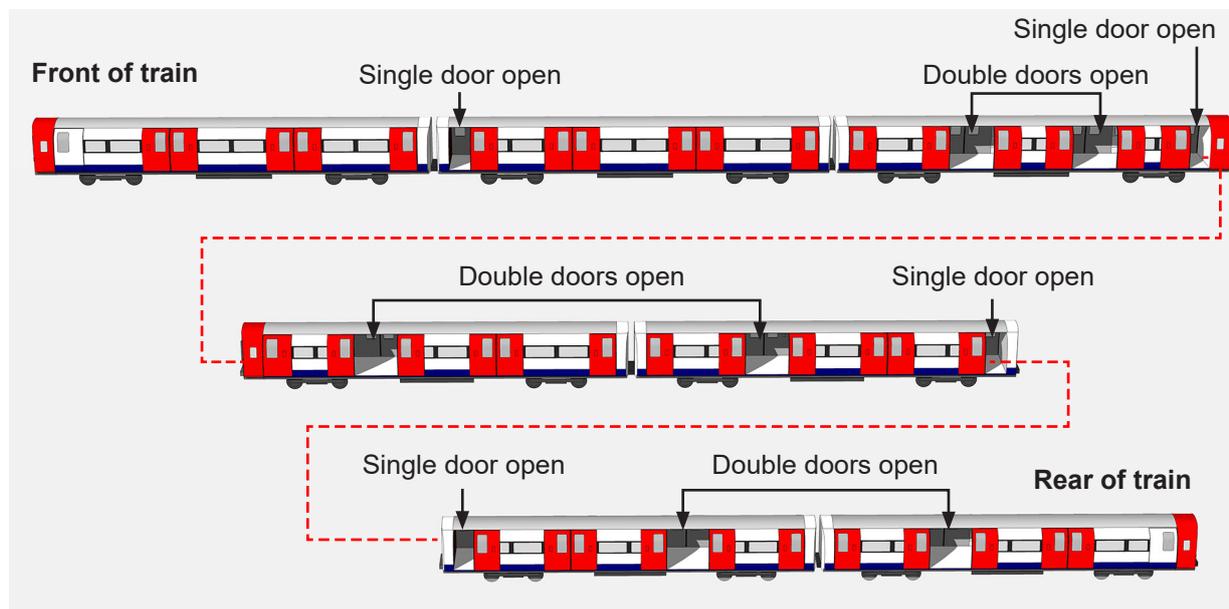
- 32 During the 56 second journey to West Hampstead, internal train CCTV shows doors were open at 10 of the 28 passenger doorways (figure 12).
- 33 The train operator did not call control (ie the Jubilee line control room) while he was at Finchley Road station to tell them there was a problem with the train, and control did not call him. Control would not normally call a train operator unless a delay exceeded two minutes. The train was at Finchley Road station for less than two minutes and LUL train performance records show that it departed 1 minute 19 seconds later than timetabled.

Figure 12: Location of open doors on the train (note some doorways have single doors and some have double doors)

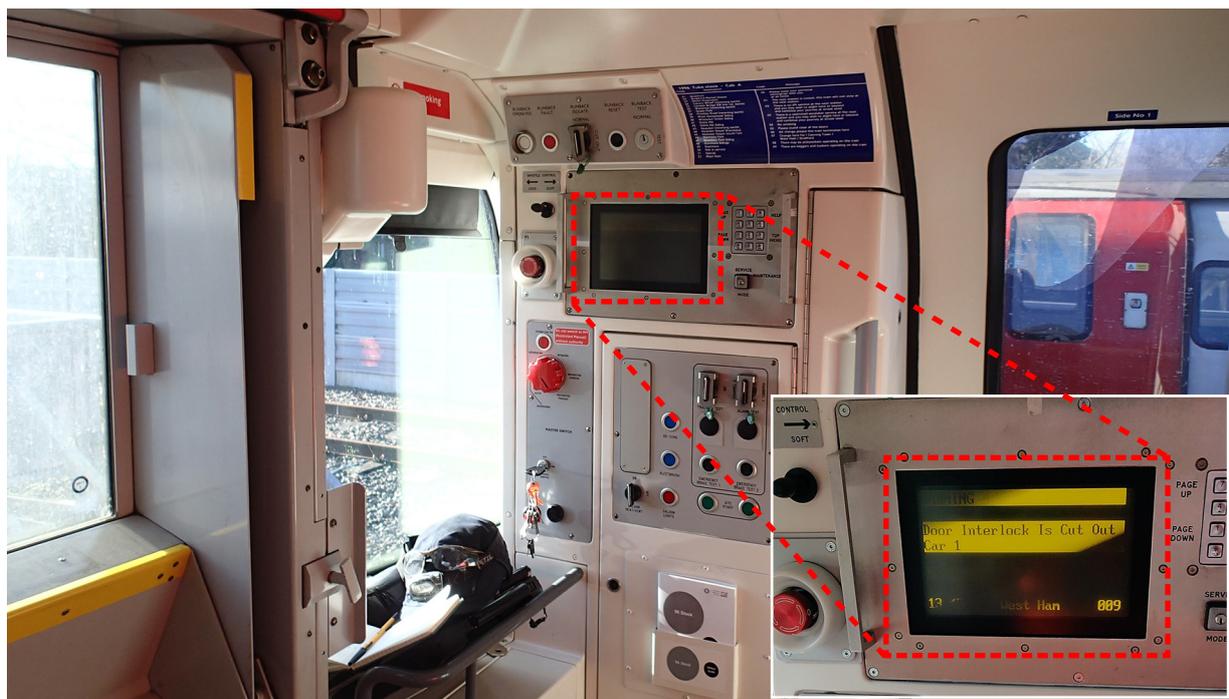
70 Operation of the TDIC switch resulted in the TMS display screen in the driving cab displaying a message saying '*door interlock is cut out car 1*' (figure 14). However, the train operator did not notice this, probably because this screen is on the opposite side of the cab and not in his direct line of vision when looking at the track ahead of the train (figure 4). As it was an information message it was not required to be brought to his attention by the sounding of a warning tone, and did not require any acknowledgement by him.

71 On some other types of London Underground train (table 6), when the TDIC switch has been operated either a reminder sounds in the driving cab and/or the ATO start function is disabled if the train operator attempts to start the train. Such a feature was not present on the train involved in the incident at Finchley Road (paragraph 93).

Figure 14: TMS display showing TDIC switch operated (not train involved in the incident)

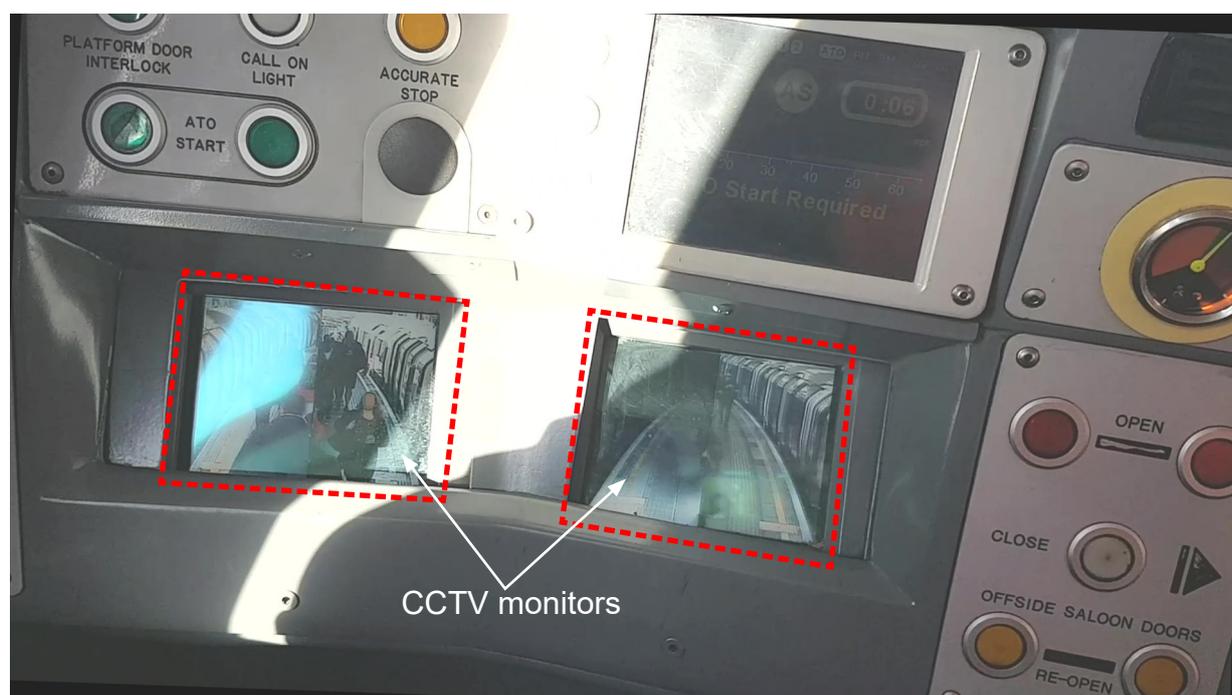
72 The train operator recalled having to use his hands to shield the in-cab CCTV monitors from sunlight when checking if it was safe to start the train, and during the time the train was leaving the platform (paragraph 14). Post-incident observations by the RAIB at a similar time of day to that of the incident showed that sun glare made it difficult to see the side of the train on the CCTV monitors (figure 15).

Figure 15: Sunlight shining onto the monitors (image taken with the sun in a similar position to that at the time of the incident)

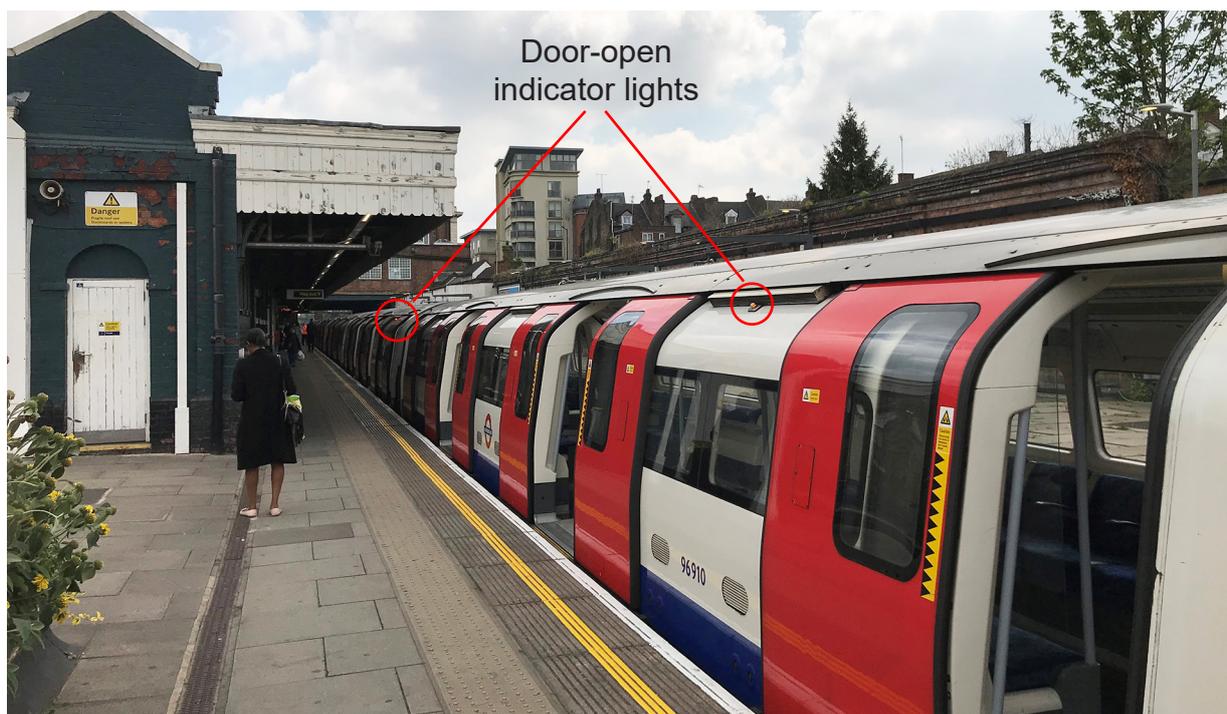
- 74 On the outside of the train an orange light is provided on each car (figure 17). These illuminate when the doors on that car are open and extinguish when the associated doors are closed. Post-incident observation by the RAIB showed that it was difficult to differentiate between their lit and unlit state on the in-cab CCTV due to a combination of their recessed design and sunlight shining on them. For these reasons they were not sufficiently conspicuous to draw the train operator's attention to the fact that some doors had not closed.

Figure 17: Door open indicator lights on outside of train
