Rail Accident Report

Collision between two road-rail vehicles at Cholmondeston, Cheshire 19 September 2018

Report 08/2019
July 2019

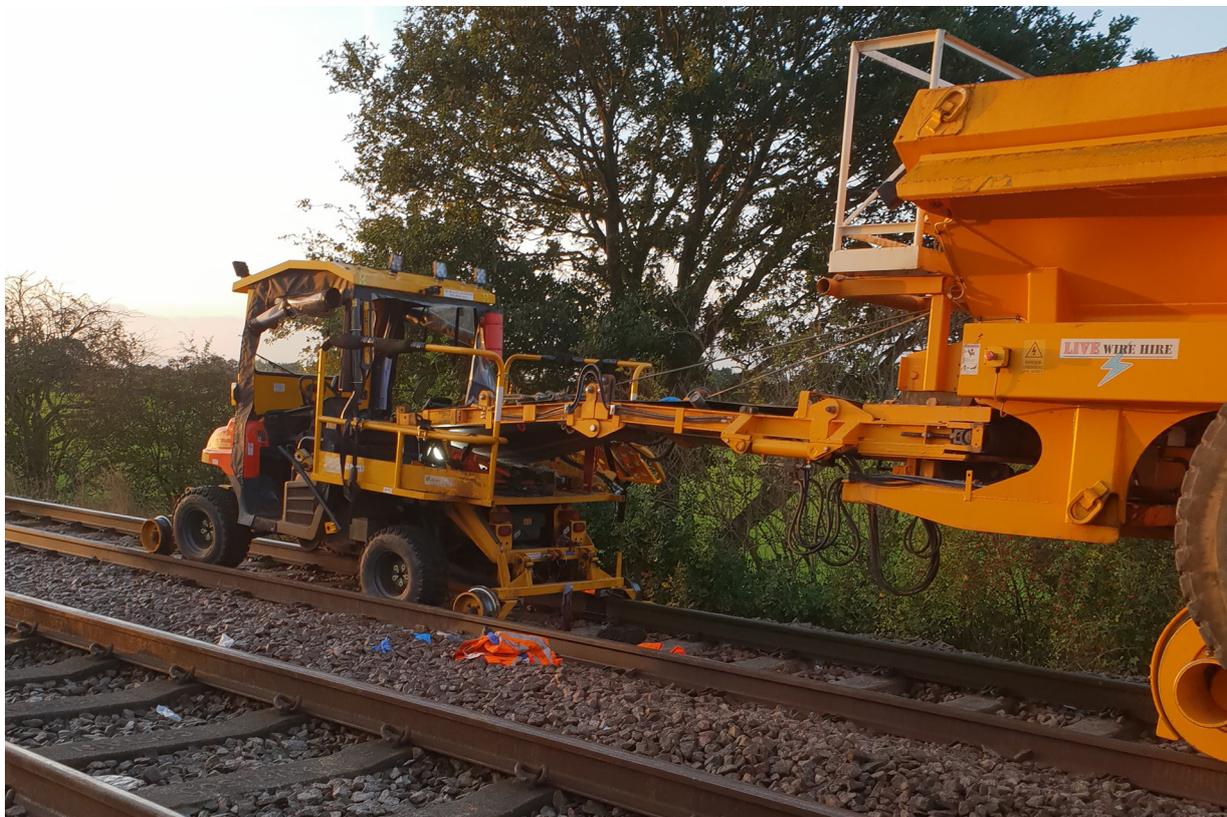
Figure 7: The position of the two vehicles after the collision

- 4 One of the track workers in the kubota suffered life changing leg and back injuries, while the other suffered sprains and bruising to his arm. There was significant damage to the kubota and damage to the conveyor belt mechanism on the rear of the ballast distributor. There was also minor damage to the track as a result of the kubota becoming derailed.

- 43 The kubota's machine operator also recognised that the ballast distributor was not slowing down and got into the driving seat to attempt to move it forwards to prevent a collision. The kubota's engine was already running and the machine operator started moving the kubota forwards, but he was unable to prevent the collision from occurring (figure 7).

- 44 The two track workers in the back of the kubota tried to leave the vehicle before the collision. One was able to clamber over the side. The other was unable to escape in time and became trapped between the conveyor on the ballast distributor and the cab of the kubota. The third track worker, who was in the passenger seat in the front of the kubota was able to get out before the collision. The kubota machine operator remained in the driving seat, but did not suffer any injuries.
- 45 Following the collision, the kubota became derailed and was pushed for a distance of about 30 metres along the track before the ballast distributor came to a stop.

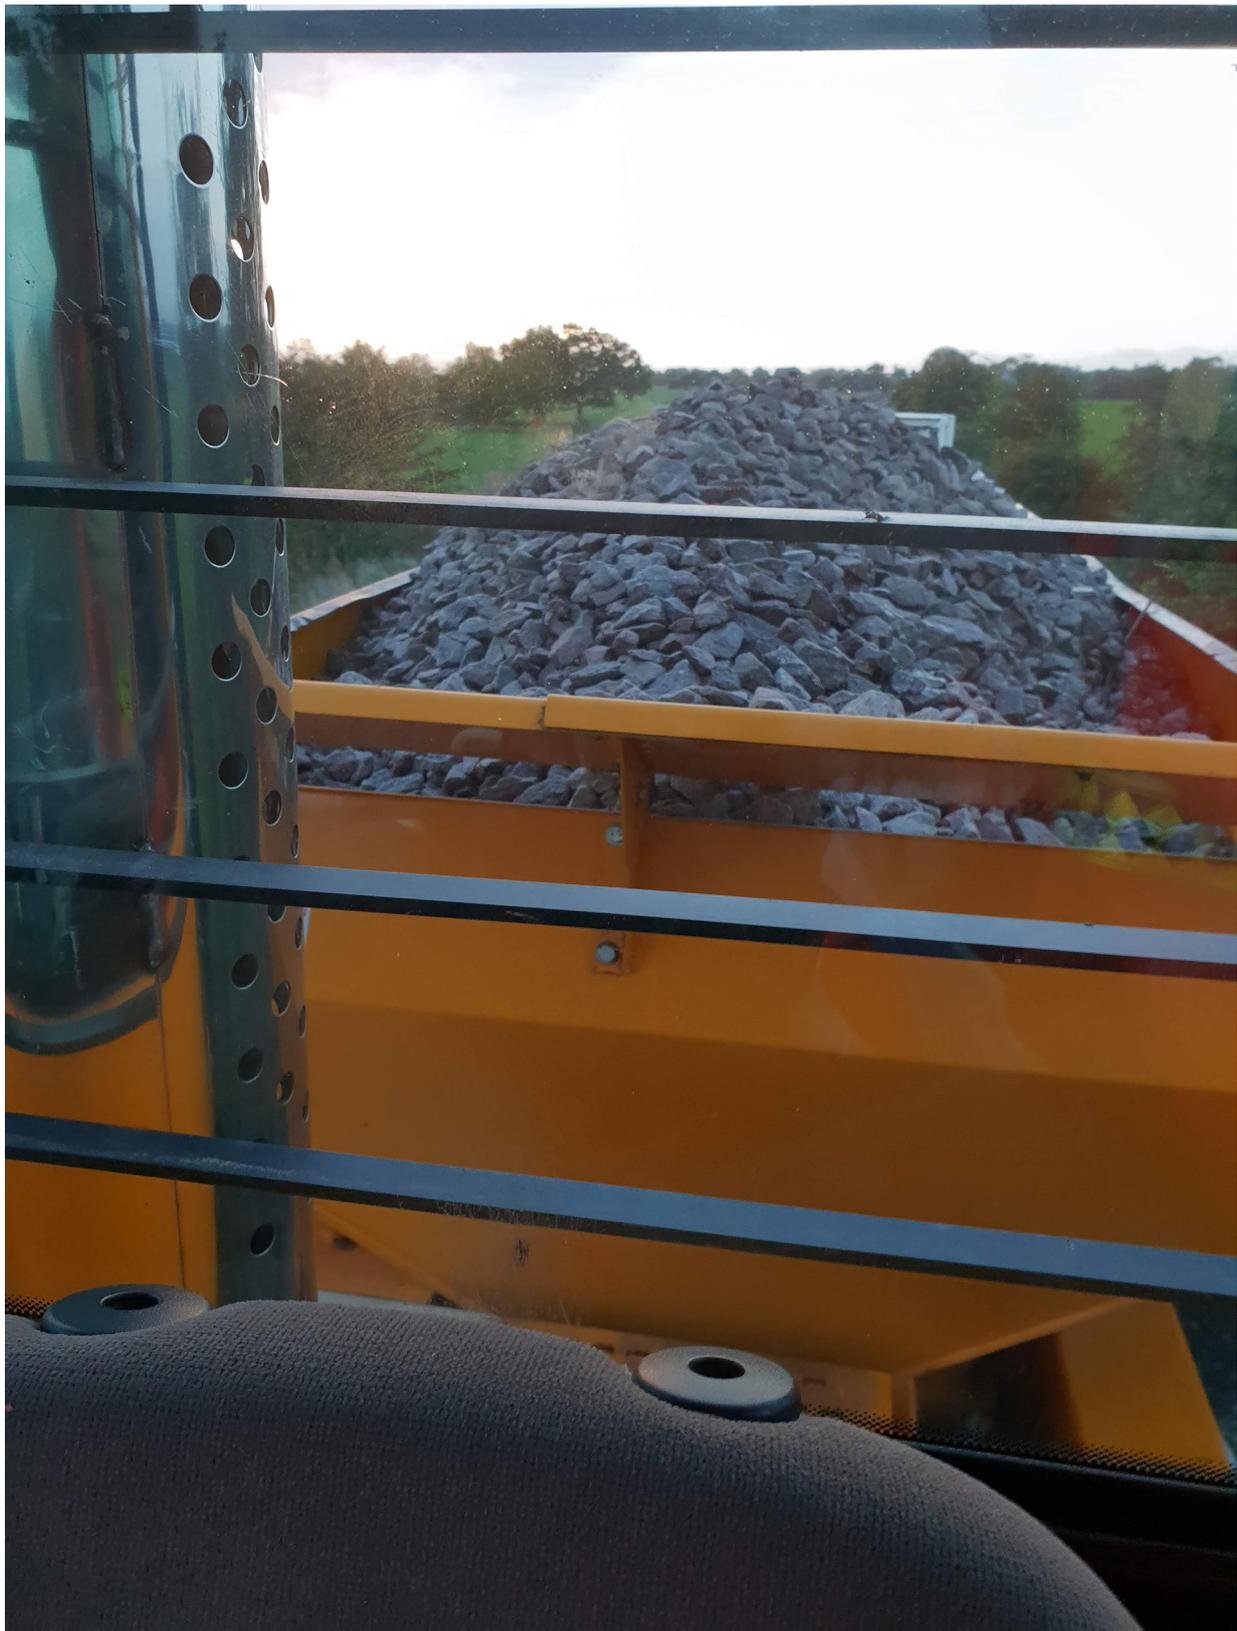
Figure 8: Rear visibility from the driver's cab (as found after the collision)

- 59 The ballast distributor was originally a unidirectional road machine that was converted for bidirectional use on the railway. However, no modifications were made to the cab to improve rear visibility as part of that conversion. This was despite use on the railway requiring routine travel in both directions. The driver's seat and the second person's seat are both fixed facing forward and are positioned at a height that means the view to the rear is obscured by the hopper and any load (figure 8). The need for the driver to operate foot pedals when travelling also limits his ability to turn round to attempt to look towards the direction of travel when reversing.

- 60 Although the ballast distributor is fitted with external rear view wing mirrors, these are not intended to be used to see the line ahead when travelling backwards in rail mode. Handbook 15 of the railway Rule Book (GERT8000 HB15 'Duties of the machine controller and on-track plant operator') states that 'the OTP operator must always have a clear view of the line ahead' and that 'mirrors cannot be used for this purpose'.

- 150 Following the accident, AP Webb Plant Hire briefed its staff on the importance of having a clear view of the line ahead when reversing machines, and on complying with any operational restrictions contained in the ECC/EAC for each machine. It also briefed on the importance of complying with these requirements when faced with pressure at site from other staff. It offered staff support from their managers by telephone if they were being pressured to work unsafely or outside the prescribed limitations of machines.

- 154 Immediately after the accident, Network Rail barred this type of ballast distributor from being used on its infrastructure. However, this bar was lifted on condition that all reverse movements were controlled by a machine controller who was positioned on the ground. This condition reflected the existing requirement specified in the ECC for the ballast distributor and in the Rule Book. ORR challenged the decision to reinstate these machines without requiring additional engineering controls, and is in ongoing discussions with AP Webb Plant Hire in relation to their use. Network Rail has also enhanced its OTP monitoring activities in relation to use of this type of RRV.

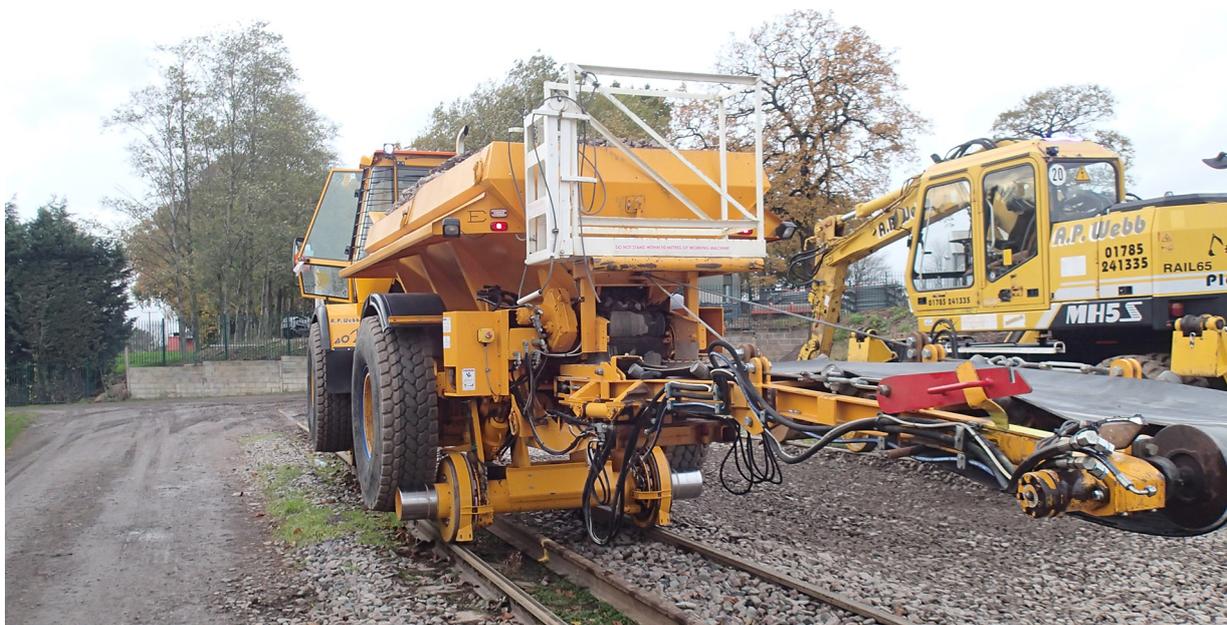
Figure 9: Rear platform on the ballast distributor

- Provision of staff on the ground to control reverse movements.
- 64 Although the ballast distributor has a platform at the rear (figure 9), this was intended to allow personnel access to view the hopper contents. It was not intended for use while moving and was not fitted with any controls or seating.

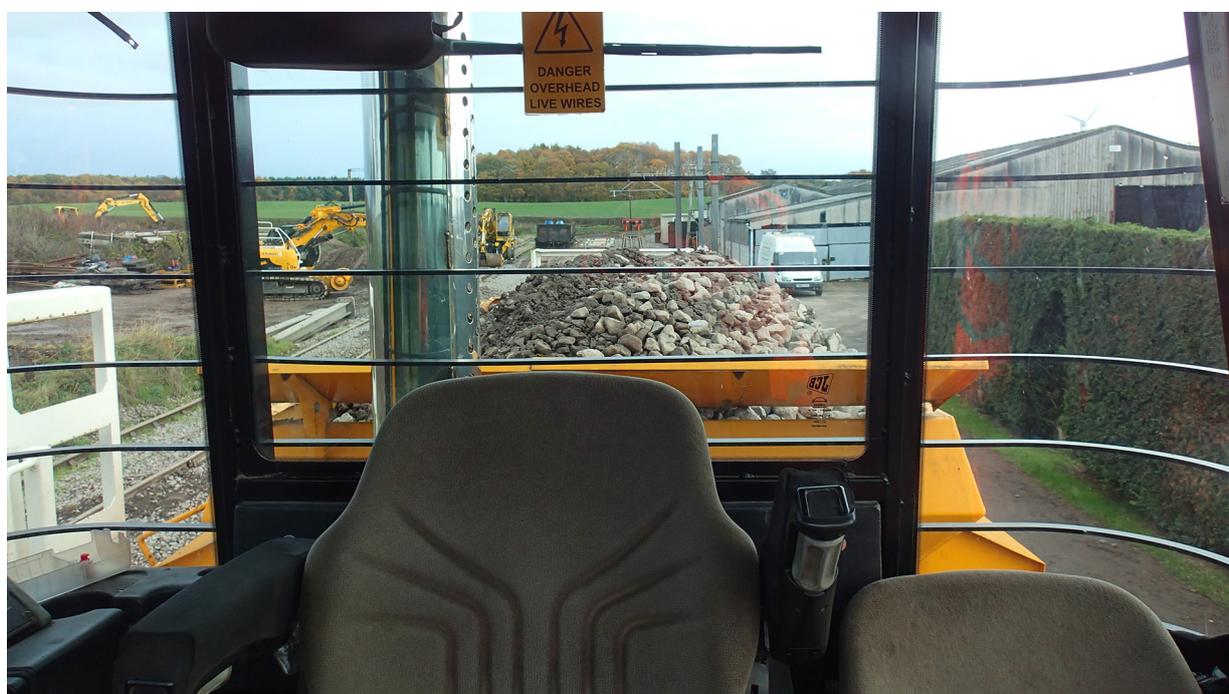
Figure 10: Driver's and second person's seats in the ballast distributor cab

83 The presence of a dedicated second seat in the cab (figure 10) is likely to influence the behaviour of machine controllers when travelling. Because it is permitted for machine controllers to ride in the cab when traveling forwards, the convenience and relative comfort, compared to walking alongside the machine, might have led them to lose sight of the ECC and Rule Book limitations in the reverse direction, contributing to riding in the cab becoming the accepted norm.
