# Narrowly avoided collision between a train and a track worker at Ynys Hir, Ceredigion, 2 April 2019

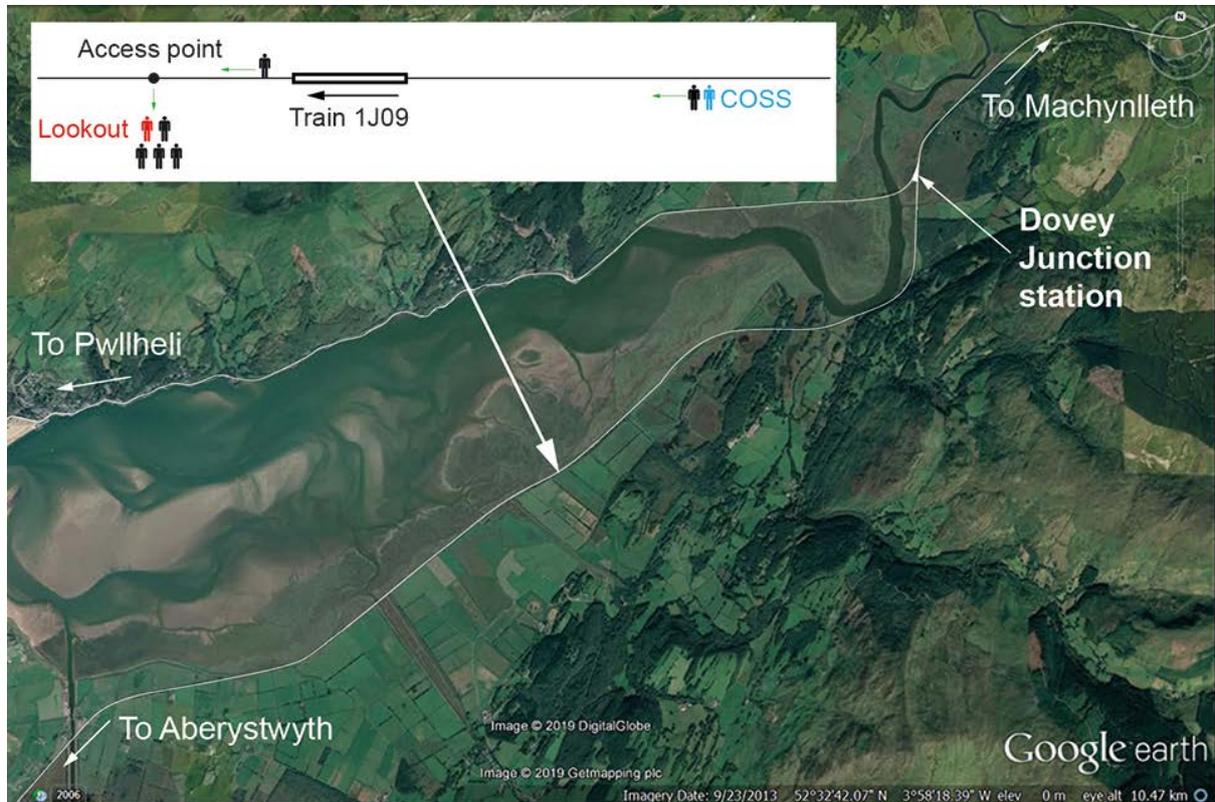
**Track layout showing the location of the incident, the direction of the train and the approximate position of the work group at the time of the incident**

The Network Rail team leader sighted train 1J09 when it was distant. He and his colleague moved to a position of safety. By now, the Ganymede Solutions staff were reported to be around “150 yards” ahead. The team leader recalled shouting at them to get off the track. He also used his whistle, but he couldn’t make himself heard. The six Ganymede Solutions staff carried on walking, their backs to the approaching train.

The driver of train 1J09 saw the Network Rail team leader and track worker at 11:57:38 hrs and sounded two blasts on the train horn; they both raised their arms to acknowledge this. Around 10 seconds later the driver saw the track worker in the four foot. The driver again sounded two blasts on the horn, and immediately started to reduce traction power. The track worker did not hear the train horn. The lookout and the four other Ganymede Solutions staff then saw the train as they turned to leave the track at the access point. One of them, appreciating the imminent danger, shouted “one on” and the lookout made arm gestures for the track worker to move out of the way. The RAIB found no evidence to suggest that the lookout had seen train 1J09 before this.

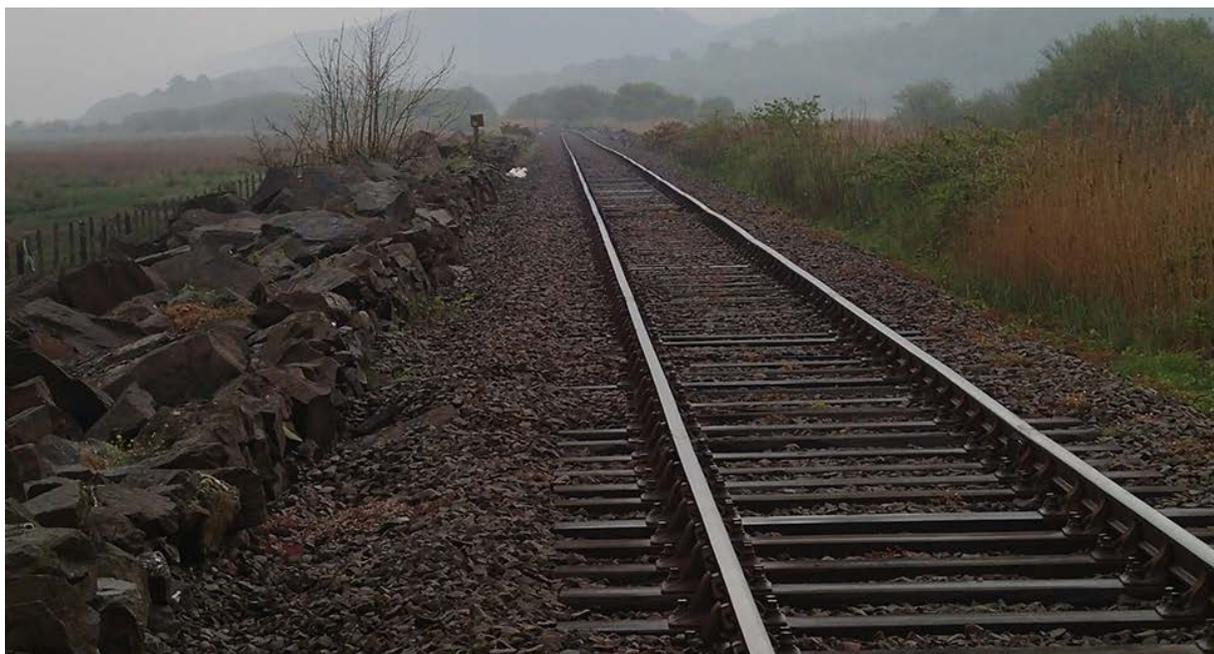
**View of the track from the access point looking towards Dovey Junction station**

The Network Rail team leader and track worker had a good view of trains approaching from Dovey Junction station, and expecting to see train 1J09, started to look back regularly. This may have slowed them and allowed the Ganymede Solutions staff to get even further ahead. It was probably around that time that the track worker involved in the near miss stepped off the track to answer a mobile telephone call. After the call he continued walking along the track, now behind his five colleagues, but still ahead of the two Network Rail staff.
