Rail Accident Investigation Branch

Rail Accident Report

Overspeed at Sandy South Junction, Bedfordshire 19 October 2018

Report 10/2019
August 2019

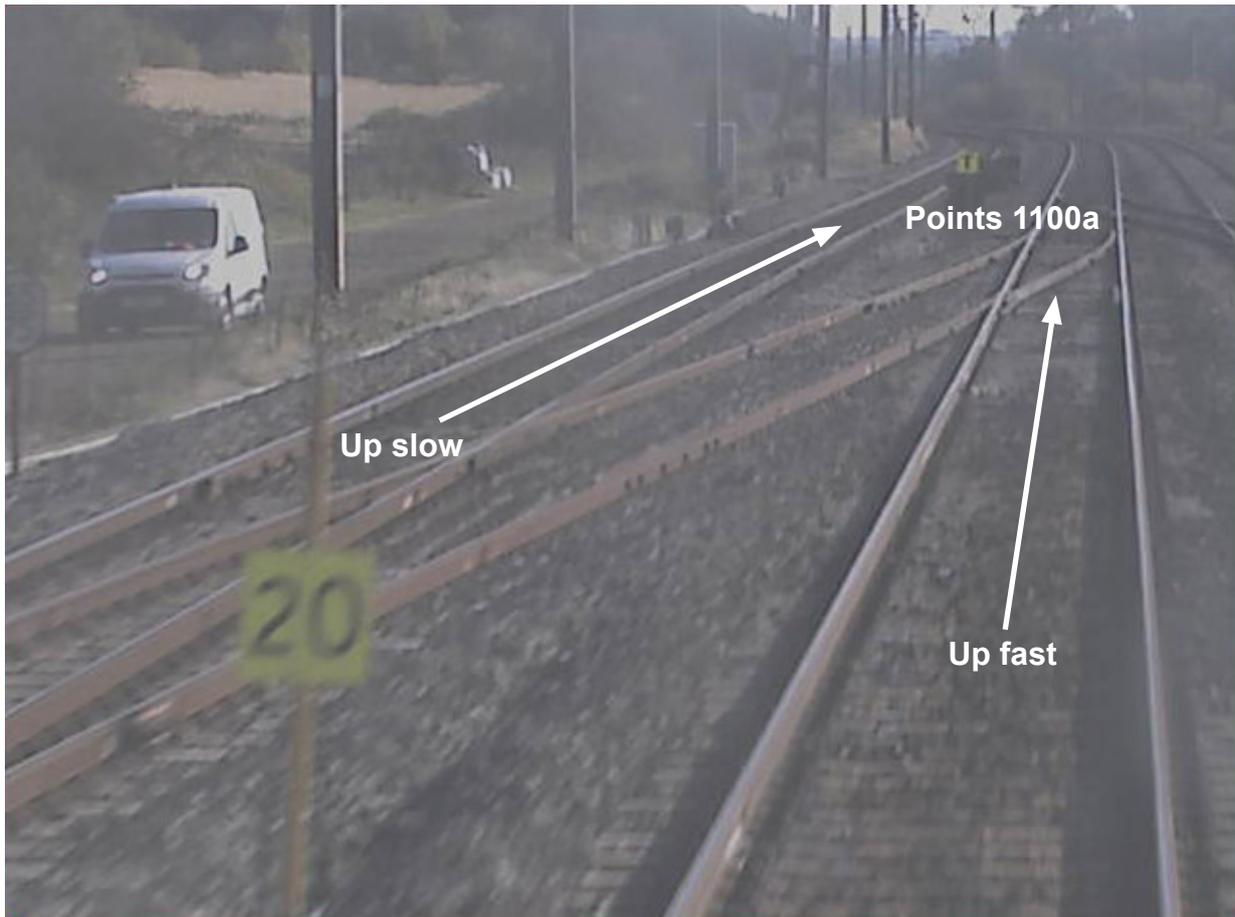
Figure 2: Forward facing closed-circuit television view of points 1100A and its associated crossing on the East Coast Main Line at Sandy South Junction annotated to show key features (image courtesy of LNER)

- 23 On 18 October 2018 at around 10:00 hrs, a Network Rail patroller carrying out a basic visual inspection of the track identified a crack estimated to measure 60 mm long in the crossing of 1100A points at Sandy South Junction.

- 24 Network Rail's maintenance delivery unit sent out a team to implement a 40/70² mph speed restriction, in accordance with the Network Rail company standard governing such situations. Around 13:30 hrs a member of this team measured the crack at 85 mm in length.

- 25 Due to the length of the crack, the 40/70 mph emergency speed restriction was no longer appropriate and, in accordance with Network Rail standard, NR/L2/TRK/1054, a 20 mph (32 km/h) emergency speed restriction was imposed. Hourly line blockages were also imposed to enable an inspection of the crack, and a watchman was appointed to keep a watch on the crossing and the trains traversing the points.

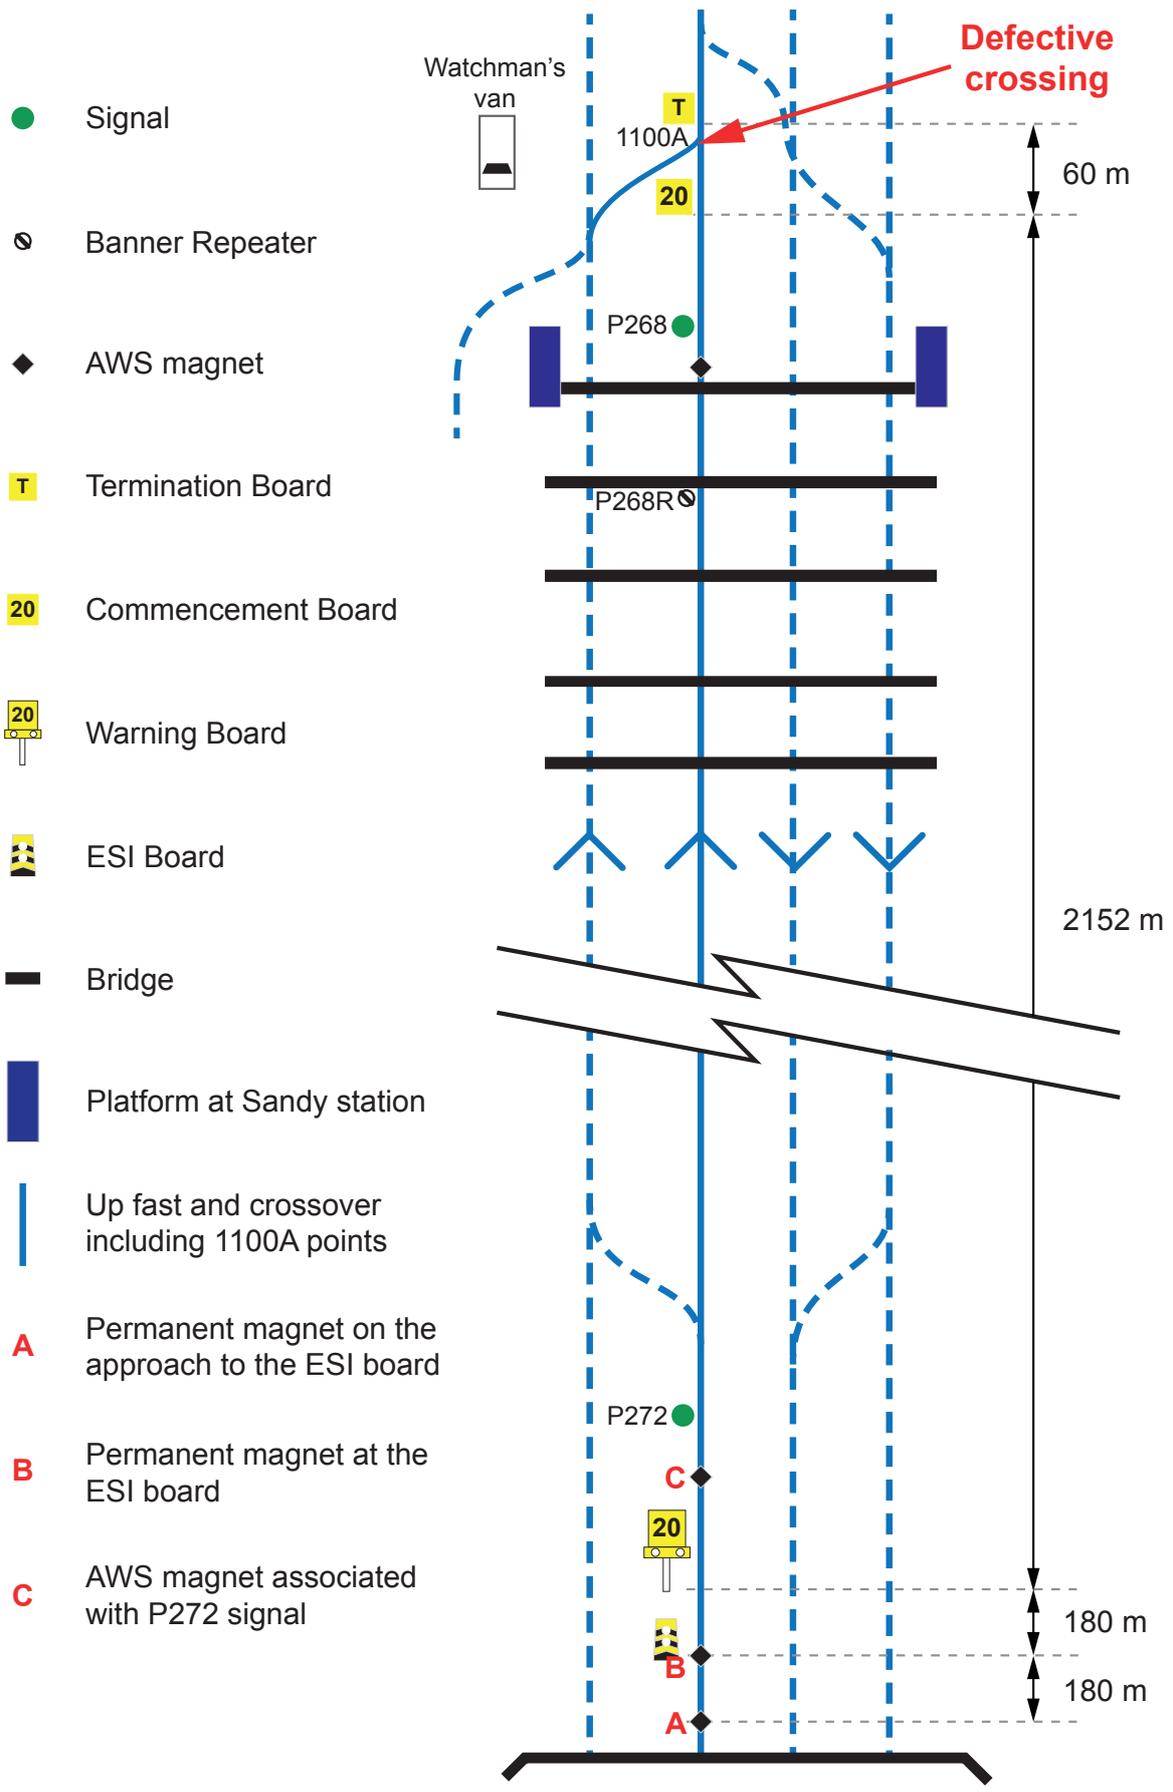
Figure 5: Layout of emergency speed restriction equipment at Sandy (not to scale)

- 26 The team installed emergency speed restriction signage in accordance with railway group standard GK/RT0075. Because of the presence of a signal and its associated AWS magnets, the warning AWS magnets and associated boards for the emergency speed restriction were placed further back along the line than the standard distance, giving an additional 221 metres of deceleration distance for trains before they encountered the restriction.

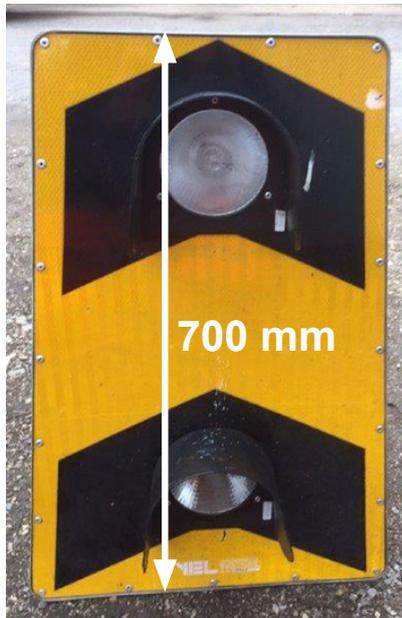
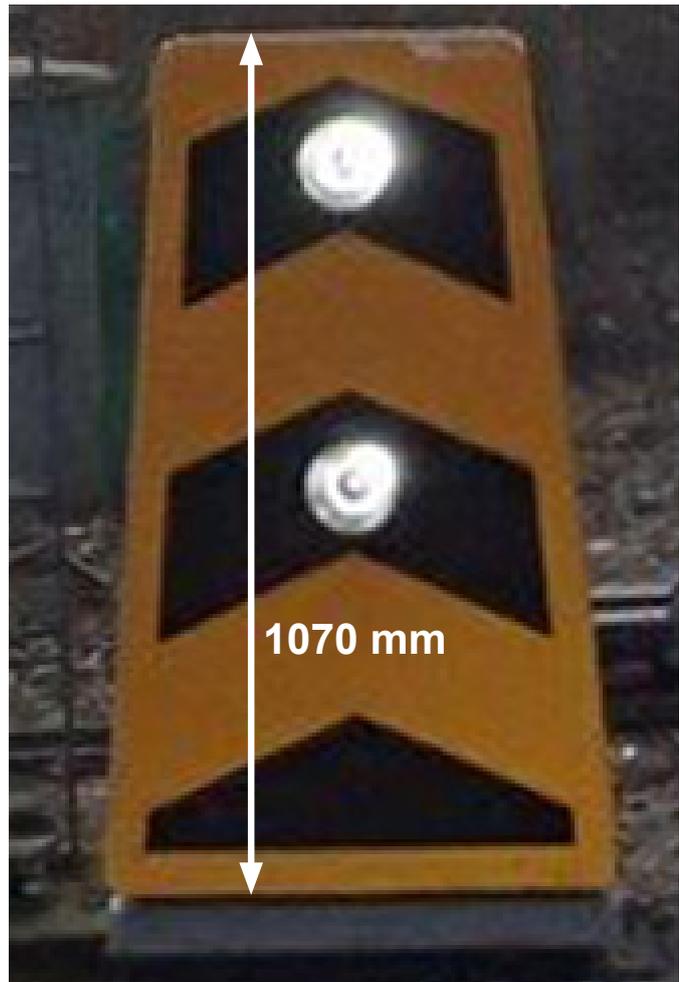
Figure 6: An example of a miniature ESI board on the left, similar to the type used at Sandy (see paragraph 69), and a full size board on the right, shown at the same scale

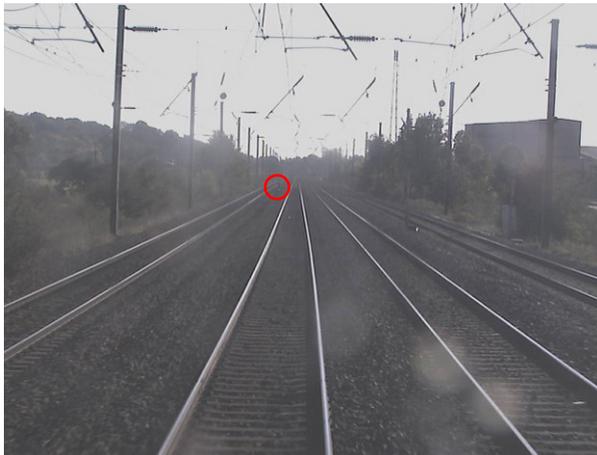
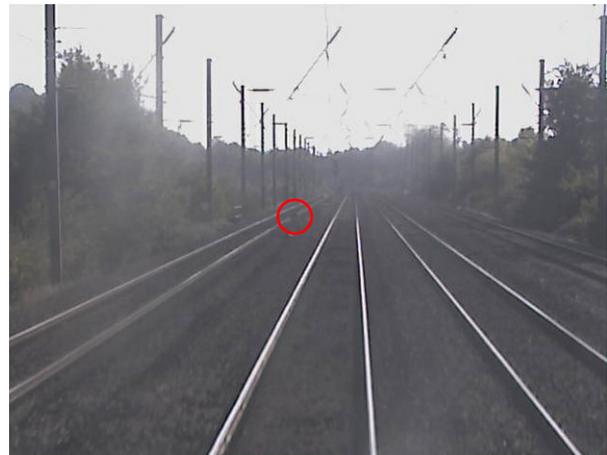
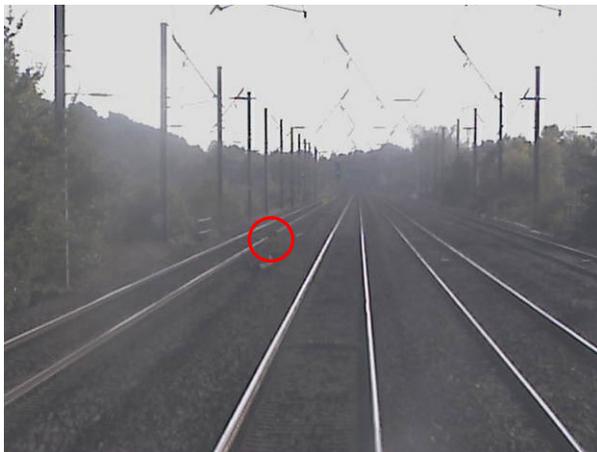
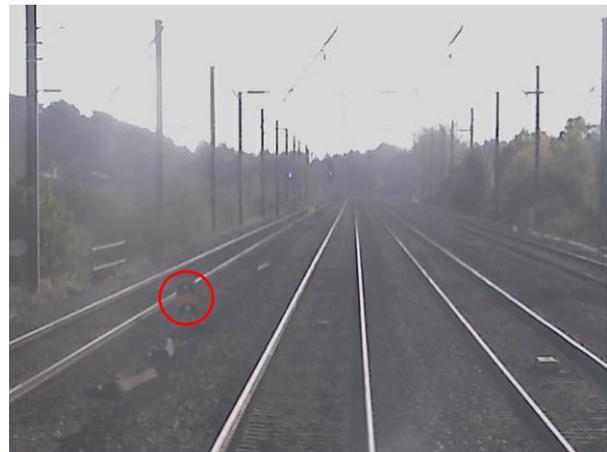
66 The driver stated that he did not see the ESI board. The board would have come into view at a range of around 400 metres, 7 seconds before the train passed it. However, the miniature ESI board is not conspicuous in the forward facing closed circuit television (FFCCTV) footage provided to the RAIB (figures 7a-7d) (see paragraph 69). While the quality of the video recording may not reflect the actual conditions, it is apparent that the sun was shining brightly from behind the ESI board and there was significant shadowing cast over the board by structures and vegetation on the right hand-side of the railway line. There are also some reflections from small unidentifiable items in the space between the up slow and up fast running lines a short distance on the approach to the ESI board, which may have diverted attention from the board itself.

Figure 7a: FFCCTV view of ESI about 5 seconds away from it (image courtesy of LNER)

Figure 7b: FFCCTV view of ESI about 3 seconds away from it (image courtesy of LNER)

Figure 7c: FFCCTV view of ESI about 2 seconds away from it (image courtesy of LNER)

Figure 7d: FFCCTV view of ESI board about a second away from it (image courtesy of LNER)

67 The lights on the board flash with the aim of drawing the driver's attention to the sign. The RAIB conducted some subjective tests with a similar ESI board and found that a slight horizontal rotation of the board made the lights on the board very hard to see, and this could have reduced the conspicuity of the board itself as it made it more difficult to pick the board out from its surroundings.

- 68 Although there is no direct evidence that the board was incorrectly aligned, RAIB found that there is a significant reduction of luminous intensity when the boards are viewed at an angle. This is in line with the requirements of the standard to which the boards are designed (figures 8a and 8b) as it is intended that only the drivers approaching on the line to which the equipment applies should view them as they may cause an unnecessary distraction to drivers on other lines. For free standing units there is no way to accurately align the boards for optimum visibility, and even the type which are held in place using clamps which attach to the rails have no adjustment to take into account any curvature of the line.

- 3 *The intent of this recommendation is to review the design and use of the emergency speed indicator board in order that the flashing lights are clearly visible for as long as possible even when the board is in shadow or bright sunlight.*

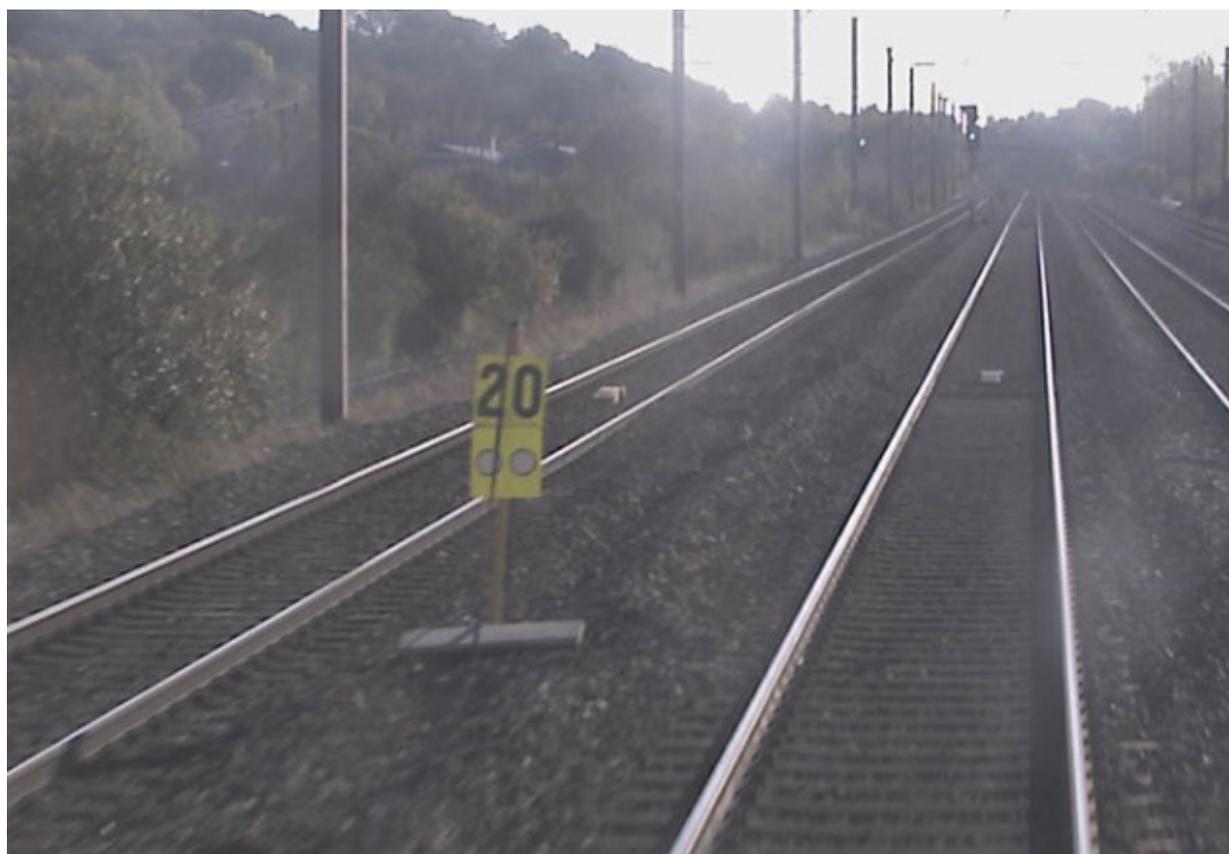
- 36 The driver saw the warning board, and stated that he thought there was an arrow associated with it, indicating that it applied only to trains on a diverging route.

- 73 The driver probably did not see the ESI board and did not recall the first AWS warning. Therefore, he was not expecting to encounter the warning board (paragraph 78). It is likely that he tried to make sense of it in the short time (about one second) that it was visible to him by concluding that it did not apply to him, but to the approaching diverging route, although there was no arrow that would have indicated that it applied to a diverging route (figure 9). Figure 10, shows how the signage would have appeared had the restriction applied in a similar location, but on the up slow line, as the driver believed was the case.

Figure 9: FFCCTV view of the warning board (image courtesy of LNER)

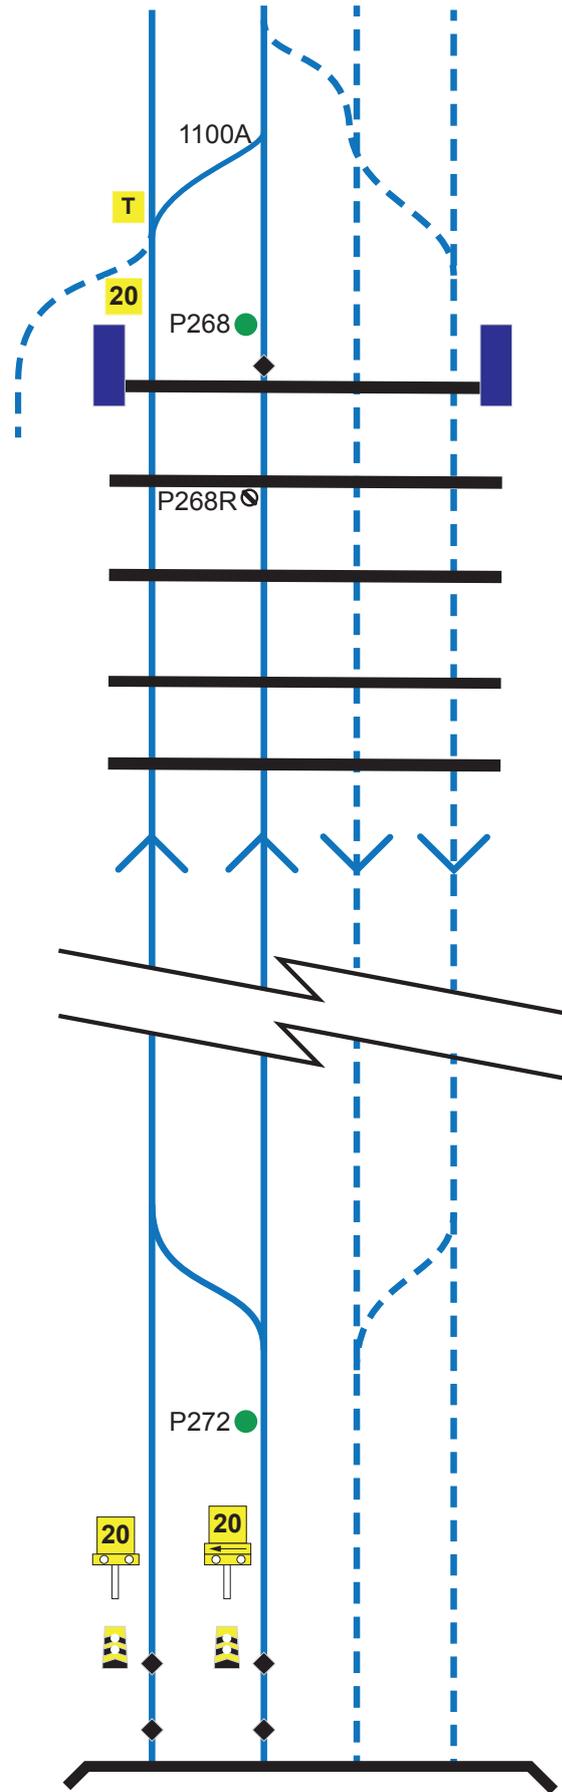
Figure 10: Lineside signage as it would have appeared, had the speed restriction applied in a similar location on the up slow

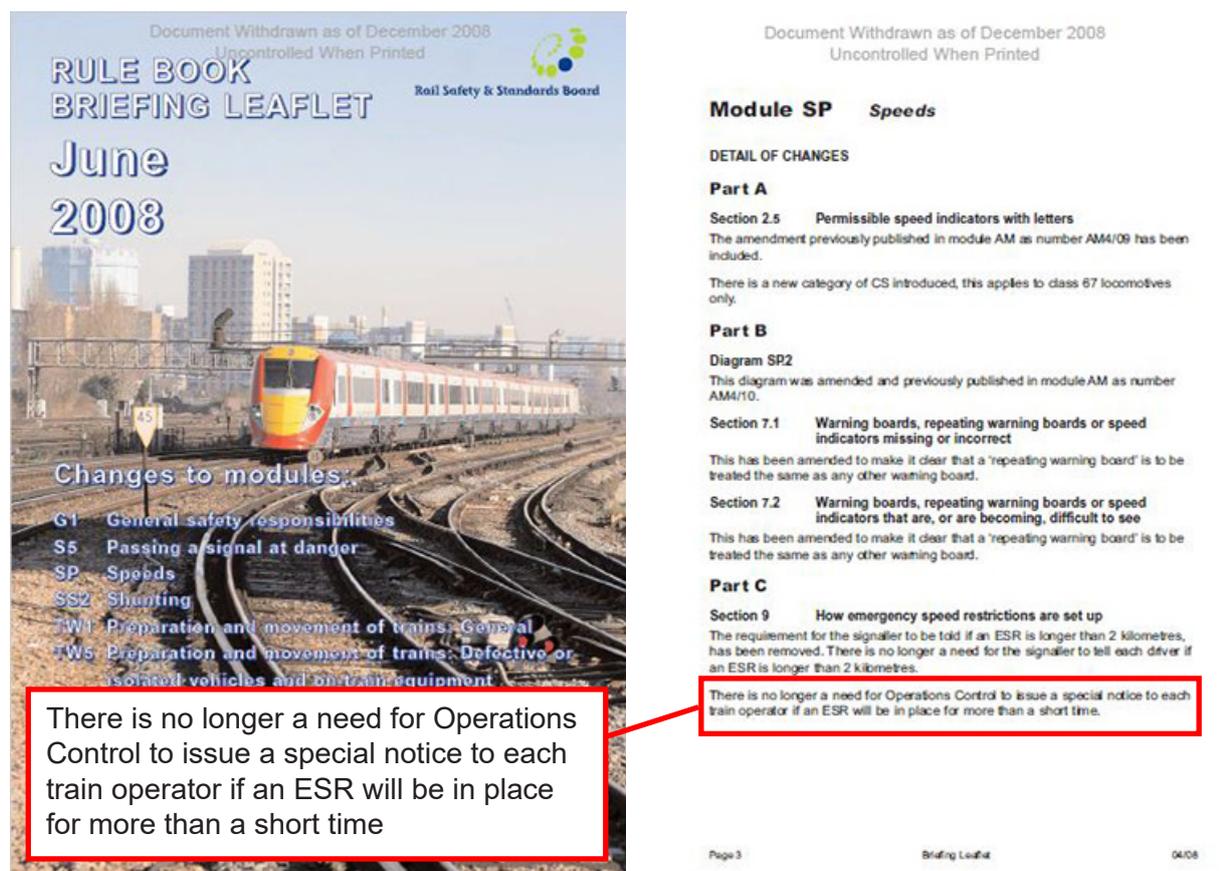
- 33 At 14:31:06 hrs train 1E11 passed over the first AWS magnet associated with the emergency speed restriction ahead. The driver stated that he had no recollection of the horn that sounded in his cab, however he did acknowledge this warning one second later, by pressing a button on the desk in front of him. He stated that he did not see the ESI board.

- 90 RSSB produced a leaflet in June 2008 (figure 11) to explain the changes to the rule book for that re-issue.

Figure 11: Extract from the RSSB's Rule book briefing leaflet June 2008

- 5 *The intent of this recommendation is to learn lessons from the 2008 change to the rules relating to emergency speed restrictions and to consider the extent to which these have been addressed by the current processes which are applied by standards committees.*
