# Derailment of a freight wagon at Carpenters Road North Junction, near Stratford in East London, 11 June 2019

## Summary of the accident

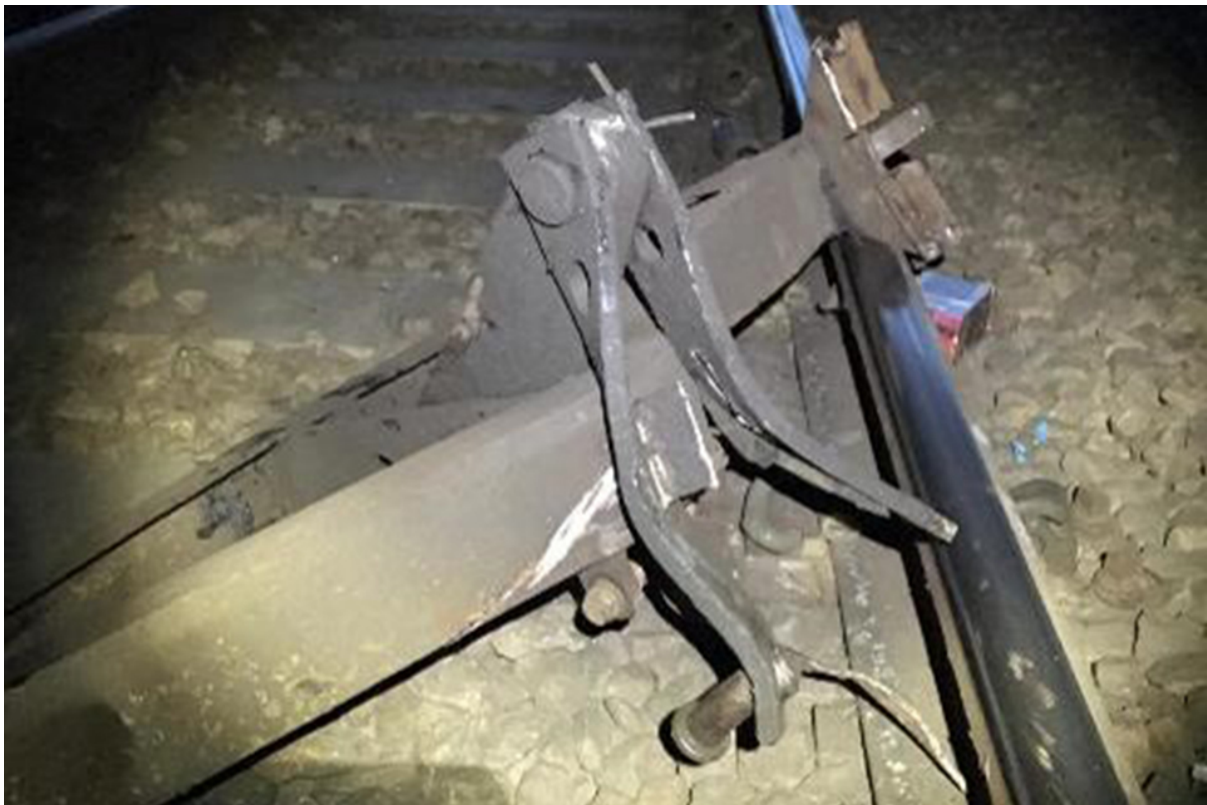
At around 19:08 hrs on 11 June 2019, an empty wagon in a freight train derailed while travelling at approximately 15 mph (24 km/h) around Carpenters Road North Junction (figure 1). It then travelled around 400 metres, causing damage to railway infrastructure, before re-railing at Carpenters Road South Junction. The wagon derailed because it ran over a substantial part of its own brake equipment which had fallen onto the track beneath it (figure 2).

Figure 2: Detached brake gear found after the accident (courtesy Network Rail)

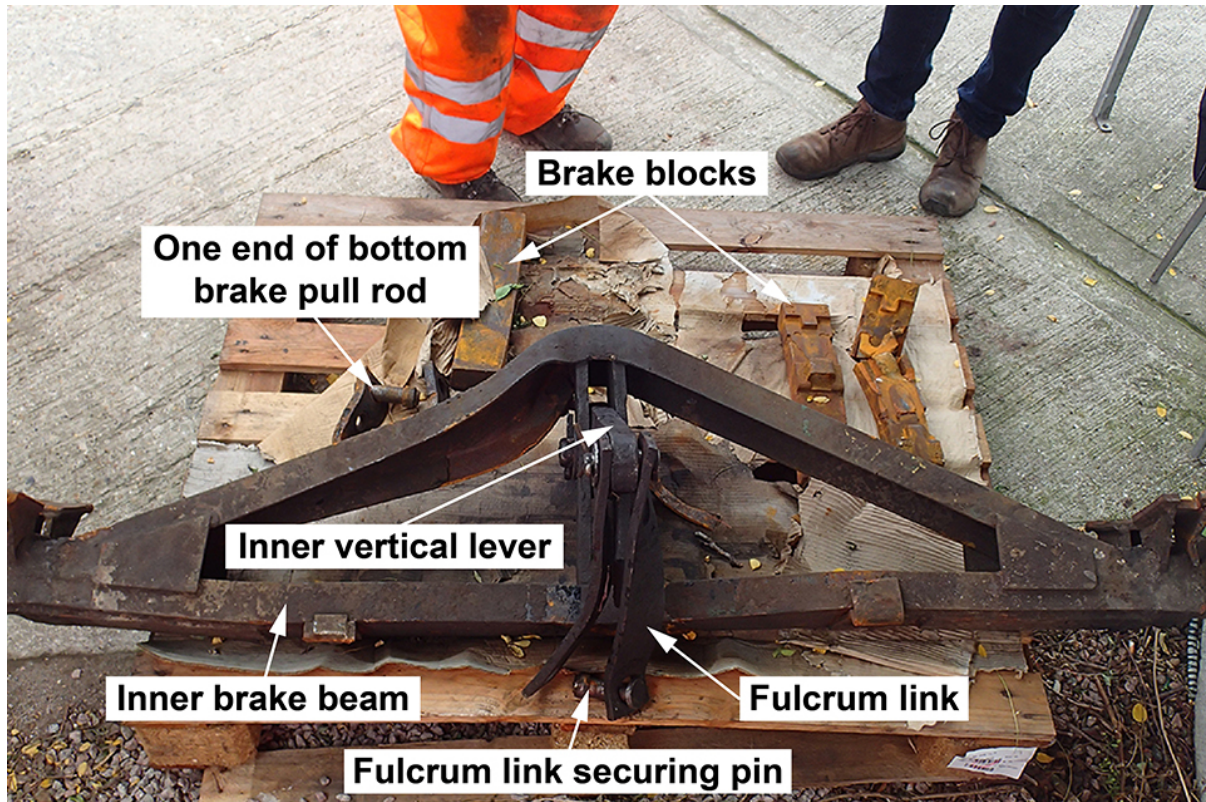
The braking components that fell from the leading bogie of the seventh wagon (figure 6) included a bottom brake pull rod, the leading wheel set inner brake beam and some associated components including brake blocks. This bottom brake pull rod had been positioned beneath the leading axle with each end connected to a brake system lever by a securing pin.

Figure 6: Detached wagon brake components

The most probable cause of the brake components falling from the underside of the wagon was a missing split pin in the securing pin at the leading end of the bottom brake pull rod. The securing pin then worked loose allowing the leading end of the pull rod to drop and bounce along the track until it struck switch and crossing components at Carpenters Road North Junction. This impact pushed the trailing end of the pull rod against the lever attached to the inner brake beam, causing this and associated components to break away from the bogie.

Evidence supporting this sequence of events comprises marks on the track indicative of the bottom brake pull rod bouncing on sleepers, and the deformation of components consistent with the inner end of the bottom brake pull rod exerting significant force on the inner vertical lever and fulcrum link (figure 6).

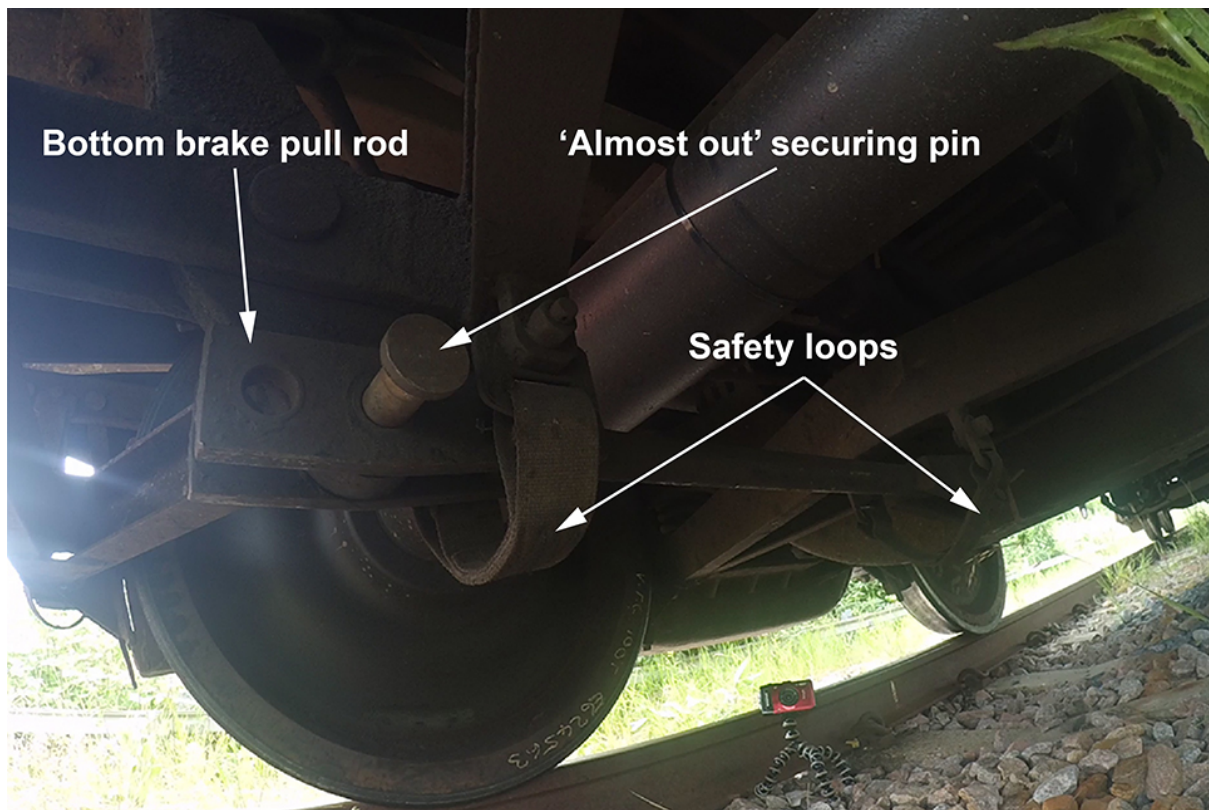
The investigation also found that the split pin was missing from the securing pin at the corresponding position on the bogie at the trailing end of the wagon, which had allowed the securing pin to almost work loose from the outer end of its bottom brake pull rod (figure 7). The absence of witness marks on the inner surface of the hole through which the split pin is inserted suggests that a split pin was never fitted or was not correctly fitted to this particular securing pin (figure 8).

**Figure 7: Trailing end bogie showing pin 'almost out' on trailing wheelset due to missing split pin at the end furthest from camera**

A detached bottom brake pull rod should not lead to an unsafe outcome. A safety loop is fitted underneath both ends of each bottom brake pull rod, which is intended to catch a detached pull rod and so prevent it falling onto the track (figure 7). The safety loops at the ends of the detached bottom brake pull rod show no evidence of significant contact with the detached rod. RAIB detached a bottom brake pull rod from its vertical lever at the other end of the wagon, and found it was successfully caught by the safety loop. However, when the detached rod was pushed back and forth there was sufficient travel for it to pass out of the safety loop and fall to the track. Such movement could be generated when the vehicle is in motion.

The owner of the wagon involved in the accident reported to RAIB that it is redesigning the arrangement of the safety loops to bring them closer together and so prevent a detached bottom pull rod falling past the safety loops. It is also intending to introduce a process to give an individual the responsibility for checking/inspecting the work which has been carried out either by themselves or others.

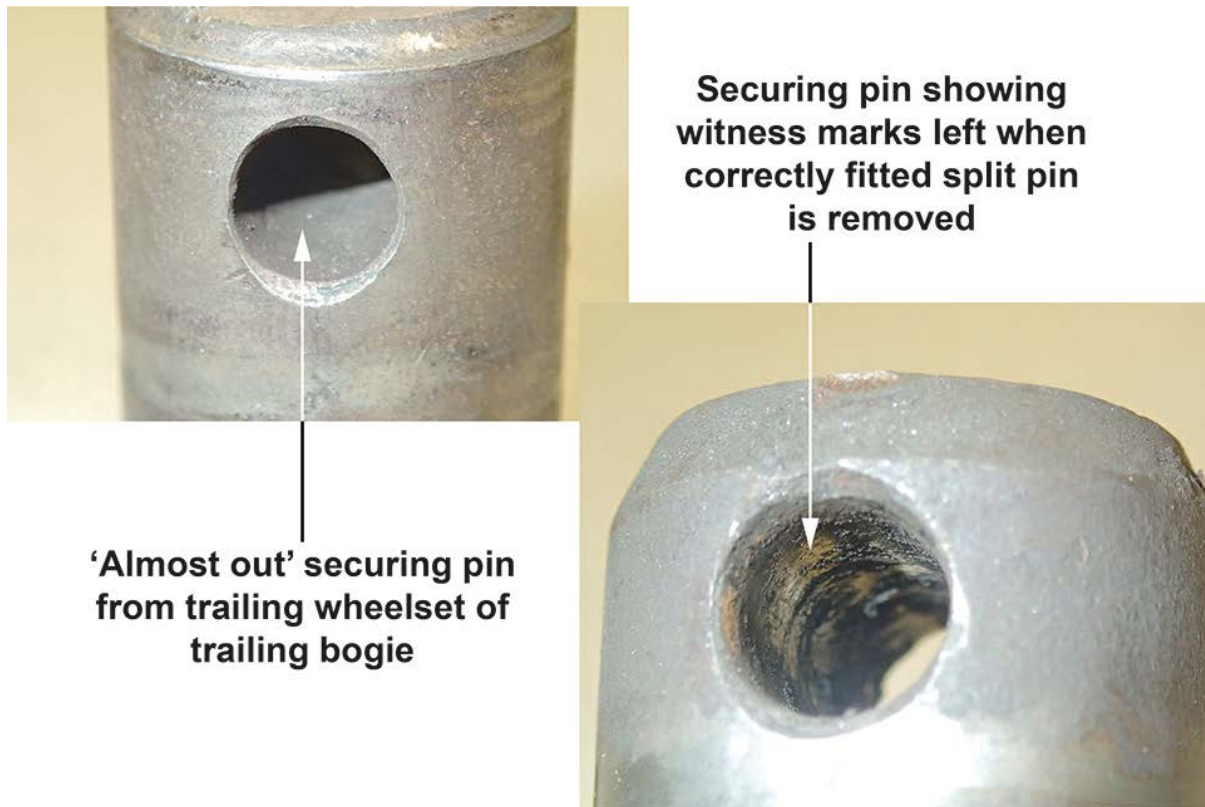
**Figure 8: Comparison between 'almost out' securing pin (left image) and a securing pin that had been in service with a correctly fitted split pin (right image)**

The bottom brake pull rod which fell from the wagon, and the bottom brake pull rod with the 'almost out' securing pin, were last disconnected from the braking system on 10 April 2019 when the associated wheelsets were replaced. New split pins should have been fitted when the brake pull rods were reconnected, but it is likely that the split pins at the two outer-ends were unintentionally omitted or not fitted correctly (figure 8).

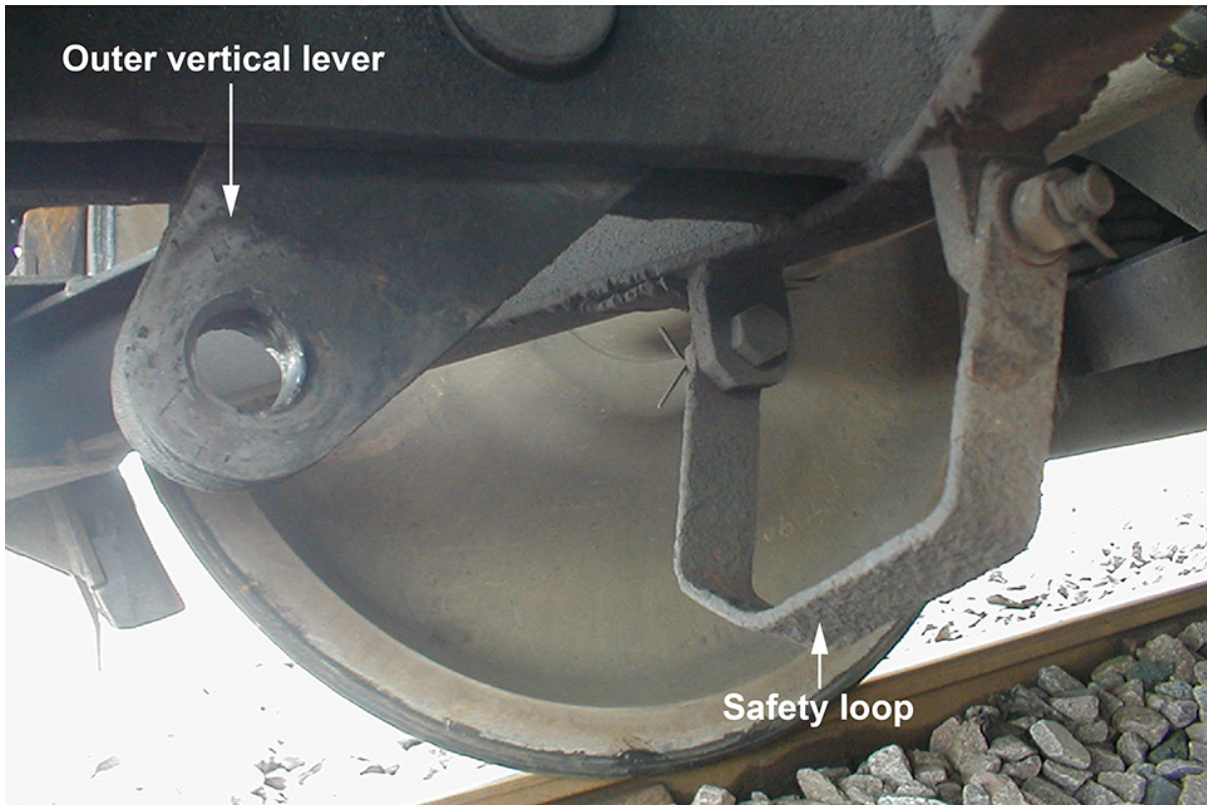
On 12 July 2001, it was reported through the GB rail industry's 'safety related defects on rail vehicles' reporting system (the NIR system) that a bottom brake pull rod, fitted to the same type of wagon as that involved in this accident, had become detached and that the safety loop failed to catch it when it fell from the underside of the wagon (figure 9). Photographic evidence indicates no significant contact between the detached lower brake pull rod and the safety loop. The NIR system does not record the details of any actions that were subsequently taken by the owners of the wagon type.

**Figure 9: Photograph of underside of wagon involved in July 2001 incident**
