Rail Accident Investigation Branch

Rail Accident Report

**Near miss with a track worker near Gatwick
Airport station
2 December 2018**

Report 12/2019
September 2019

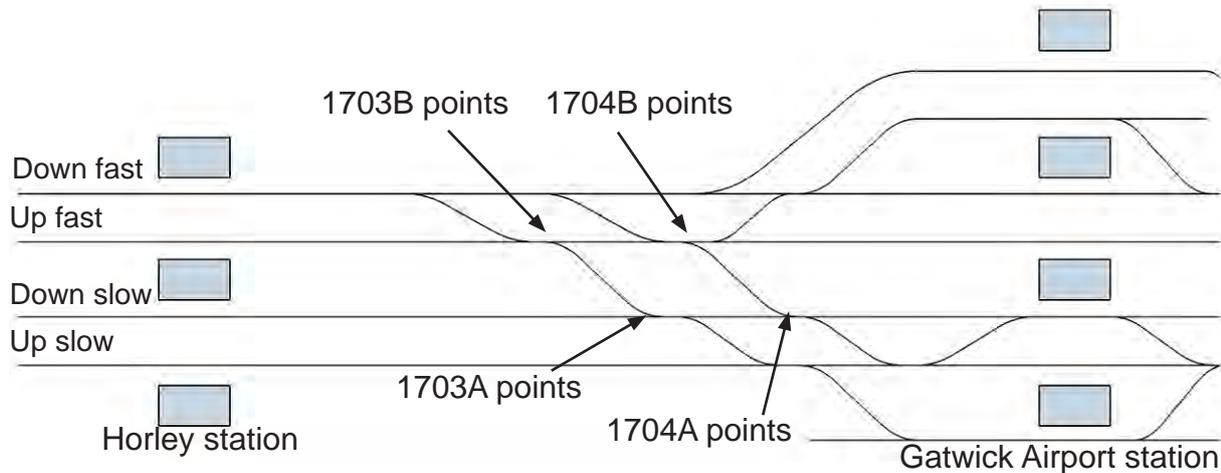
Figure 2: Track work in the area of the incident (not to scale)

- 5 The railway at this location comprises the up and down fast lines, up and down slow lines and crossovers between these (figure 2). The maximum permitted speeds for trains is 90 mph (145 km/h) on the fast lines, 70 mph (112 km/h) on the slow lines and 40mph (64 km/h) on the crossovers.

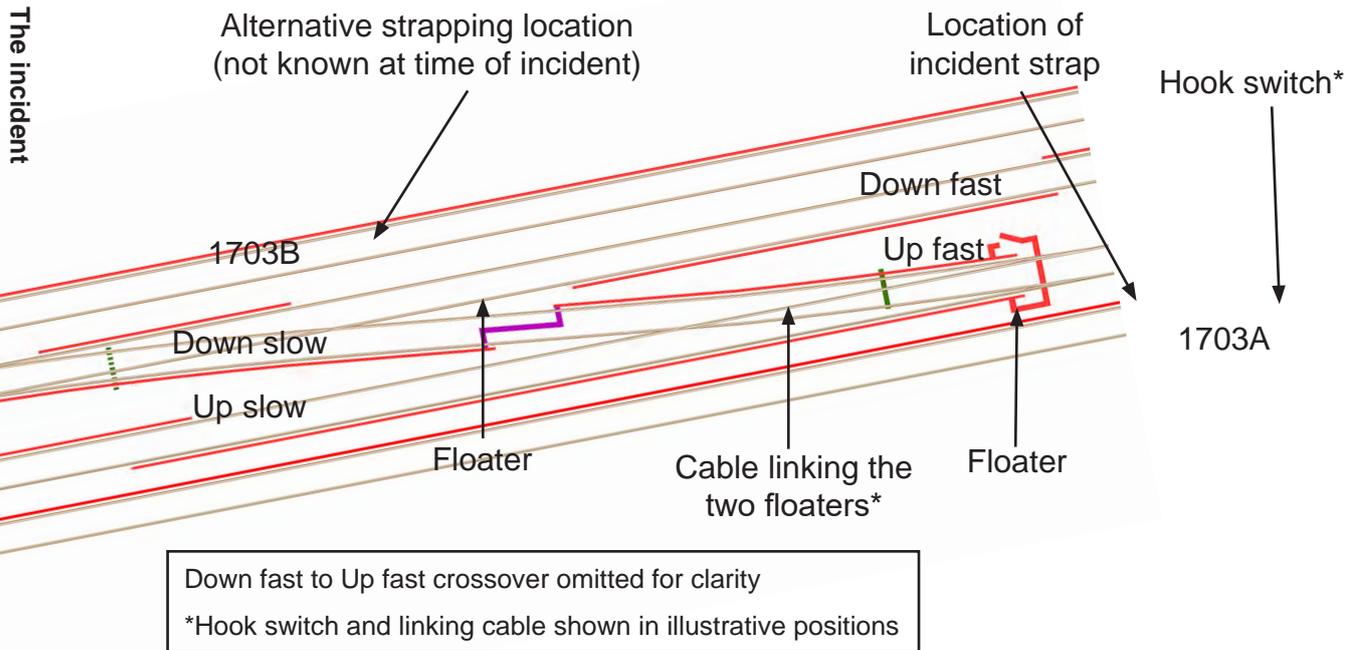
Figure 3: Crossover between 1703A and 1703B points (1704 points similar)

- 19 The infrastructure at the location of the incident includes two crossovers between the up fast and down slow lines. One, about 450 metres north of Gatwick Airport station, links 1703A points on the down slow line to 1703B points on the up fast line. The other, around 160 metres nearer the station, links 1704A points on the down slow line to 1704B points on the up fast line.
- 20 Conductor rails are provided on one side of each of the fast and slow lines. Two short conductor rails, known as floaters, are positioned alongside each crossover (figure 3). The pair of floaters at each crossover are linked by a cable, with the floater nearest the down slow line connected to the conductor rail by a cable and a hook switch, which can be opened and closed to allow the electrical feed to both floaters to be disconnected and reconnected.

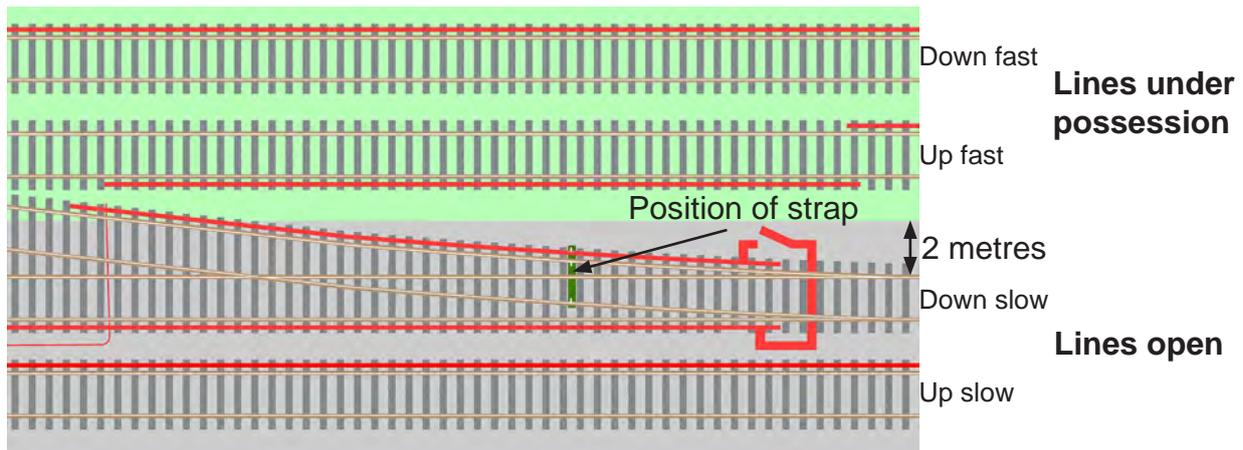
Figure 5: Strap location at 1703A points

- 36 When COSS1 and the strapping operative reached the crossovers, they fitted the straps at 1703A and 1704A points. This required work in the four-foot of the down slow line (between the rails, figure 5) which was open to traffic, but no trains passed.

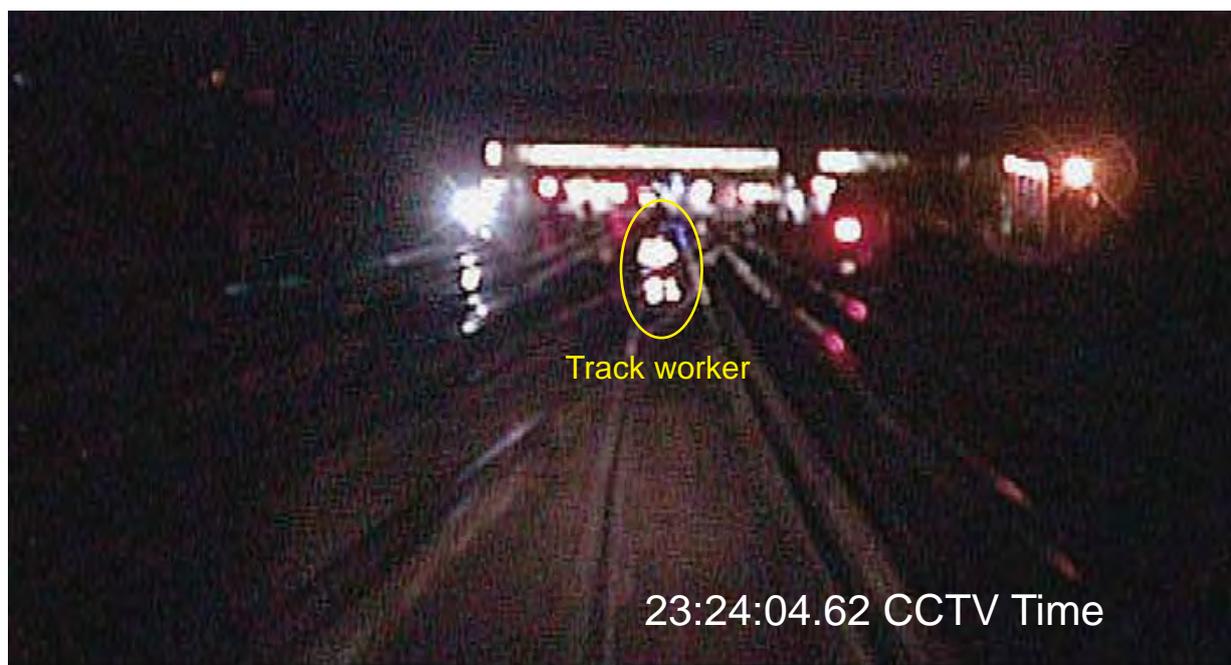
Figure 6: Forward facing CCTV image when train 1C82 was 3 seconds from COSS1 (courtesy of Southern)

- 42 Around 6.5 seconds before reaching COSS1, when the train was about 122 metres from 1703A points, the driver sounded the horn and did so continuously for around 5.5 seconds until about 1 second before the train reached COSS1.
- 43 When the train horn was sounded for the second time, the CCTV images show COSS1 starting to stand up and then stepping sideways out of the four-foot holding the short circuiting strap (figures 6 and 7). COSS1 raised his arm to acknowledge the train once he was clear of its path.

47 The forward facing CCTV footage recorded by train 1C82 shows that COSS1 was in the four-foot of the down slow line at 1703A points as the train approached (figure 6). COSS1 was stationary and leaning down while removing a short circuiting strap. He moved clear of the train around one second before it passed him.
