# Rail Accident Report

**Fatal accident at Tibberton No. 8 footpath  
crossing  
6 February 2019**

Report 13/2019  
October 2019

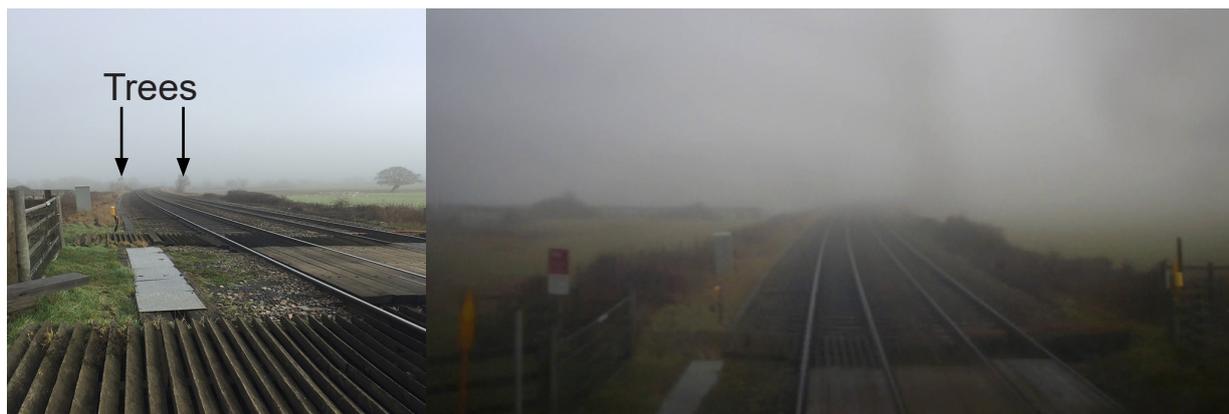
Figure 9: (left) Site conditions at 10:45 hrs and (right) FFCCTV from train 1M29 showing site conditions at 09:58 hrs (left image courtesy of Network Rail, right image courtesy of CrossCountry Trains)

- 62 **Because of the fog, the approaching train was not visible until it was three to four seconds away from the crossing.**
- 63 When train 1V05 left Birmingham New Street station at 09:30 hrs the weather was overcast but clear. It was only when the train passed Barnt Green on the outskirts of Birmingham that fog began to appear. Visibility got progressively worse and witness evidence indicates that by the time the train reached Bromsgrove, visibility was limited to a '*couple of hundred metres*'. The weather at this location on the day of the accident was described as '*very foggy*'.

- 64 The CCTV footage from train 1V05 shows how the fog progressively thickened as the train approached Tibberton No. 8 footpath crossing. Based on the footage, the RAIB calculated that the sighting time four kilometres north of Tibberton No. 8 crossing was approximately eight seconds. As the train approached the crossing, the visibility and hence the sighting time reduced to between three and four seconds.
- 65 Railway staff who attended the site took a photograph (figure 9) approximately 45 minutes after the accident (at around 10:45 hrs), at a time when the fog had started to lift. They indicated that at the time of their arrival on site (at around 10:20 hrs), the trees shown on the photograph were not visible.

- 66 A still image in the FFCCTV footage from train 1M29 which passed over the crossing approximately 20 seconds before the accident is shown in figure 9. The same trees cannot be seen on this footage. The trees are about 225 metres away from the crossing which, at a travelling speed of 100 mph (161 km/h), represents 5 seconds of warning time. A second later, the tree on the left-hand side starts to become visible.
- 67 At the time of the accident, the sighting time of a class 170 train<sup>21</sup> from the crossing was therefore between three and four seconds<sup>22</sup>. This is significantly less than the minimum required warning time of 7.6 seconds calculated in the narrative risk assessment.

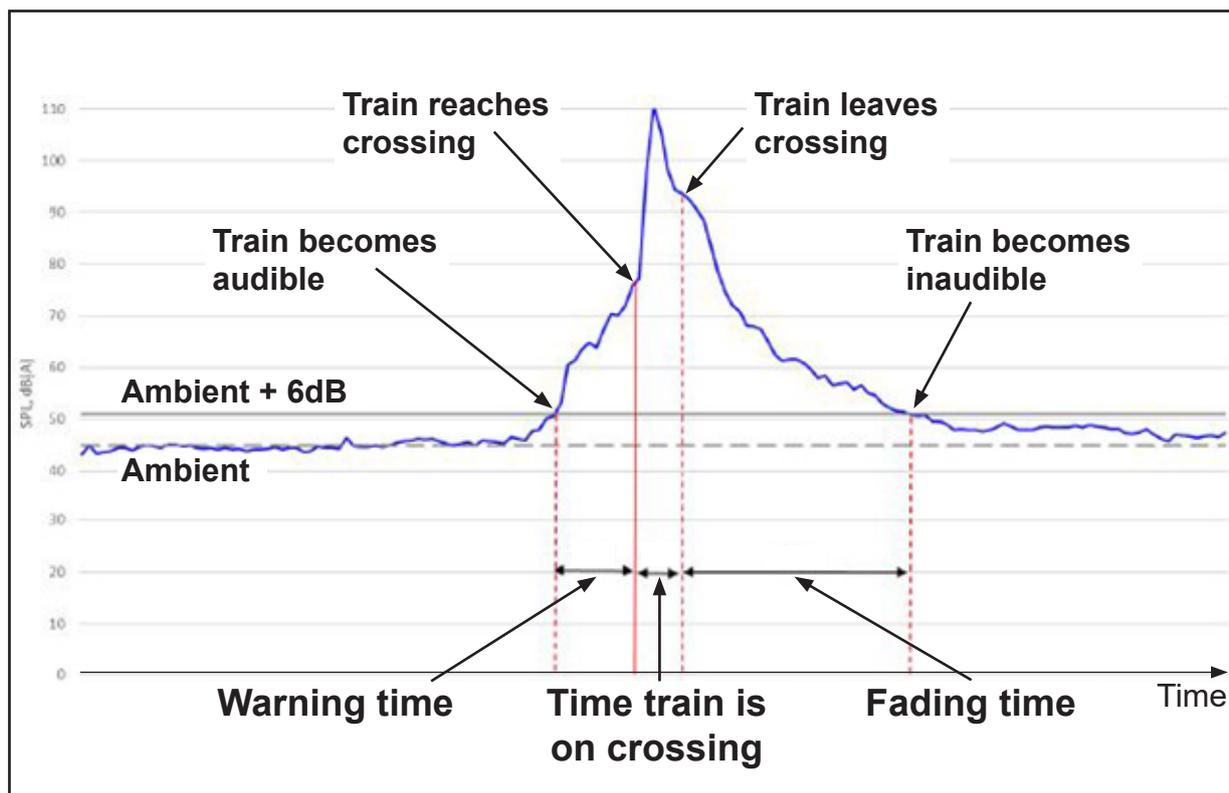
Figure 10: Typical sound trace recorded at Tibberton No. 8 footpath crossing

- 70 Measurements of background sound pressure levels (SPL) were carried out and found to be between 34 and 46 dB, depending on the time of day. The acoustic specialist advised the RAIB that there was no existing standard or research which defined the required difference in sound pressure level to make the general noise caused by an approaching train audible above the ambient noise<sup>23</sup>. Based on his experience, he suggested that a 6 dB difference represented a 'just audible' condition<sup>24</sup> (this being double the sound pressure). A typical sound trace of a train passing the crossing is shown in figure 10.

- 73 Table 1 shows that, depending on the background sound level, the time from a train becoming 'just audible' to the front of it arriving at the crossing varied between three and eight seconds. The time for it to become 'just inaudible' was longer, between eight and seventeen seconds.
- 74 The time from the train becoming 'just audible' to the front of the train reaching the crossing is the audible warning time. Therefore a user standing at the crossing is provided with three to eight seconds of audible warning time for the types of train considered (class 170 and class 220/221), from either direction. For a class 170 train approaching on the down line, as was the case during the accident, the audible warning time was between three and four seconds.
- 75 This is significantly less than the minimum required warning time of 7.6 seconds calculated in the narrative risk assessment.

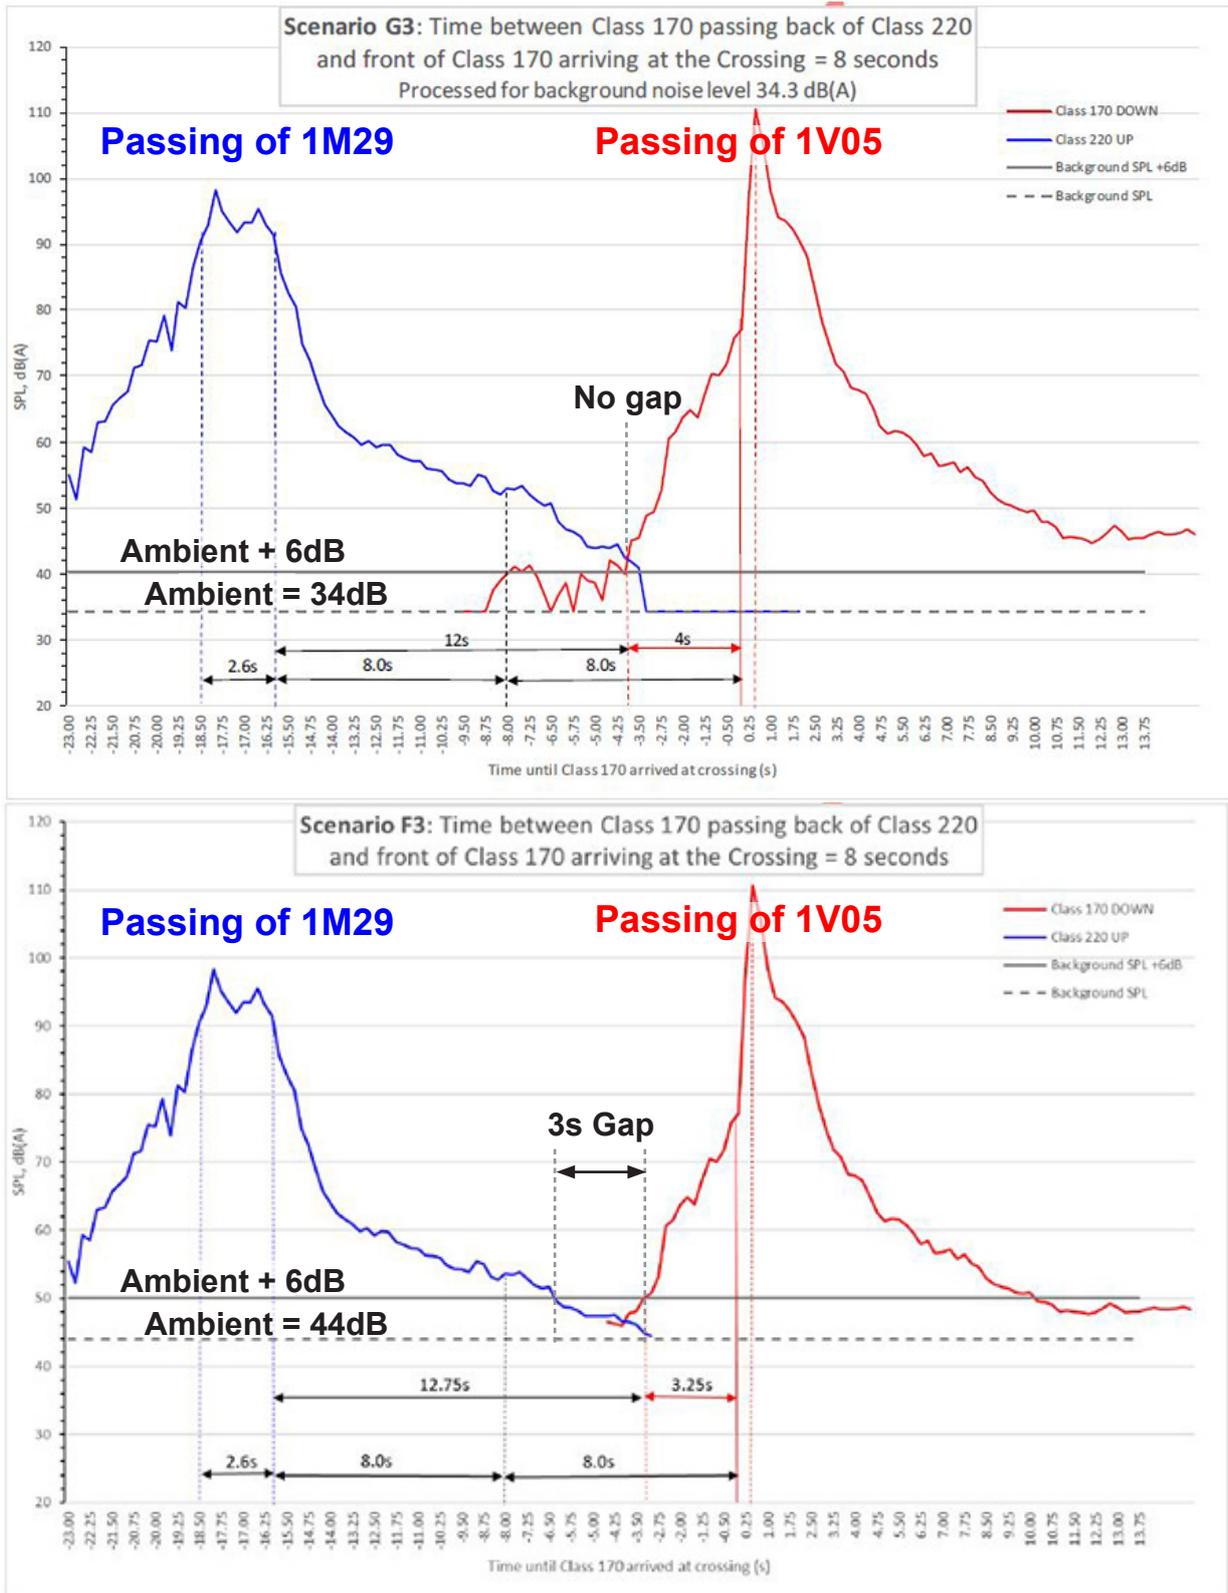
Figure 11: Passing of the two trains (low/high ambient)

- 78 Figure 11 shows that, for a low ambient sound level at 34 dB, the sound of the passing train (1M29) reached the inaudible level just as the sound of the approaching train (1V05) became audible. Figure 11 also shows that, for a higher ambient sound level at 44 dB<sup>26</sup>, the sound from the passing train (1M29) had been inaudible for approximately three seconds before the sound of the approaching train (1V05) became audible.
