# Door open in traffic between Shenfield and Hockley stations, 22 August 2019

## Summary of the incident

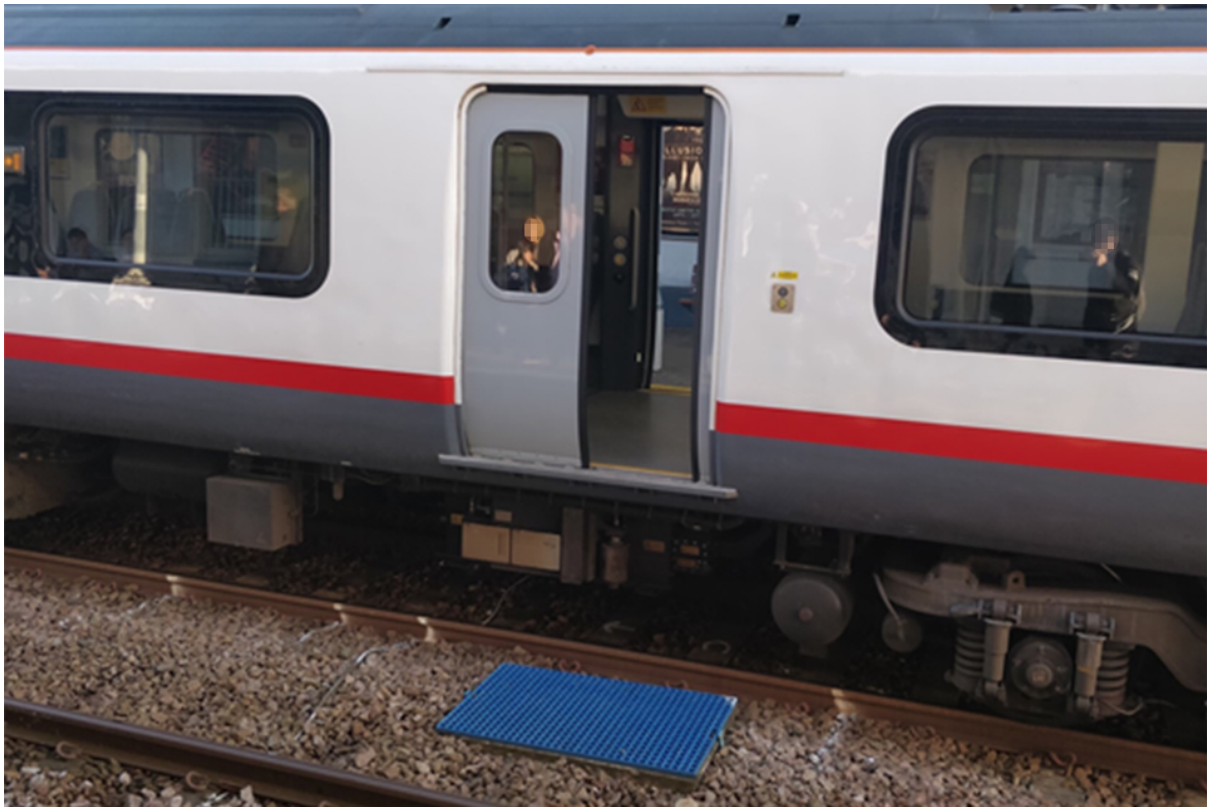
There is no evidence of abnormal door behaviour before the train stopped at Shenfield station, where doors on the right-hand side of the train were opened. When the train driver subsequently operated the door close control, the door involved did not close completely. The partly open door was not apparent from the position where platform staff visually check that doorways are clear of obstructions before a train departs. The door interlock system, designed to detect if any doors are not fully closed, detected that all doors were closed. As a result, the 'doors open' indication, given by a yellow hazard light on the coach side, had extinguished and the driver received a visual indication all doors were closed. Because the door interlock system detected that all doors were closed, the train was able to move away when commanded by the driver.

**The door involved in the incident, at Hockley station (image courtesy of Tim Neobard). Note: the blue panel below the open door is not part of the train**

The train departed from Shenfield at around 06:58 hrs and, during the following 23 minutes, stopped at four stations with platforms on the left-hand side, including Hockley, where a passenger reported the open door to the driver and the train was taken out of service.

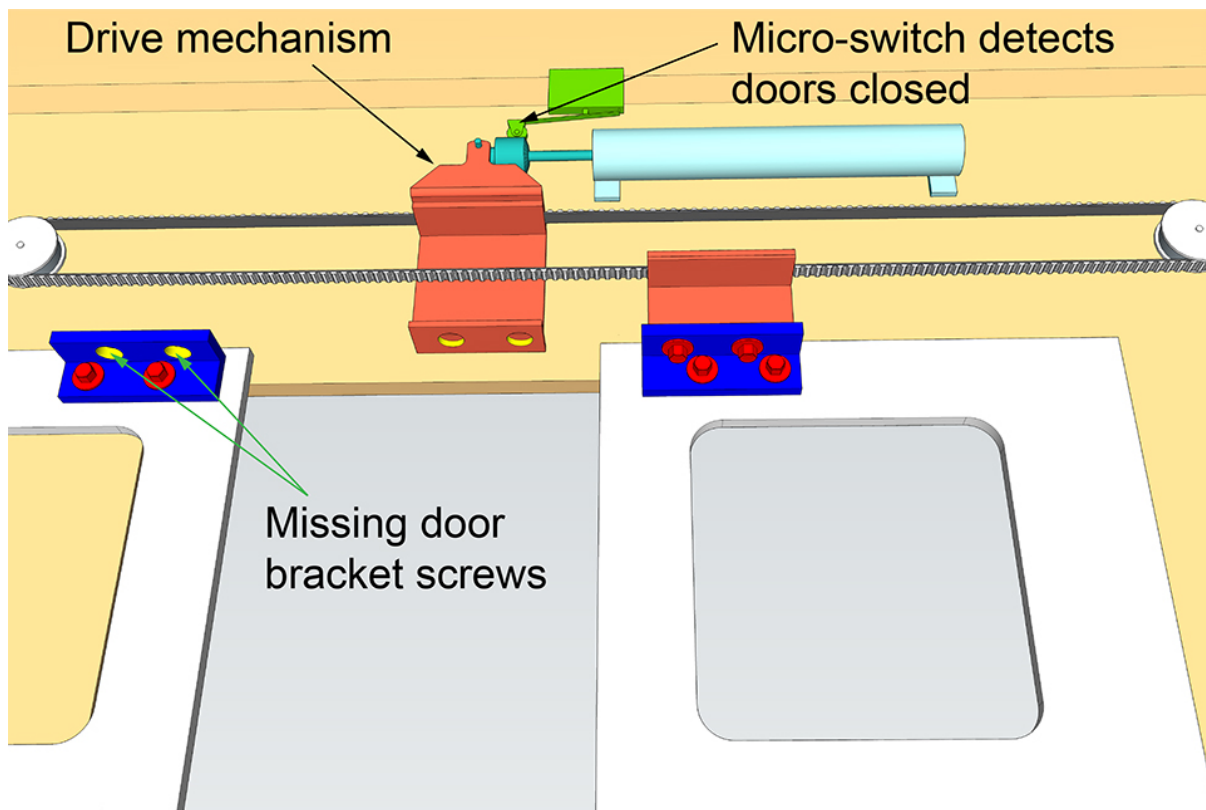
**Schematic of door mechanism with one door leaf remaining open because it is detached from mechanism (only relevant components shown, not to scale)**

The door leaf which remained open between Shenfield and Hockley had become detached from the drive mechanism because the two screws fixing its bracket to the drive mechanism had worked loose and fallen from the bracket. The two screws and the associated four wedge lock washers were found by the driver, while at Hockley, when he opened a panel giving access to the door equipment. With the screws fallen from the bracket, the door leaf did not respond to movement of the drive belt and was free to open and close in response to the train's motion.

The interlock circuit on class 321 trains monitors the position of the doors using a micro-switch which detects the position of the drive belt piston rod. This rod moved to the door closed position when the driver operated the 'doors close' control at Shenfield so the interlock incorrectly indicated that all the train doors were fully closed.

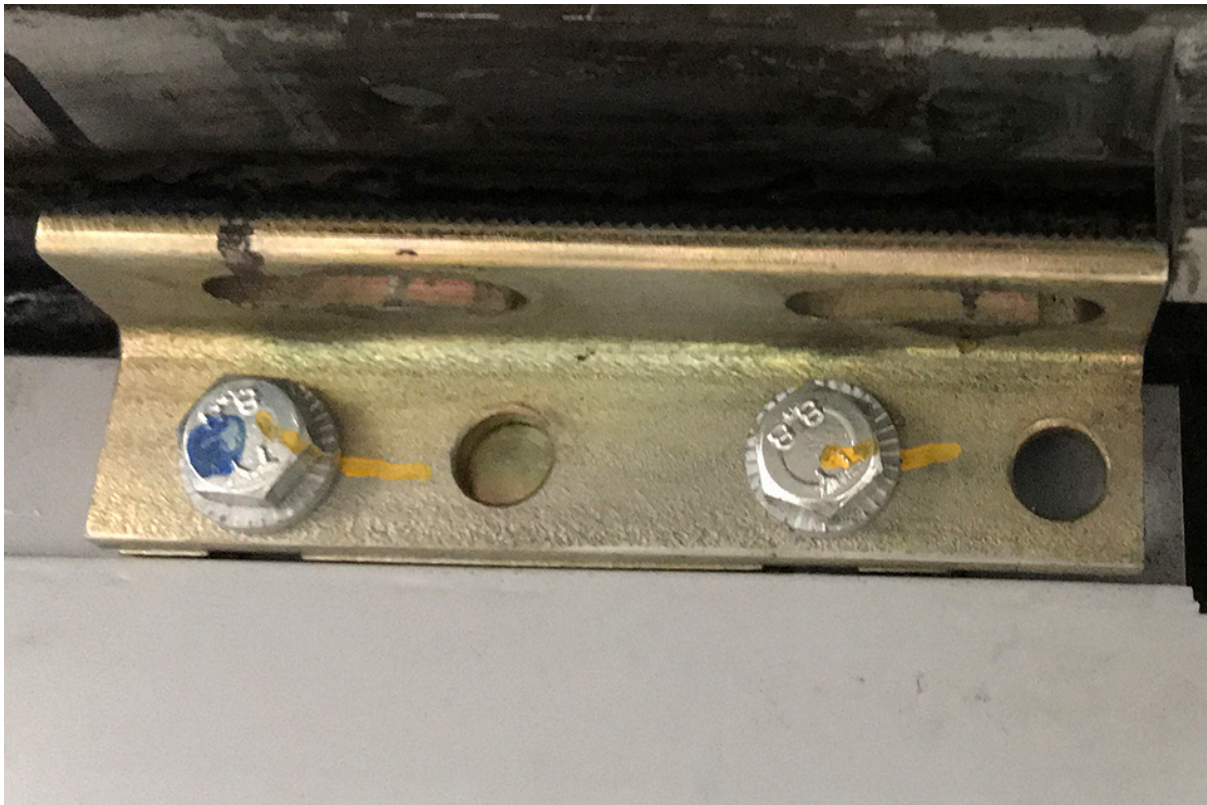
Refurbishment by Wabtec included providing new screws for the brackets connecting the door to the drive belt. The fastening arrangement was specified by Eversholt document (EV/VI 3216 Task OR3512) as two screws on each bracket flange with a pair of wedge lock washers fitted beneath each screw head, the aim being to avoid the screw working loose. A screw torque of 22 Newton metres (Nm) was given in an associated Eversholt technical procedure. The specification was dated February 2012 and replaced an earlier version which required a different method designed to prevent loosening of the screws at this location.

Wabtec required its staff to paint a yellow mark across the screw head, washer and bracket when they had tightened each screw to the specified torque. This assists maintenance staff to identify any subsequent loosening of the screw, as rotation results in misalignment of the marks.

Wabtec also required that a second person should witness the tightening, check 50% of the screws by applying 80% of the specified torque and then applying a blue dot to the screws which they had checked.

There were no yellow marks on the two screws which fell from the connection between the bracket and the drive belt, and no yellow mark adjacent to the corresponding holes in the bracket. Both these screws carried a blue verification dot. Yellow marks were present on the screws which secured the bracket to the door and one of these also carried a blue dot.

**Door bracket with upper flange showing absence of yellow marks on holes from which screws connecting to the drive belt had fallen. Both screws connecting the side flange to the door have yellow marks and one has a blue mark. The other two holes on the side flange were not required to contain screws.**

Following the second plain spanner check, Greater Anglia loosened and re-torque-tightened all door bracket screws on its refurbished class 321 units. When specifying the torque to be applied, Greater Anglia identified an inconsistency between the torque value of 22 Nm specified by Eversholt and the 29 Nm recommended by the wedge lock washer manufacturer. As Greater Anglia believed that the tapped holes in the door would not reliably withstand the wedge lock washer manufacturer's recommendation, it consulted the wedge lock washer manufacturer when specifying a torque of 25 Nm for this work. Eversholt is reviewing the required torque after commissioning an independent review of the fastening system which recommended that the 25 Nm torque should be maintained.

Greater Anglia has stated that it has introduced an enhanced door bracket screw monitoring programme and will undertake further remedial action if necessary, until it is satisfied that the issue has been resolved.
