SS Richard Montgomery 2006 Survey Report

Executive Summary

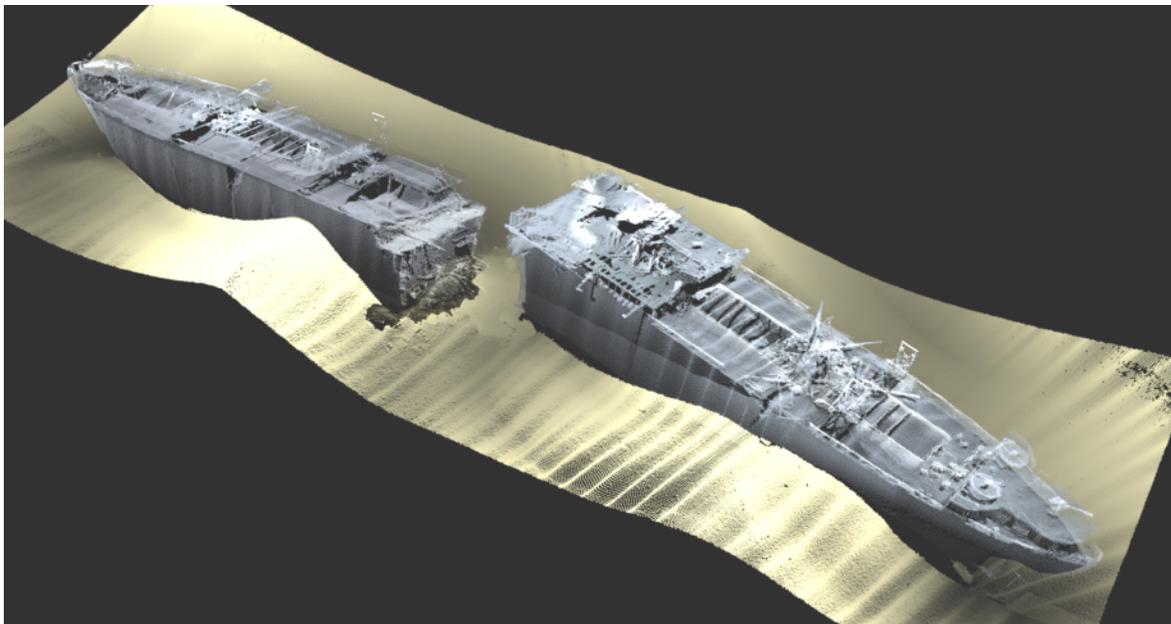
The wreck still looks in remarkably good condition. The results of the 2005 and 2006 surveys indicate that there are some structural problems with the hull, which is consistent with other wrecks of a similar age.

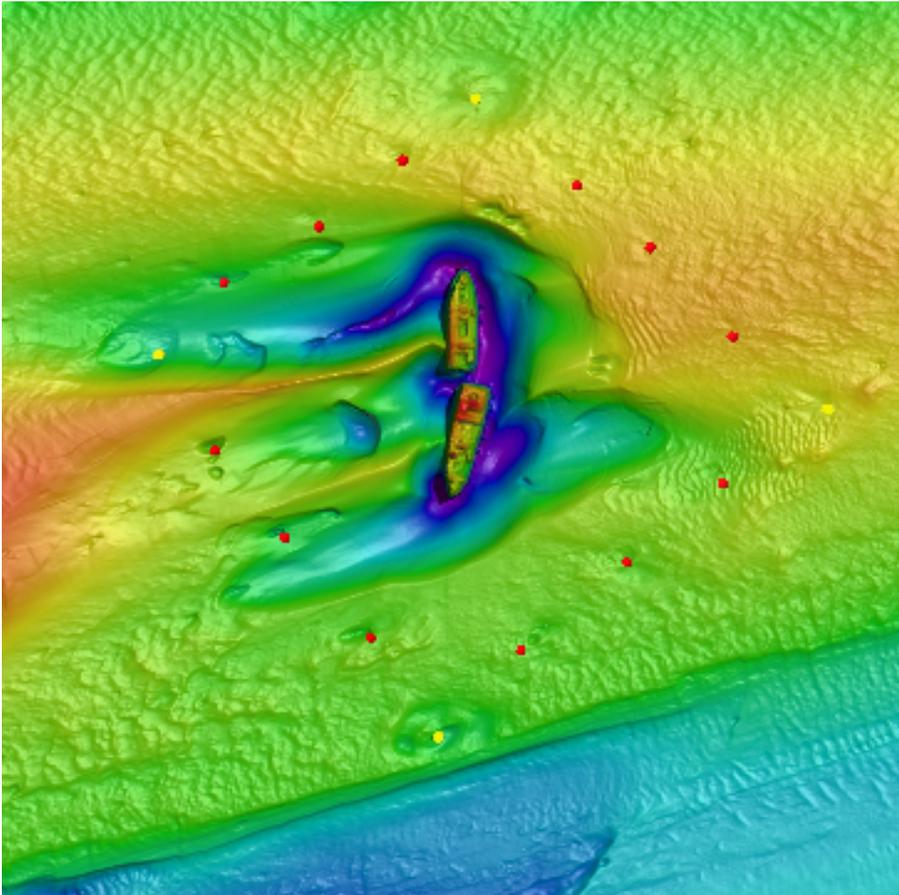
An area around the wreck is marked with twelve red danger buoys and four yellow navigational buoys at cardinal points. Each buoy's position is indicated in the figure above and, in some cases, their sinkers and associated scour can be identified on the seabed close to the buoys.
