REPORT
ON THE WRECK OF THE
SS RICHARD MONTGOMERY

Maritime and Coastguard Agency
Spring Place
105 Commercial Road
Southampton
SO15 1EG

November 2000

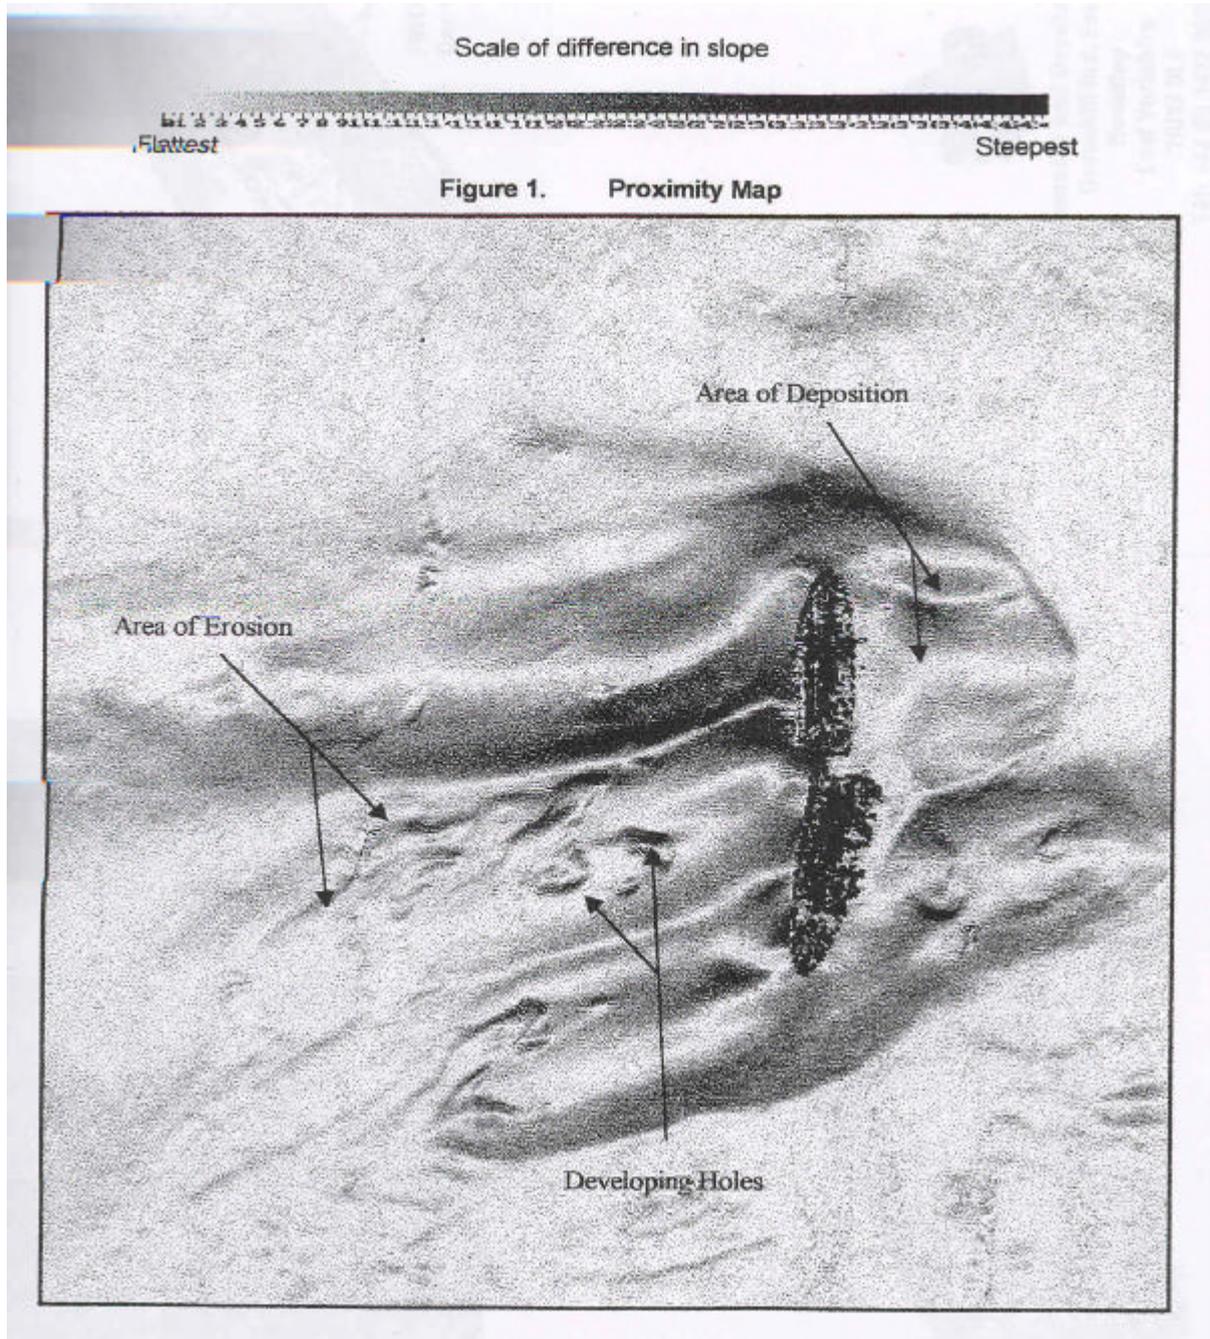
MONOCHROMATIC GRADIENT PLOT 2000

16. The monochromatic gradient plots in Appendix 4 reveal details of the ship's structure. These plots also reveal details of small seabed topographical features such as sand ripples over the area.

20. The orientation and position of the wreck were observed. The following points were noted:
- The crack observed in the starboard side of the forward section in last year's survey was not detected in the 2000 survey.
 - A hole has been observed in the port side of the forward section. The dimensions of the hole are approximately 1 m wide x 2.5 metres high. It is approximately 1.5 metres below deck level. This suggests significant deterioration of the hull plates.
 - Eight items of overhanging debris have again been detected. These have been provisionally identified as derricks from forward and aft masts, and 4 life-boat davits.
 - The debris between the two pieces of wreck is generally unchanged from the previous survey.

21. The inspection of the wreck shows that there has been some changes to the structure below surface. In last year's survey, an object was observed to have fallen from the superstructure onto the seabed, and 2 large holes have been observed on the seabed to the west of the aft section of the wreck. This year a hole has appeared in the side of the port bow.

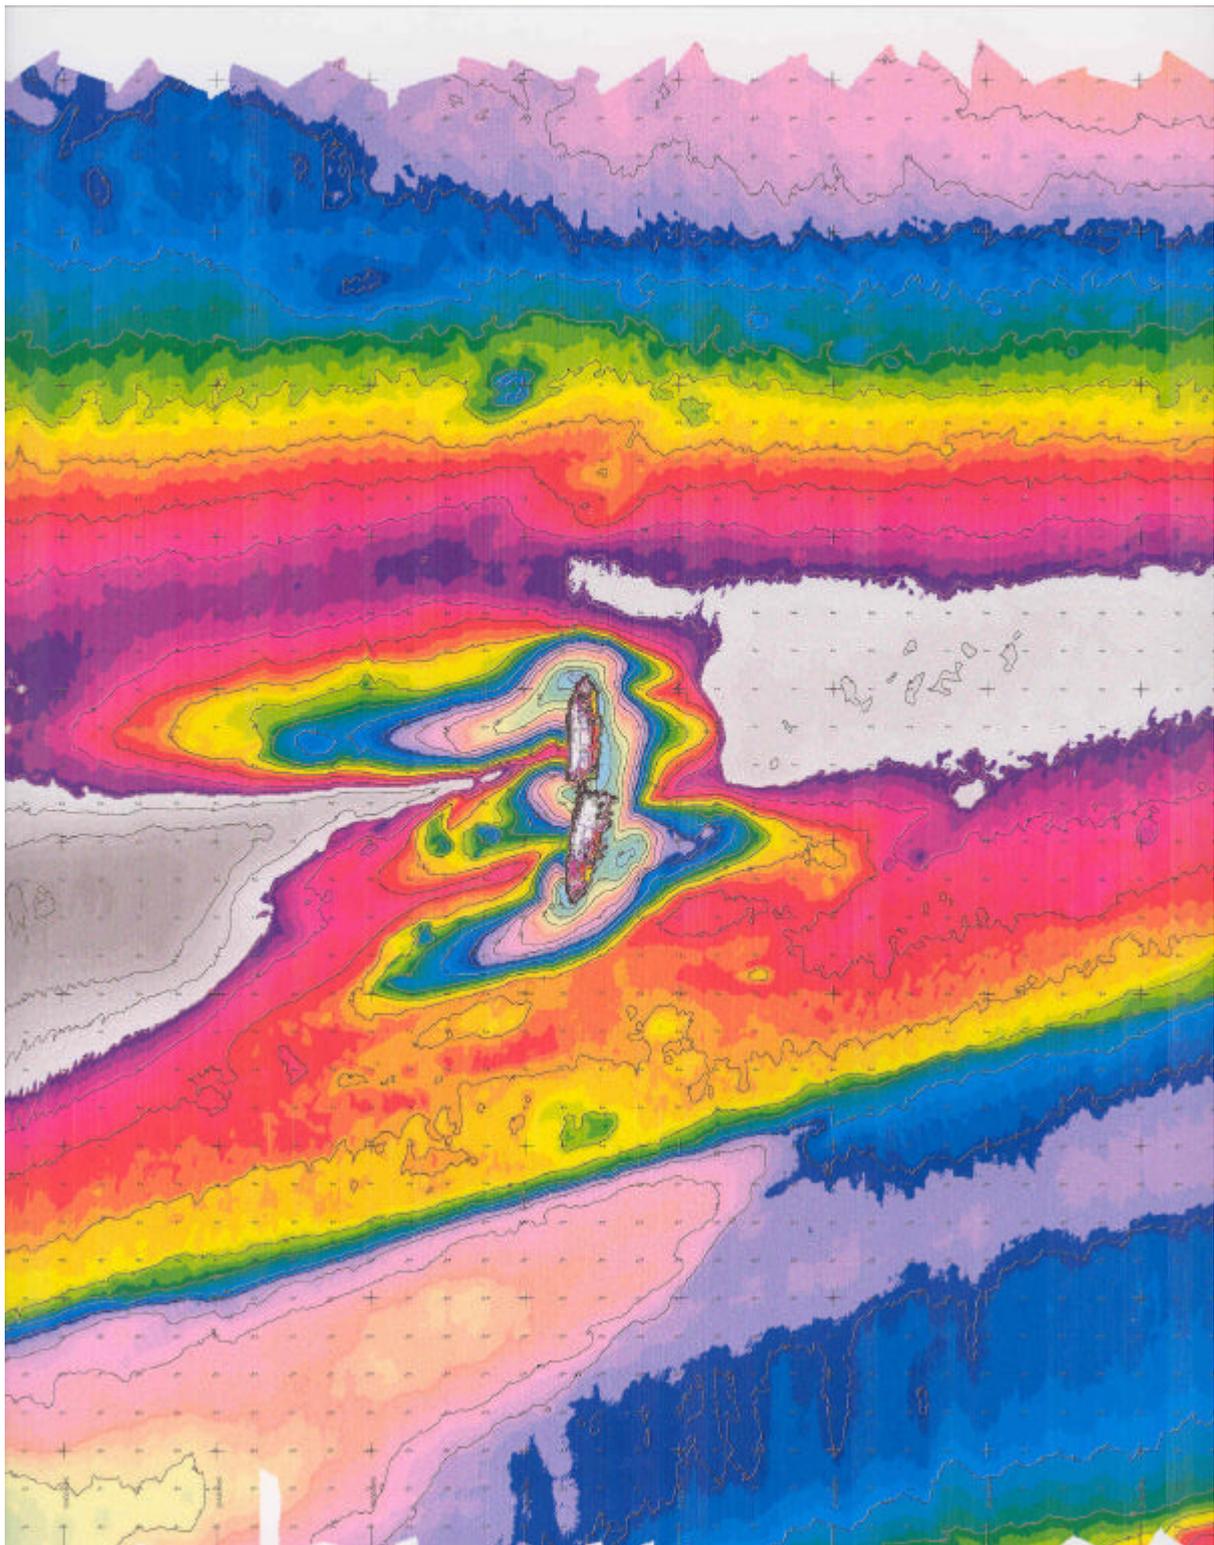
17. The following features within the survey area might be observed from the solid contour plot at Appendix 5:
 - **The Wreck Site**
The wreck site occupies the central part of the survey area. It is the area enclosed by the 9-metre contour and may be considered to be the area of seabed topography most influenced by the presence of the wreck.

- **The Medway Dredged Channel**
The Medway dredged channel occupies the southern part of the survey area, which is orientated in the region of 072°/252° and is bounded by the southernmost 9-metre contour in the survey area.

- **The Sheerness Middle Sand**
The Sheerness Middle Sand occupies the central part of the survey area. This sand bank is most extensive in the western part of the survey area. It is broken by the wreck site and continues to the east of the wreck site. The 6-metre contour of this feature is continuous to the north, and to the south this feature is continuous along the 8-metre contour.

- **The Great Nore Anchorage**
The Great Nore Anchorage forms a north eastern boundary to the survey area.
18. The survey shows that the 15-metre contour is more extensive than shown on the published chart. This contour extends some 10 to 30 metres from the east side of the wreck into two elongations to the west side of the wreck. On the east side, the contour is at its maximum distance from the wreck opposite the centre part of each section. The elongation at the bow of the vessel extends some 80 metres on a bearing of 238° and at the stern, the elongation is shorter at only 25 metres to the south west. From the colour contour plot at Appendix 4 it can be seen that the shallowest parts of the wreck are at a similar depth to the shallow parts of the Sheerness Middle Sand.
