REPORT  
ON THE WRECK OF THE  
SS RICHARD MONTGOMERY

Maritime and Coastguard Agency  
Spring Place  
105 Commercial Road  
Southampton  
SO15 1EG

March 2000

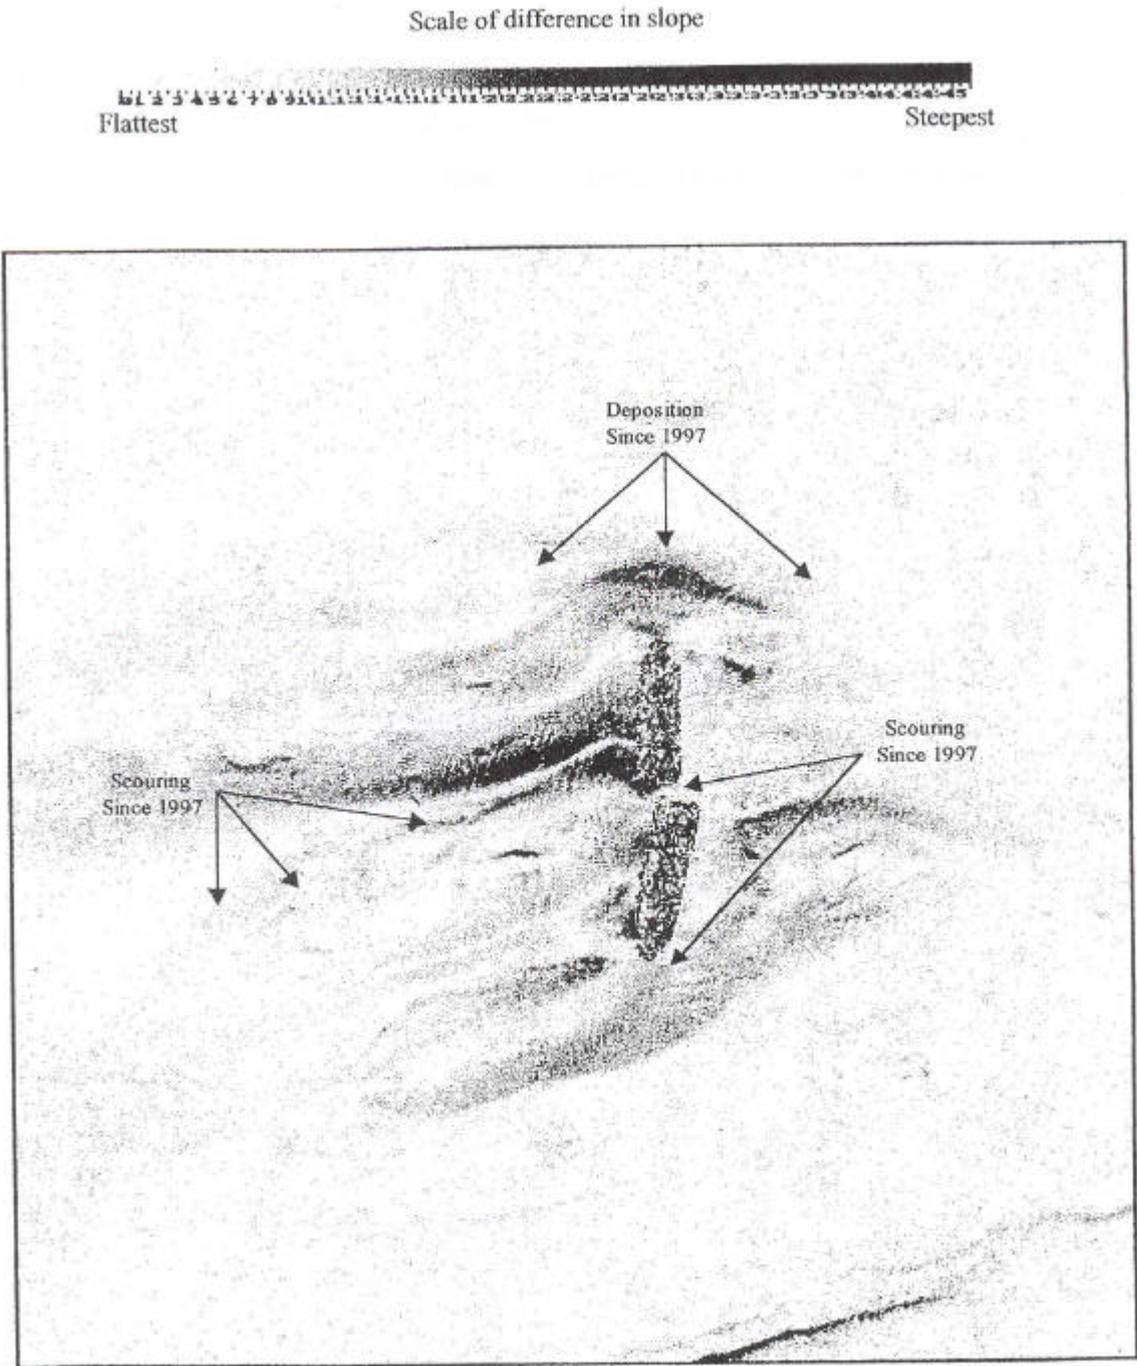
MONOCHROMATIC GRADIENT PLOT 1998

13. The monochromatic gradient plots in Appendix 3 reveal details of the ship's structure. These plots also reveal details of small seabed topographical features such as sand ripples over the area.

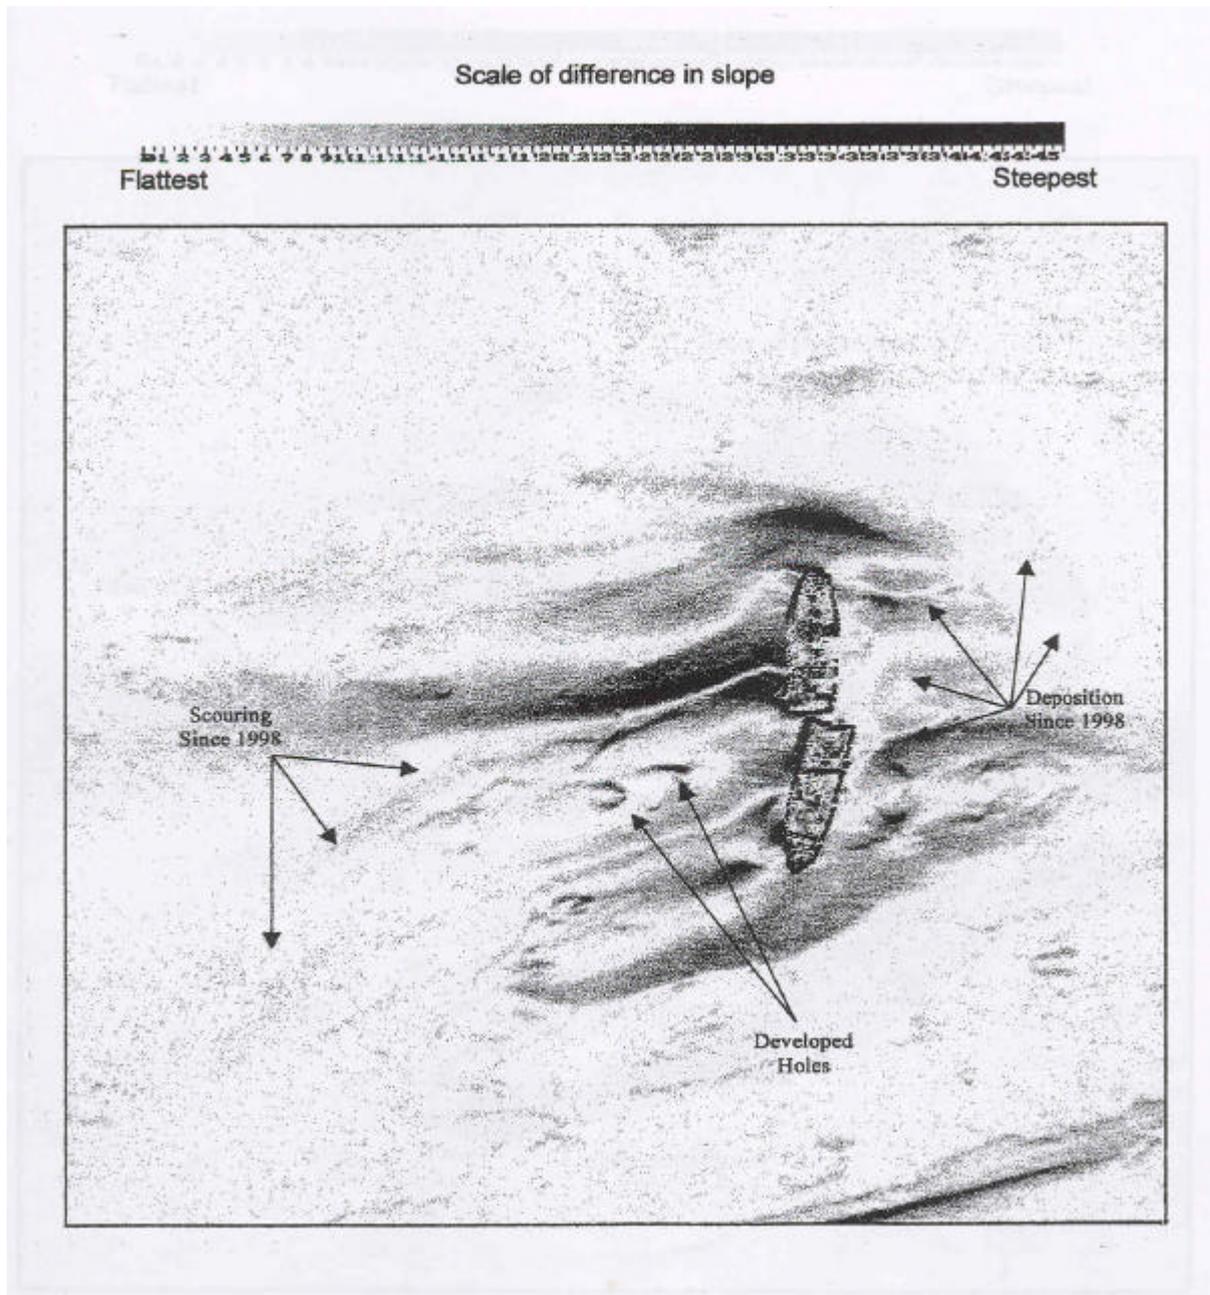
# MONOCHROMATIC GRADIENT PLOT 1999

11. The presence of the wreck on Sheerness Middle Sand has caused localised changes in the seabed topography. The wreck was examined in detail and appears stable although showed some minor, but possibly significant changes to the structure and surrounding seabed. Slight changes in the scouring, and the development of 2 holes in the seabed nearby were also noticed. An area of small contacts in the break of the wreck was again detected. The most noticeable change was an object which had fallen from the superstructure, possibly indicating decay.
