SAFETY FLYER TO THE FISHING INDUSTRY

Fishing Vessel *Artemis* (FR 809) fatal fall within accommodation space

29 April 2019

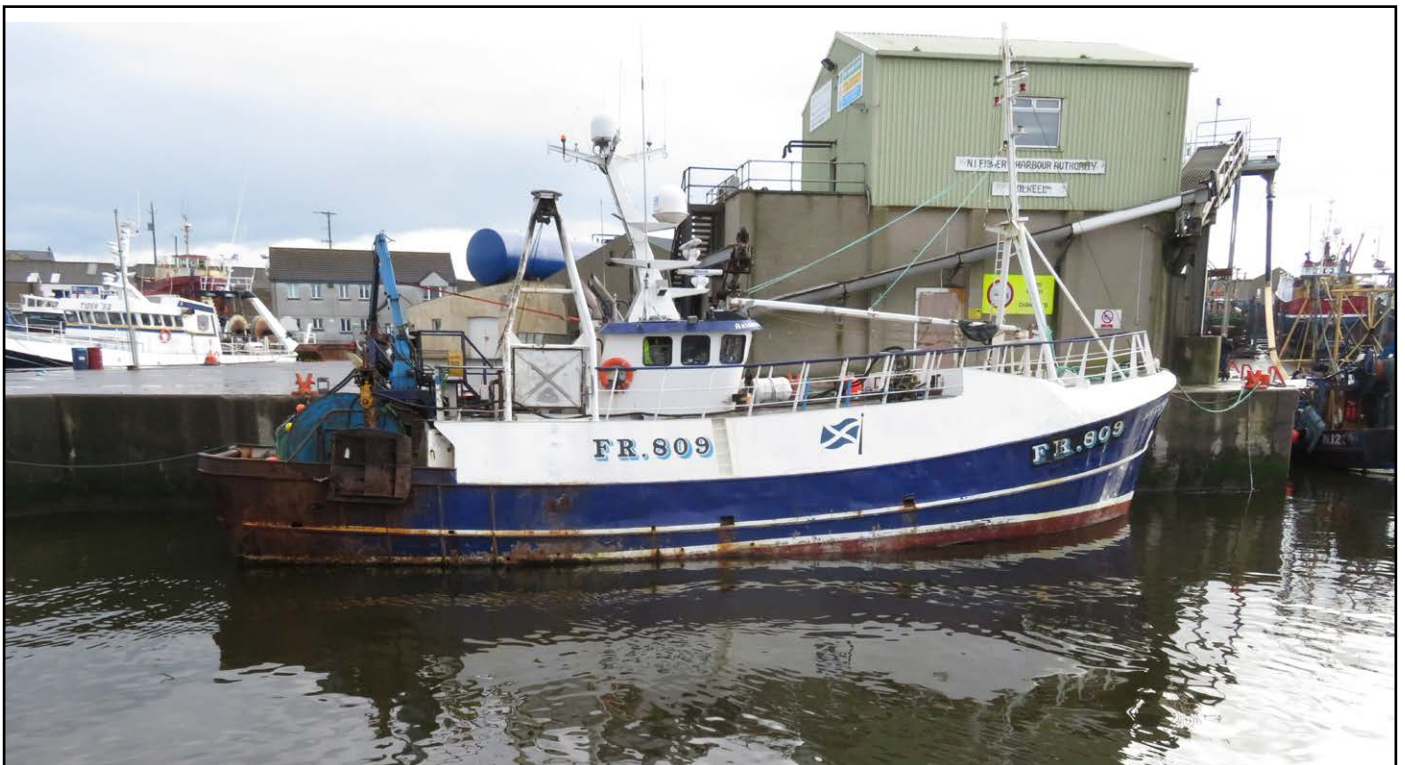
At about 1630 on 29 April 2019, the skipper of the UK registered fishing vessel *Artemis* (**Figure 1**) suffered severe head injuries and died after he fell head-first through an access hatch between the vessel's wheelhouse and its mess deck 2.1m below. The vessel was berthed alongside in Kilkeel, Northern Ireland and the skipper had just returned from an afternoon ashore with one of his deckhands. They had both spent 3 hours in a local public house drinking alcohol.

Figure 1: *Artemis* alongside Kilkeel, Northern Ireland

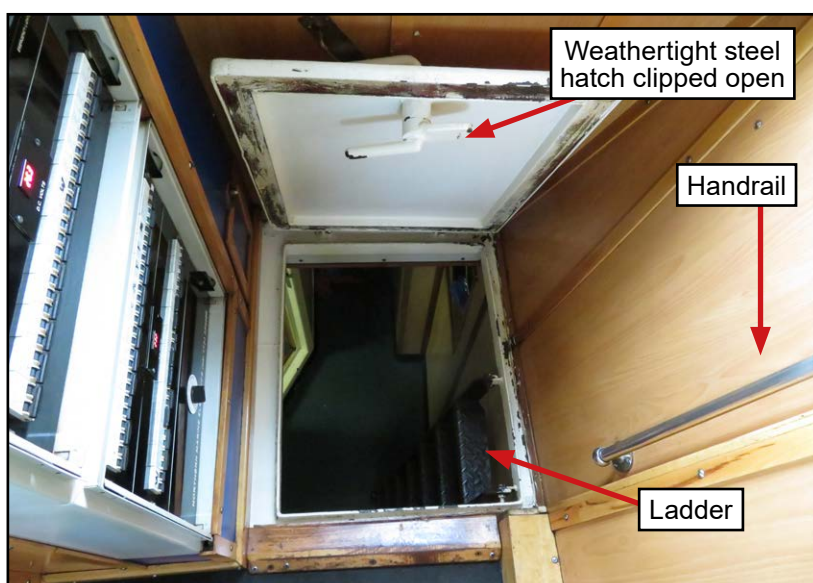
It was not possible to determine whether the skipper slipped, tripped or stumbled before he fell through the hatch because there was no one in the wheelhouse to witness it. However, it was apparent that the access route layout, which had been modified after build, and the effects of alcohol, both contributed to the fall and the severity of the injuries suffered.

Post-build modifications to the access route between the vessel's wheelhouse and the mess deck increased the likelihood and consequences of someone falling through the mess deck hatch. It placed those working in the wheelhouse at significant risk of falling through an unguarded opening (**Figure 2**). Fishing vessel risk assessments understandably concentrate on the dangerous activities that surround the operation of the vessel's fishing equipment, however, the risks posed by internal hatches, ladders and stairways should not be overlooked. In this case, although the vessel had been surveyed many times since the modifications were made to the wheelhouse hatch and ladder, it was clear that the hatch required a physical barrier to prevent personnel inadvertently falling through the opening.

Figure 2: Hatch and ladder to crew accommodation
