Equipment explosion on an empty passenger train, 26 September 2019

Summary of the accident

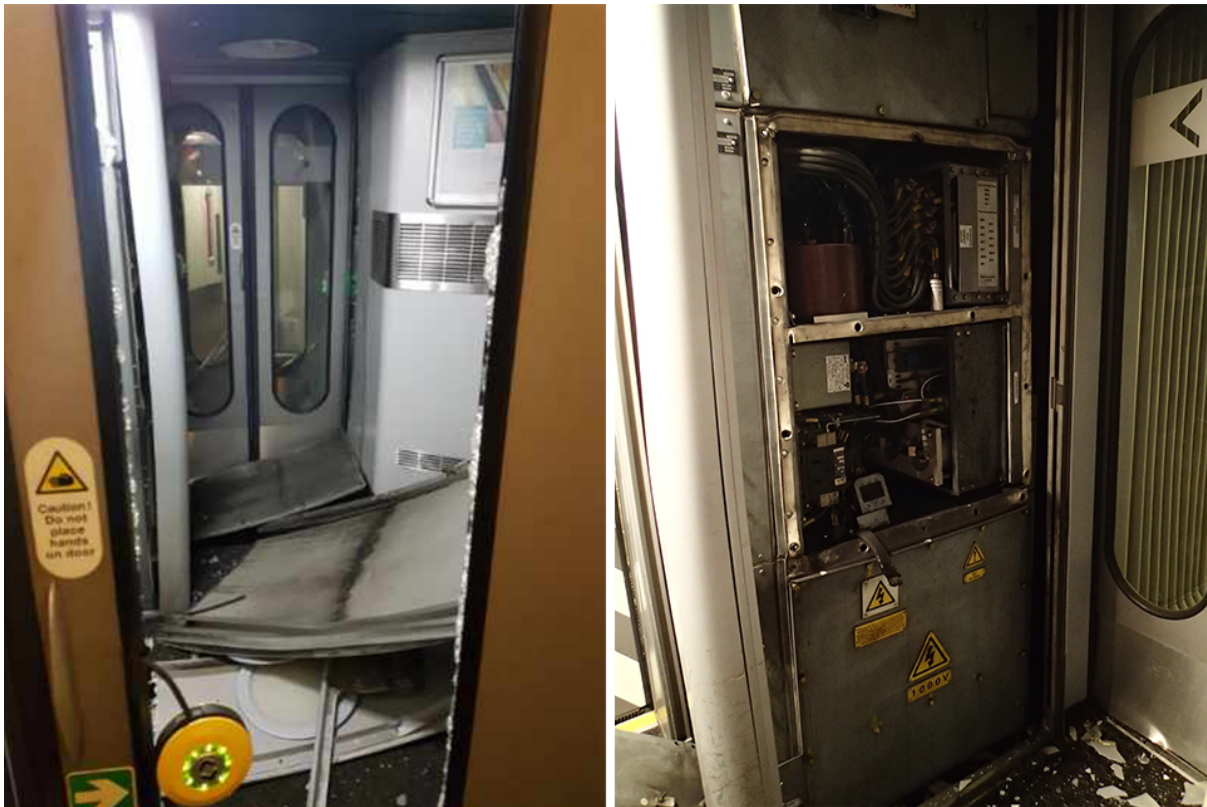
Damage caused by the explosion (left, photograph courtesy of XC Trains Ltd) and (right) the electrical equipment case. The explosion took place in the middle section of the equipment case shown in the photograph.

The explosion was caused by the failure of an electrical capacitor located in the middle section of the equipment case. A capacitor is a device which stores electrical charge. The failed capacitor generated hydrocarbon gases which mixed with air in the equipment case, and the mixture then ignited. The electrical equipment concerned is found on both the class 221 units and class 220 units and was supplied to Bombardier Transportation by Alstom.

Inspection of the damaged cover from the middle section of the equipment case on unit 221132 following the 2019 explosion showed that only two of the eight stand-off spacers were present. It is likely that the missing spacers were mislaid or otherwise not re-fitted following work that was done within the equipment case between the 2011 check and the 2019 explosion.

Following this accident, XC Trains Ltd issued National Incident Report (NIR) number 3610 to alert other users of similar equipment to the risks which it highlighted. Bombardier Transportation has reported that it has checked all class 220 and 221 coaches to ensure that spacers are fitted in accordance with the first stage of the modification. Bombardier Transportation are modifying the spacers such that they are permanently fitted to the equipment case covers (and therefore cannot be mislaid). A louvred cover has now also been fitted to the middle section of the equipment case on coaches which did not receive the modification as part of the second stage of the modification programme.

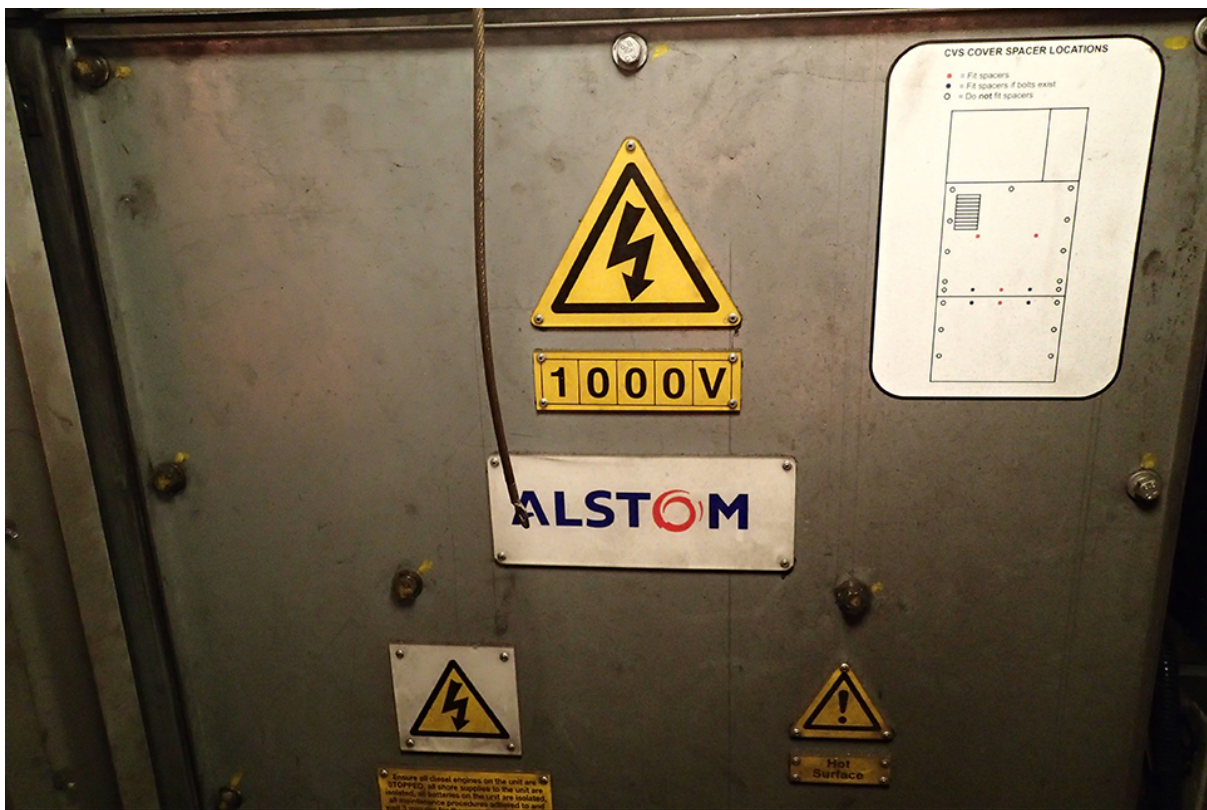
Cover for the equipment case middle section without louvres

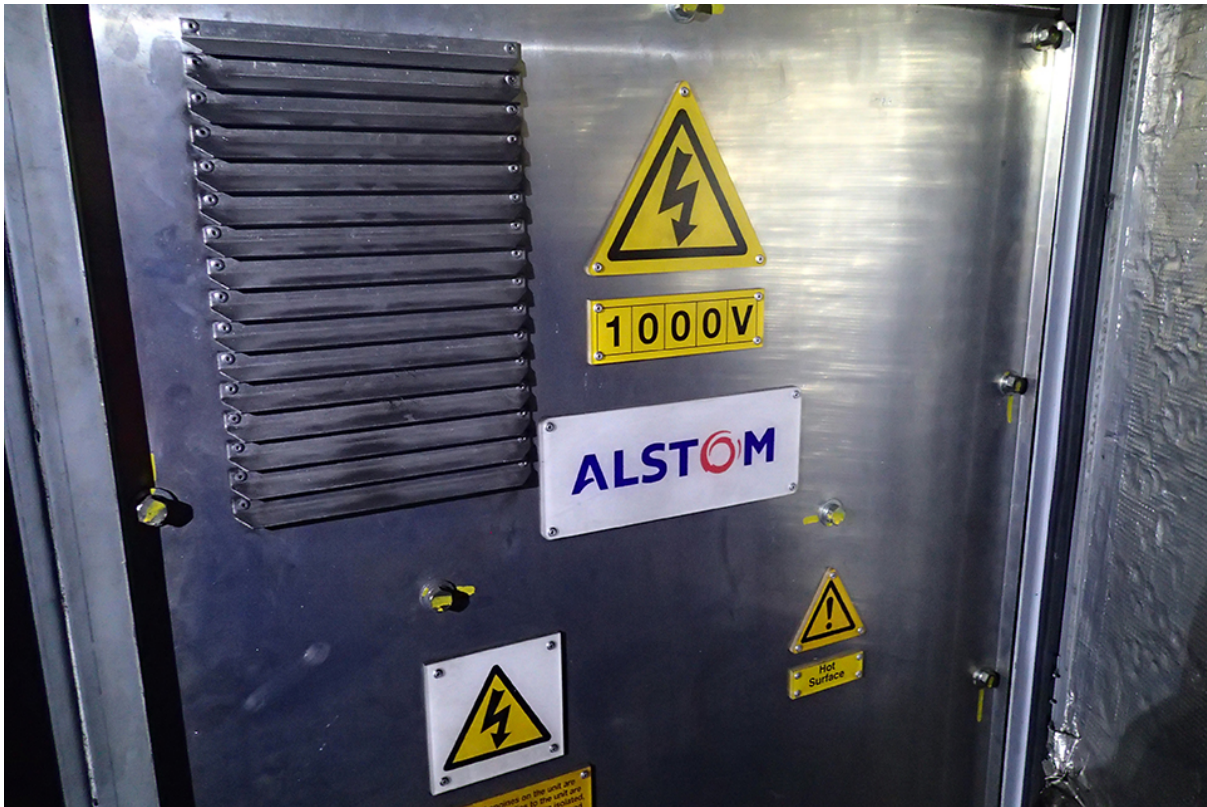
The second stage of the modification was intended to allow air flow between the lower and middle sections of the equipment case. This involved providing holes between the sections so that air would be moved by an existing fan in the lower equipment section. Air could then pass out from the middle section through a new louvre which was fitted to the front cover.

Cover for the equipment case middle section with louvres
