Post-incident reporting for reservoirs

Annual report 2018

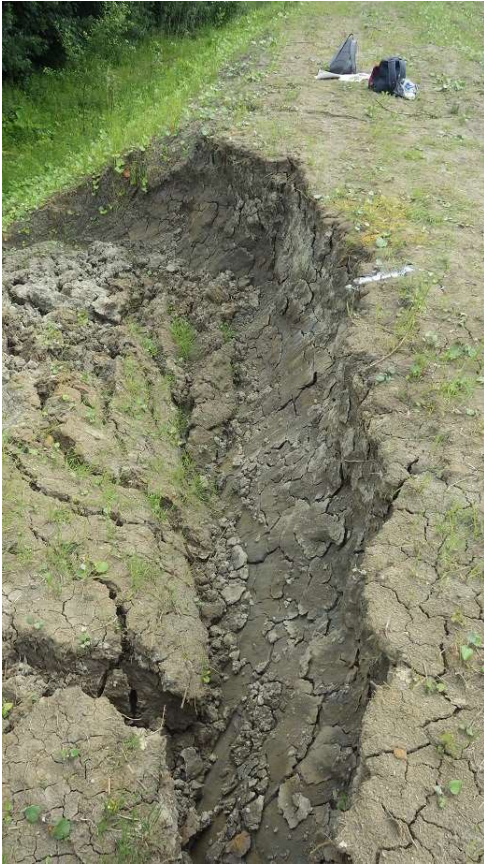
Shortly after the reservoir had been filled to top water level the supervising engineer noticed slope instability on the downstream face of the dam. The supervising engineer consulted the former construction engineer. They agreed that the water level should be lowered to preserve reservoir safety. The reservoir undertaker failed to act on this advice. We were then informed, and we appointed the former construction engineer to act on our behalf under section 16 of the act to advise us on how to respond to the incident.

Three slip failures within the outer shoulder of the reservoir had happened without any release of water. However, flood mapping showed several properties would be at risk from a breach in the reservoir. Residents were made aware of the situation, but were not evacuated. The water levels in the reservoir were lowered to a safe level. A slope failure occurred in the upstream shoulder during this process.

Photo 1: One of 3 slip failures in the outer shoulder of the embankment

This was a major incident which we have investigated. The original planning process did not identify the building of the reservoir as being covered by the act. Improvements were made to the reservoir embankments under section 8 of the act. However, these proved insufficient to ensure its stability. Since the incident, a notch has been cut in the embankment to prevent the reservoir from filling.

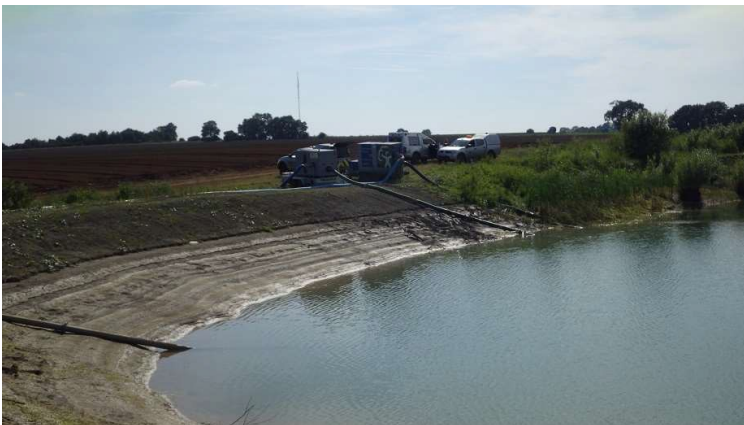
Photo 2: Reservoir being emptied by pumping

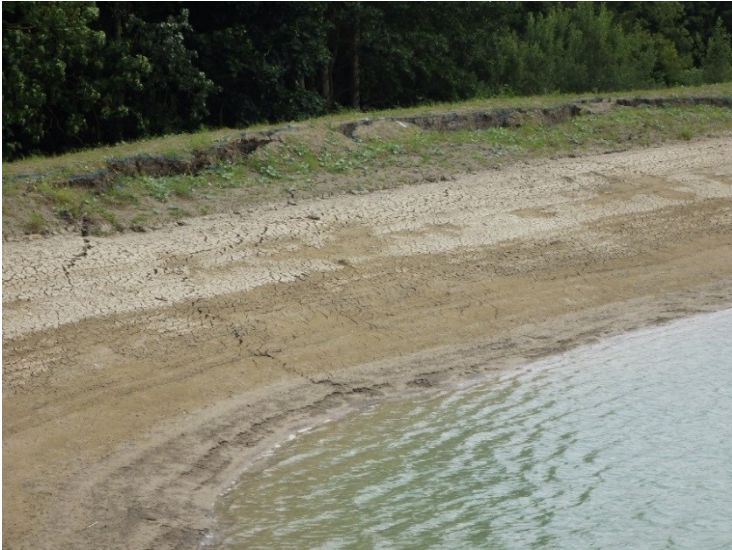
Photo 3: Slip failure in the inner shoulder of the embankment due to rapid emptying of the reservoir

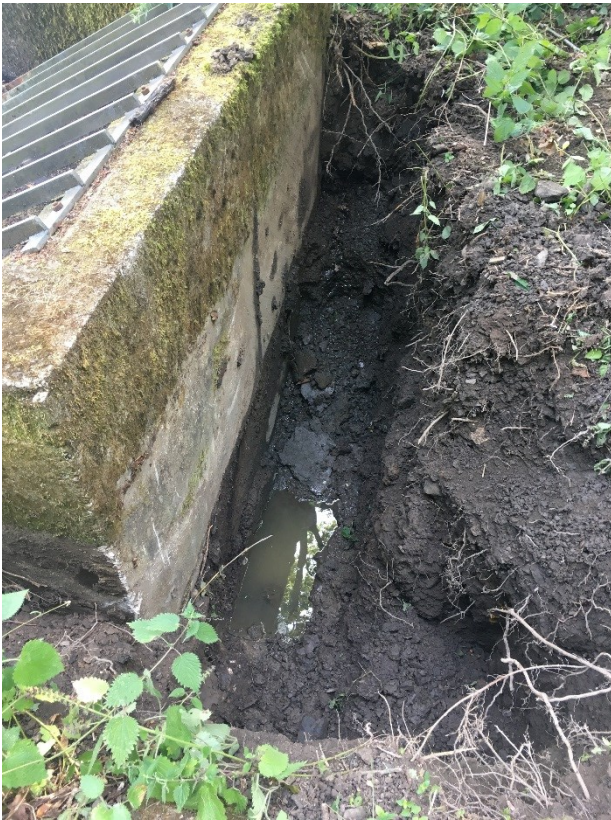
A sink hole and leakage were observed adjacent to a headwall structure on the dam embankment. The reservoir's water level was lowered using the scour valve and the undertaker appointed an inspecting engineer. An investigation of the headwall was not conclusive. However, it appears there may have been a defect in the headwall, which contributed to internal erosion. The defective fill material was replaced and the repair was successful.

Photo 4: Excavation of fill adjacent to conduit headwall

It's relatively common for internal erosion to occur adjacent to hard structures and conduits through dam embankments. It is important that undertakers carry out regular inspections for sink holes in such areas and to watch for leakage on the line of conduits.

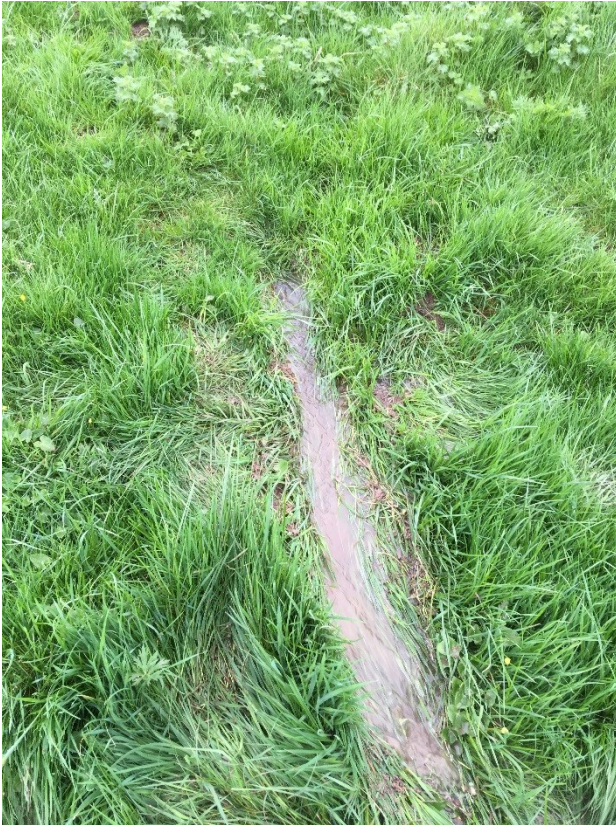
This incident is about the deterioration of a river bank adjoining an off-line flood storage reservoir. A period of sustained high river flows and tidal conditions generated leakage through the upper part of the embankment through rabbit and mole hills. This led to some overtopping of the embankment at low spots.

Then further seepage was found in the areas adjacent to the remediated section of embankment. This was due to moles burrowing into the embankment. This led to more temporary works being done. A permanent solution to repair and raise the bank has been planned.

Photo 5: Leakage from animal burrow

Burrowing animals can cause damage to earth embankments. In this case they became noticeable when sustained high water levels caused leakage, due to internal erosion between burrows, weakening the embankment and making it more prone to overtopping and erosion.

The reservoir undertaker reduced the risk of further deterioration by placing geotextile membrane on the outer face of the embankment and covering it with sandbags. The area was fenced off to prevent cattle getting to the reservoir. The supervising and inspecting engineers were informed and consulted on the temporary works.

This incident shows that steps need to be taken to prevent burrowing animals damaging embankments. Care is needed in the design and planning of permanent remediation works for the whole site.

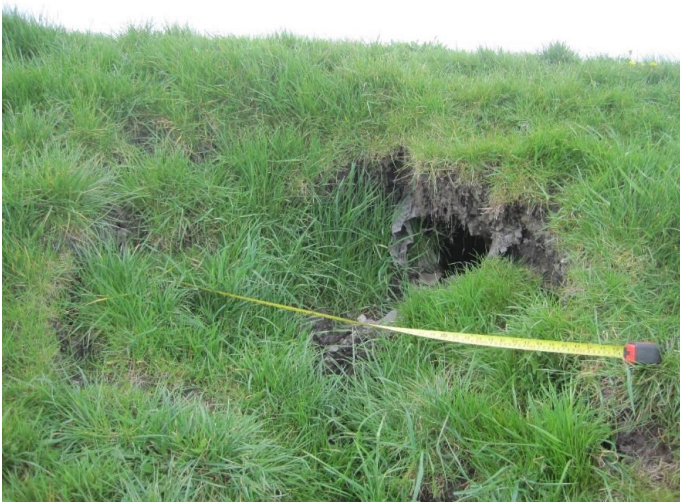
Seepage was found at several locations on the downstream face of a non-impounding reservoir. This was along the embankment approximately one-third of the dam height down from the crest of the dam. Two months earlier, a sink hole had been detected on the

Photo 6: Sink hole near the dam crest

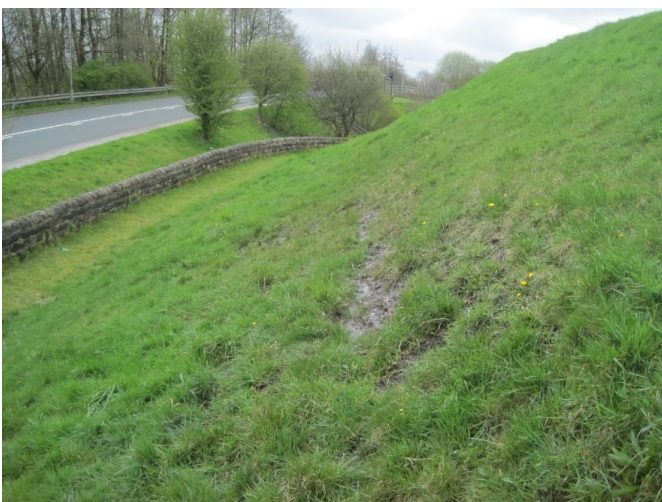
The inspection frequency was increased and an inspecting engineer was called to the site. The seepage points were mapped and the reservoir water level reduced to 1m below the overflow level. Trial pits were excavated on the crest to uncover the top of the core wall. These were inspected as part of a statutory inspection. The inspecting engineer also asked for piezometers to be installed as part of a stability assessment of the embankment.

Photo 7: Line of seepage on the downstream face

Further seepage studies were done using several geophysical survey techniques. The seepage and stability studies will inform any works to raise the core wall or to improve its performance.

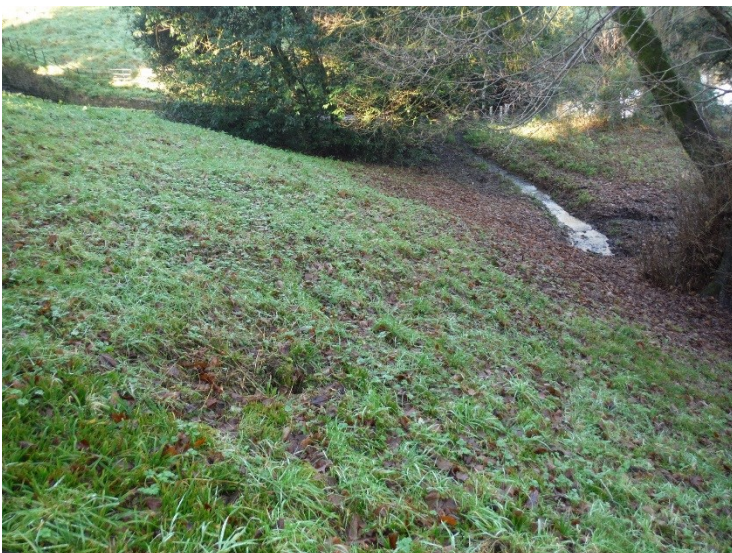
Leakage was found at the downstream toe of an earth fill embankment dam during a weekly inspection. There had been low-level seepage at this location for some time. However, this increased after a period of sustained high water levels due to rainfall. The rate of leakage was estimated as 0.5 litres per second.

A number of trees are present on the dam crest. However, it's unclear if the impact of the trees caused the leakage. The site investigation identified geotechnical differences in the fill material in the leakage zone. This suggests that a more permeable zone had been in the dam body during construction over 250 years ago.

Photo 8: Leakage from the embankment right mitre

The water level in the reservoir was lowered to a safe level and maintained at this level. An inspection under section 10 of the act and a site investigation were undertaken to inform the work needed to seal the embankment. The investigations found a higher amount of gravel and cobbles within the clay matrix in one location. Five minutes after dye was introduced into the borehole it emerged from the point of leakage at the downstream toe of the dam. This confirmed the area of leakage. The embankment was repaired by injecting cement-bentonite grout using the tube-à-manchette method.

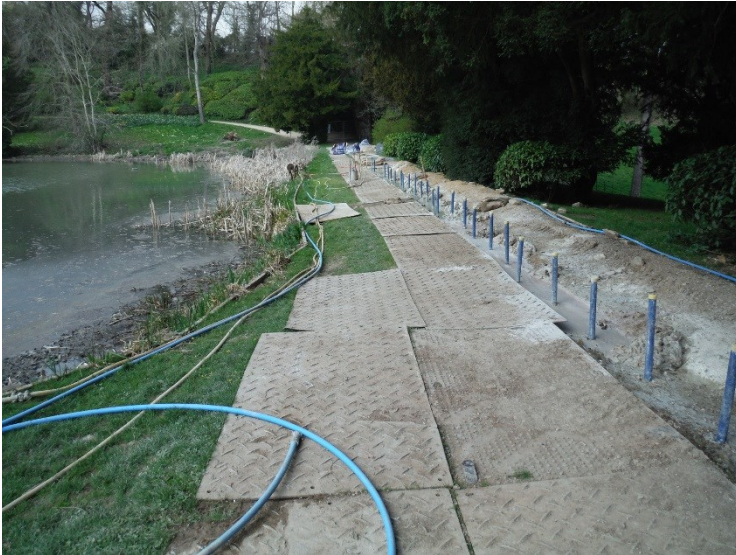
Photo 9: Grouting works to remediate and improve the embankment using the tube-à-manchette method.

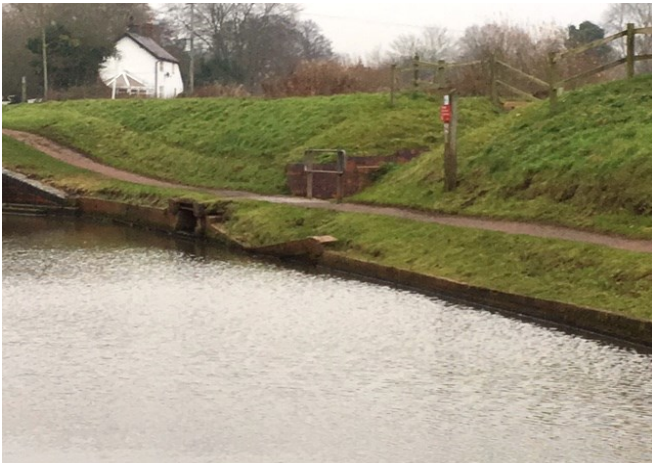
This incident happened at a canal reservoir where the canal runs parallel with the downstream toe of the dam. It's separated by a tow path and masonry canal wall which forms the sides of a lock. Routine inspections showed that the section of wall between the two lock gates was failing. It was thought that this damage was due to the condition of the masonry and boat impact damage.

The canal was emptied and investigations identified that the section of canal wall between the locks was damaged. There had also been several structural repairs and the foundations had been replaced or improved. The failed section of wall was of a different construction to the adjacent wall sections.

Photo 10: Damaged section of wall

There was no active seepage or erosion from the spillway structure. The reservoir outlet pipe below the wall was surveyed by CCTV and was found to be in good condition. The investigation concluded that the action of boat traffic had destabilised the wall. It also showed that the damaged section of wall had not had the same improvements as the adjacent wall sections. This is possibly due to the pipe passing beneath it. The damaged section of wall was reconstructed with the lock emptied.

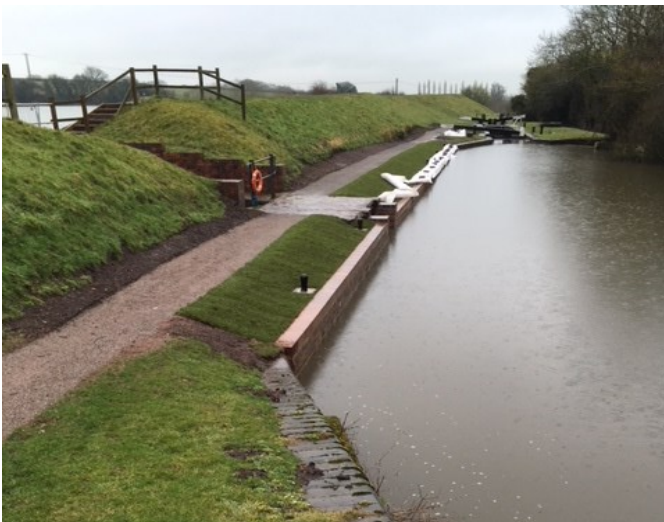
Photo 11 Repaired wall
