Rail Accident Report

Runaway locomotive at Beddgelert, North Wales 16 April 2019

Report 02/2020
February 2020

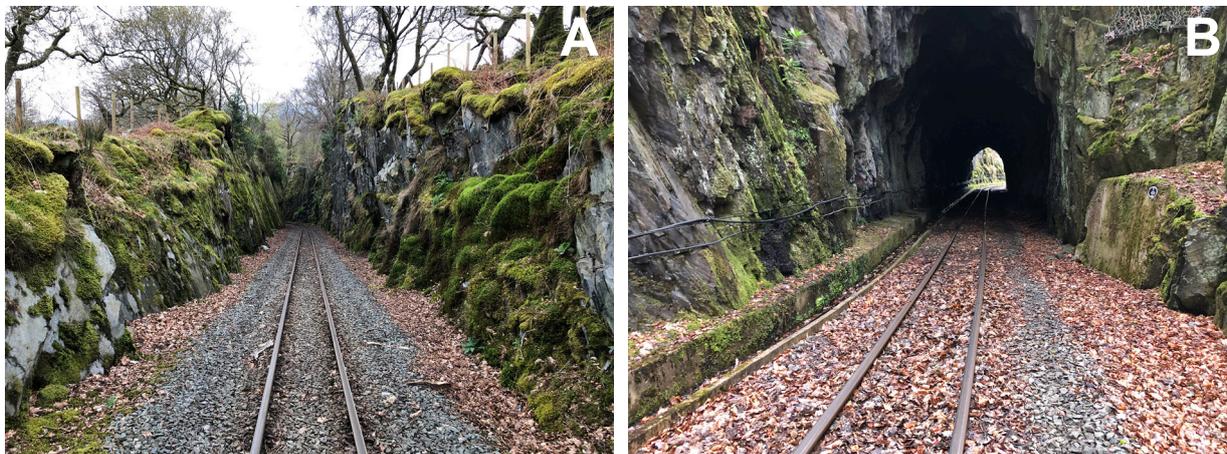
Figure 5: Photographs showing the general aspect and track conditions a) looking south into Cutting Mawr; and b) looking north into Goat Tunnel

- 21 The rails throughout the area of the incident were wet. There were leaves around the rails, particularly in the areas around Cutting Mawr and Goat Tunnel (figure 5). Some wheelburns, which can occur if train wheels spin on the rails, were noted in the area, indicating the presence of low adhesion conditions. However, it was clear from the spacing and arrangement of the wheelburn marks that they had not been caused by 'Vale of Ffestiniog'.

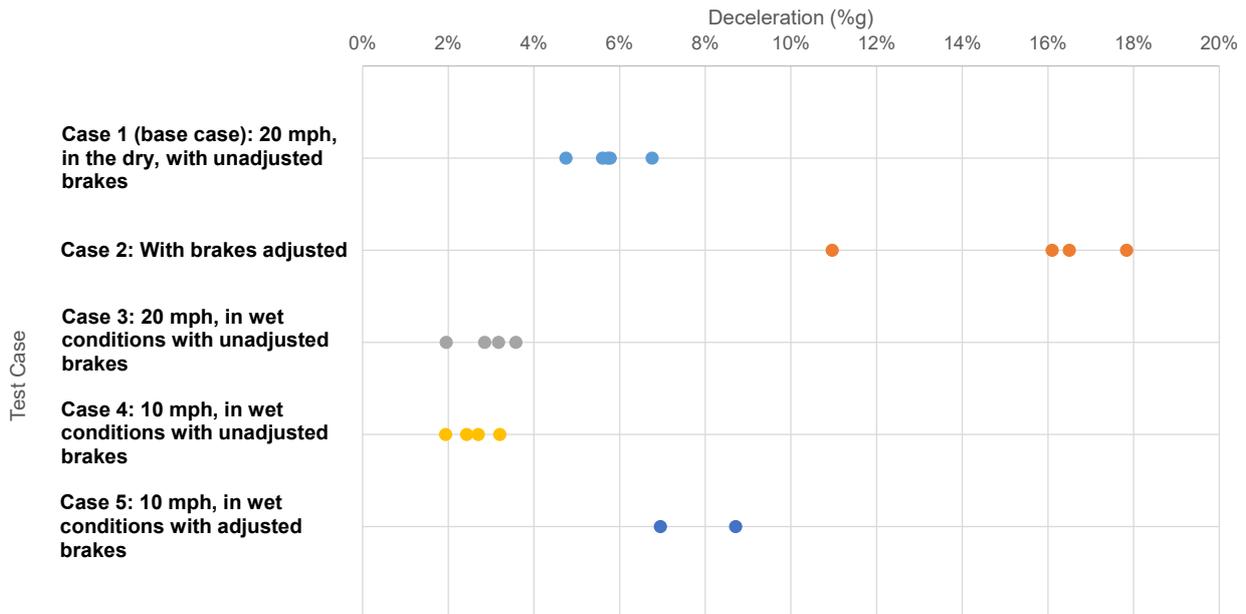
Figure 6: Graph showing the decelerations achieved by 'Vale of Ffestiniog' in the five different test cases

- 45 The resulting decelerations, expressed as a percentage of the acceleration due to gravity⁶ are shown in figure 6, in each of five different test cases. There was some scatter in the results due to imprecision of the speedometer, and the differing temperatures of the brake blocks as the tests were repeated.

- 46 The tests showed that, regardless of speed, when the brakes are adjusted as they were on the day of the incident and the rail is wet, the locomotive achieves a deceleration of between 2%g and 4%g. In the incident, this low level of braking would have been more or less balanced by the accelerating effect of the downhill gradient of 1 in 40 (which would cause an acceleration of around 2.5%g), and the idling tractive effect of the locomotive being left in gear. The braking would have been assisted by a small amount of rolling resistance from the wheels. The tests also showed that adjusting the brakes resulted in much higher deceleration, regardless of the speed or conditions.

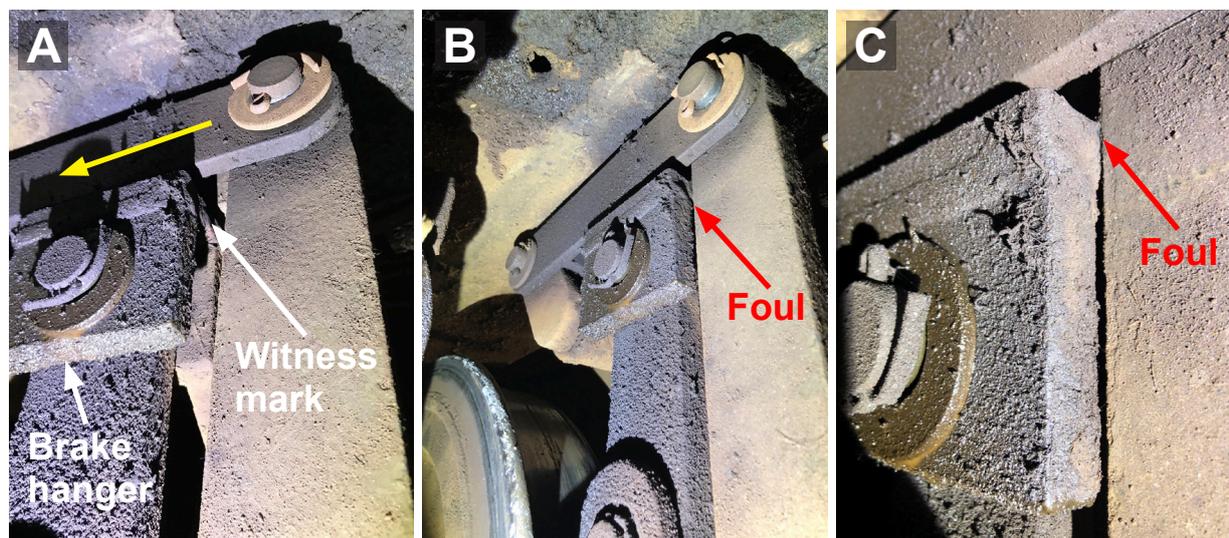
Figure 7: Photographs showing the location of the foul in the brake linkage (red arrows), (a) with brakes off; (b) with brakes on and (c) close-up view with brakes on. The yellow arrow in (a) indicates the movement of the link when the brakes apply.

51 Following the incident, the locomotive was hauled to Boston Lodge works for a detailed inspection by FRC and RAIB. This inspection identified that the four sets of brake equipment, one in each corner of the locomotive, which operate independently of each other, had the same mechanical fouling problem. As the brakes were applied, a link in the brake mechanism was found to foul on the associated brake hanger⁷. With the brakes released, witness marks on both components were evident (figure 7).

52 The foul meant that the movement of the brake linkage, and hence the brake blocks, was obstructed, preventing full brake force being applied to the wheels.

- 58 At some point during the operation of the locomotive, the clearance within each brake mechanism, indicated by the blue arrow in figure 9, reduced to zero, resulting in the fouling noted in figure 7. Once the foul occurred, any further force applied by the brake cylinder would not translate to additional movement of the brake blocks against the wheel, hence limiting the brake force applied.

- a) there was a mechanical foul in all four brake mechanisms which limited the movement of the brake blocks and thus the force between the brake blocks and the wheels when the brakes were applied (paragraph 50), which occurred due to a combination of the following factors;
 - i. FRC had modified the locomotive's brake system, unintentionally reducing the clearance between the outboard brake linkages and brake hangers (paragraph 54, **Recommendation 1, Learning point 1**);
 - ii. the brake blocks and wheels were partly worn (paragraph 60); and
 - iii. the issue of the reduced clearance has not been previously detected by the railway (paragraph 64).
- b) the locomotive was being driven light and therefore was reliant solely on the capability of its own brakes (paragraph 72); and
- c) there was lowered friction between the brake blocks and wheels due to the wet conditions (paragraph 69).

Festiniog Railway Company should systematically review how it monitors, assures and records the inspection and maintenance of brakes and other safety critical systems on its rolling stock and locomotives, and implement measures to address any shortcomings found (paragraph 98a).

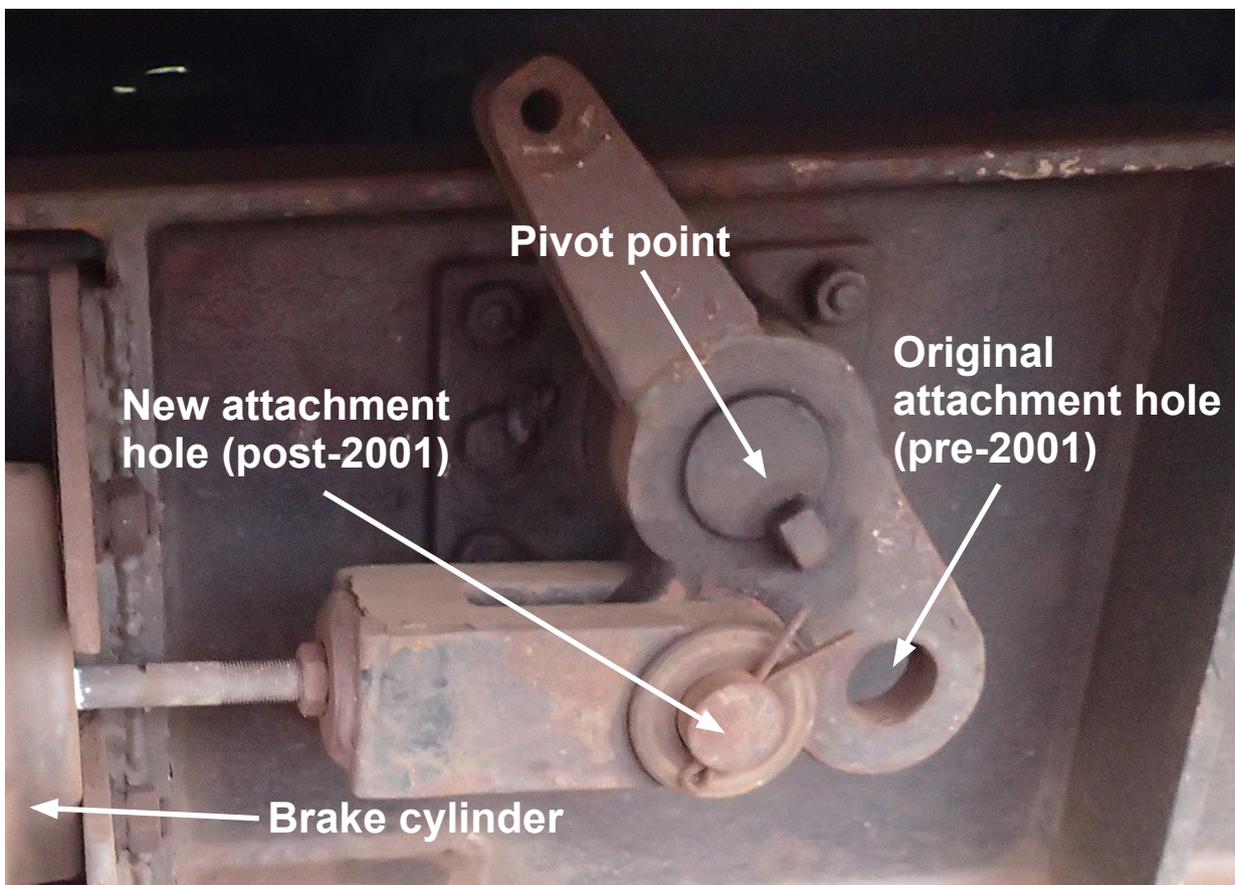
Figure 8: The original and new (2001) brake cylinder attachment positions

- 54 **FRC had modified the locomotive's brake system, unintentionally reducing the clearance between the outboard brake linkages and brake hangers.**
- 55 Around 2001, after operating the locomotive for a few years, FRC found it was experiencing an issue with leaking seals on the locomotive's brake cylinders. FRC was unable to source replacement seals, so the engineer who had originally rebuilt the locomotive (paragraph 14) proposed to increase the cylinder air pressure to alleviate the issue. The associated increase in the locomotive's braking force would lead to undesirable differential braking between the locomotive and any hauled carriages, causing a jerky ride for passengers. To prevent this, the engineer decided to reduce the leverage applied by the brake cylinder, which would return the brake force to the 'pre-modification' level, despite the increased air pressure. He achieved this by reducing the distance between the brake cylinder attachment point and the first pivot in the linkage (figure 8). To prevent a clash with the original attachment hole, he welded a metal lug onto the side of each of the first links, with a new attachment hole.

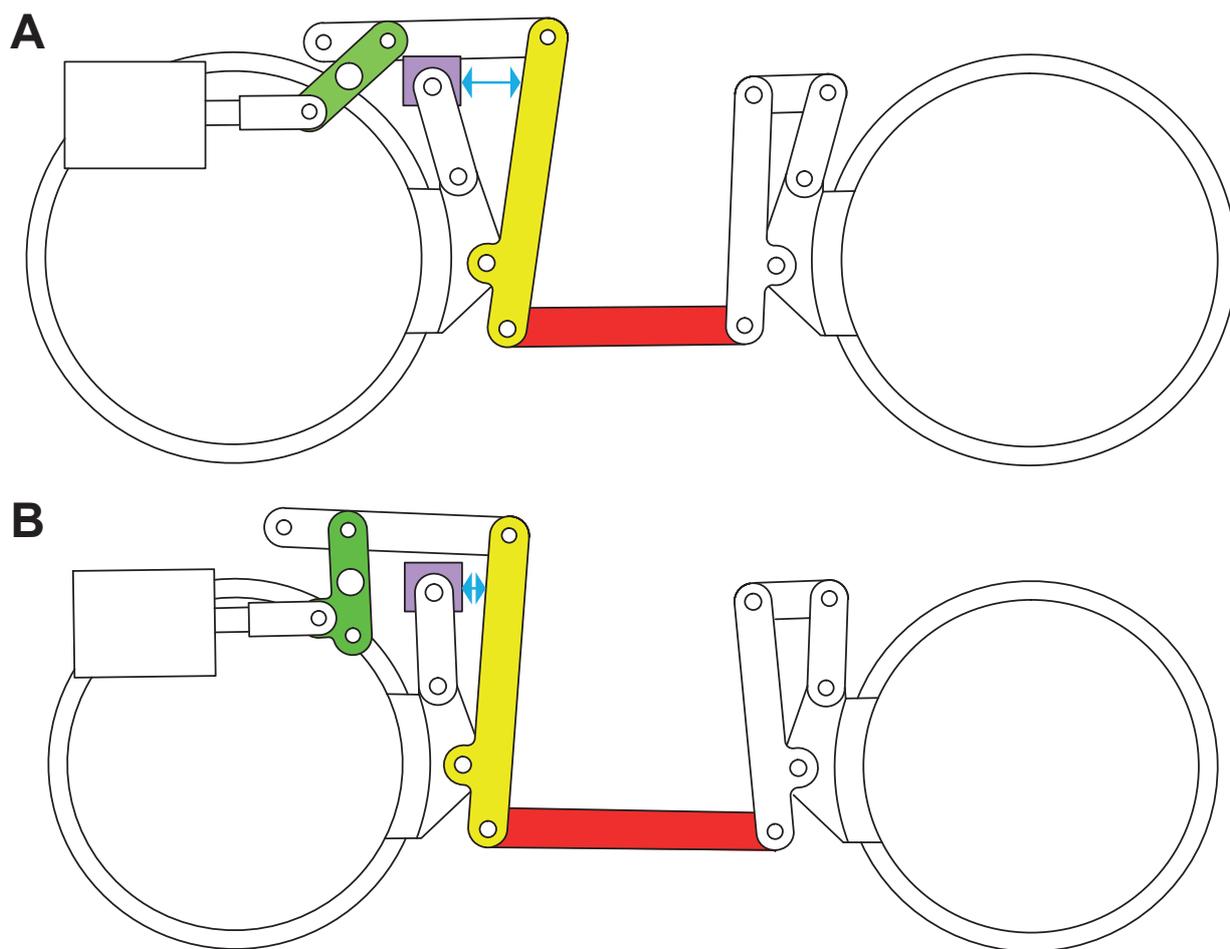
- 56 The change in the attachment position altered the angle of the first link in the brake mechanism. This resulted in a change to the geometry of the remainder of the linkage, which was compensated for using a turnbuckle slack adjuster (shown in red in figure 9) within the mechanism.

- 57 A result of this modification was a reduction in clearance (shown by the blue arrow in figure 9) between the outboard brake hanger (shown in purple) and the long vertical link (shown in yellow) on the outboard side of the slack adjuster. Although initially there would be a clearance when the brake block positions were adjusted to be closer to the wheels with the brakes off, as the wheels and brake blocks wore, the brake blocks would have further to travel. Because of this, when the brakes were applied, the clearance (shown in blue) would reduce.
