UNEXPLODED ORDNANCE DESK STUDY

Lodge Hill Camp (LHC) & Lodge Hill Training Area (LHTA) Chattenden Kent

UNEXPLODED ORDNANCE SITE INSPECTION REPORT

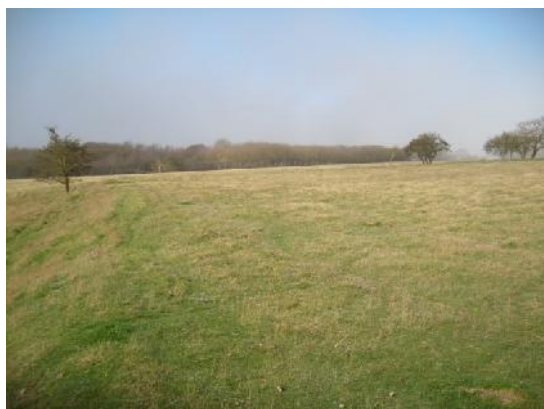
Open Pasture (Previously searched by EOC)

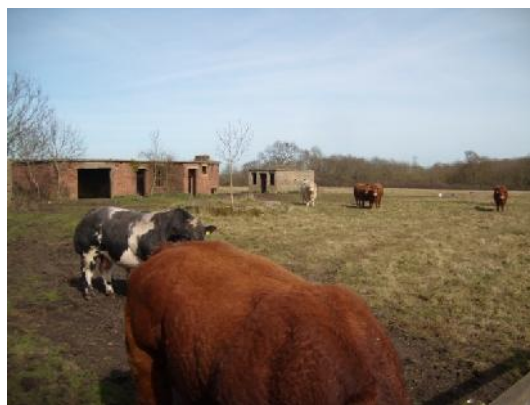
Livestock near the wartime HAA Gun Battery

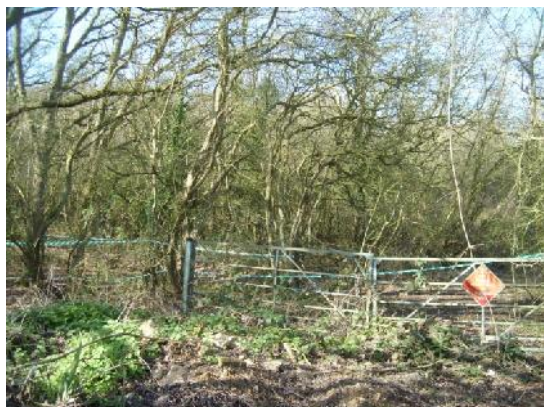
Minefield Warning Sign

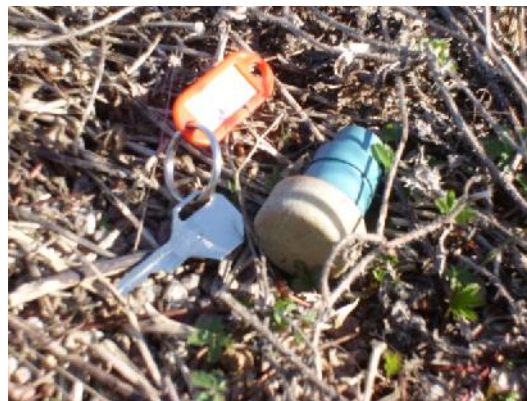
Live Anti-personnel Mine (Smoke Charge)

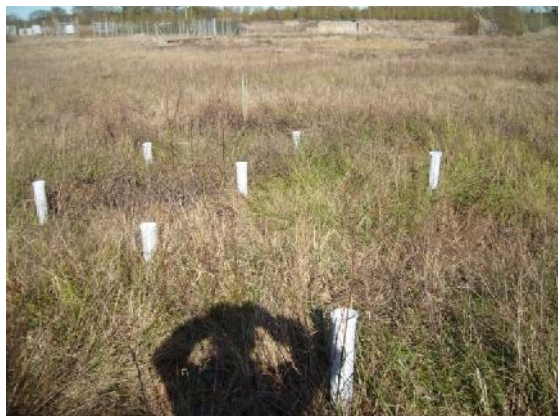
- Bomb location training areas. One such area still has detection boreholes in place and these were checked using a downhole LW120. Readings indicated the presence of a large steel mass (probably the training target bomb) at a depth of 3.5m.

Buried Bomb Area (Steel mass at 3.5m depth)

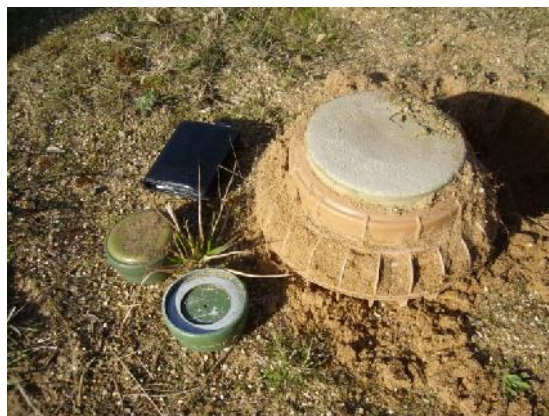
EO/UXO Landmines (State not known)

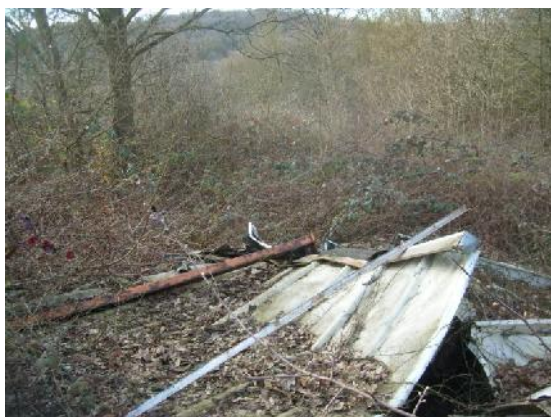
Bosnia Style Trenches

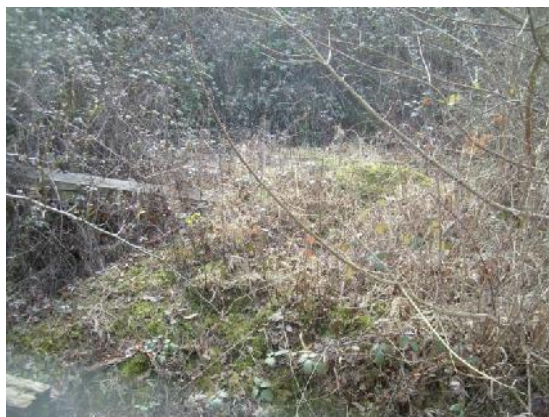
EO/UXO

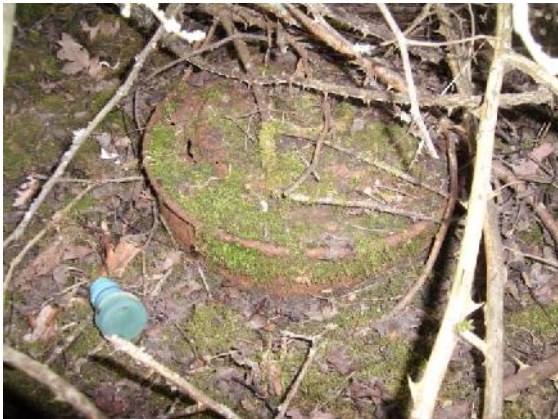
EO/UXO Landmines (Believed Live)

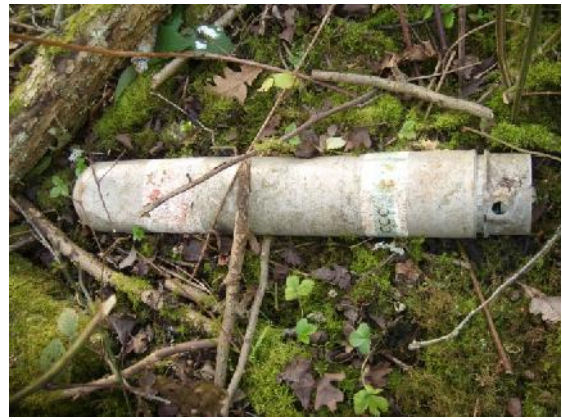
EO/UXO (State not confirmed)

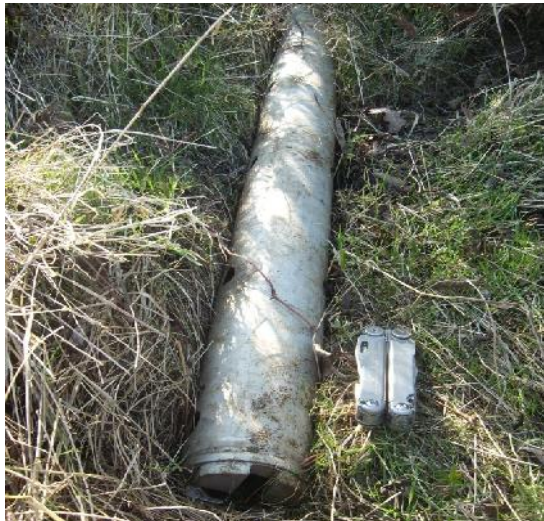
EO/UXO Missile (Believed Inert)

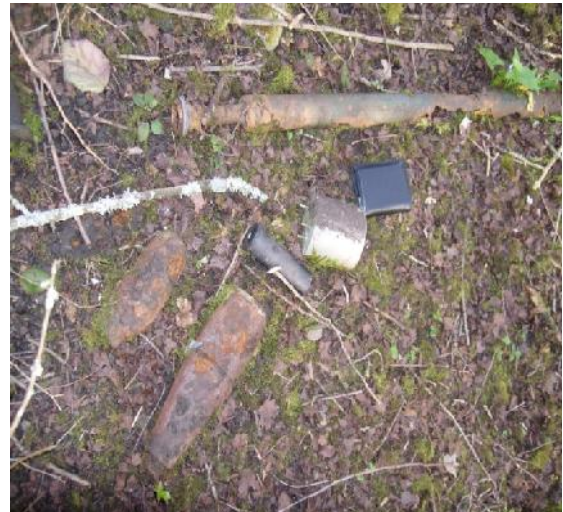
EO/UXO Projectiles (State not confirmed)
