Marine Accident Investigation Branch (MAIB) - Safety Digest 3/2002

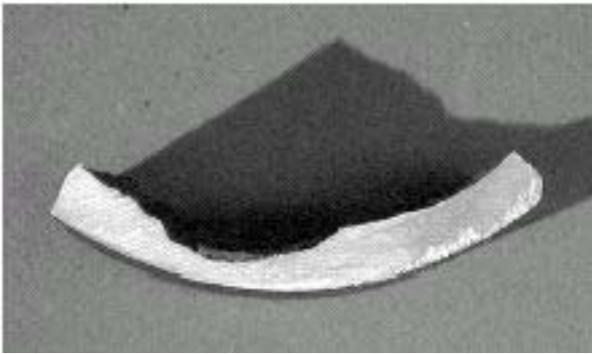
One sample had a blow out like rupture in the form of a window opening characteristic of hydrogen damage. The rupture lip was fairly thick and appeared to be located slightly off the middle of the fireside half. The other sample had two linear fissures at the fireside face, one oriented longitudinally and the other transversely.

The internal surface of the tubes had severe gouging and wastage on the fireside half where as the sheltered half was unaffected. The wastage was in the area of the ruptured section and its immediate vicinity.

Checks at five points on the tube samples showed undulating thickness ranging from 2 to 4mm on the fireside whereas the unaffected sheltered side showed a uniform thickness of about 6 mm. The thickness of the rupture lips at the window opening and open fissure areas was about 1 to 2 mm. Further study showed that apart from slight signs of decarbonisation at the inter granular cracked areas, the base material of the tubes was unalloyed carbon steel. Thick lumpy deposits of oxide scale (magnetite) ranging from about 0.2 to 0.6 mm was found on the internal surface of the fireside half. Copper deposits were also found on the outer layer of the inner surface deposits. pH tests on the scale /deposits showed acidic levels in the range of 3 to 4 confirming that the corrosion was acidic corrosion.

Wall thinning in way of lumps of bore scale

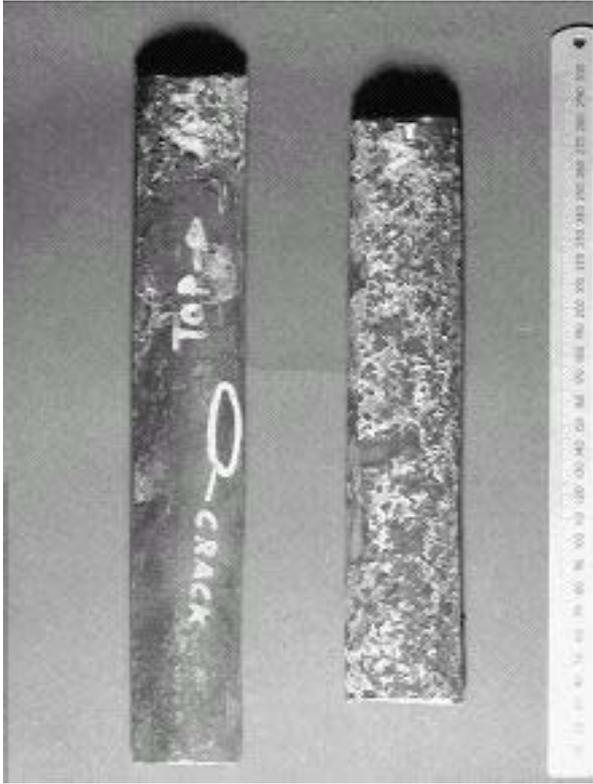
A boroscope inspection of all accessible screen tubes followed, and identified other tubes suffering from on-load corrosion. All had localised scale build-up in line with the flame, together with tube wall wastage underneath the scale. Subsequently, No 3 boiler was chemically cleaned, and all screen tubes were scanned for thickness. No 2 boiler was similarly treated. The screen tubes on No 1 boiler had been renewed recently, so were in good condition.

Outer surfaces of tube strips

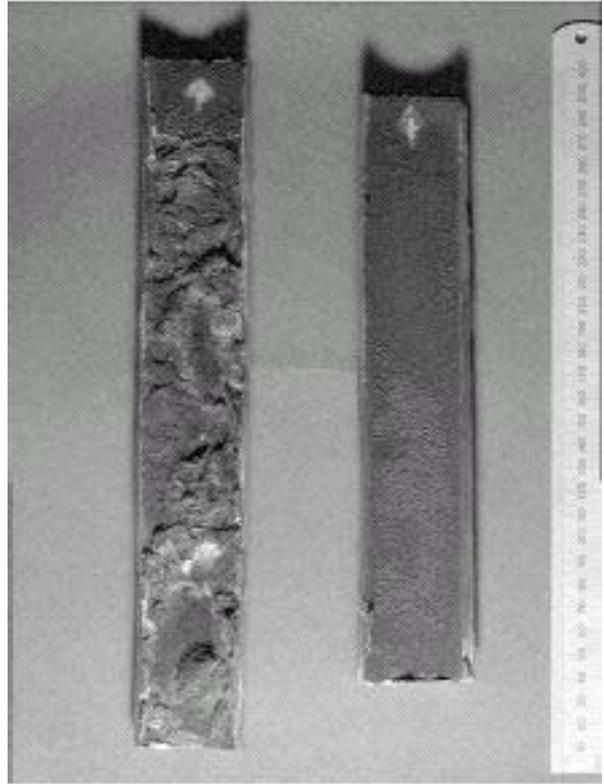
Inner surfaces of tube strips

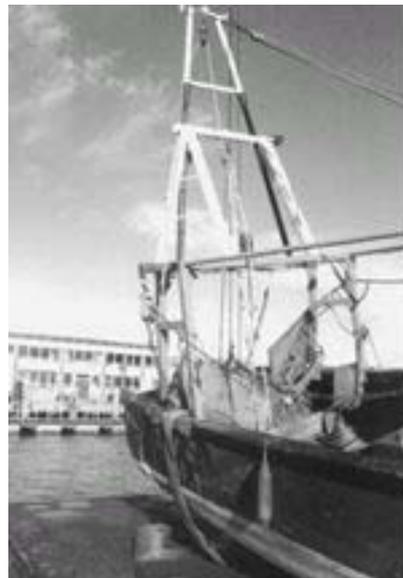
The gantry and A frame

The situation seemed to stabilise with the vessel listed to starboard, and with freeing ports on the aft starboard side underwater. As the crewmember cut the net to release the unwanted load, the vessel encountered the wash from a passing vessel. She rolled, took water over the starboard bulwark and capsized rapidly. Within minutes, she inverted and foundered.
