Marine Accident Investigation Branch (MAIB) - Safety Digest 2/2004

This Safety Digest draws the attention of the marine community to some of the lessons arising from investigations into recent accidents. It contains facts which have been determined up to the time of issue.

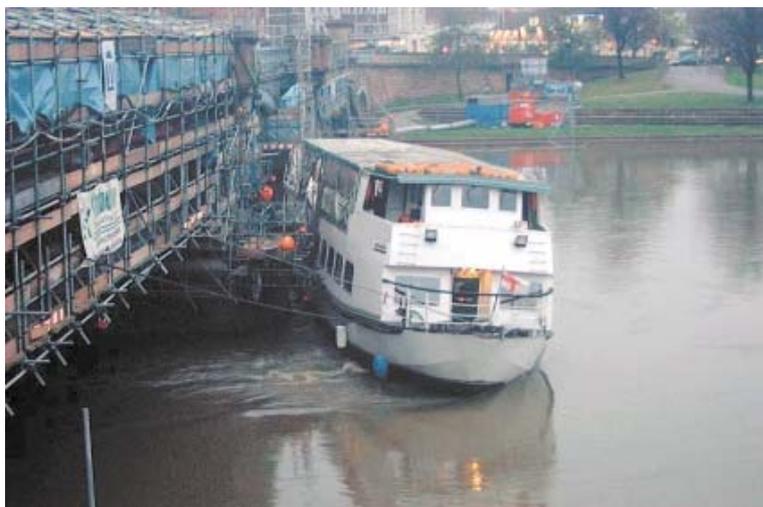
Figure 1 Vessel pinned to bridge (note: flow of river water by bow)

The accident occurred during darkness in winter, when the vessel was cruising upriver in strong currents and high levels of water. As she passed through the centre arch of the bridge, her starboard quarter struck scaffolding. The strong current pushed her on to the upriver side of the bridge's buttress, where she was pinned. She was further damaged when a scaffolding pole pierced one of the windows and side plating on the lower deck.

The accident happened because control of the vessel was lost in the fast and confused flow of water through the centre arch of the bridge; navigation under the bridge was already difficult, due to the repair scaffolding.

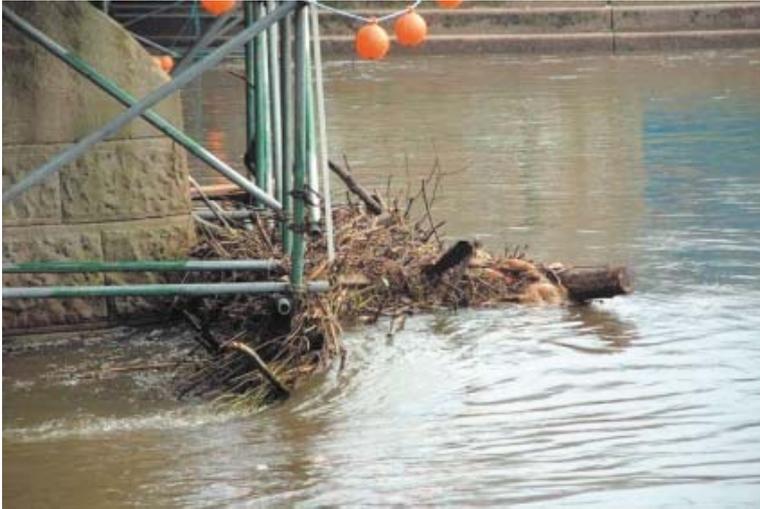
Figure 2 'Flotsam' on southern buttress

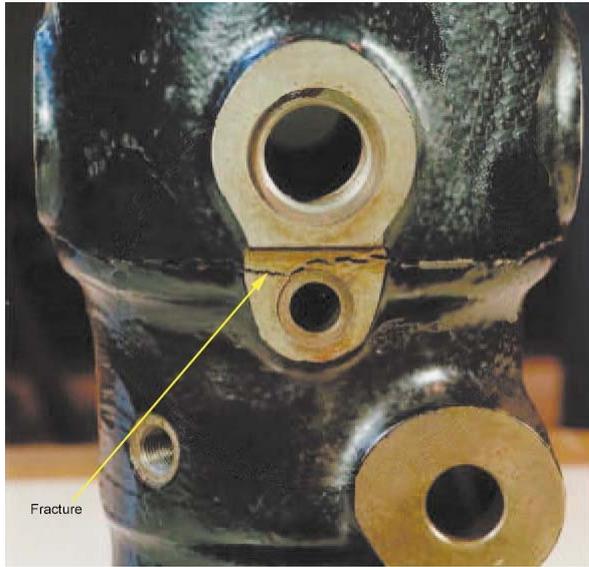
Pumps fractured body

The fire was the result of a defective high pressure fuel pump spraying fuel over a hot indicator cock on a cylinder head. The pump's failure was caused by a manufacturing defect, the likelihood and consequences of which could not have been anticipated by ship's staff. The pump's body fractured because of substandard properties of the casting (see figure). This problem has been addressed by owners and manufacturers.

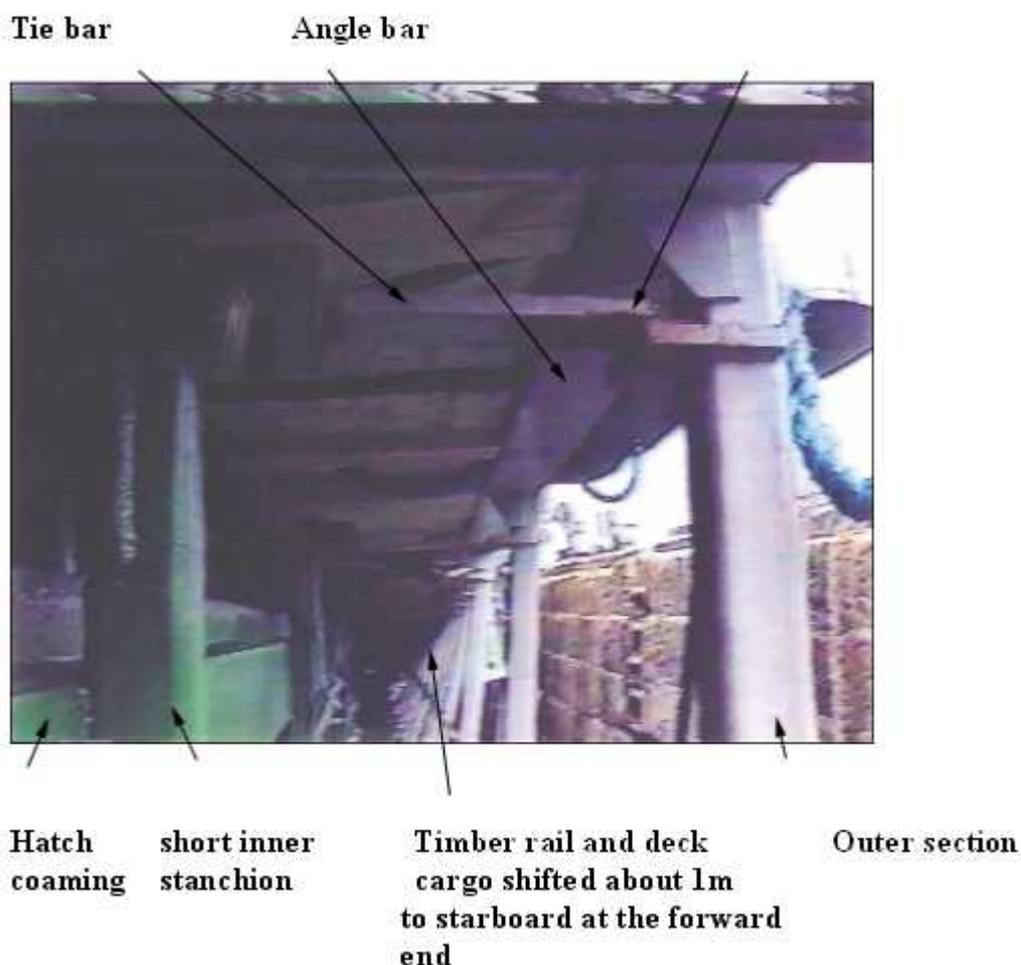
The main cause of the accident was a failed starboard timber rail. The timber rail was a steel framework, consisting of outer stanchions along the main deck edge, and short inner stanchions attached to the sides of the hatch coamings. The stanchions were connected with tie bars (see figure). A horizontal angle bar was welded to the tops of the outer stanchions, to tie the framework together and to stop the cargo shifting outboard.

When the wave hit, the heavy cargo probably moved slightly, and the tie bars failed, allowing the deck cargo to move further. No structural calculations had been made for the timber rails, and the framework's strength had not been properly verified.

1. If you carry packaged timber on deck, and your vessel is fitted with timber rails, ensure they are strong enough to withstand the sideways forces generated during rough sea conditions. Detailed structural calculations should have been made to ensure that those fitted to this vessel were of adequate strength, and this should have been verified by a classification society.

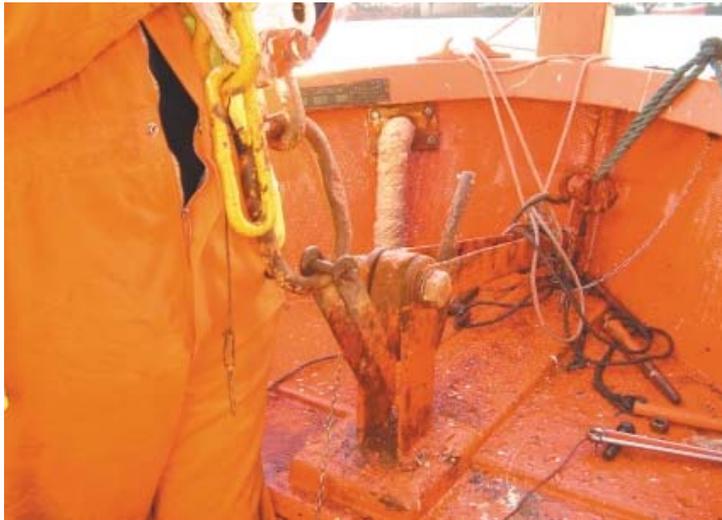
Figure 3 Full blocks chain ring incorrectly positioned over safety pin

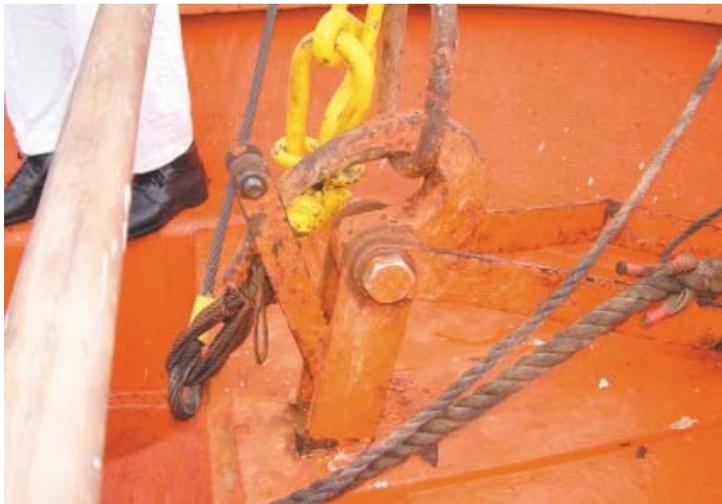
The forward hook assembly had sustained considerable damage. The bill of the hook had been bent down, and the hook support structure had also been clearly deformed - as shown in figure 4.

Figure 4 Forward hook assembly showing damage

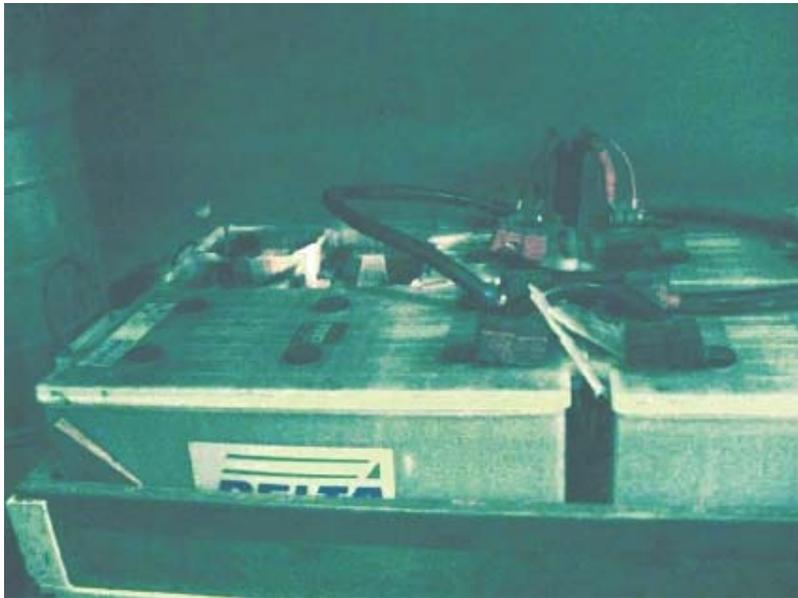
Part-way through the work, while the angle grinder was in use, there was an explosion in the compartment. The top of one battery was blown off and acid leaked into the surrounding containment tray (see figure). Fortunately nobody was injured.

An investigation found that the compartment's ventilation fan was out of order, and had been for some time. It was concluded that lack of ventilation had allowed hydrogen gas from the batteries to accumulate, to produce an explosive mixture that was ignited by sparks from the angle grinder.

Damage to battery

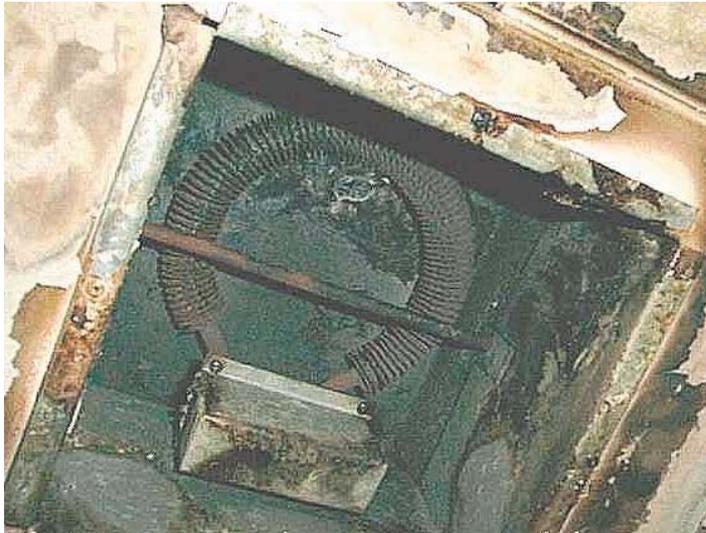
Electrical heating element

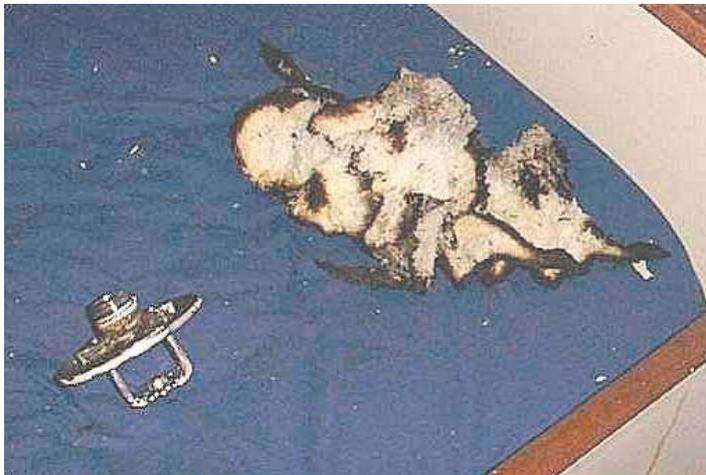
The thermostat was connected to an electrical heating element within the vent. By turning the thermostat to fully on, this, in turn, switched the heating element fully on and ensured that it stayed on. At that stage, the towel, which had been stuffed into the diffuser area some time ago, caught fire.

Burnt towel

- 1. Never restrict the flow of any ventilation, other than by using the available controls. This incident could have had a far more serious outcome if the crew member had been asleep in the cabin, or had not returned to the cabin when he did.**
- 2. Let the engineers on board fix problems of a technical nature. That is what they are there for. There any number of reasons why a cabin vent might be blowing out too much hot or cold air. If there are no accessible controls, or they do not appear to work, then report the problem.**
- 3. When adjusting any temperature controller, it is good practice to wait to see the effect this will have before leaving the space.**
- 4. Where thermostats, or any other heating controls, are made available, the operating instructions for them should be provided in the cabin, or stuck to the bulkhead beside the controller.**

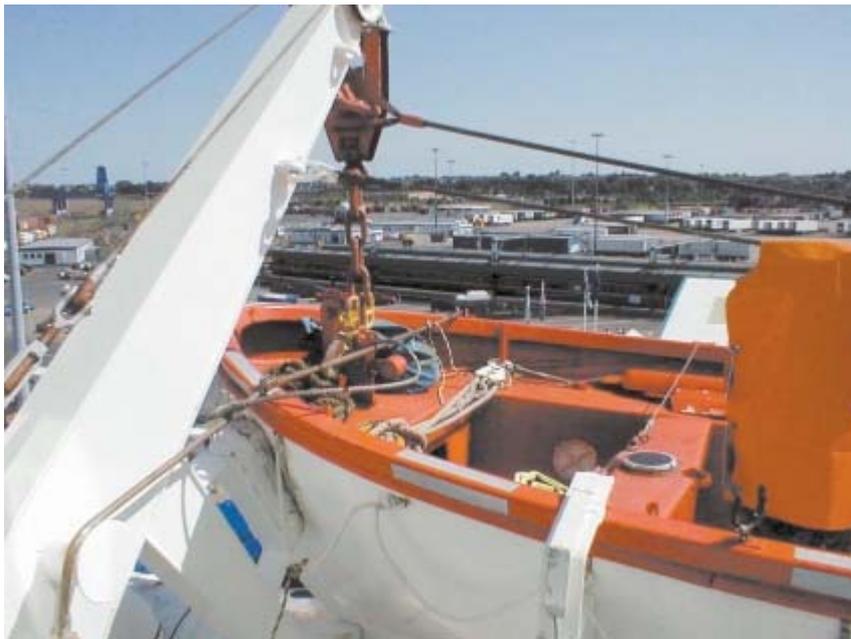
A lifeboat drill was being carried out on a cruise ship in port. The gripes were slipped and the winch brake was released to begin the launch. As the davit arms swung out and the boat began to lower, a tricing pendant at one end became caught beneath the suspension hook's balance weight. As lowering continued, the tricing pendant tightened until it lifted the weight and opened the hook. The fall released and the boat swung; it was left hanging by the other fall (see figure).

Gripe, Tricing pendant and Unguarded suspension hook balance weight

- 4. If unguarded balance weights are fitted, they should be observed while the lifeboat is being lowered, to ensure they are not lifted accidentally. If crew are in the boat when this happens, a serious accident could result!**

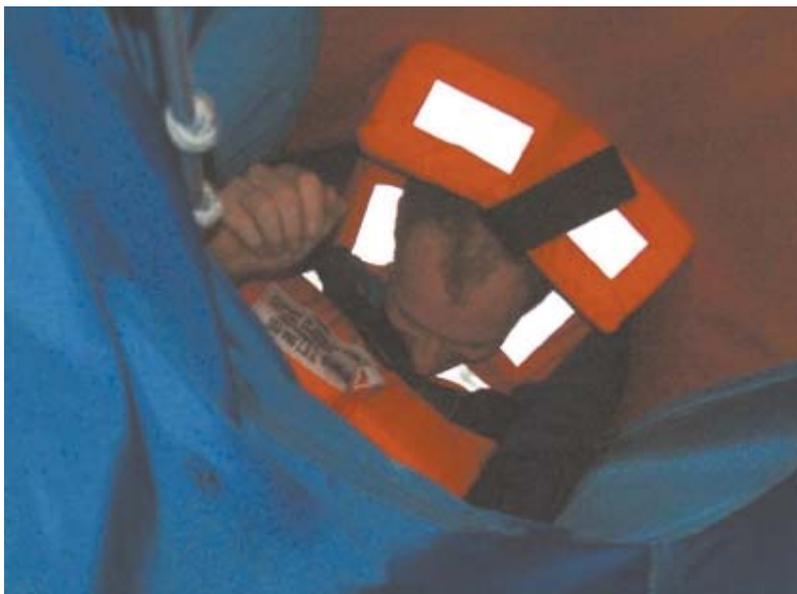
There were no witnesses to the evacuee's descent, so it is impossible to determine exactly how she assumed the position in which she was found. However, she probably became stuck when her lifejacket rode up over her head and then, in the ensuing struggle to free herself, caught her feet so that her legs became raised in such a way that she assumed a piked position in the next tube.

Lifejacket having ridden up

- 5. The initial cause of this accident was the lady's lifejacket riding up. It is essential to ensure that lifejackets for use in vertical chutes cannot ride up.**

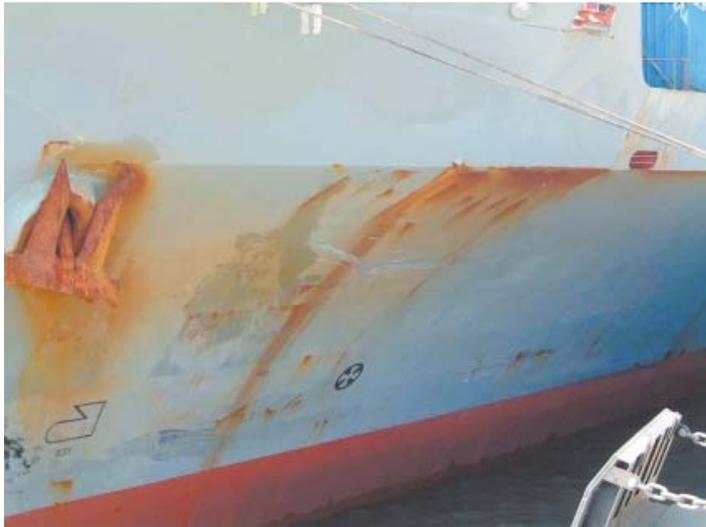
Damage caused by impact

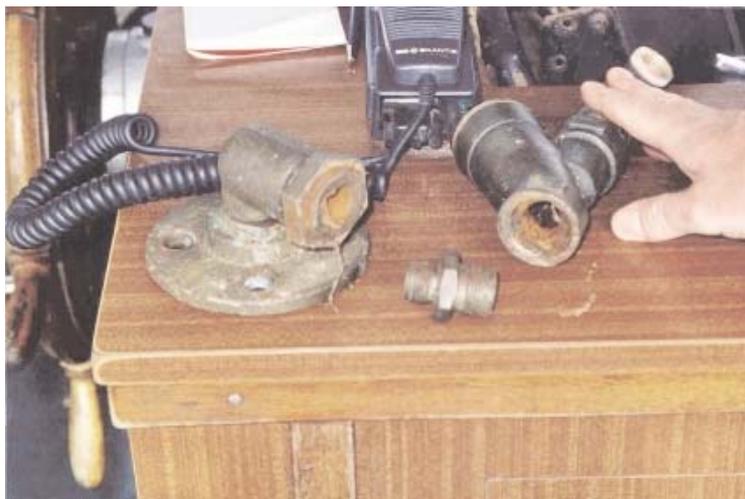
The fracture occurred at a screwed joint between steel and brass piping; the problem was probably caused by galvanic action (figure 2).

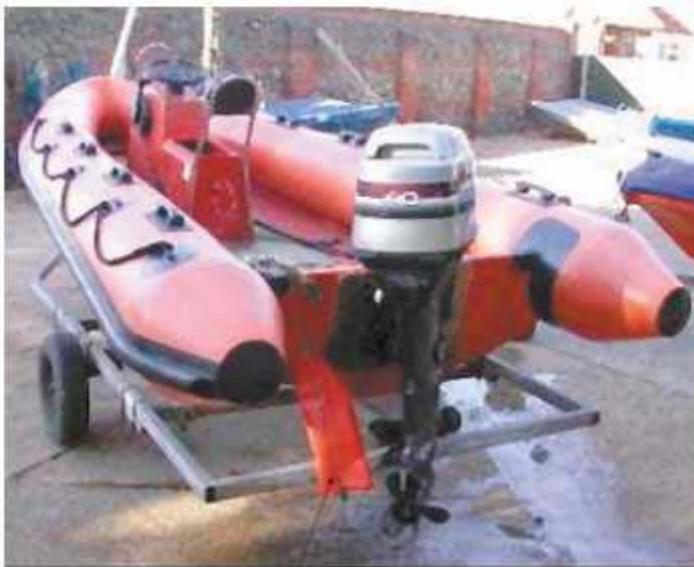
All three managed to climb on to the inverted hull. Several attempts were made to locate the safety equipment pack and the radio stowed in the steering console. However, there was no air pocket beneath the hull and these efforts failed. The wave action on the inverted hull, together with the cockpit's self-draining 'elephant's trunk', had acted as an air pump. The rising wave compressing air beneath the hull and pumping it out of the 'elephant's trunk' at the stern. The falling wave was then unable to draw air in because the reduction in pressure caused the elephant's trunk to collapse.

Elephant trunk
