MARINE ACCIDENT
INVESTIGATION BRANCH

SAFETY DIGEST

**Lessons from Marine
Accident Reports
2/2005**

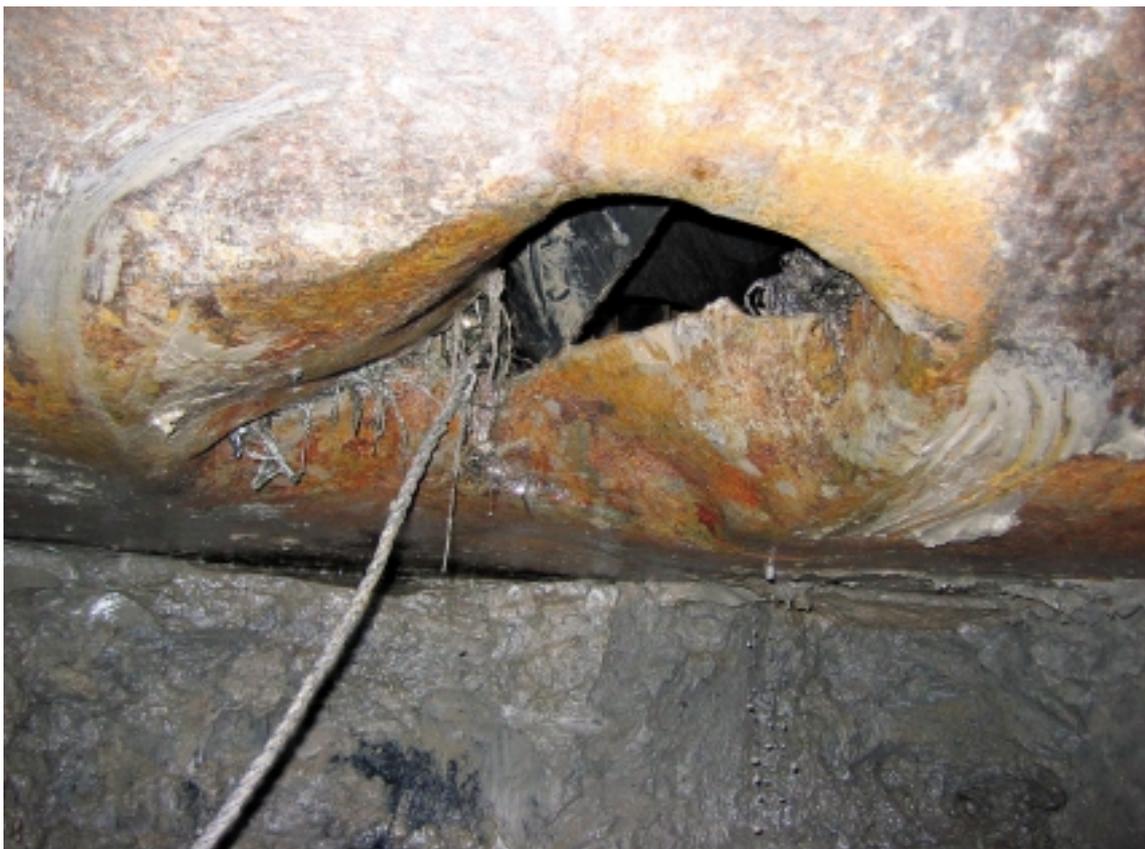
Several days later, the vessel was salvaged and moved to a drying out berth. There, an examination discovered a gash, 300mm × 450mm, in the otherwise sound single skin shell plating, at the turn of bilge in way of the engine room.

Photograph showing gash in single skin shell plating

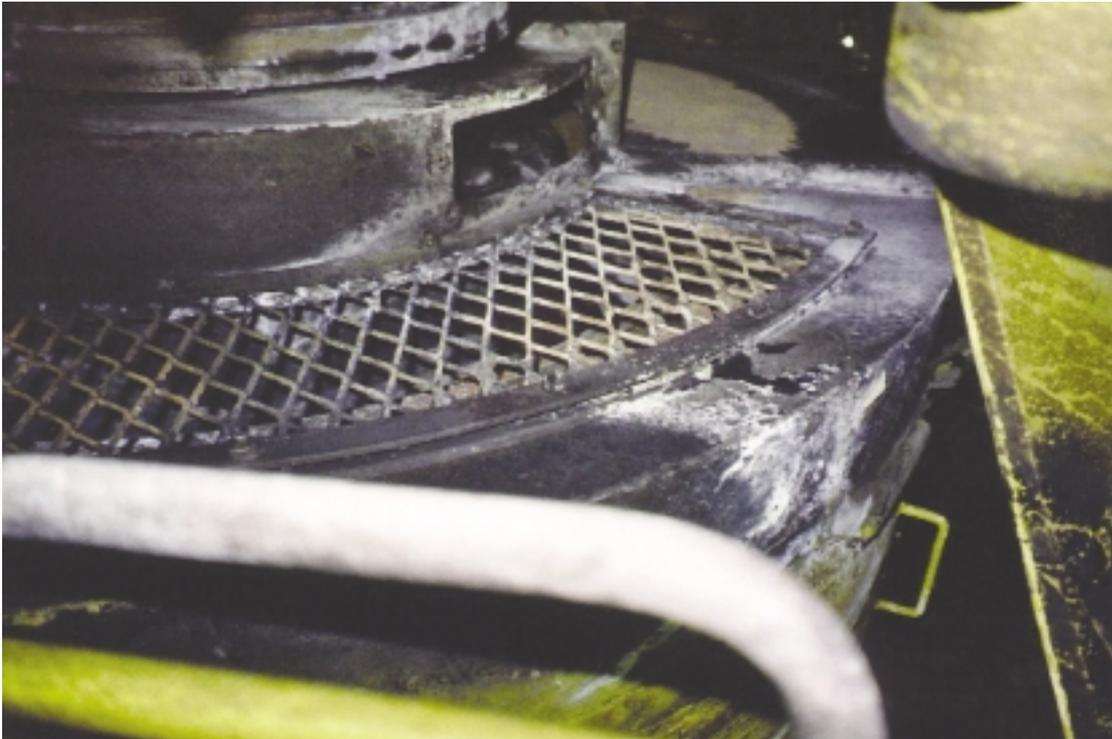
These measures extinguished the fire, and the water fog system in particular knocked down much of the smoke that had been generated. Although the clutch was totally destroyed, the fire had not spread outside the clutch's guard and no other damage was done (see figure).

Photograph showing the burnt out clutch

1. Opening the by-pass valve, however briefly, was an unnecessary operation that, combined with defects in the ball type isolating and vent valves which prevented positive operation, allowed sufficient air to enter the operating bellows of the clutch to cause partial engagement. The lack of clear engine isolating procedures allowed this practice to develop, and the defects in the two ball valves then allowed this extra process to generate an unsafe condition. Maintenance of the isolating and vent valves clearly needs attention, but clutch isolating methods need also to be clearly set out.
2. Fortunately, the engine's turning gear was engaged, effectively preventing the engine from being turned at speed by its running partner, and nobody had yet started work on the engine.

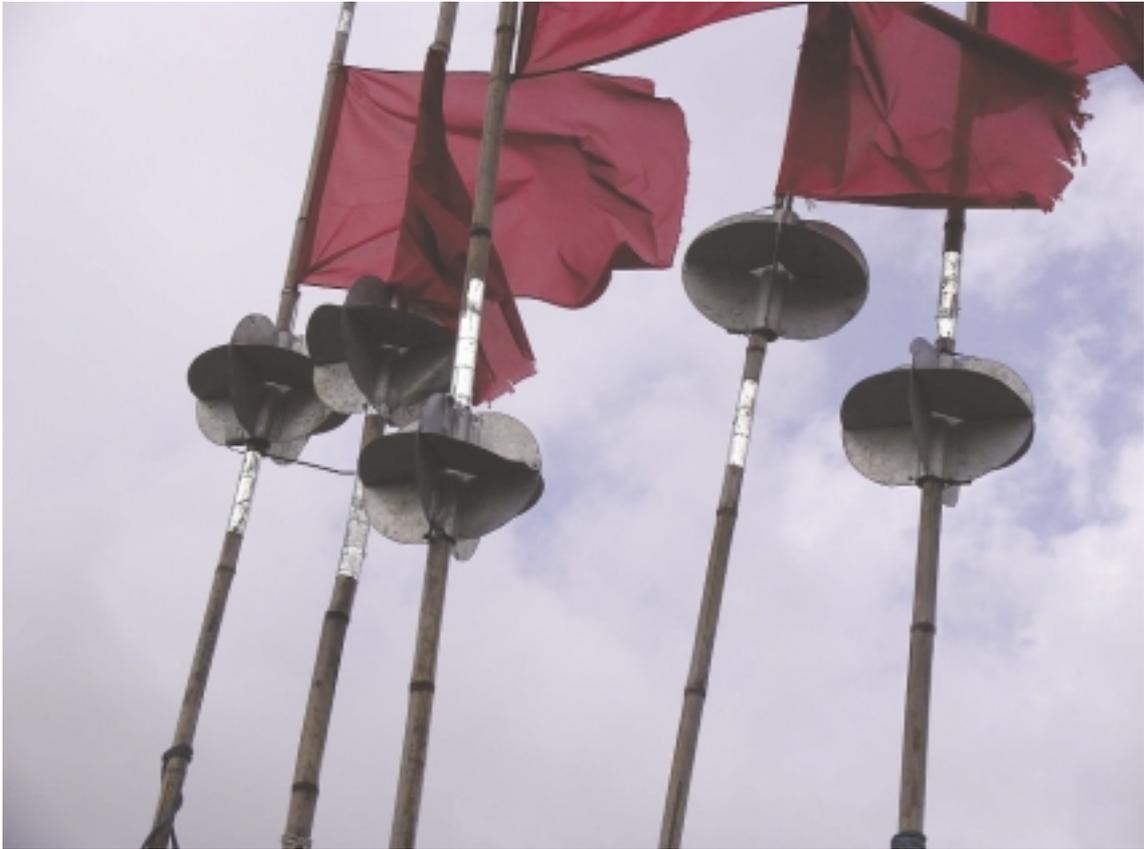
The fishing vessel had not been sighted visually or by radar, despite being painted bright yellow and having a radar reflector on her mast and fishing float radar reflectors in her rigging.

Fishing float radar reflectors

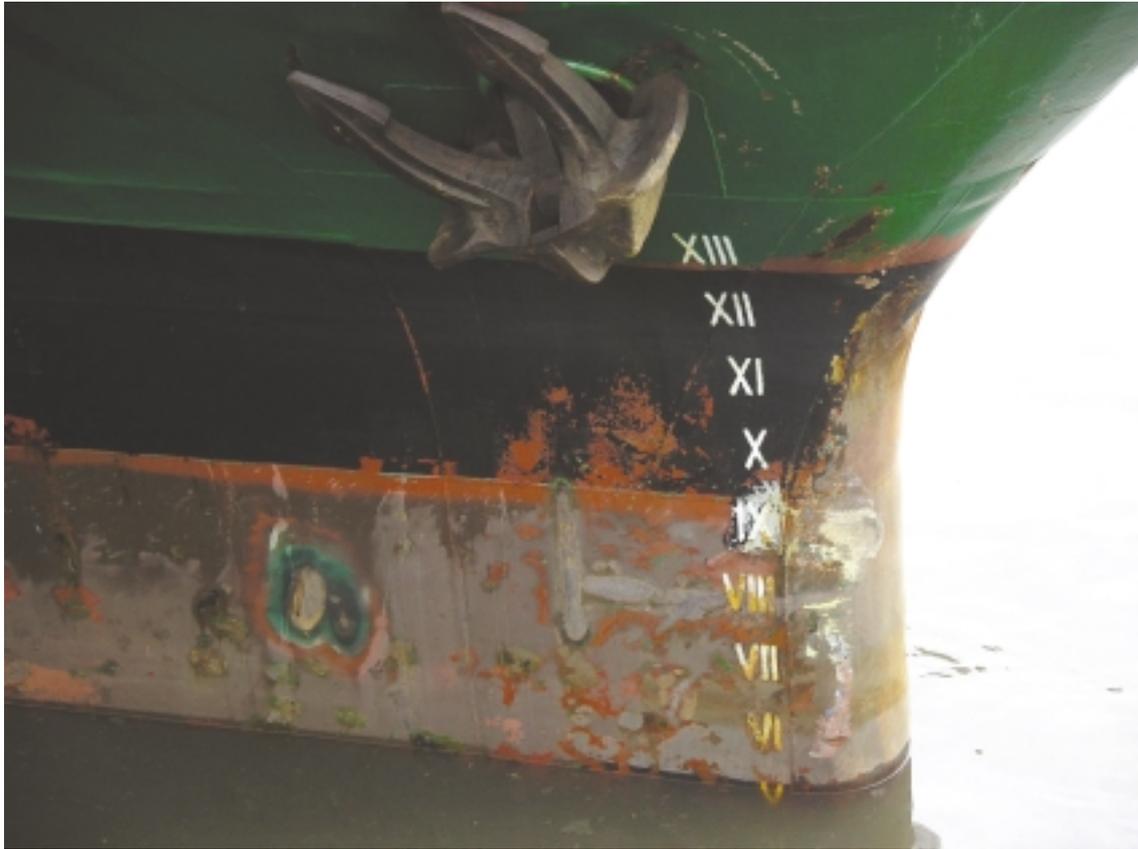
Damage to cargo vessel

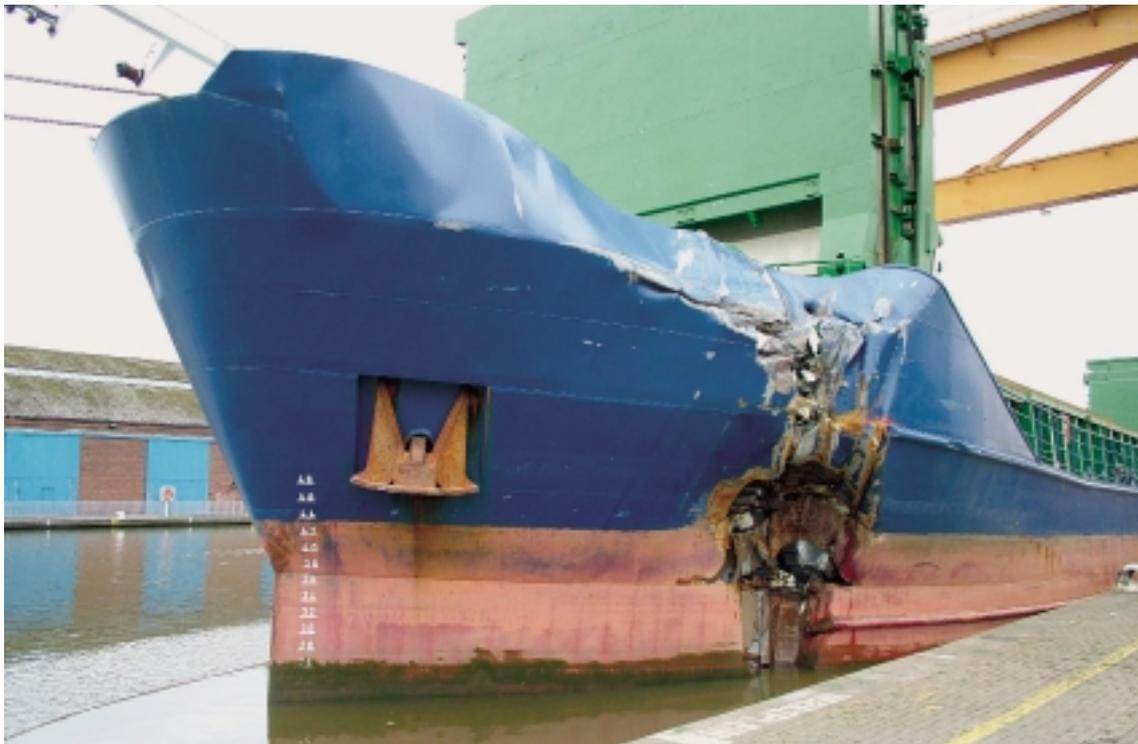
Damaged vessel

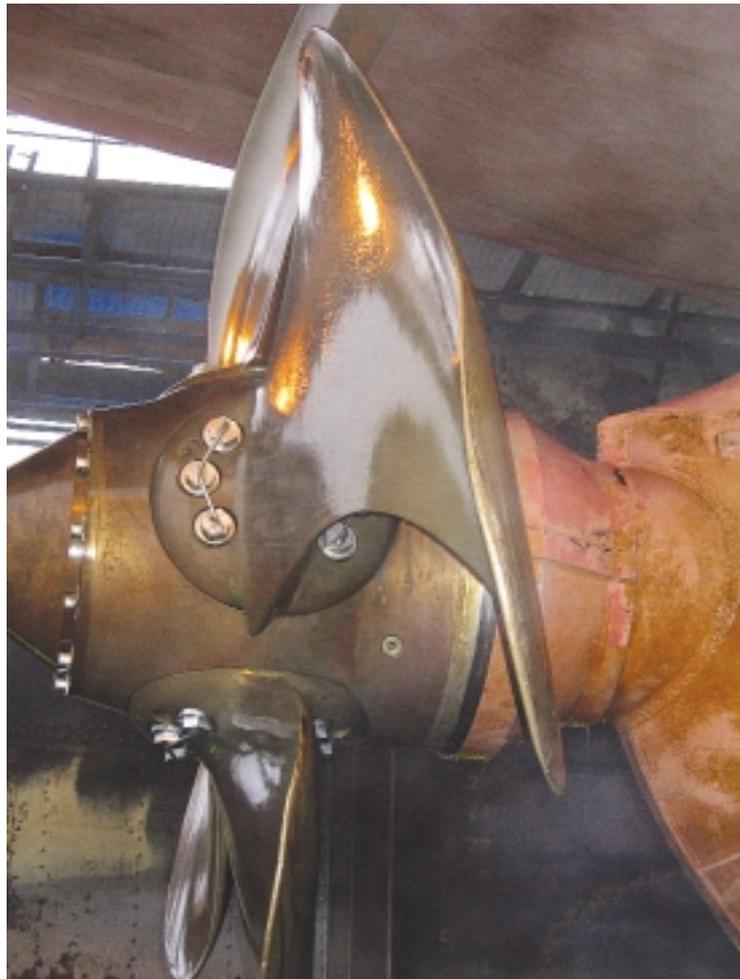
Distorted propeller blades

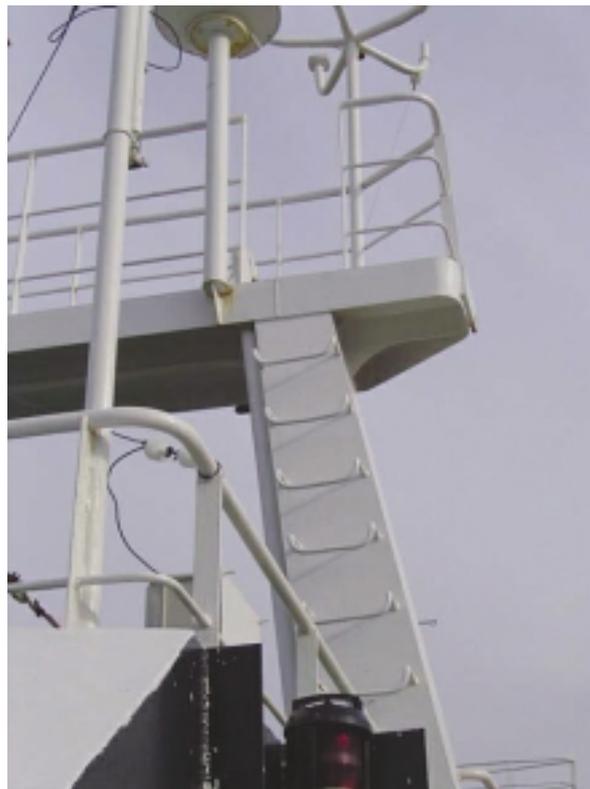
Figure 2: Port ladder and access showing unguarded gap

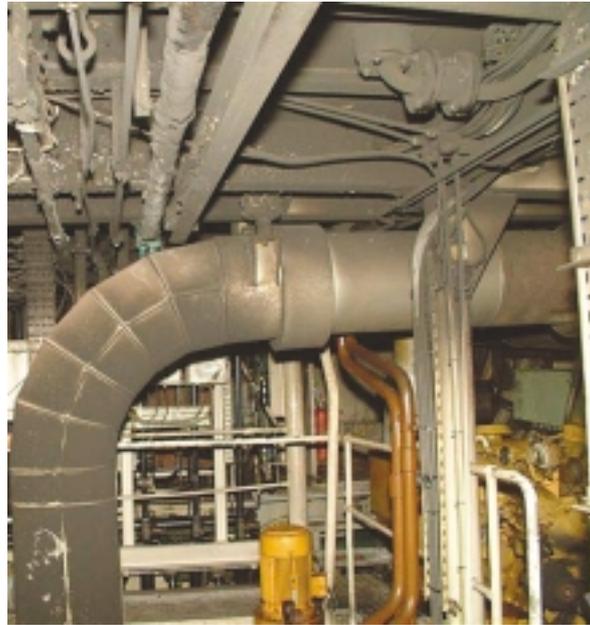
General smoke damage

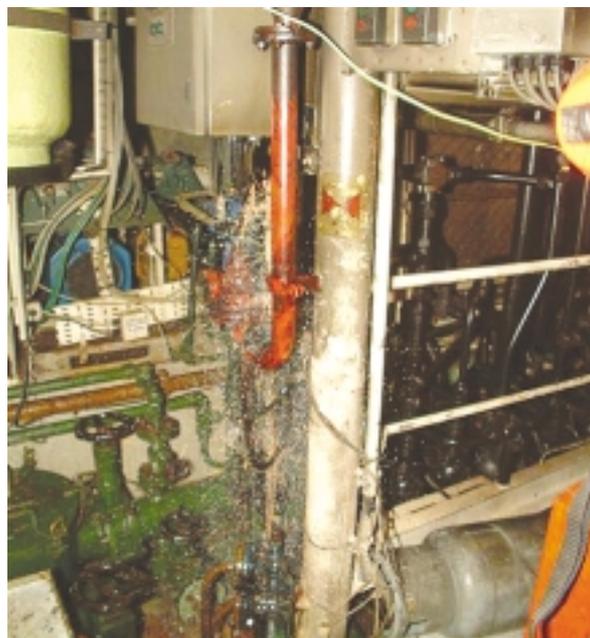
Replicated fuel leakage from main engine duplex fuel filters

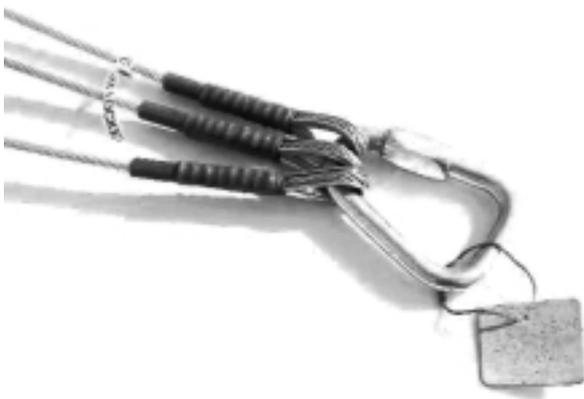
Figure 1: Lifting strop – crane hook eye

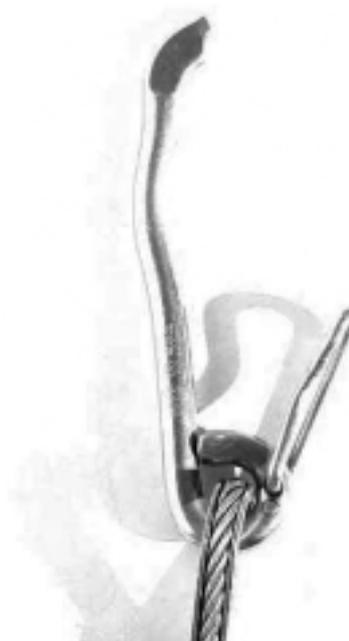
Figure 3: Failed shackle

The crane and lifting strop arrangement were all in date for test. However, the combined weight of the tender and the coxswain put the arrangement close to its Safe Working Load (SWL). The situation was likely to have been further exacerbated by wash from other vessels causing the tender to “snatch” at the strop and probably prompting the deformation process.

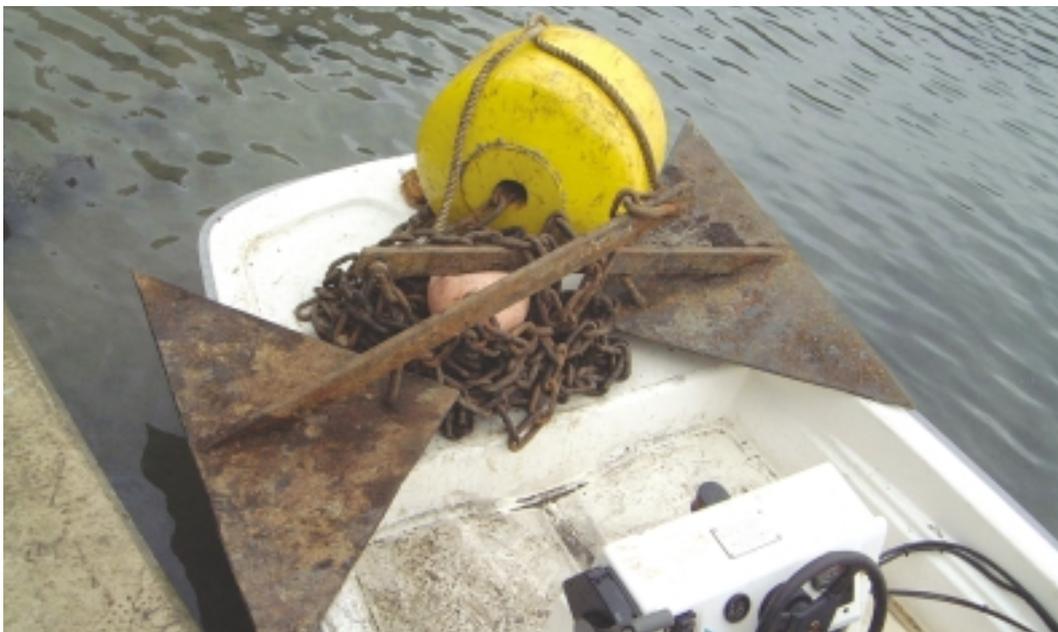
The outboard motor on the dory had failed on a number of occasions in the past and, based on its condition after the accident, it is likely that it failed as the dory was crossing the mouth of the estuary. The vessel would have been swept out into rougher water very quickly and foundered. The position in which the dory and the mooring (which was recovered from the seabed) were subsequently found supports this scenario, although it will never be known exactly what happened.

Photograph showing the mooring placed on the bow of the dory
